# Continental Motors

## ENGINE EXAMINATION REPORT

| ENGINE MODEL | IO-520-M1B |
| AIRCRAFT MAKE & MODEL | Cessna 310R |

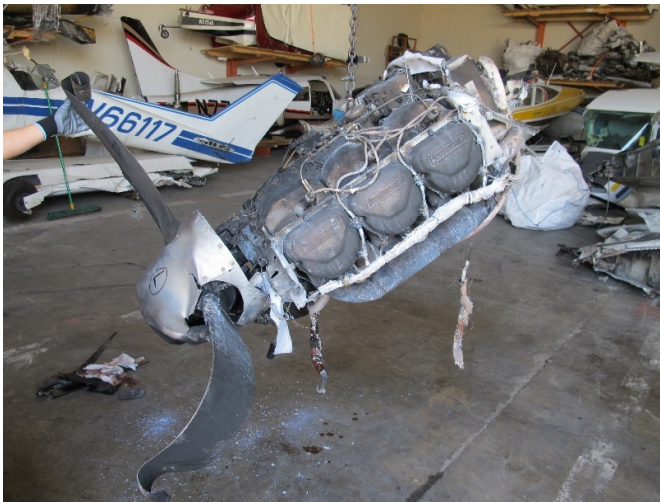
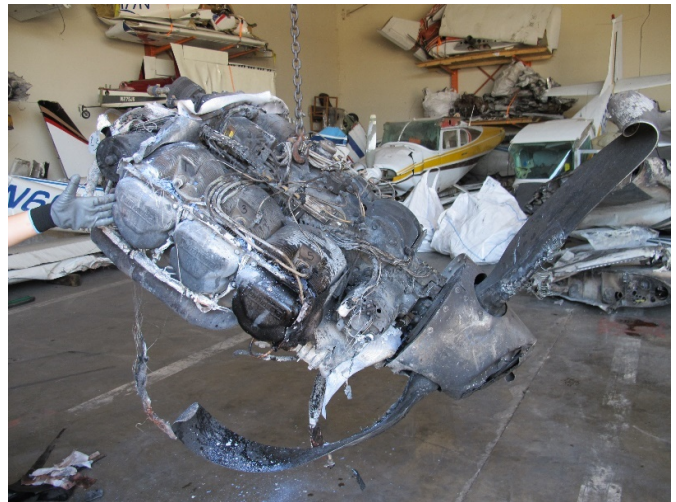
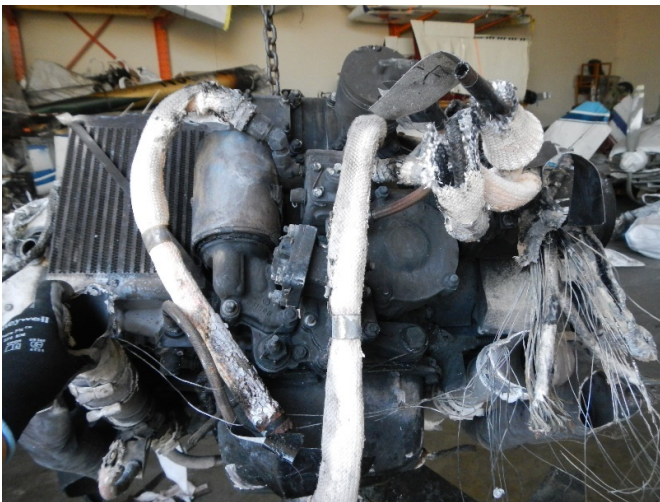
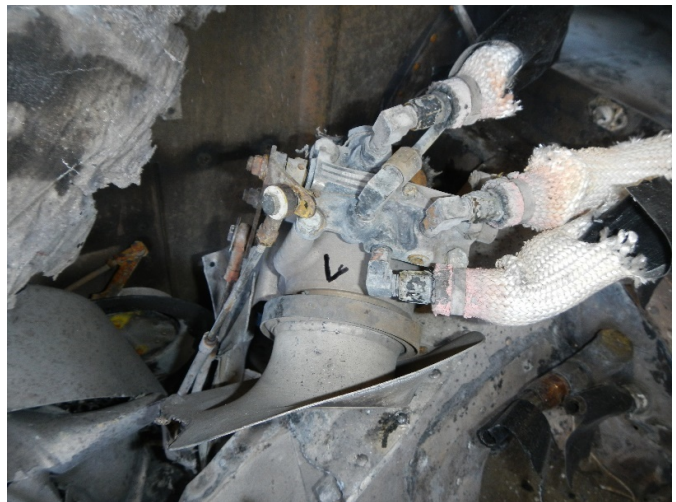
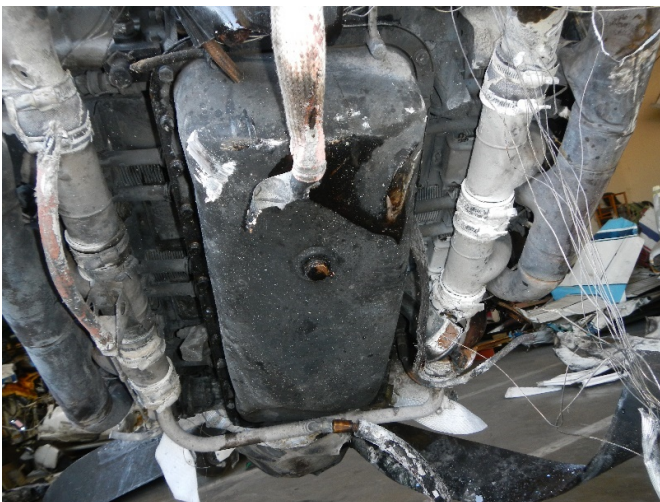
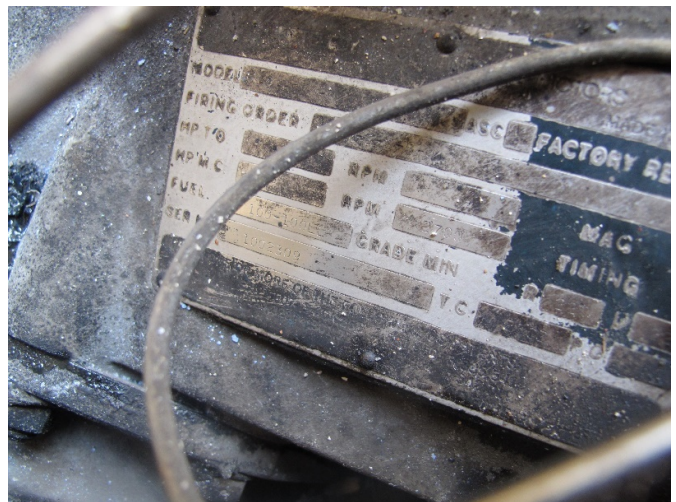
The engine was soot covered and the cooling baffle, fuel lines, and ignition leads were thermally damaged. All engine mounts were fractured and according to the aircraft recovery personnel, the fuel lines were the only items securing the engine to the airframe.

The throttle body/fuel metering unit was separated from the wye plenum and remained attached to the nacelle via the throttle and mixture control cables. The fuel pump remained attached to the backside of the engine and all of the fuel lines remained attached to their respective fittings; however, the inlet fitting was fractured at the housing. The fuel manifold valve and fuel injector nozzles remained attached to the engine and their respective cylinders.

The magnetos remained attached to the topside of the engine with the burnt remains of the ignition harness in place between the magnetos and sparkplugs.

No external anomalies were noted with the engine or the engine-related systems.

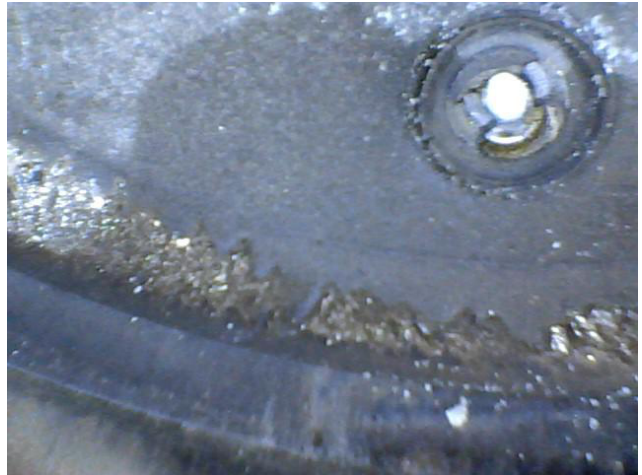
1T

Condition: The sparkplugs remained secured to their respective cylinder and each ignition terminal remained attached to its sparkplug. The top sparkplugs were removed from the cylinders and each displayed a normal worn condition with no evidence of carbon or lead fouling. The bottom sparkplugs were examined/photographed via lighted borescope.

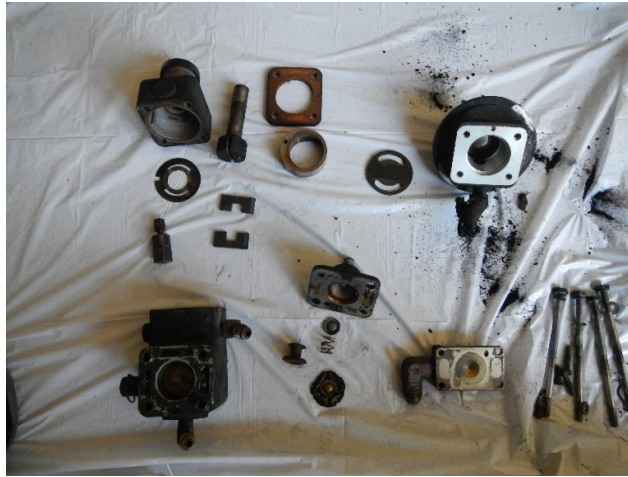
**Condition:** The engine-driven fuel pump remained secured to the backside of the engine and all of the fuel lines remained secured to their respective fittings, though the fuel inlet fitting was fractured. The pump was removed and the drive coupling was intact. The pump could not be functionally tested due to the thermal damage, but disassembly revealed that the pump vanes were intact and no pre-accident anomalies were observed with the pump's internal components.

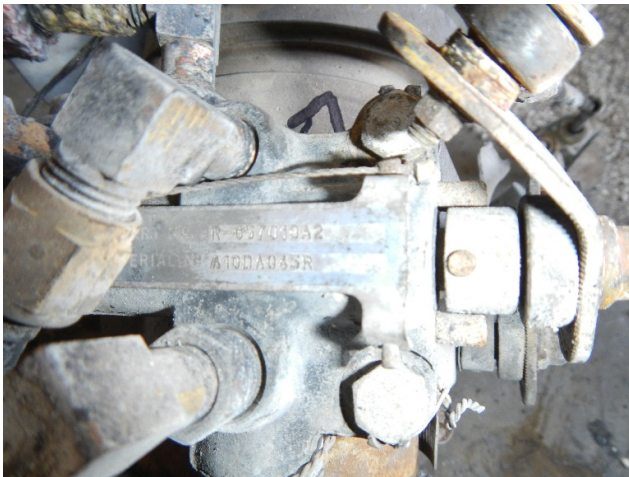
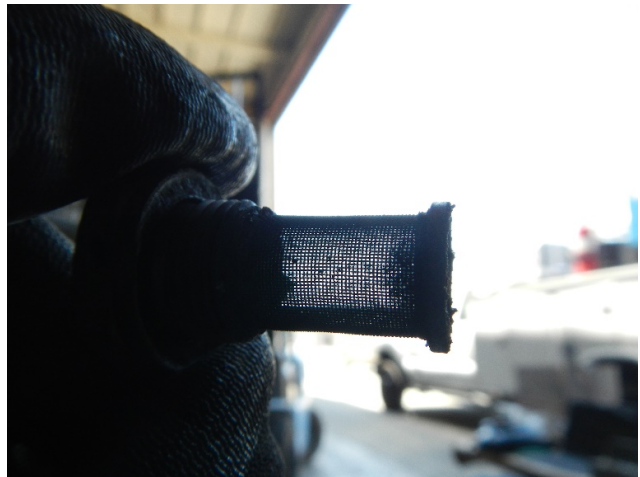
Condition: The throttle body/fuel metering unit was separated from the wye plenum and remained secured to the engine nacelle via the throttle and mixture control cables. The fuel lines leading to and from the fuel metering unit remained secured to their respective fittings, though the lines were cut by recovery personnel. The mixture control lever was bent however, manual manipulation of the mixture and throttle control levers resulted in a coinciding movement in their control cams. The fuel inlet screen was removed and no obstructions were observed.

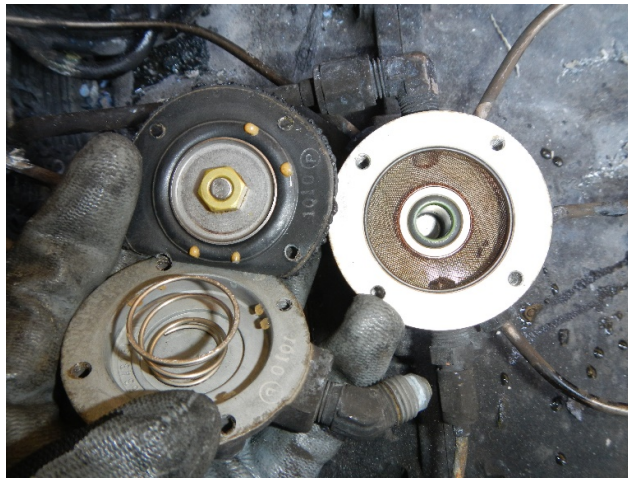
**Condition:** The fuel manifold valve remained secured to the topside of the engine and all lines to and from the manifold valve remained secured in place. The manifold valve was thermally damaged and re-solidified resin from the diaphragm was beaded up around the housing and the cap. The cap was removed and the diaphragm was intact and the plunger was in place. The screen was clear and there was a small amount of burnt debris noted behind the screen.

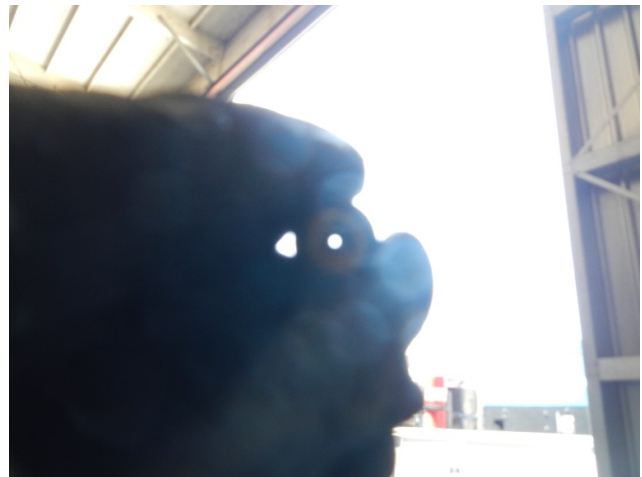
3

Condition: The fuel injector nozzles remained secured to their respective cylinders and the fuel injection lines remained intact. The nozzles were removed and there were no obstructions or blockages noted in any of the nozzles.

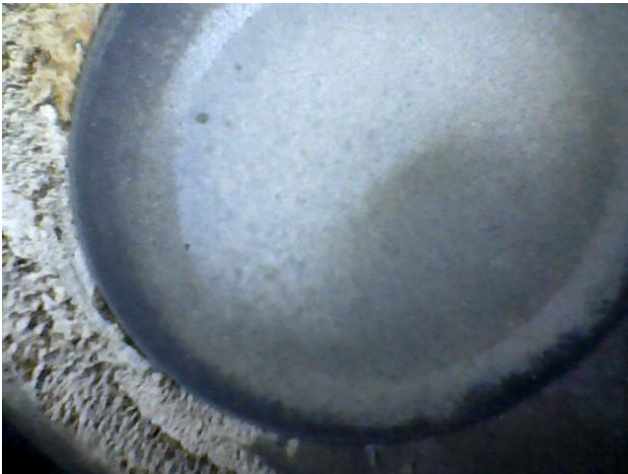
### CYLINDER #2

Condition: The cylinder remained attached to the engine and the original torque putty appeared to be intact on the attaching hardware (the serial number matched that on the build record). The cylinder was soot covered with no other signs of pre-accident anomalies. The rocker cover was removed and no pre-accident anomalies were observed with the rockers or valve springs. A borescope inspection of the cylinder's internal components did not reveal any pre-accident anomalies with the barrel, piston, valves or valve seats. A thumb compression test resulted in compression and confirmed connecting rod, piston, and rocker arm movement.

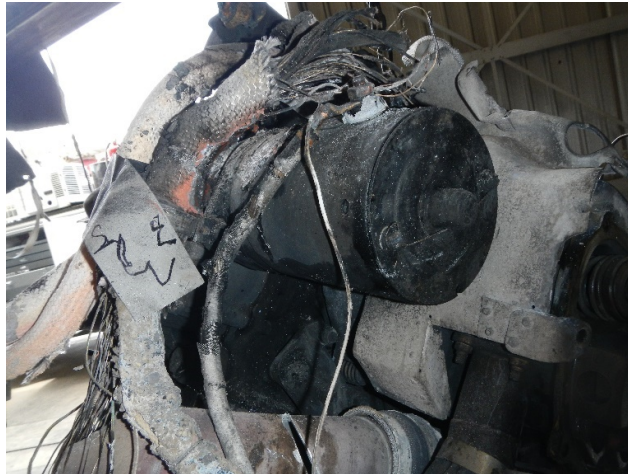
The starter motor remained attached to the adapter with no pre-accident anomalies noted.
