# Continental Motors

## ENGINE EXAMINATION REPORT

| FILE NUMBER | 16-698 |

The #3 and #4 connecting rods were fractured and separated from the connecting rod journals. The #4 connecting rod and connecting rod bearings and the crankshaft's #4 connecting rod journal displayed thermal discoloration consistent with oil starvation. The #2 connecting rod bearings also displayed incipient signatures consistent with lubrication distress. The #3 connecting rod and bearing were mechanically damaged. Approximately 2.0 quarts of oil was observed on the oil quantity dipstick following the event. Examination of the engine components and engine-related systems revealed no evidence of a pre-impact oil leak. Additionally, the right turbocharger was missing its turbine wheel and the shaft was fractured outboard of the turbine piston ring. The bearings displayed signatures consistent with lubrication interruption. The impeller contacted the inlet housing and the impeller blades displayed distortion in the opposite direction of rotation. Review of recorded engine data revealed that the oil pressure displayed a fluctuation followed by a steady reduction.

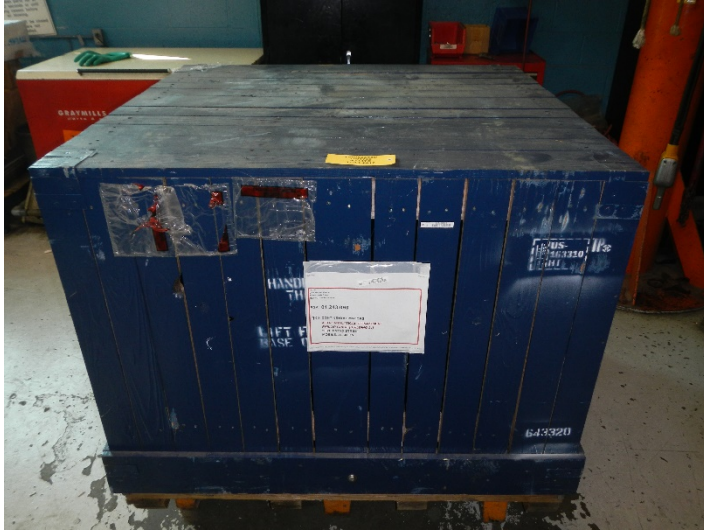
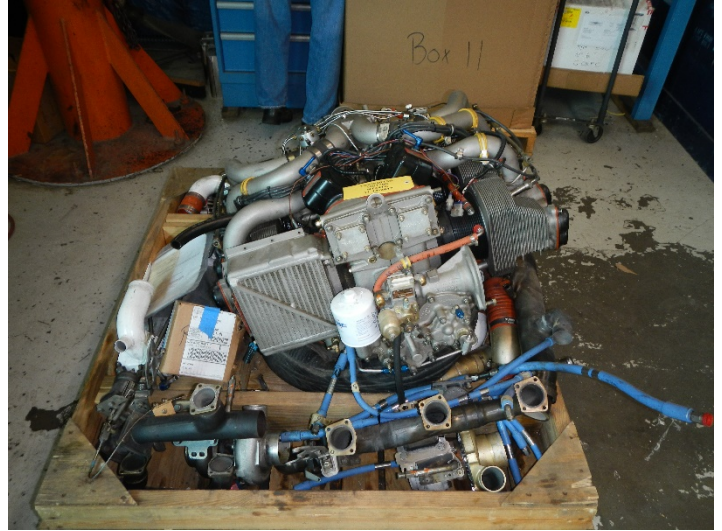
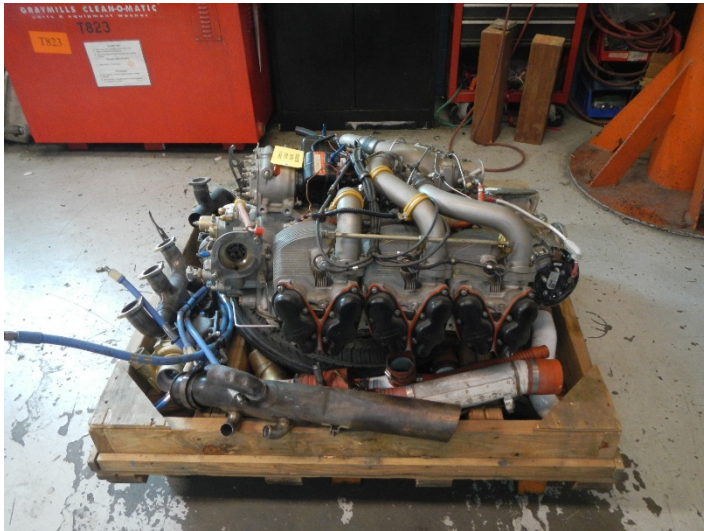
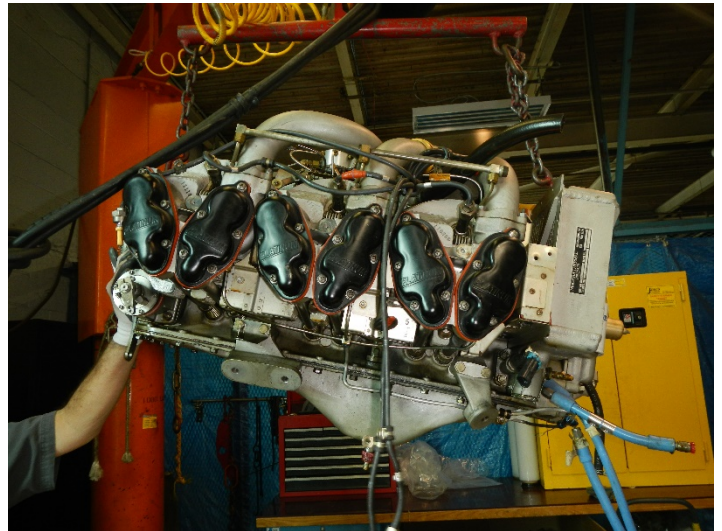
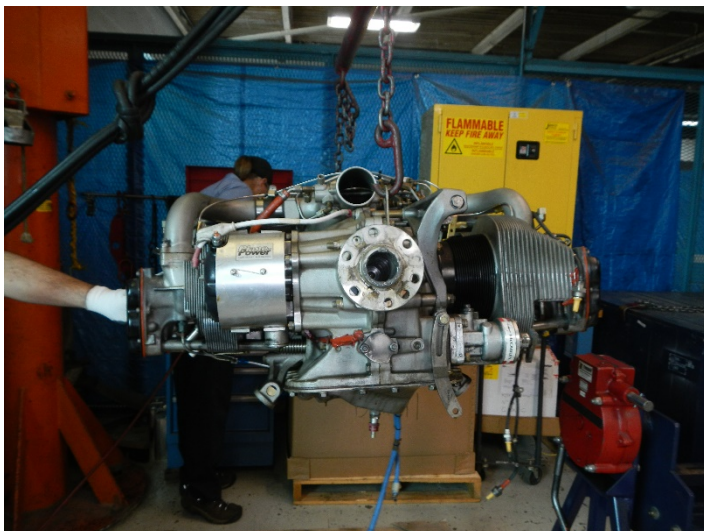
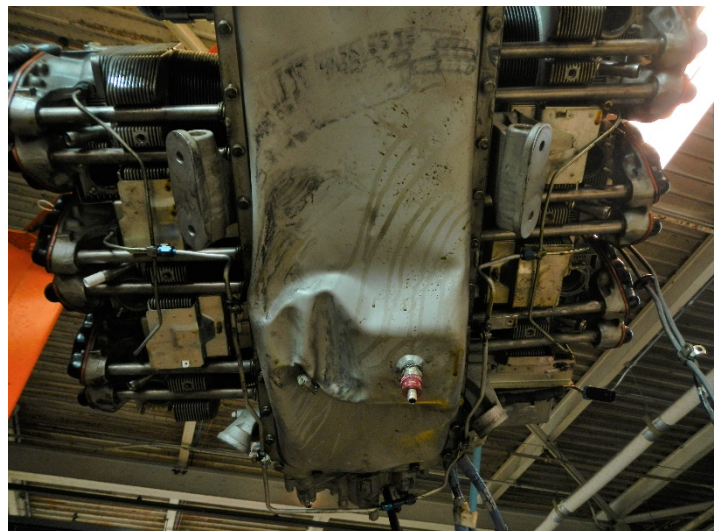
The engine was shipped to the factory with all the turbocharger components removed and placed in the crate, including the exhaust system. The top of the crankcase below the induction plenum displayed large holes in the vicinity of the #3 and #4 cylinders. The right turbocharger turbine wheel was missing.

External examination of the attached components did not reveal any signatures of a pre-existing oil leak. The engine was examined/documentated prior to its removal from the airframe. Review of the photographs taken during that prior examination did not reveal any signs of a pre-existing oil leak.

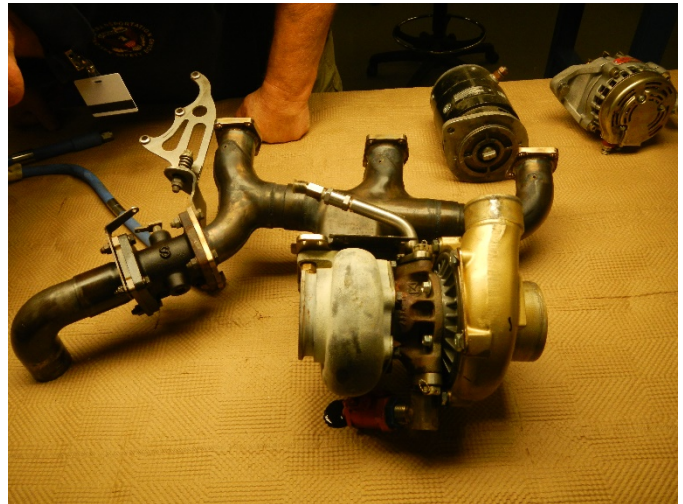
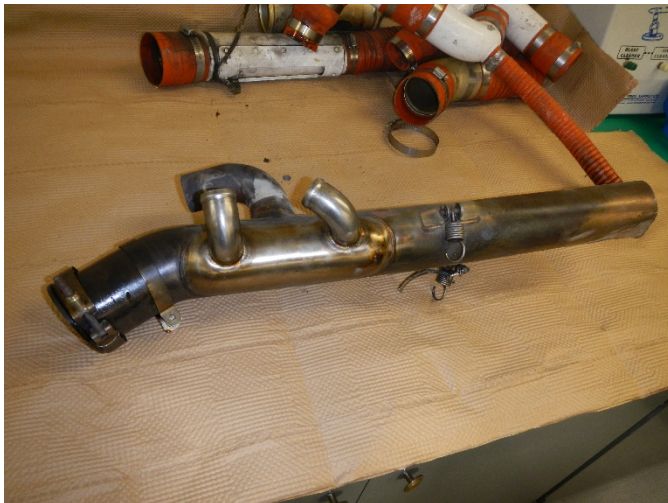
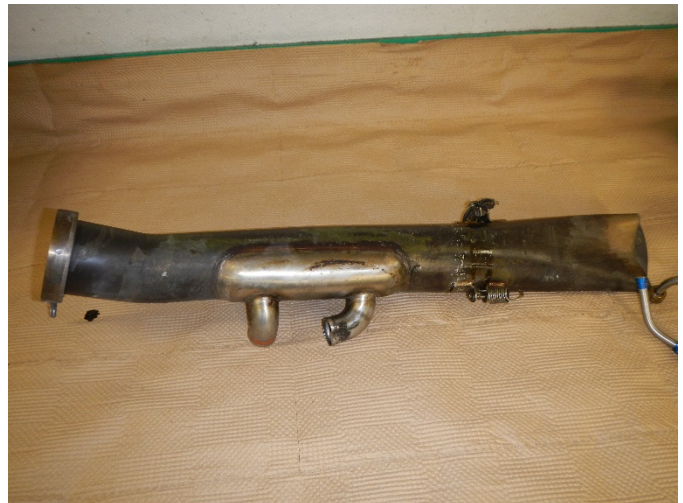
Right

Condition: The exhaust system was removed from the engine prior to shipment. There were no pre-impact anomalies noted with the exhaust risers or manifolds. The right side exhaust pipe was flattened at the exhaust end. The inside of the tailpipes were inspected using a lighted borescope. The right tailpipe displayed areas of circumferential scoring and gouging consistent with high rotational speed mechanical contact.

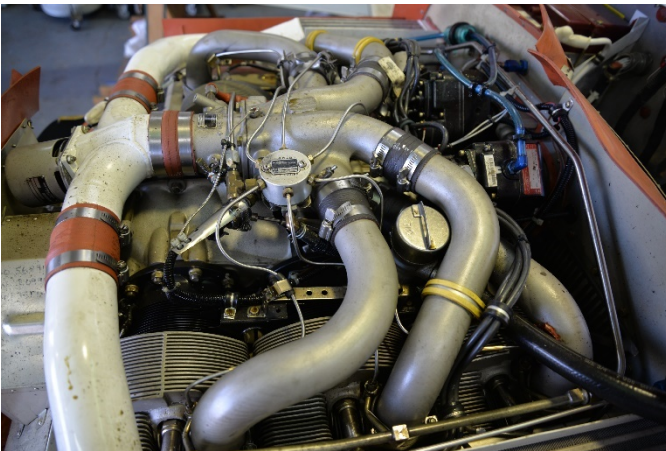
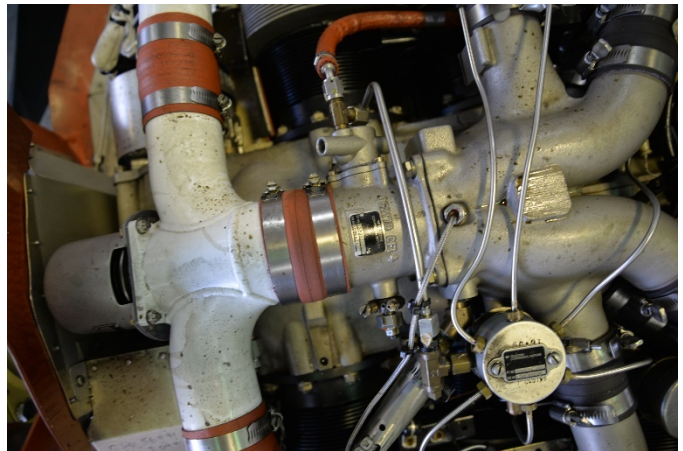
**Condition:** The throttle body, intake plenum, and intake tubes remained in place on the engine. The intake tubes and intercoolers were removed prior to shipping. There were no pre-accident anomalies noted with the intake system components. Photographs of the engine while it was installed in the airframe revealed oil splatter on the intake system components, consistent with the liberation of the connecting rods from the crankcase.

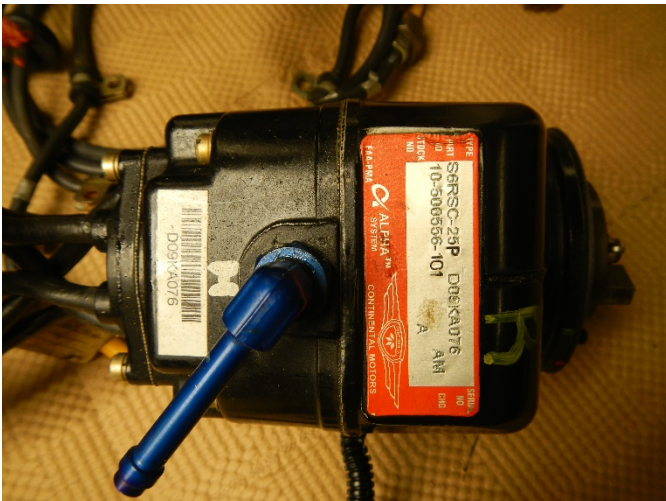
| RIGHT MAGNETO | Manufacturer: Continental Motors S6RSC-25P | P/N: 10-500556-101 | S/N: D09KA076 |
|---|---|---|---|
| Condition: | The magneto remained secured to the topside of the engine with no pre-accident anomalies noted. The ignition harness remained in place. The magneto, with the harness still attached, was removed and placed on a test stand. The magneto was functionally tested through various speeds and it produced a spark across a 7-mm gap in firing order. No pre-accident anomalies were noted with the unit. | | |

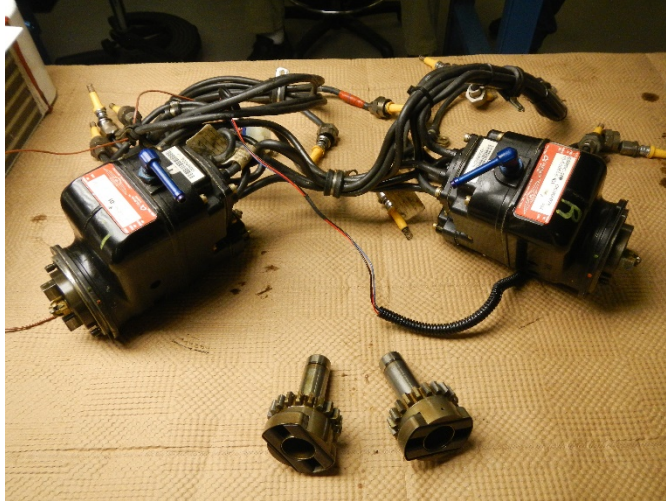
**Condition:** The ignition harness remained secured to the magnetos and each terminal remained secured to its respective sparkplug. The harness was used during the functional testing of the magnetos and no pre-accident anomalies were noted.

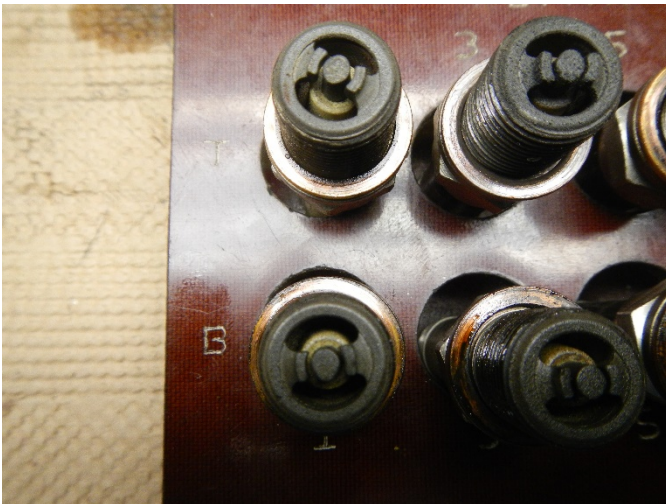
1 Top & Bottom

**Condition:** The sparkplugs displayed a normal worn condition with no signs of lead or carbon fouling. The #4 bottom sparkplug contained debris that was consistent with loose combustion deposits. No pre-accident anomalies were noted.

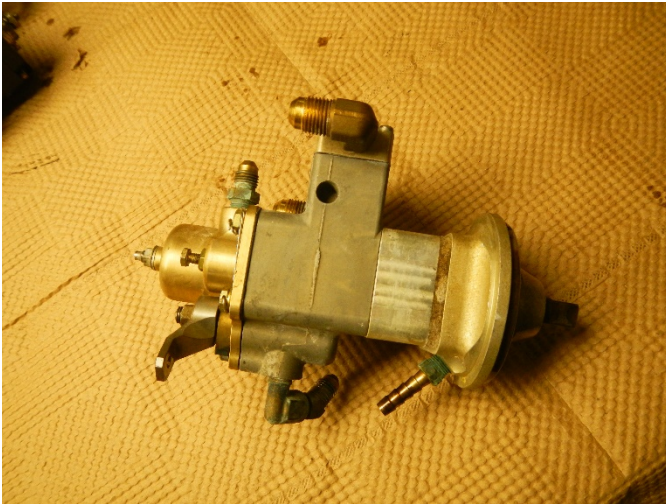
The fuel pump remained secured to the backside of the engine and the fuel lines remained in place. The fuel pump was placed on a production test stand and run through various test parameters for an equivalent pump model. Since it was a modified pump for an STC-modified engine, it did not meet Continental Motors production specifications throughout the entire test range. However, the pump was functional with no pre-accident anomalies noted. A leak was observed at the diaphragm area, but no fuel staining was observed on the housing.

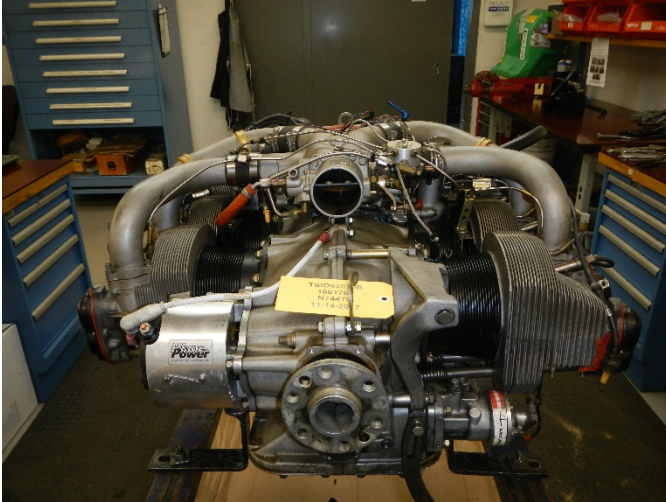
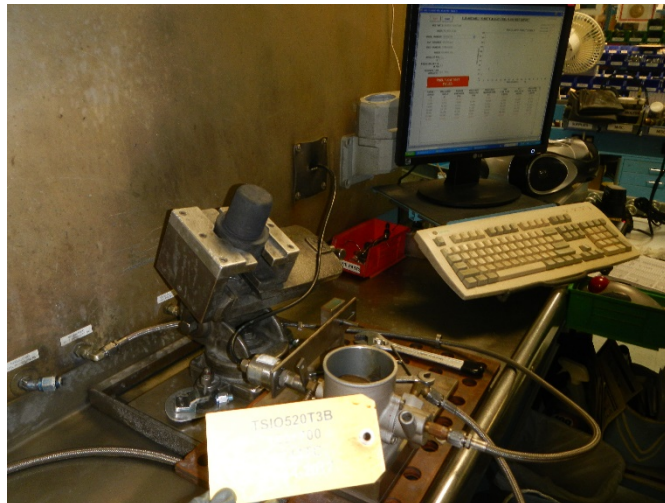
The throttle body remained attached to the topside of the engine with no pre-event anomalies noted. The unit was placed on a production test stand and run through various test parameters for an equivalent pump model. Though the fuel metering unit did not meet all of the specified test specifications, the differences can be attributed to in service adjustments. The throttle body and fuel metering unit proved functional throughout the tested ranges.

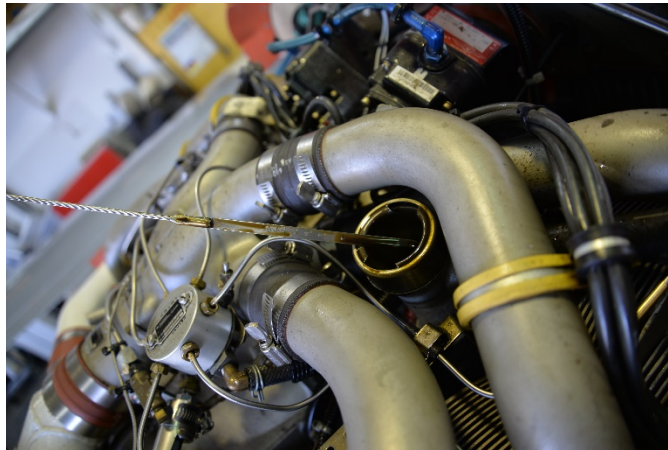
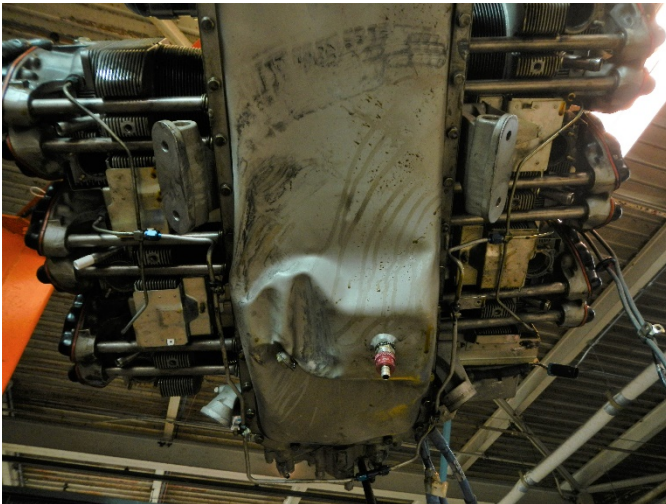
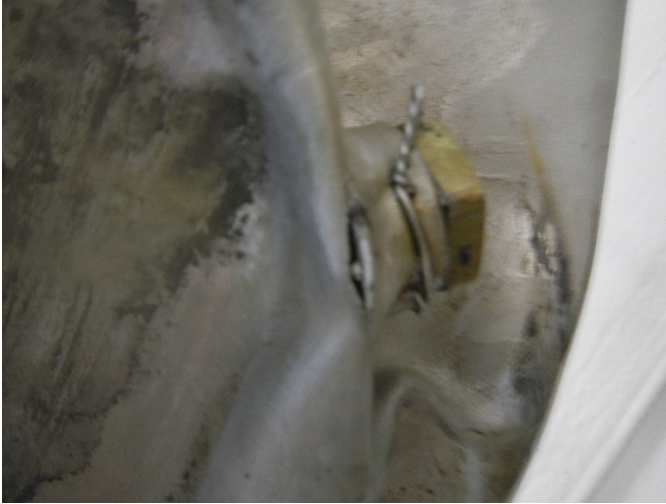
#### OIL SUMP

**Condition:** The oil sump remained intact and attached to the bottom side of the engine, but it displayed a small puncture in an area relating to significant deformation damage. Photographs taken prior to engine removal from the airframe show a little over 2 quarts of oil registered on the oil dipstick. Approximately 1.5 quarts of oil was drained from the sump after it was shipped to the factory. The sump contained fractured crankcase components, lifters, multiple connecting rod pieces, a piston pin, and connecting rod bearings.

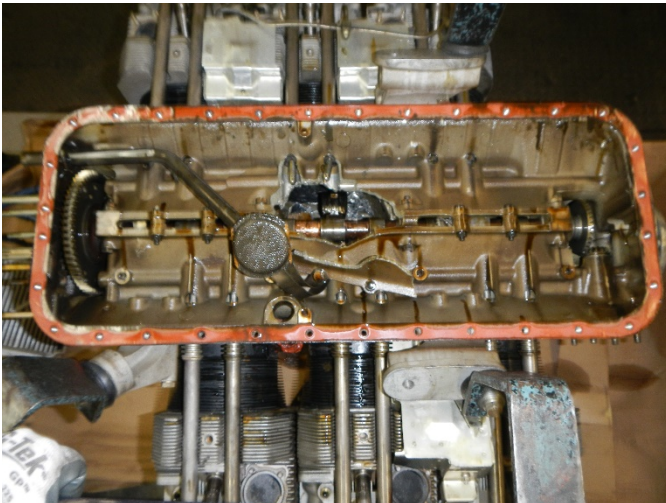
### OIL PICKUP TUBE & SCREEN

The oil pickup tube and screen remained intact, but the tube was deformed like the sump. The screen contained some small metallic particles, but it did not appear blocked.

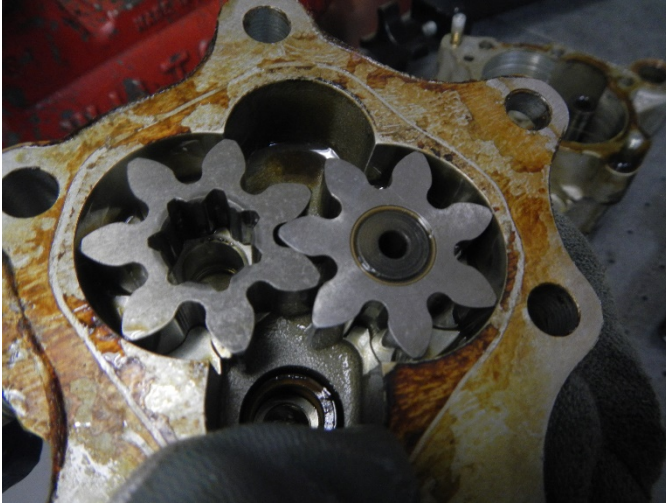
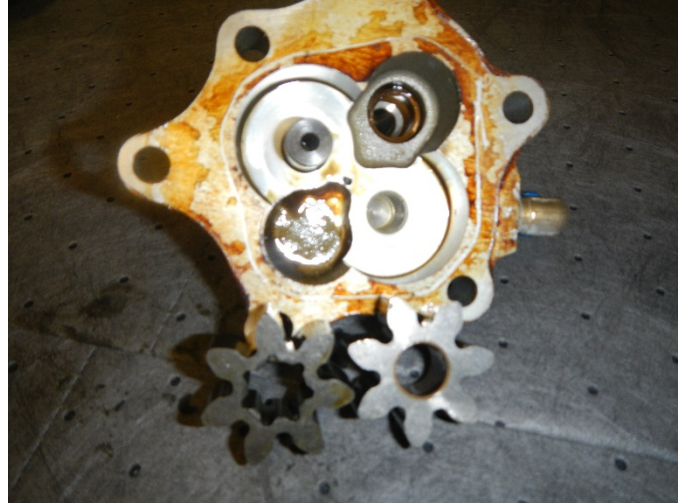
### OIL PUMP

The oil pump remained secured to the backside of the engine with no external anomalies or oil leaks noted. Disassembly of the pump revealed evidence of hard particle passage with circumferential scoring noted on the pump walls. The oil pressure relief valve face displayed some pitting consistent with material between the valve face and valve seat.

The scavenge pump remained secured to the backside of the starter adapter with no external anomalies or oil leaks noted. Disassembly of the scavenge pump revealed residual oil coating all the components with no signs of hard particle passage on any of the scavenge pump components.

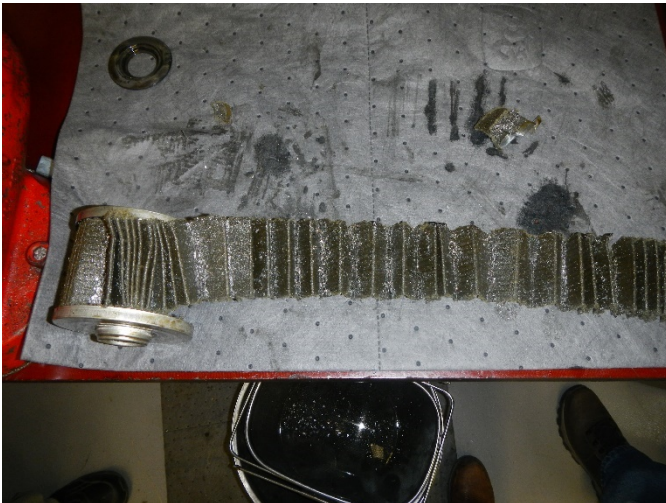
## OIL FILTER

The oil filter remained attached to the adapter and safety-wire secured it in place. There were no signs of pre-event oil leaks. The oil filter was removed and cut open. Metal contaminants were found throughout the filter's pleats.

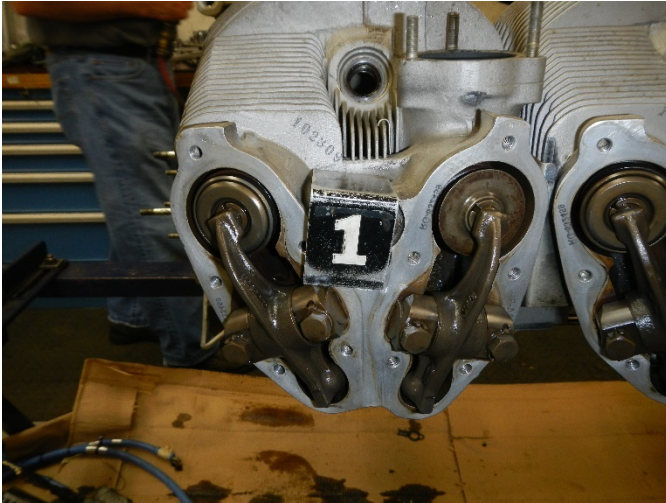
#### CYLINDER #1

Condition: The cylinder remained secured to the engine and the original torque putty was present on the cylinder attaching hardware. There were no pre-accident anomalies noted with the cylinder components.

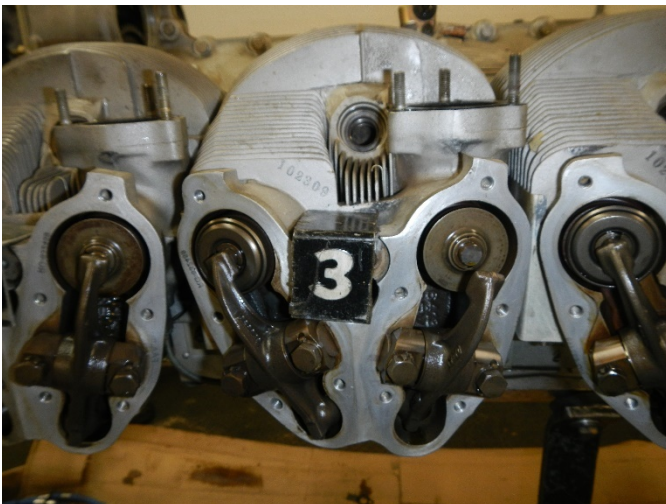
#### CYLINDER #3

Condition: The cylinder remained secured to the engine and the original torque putty was present on the cylinder attaching hardware. The cylinder skirt had to be cut due to mechanical damage that interfered with the crankcase cylinder bay. There were no pre-accident anomalies noted with the cylinder components.

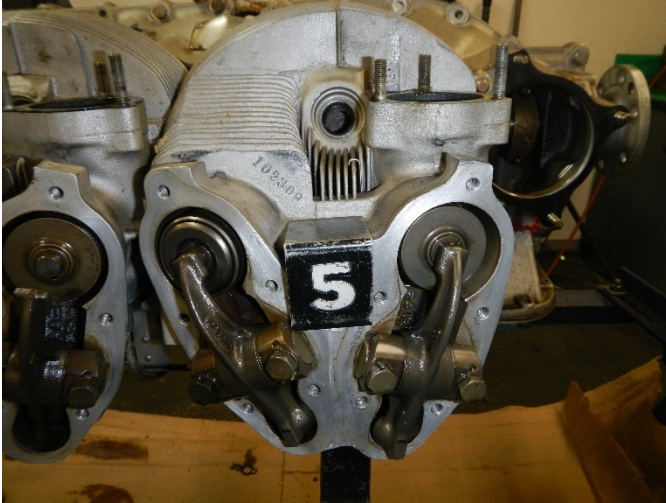
### CYLINDER #5

Condition: The cylinder remained secured to the engine and the original torque putty was present on the cylinder attaching hardware. There were no pre-accident anomalies noted with the cylinder components.

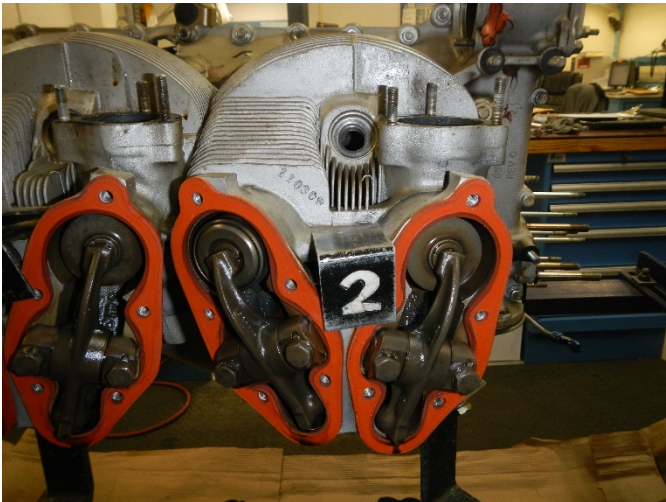
### CYLINDER #2

Condition: The cylinder remained secured to the engine and the original torque putty was present on the cylinder attaching hardware. There were no pre-accident anomalies noted with the cylinder components.

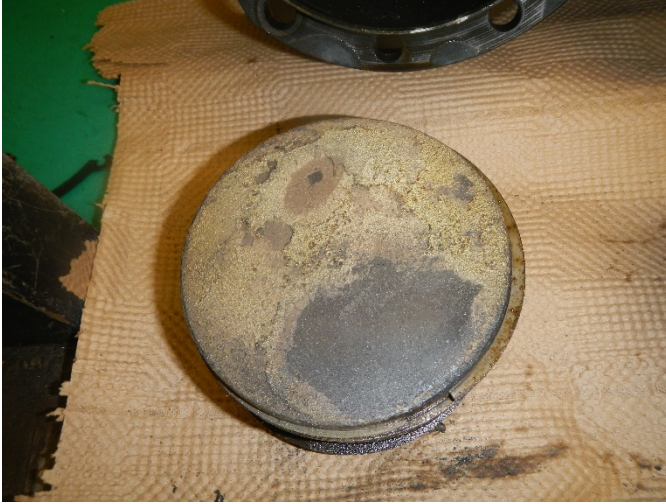
The piston face displayed normal combustion deposits and did not display any signs of pre-accident anomalies. The piston skirt displayed some scoring damage and light mechanical damage was noted.

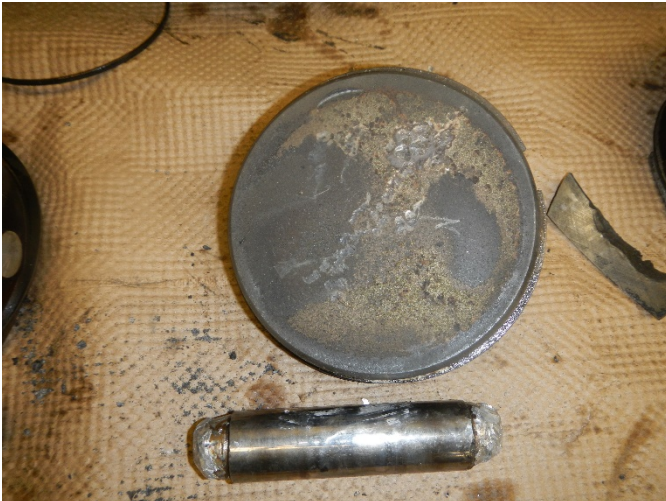
### #3 PISTON, RINGS AND PIN

The piston face displayed two crescent shaped impact marks consistent with a valve strike. However, the face displayed normal combustion deposits with no signs of piston erosion. The piston skirt was fractured below the oil control ring land and the piston pin was separated.

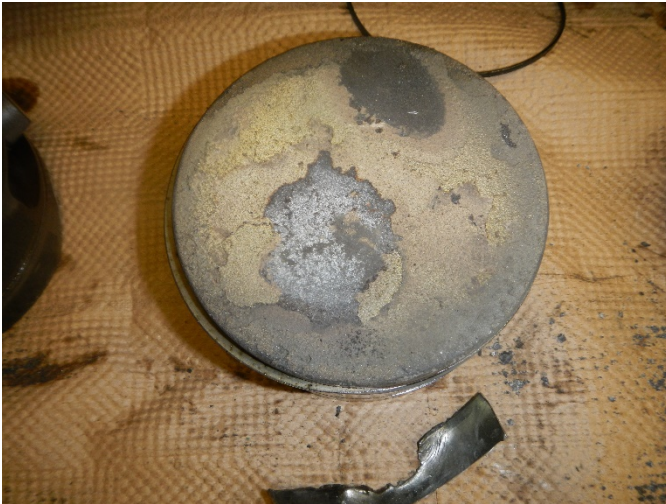
### #2 PISTON, RINGS AND PIN

The piston face displayed normal combustion deposits and did not display any signs of pre-accident anomalies. The piston skirt displayed some scoring damage and light mechanical damage was noted.

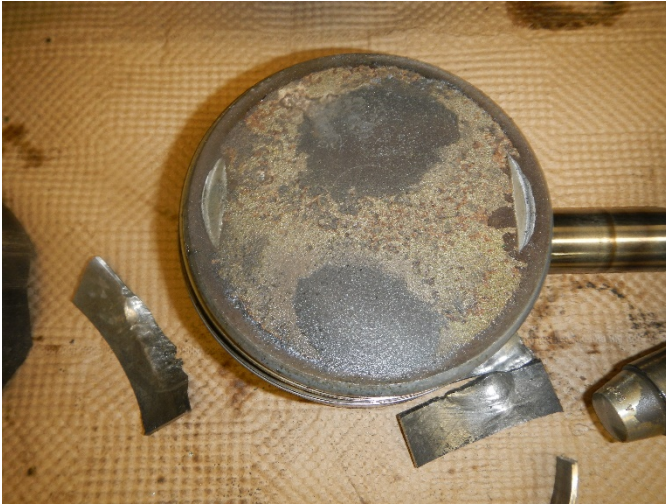
### #4 PISTON, RINGS AND PIN

Condition: The piston face displayed two crescent shaped impact marks consistent with a valve strike. However, the face displayed normal combustion deposits with no signs of piston erosion. The piston skirt was fractured below the oil scraper ring and the piston pin boss was mechanically damaged. The fractured connecting rod remained attached to the piston pin.

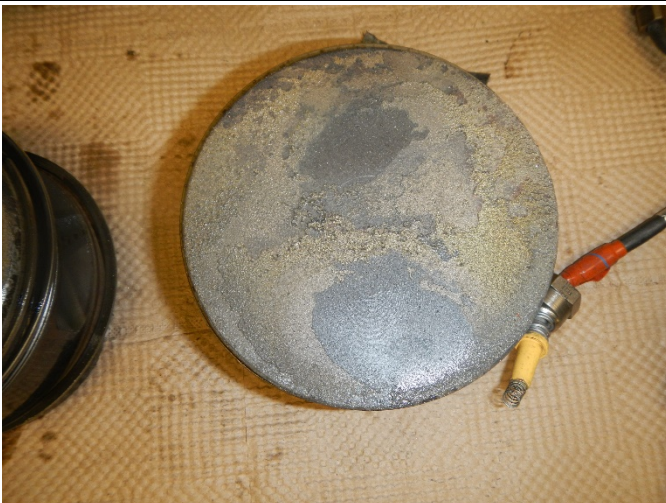
### #6 PISTON, RINGS AND PIN

Condition: The piston face displayed normal combustion deposits and did not display any signs of pre-accident anomalies. The piston skirt displayed some scoring damage and light mechanical damage was noted.

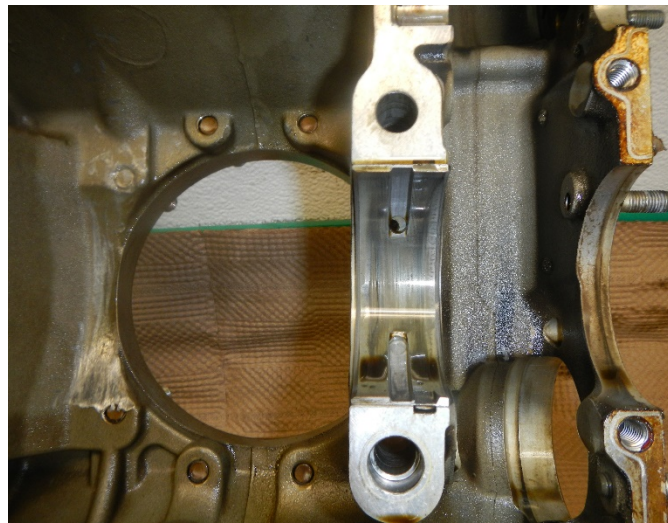
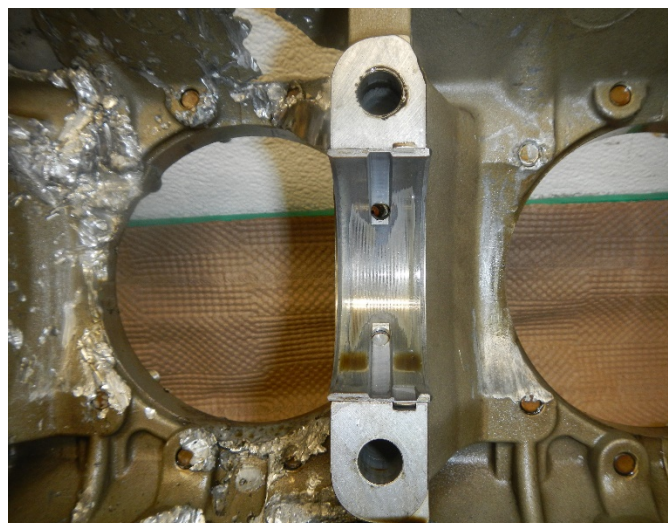
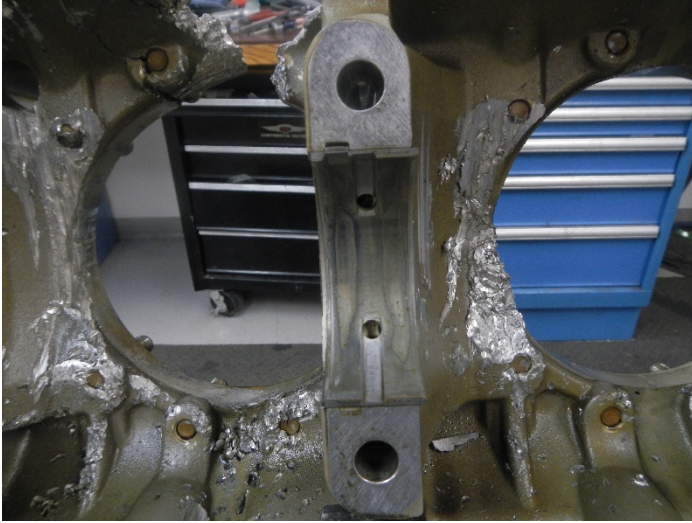
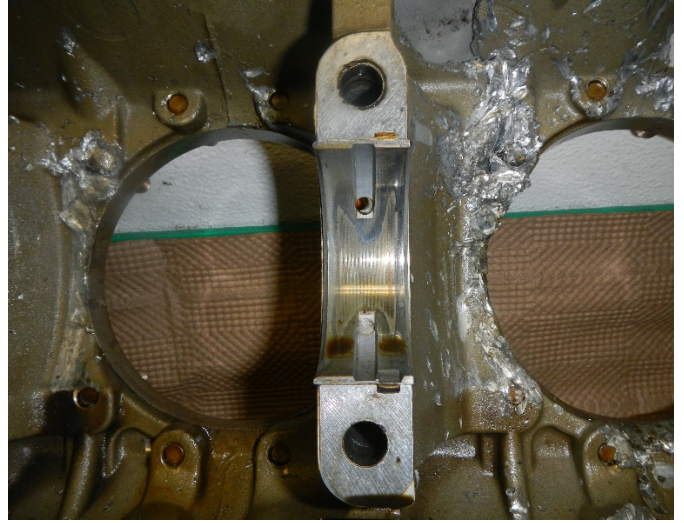
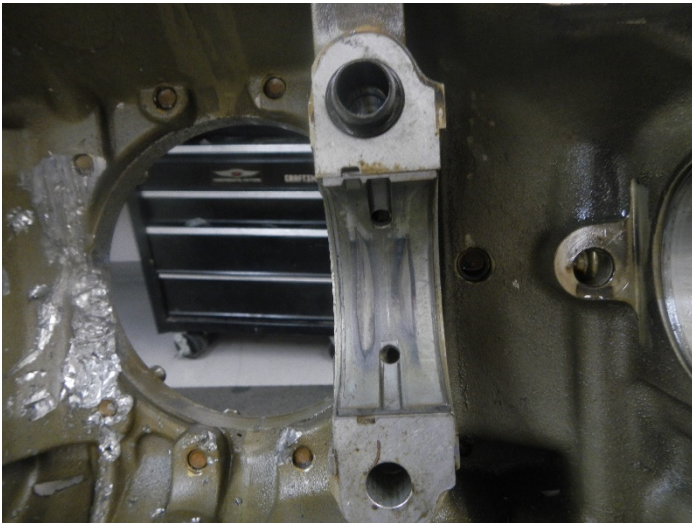
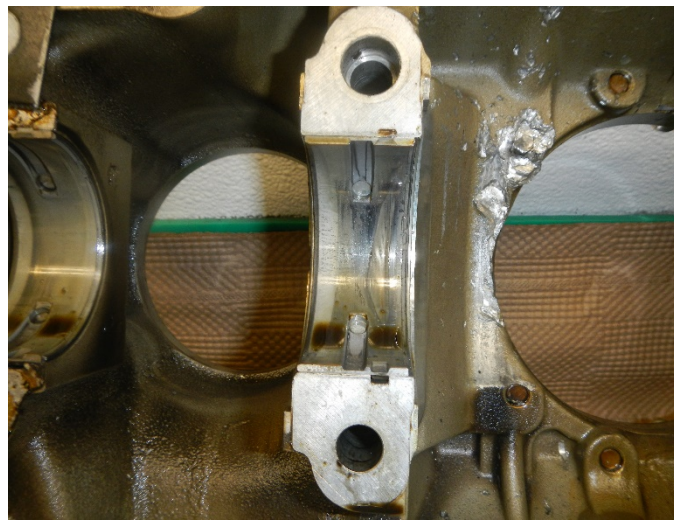
The main bearings remained in place with no signs of pre-event anomalies noted. The photographs below depict the left and right bearing halves from 1 through 5.

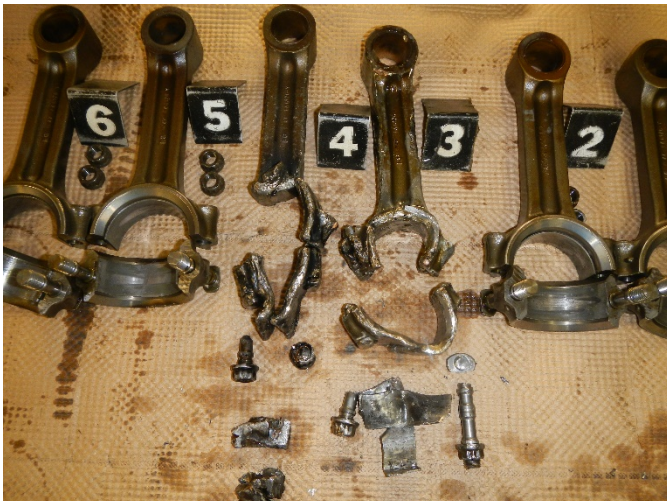
**Condition:** The thermally discolored remains of the bearing were found in the oil sump. The pieces were discolored black and sustained significant distortion and fragmentation. The oil passage to the bearing was clear.

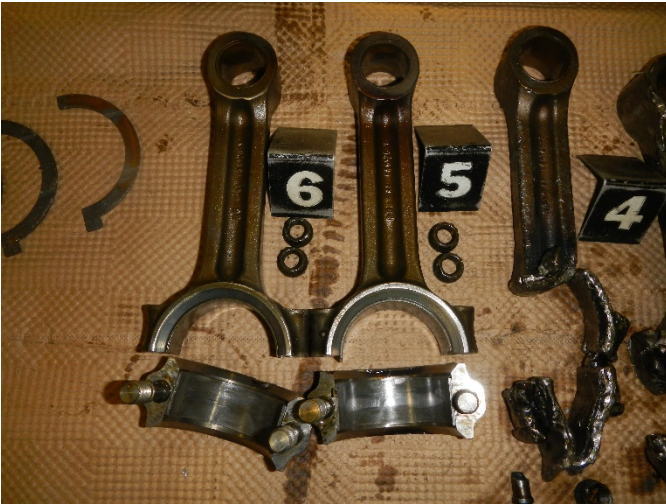
## #6 CONNECTING ROD

The connecting rod displayed mechanical damage to its rod cap, but the rod remained intact and attached to the crankshaft.

The bearing remained in place with no sign of thermal discoloration.

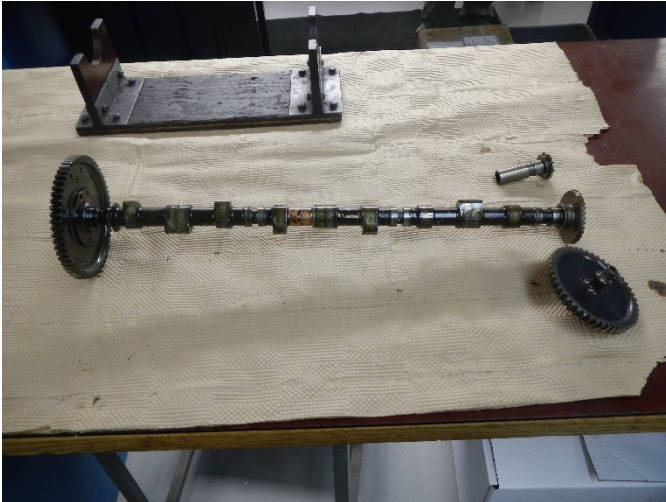
The camshaft sustained mechanical damage in an area that coincided with the fractured connecting rods. The #3 lifter housing area was fractured and lifters were not in place. There were no pre-accident anomalies noted with the lifter faces or camshaft lobes. The camshaft and beveled gear remained in place with no pre-accident anomalies noted.

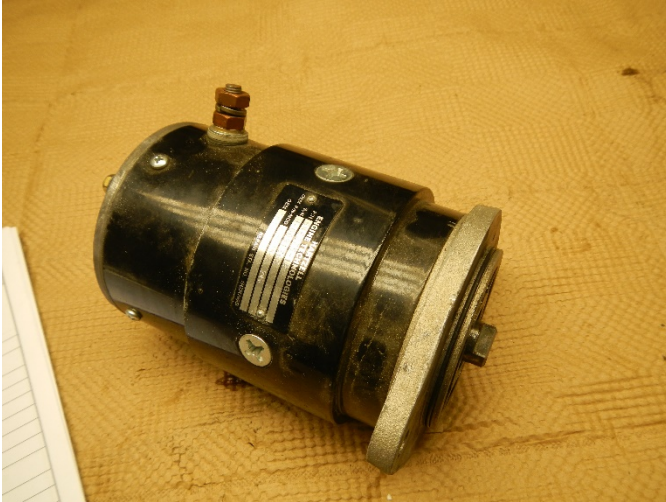
Condition: The starter motor remained in place with no pre-accident anomalies noted. The starter shaft rotated freely during manual manipulation.

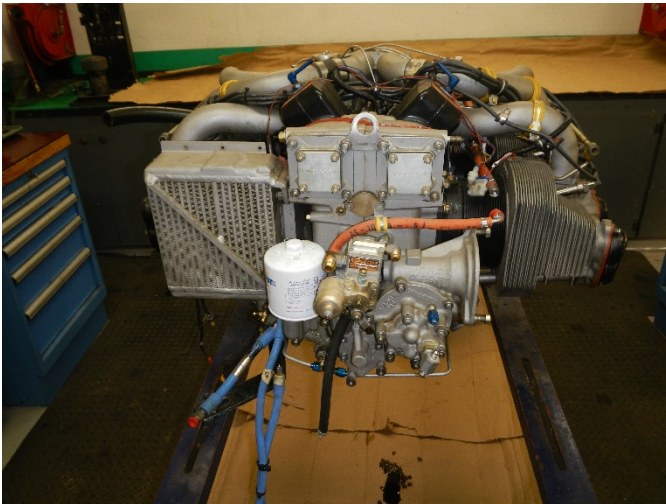
#### STARTER ADAPTER

Condition: The starter adapter remained in place on the backside of the engine with no external signs of operational distress. Removal of the unit revealed no pre-accident anomalies.

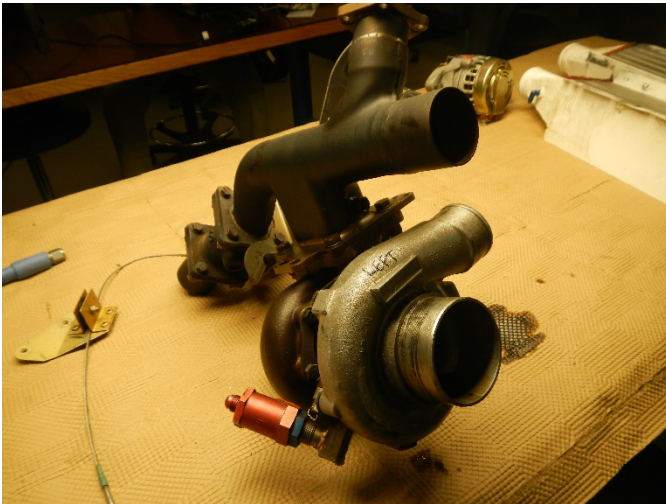
| TURBO #1 | Manufacturer: Kelly Aerospace | P/N: 466304-0003 | S/N: LIL00112 |
|---|---|---|---|
| Condition: | The left turbocharger remained secured to the exhaust transition but the transition was removed from the engine prior to shipment. Oil was observed in the impeller inlet and on the outside of the turbine wheel housing. Residual oil drained from the bearing. The impeller wheel rotated freely with a coinciding rotation of the turbine when manually manipulated. The bearing oil supply inlet screen and check valve were tested and inspected. The check valve unseated with 14 psi of air pressure applied, and the inlet screen was found clear. The turbocharger was disassembled at the HET facility. There was no evidence of foreign object damage on the compressor or turbine wheels and the housings did not display any pre-event anomalies. The turbine and compressor bearings were removed and the oil holes were clear and unobstructed. The turbine bearing displayed some discoloration and circumferential wear on its OD. See the HET examination report for more information. | | |

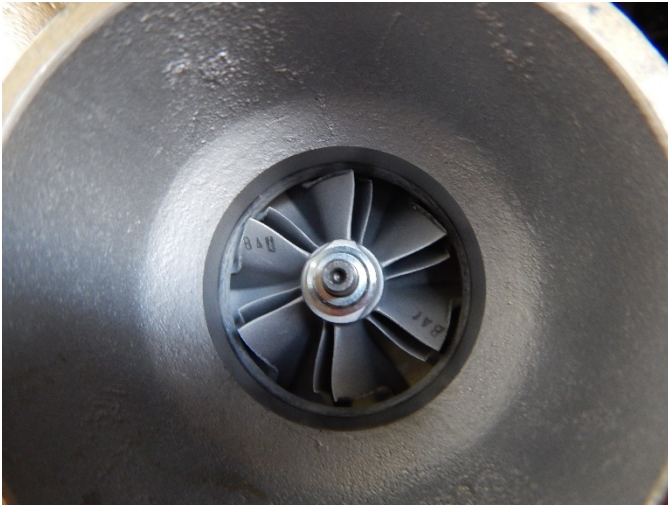
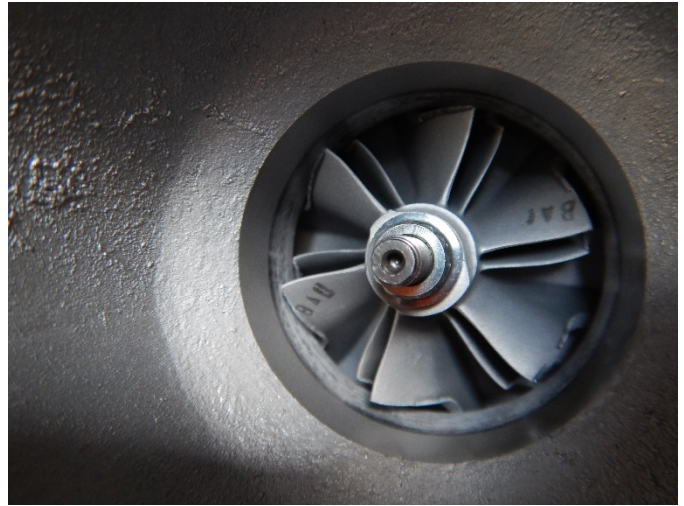
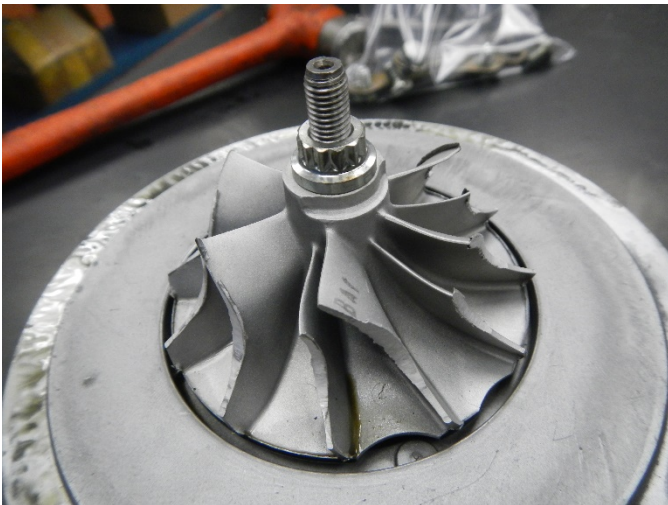
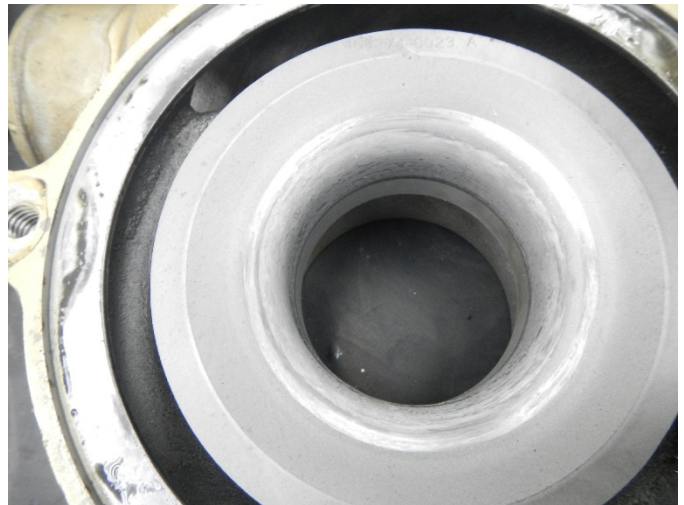
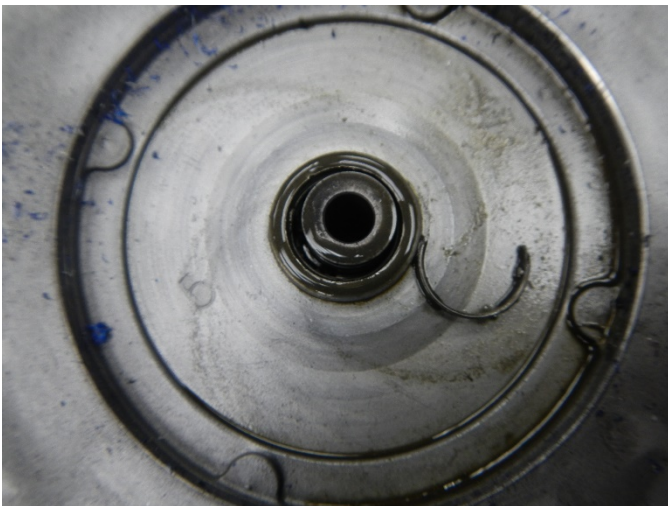
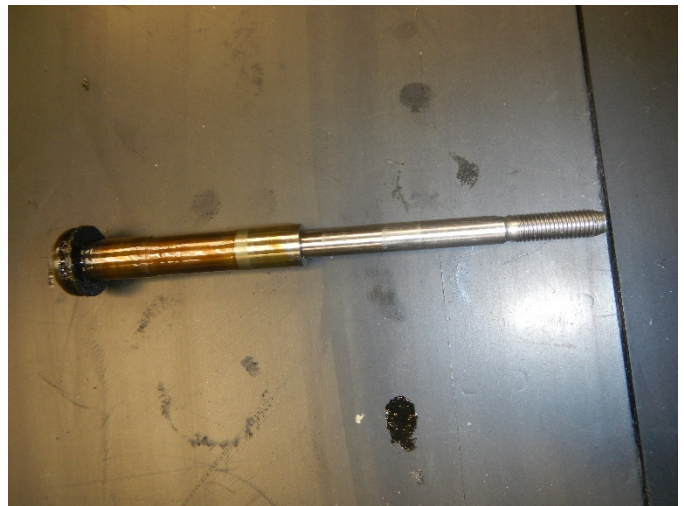
The right turbocharger remained secured to the exhaust transition but the transition was removed from the engine prior to shipment. The turbocharger's turbine wheel was missing and there was little-to-no rub or contact damage noted on the turbine wheel housing (it should be noted that a normally sized turbine wheel would not be able to exit the unit without interfering with the housing). The turbine housing was discolored with what appeared to be a pale colored exhaust residue; however, the source of the discoloration was not determined. There was an area on the housing's exhaust tailpipe mating flange that was similar in appearance, as noted with the red bracket in the second photograph. The v-band coupling remained with the tailpipe and was removed from the turbocharger prior to shipment.

The impeller and impeller housing displayed damage consistent with rotational contact. The bearing oil supply inlet screen and check valve were tested and inspected. The check valve unseated with 15 psi of air pressure applied, and the inlet screen was found clear. Disassembly of the unit revealed that the bearings' oil holes contained displaced bearing material and both the turbine and compressor bearings were worn. The bearing housing lubrication passages were clear. The turbine wheel was separated from the turbine shaft at the outboard edge of the piston ring groove. The piston ring remained in place. There was no evidence of oil leakage in the turbine housing. See the HET examination report for more information.

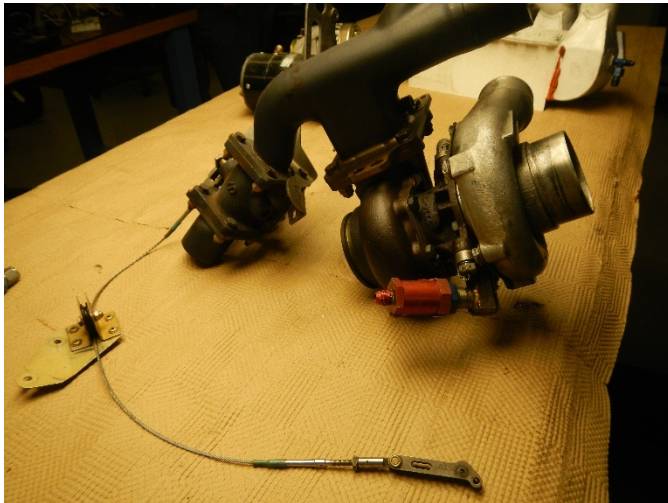
Left

**Condition:** The wastegate and wastegate controller remained with the left turbocharger exhaust system. The wastegate interconnect cable for the right turbocharger exhaust system remained attached to the left wastegate control linkage. The left wastegate was functionally tested at HET facility with no pre-accident anomalies noted.

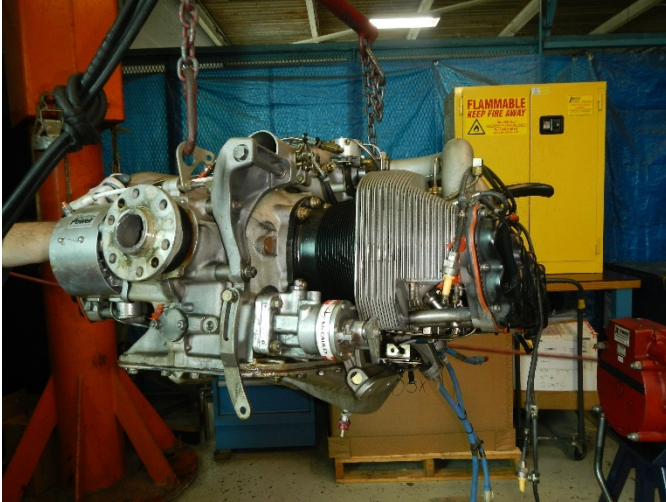
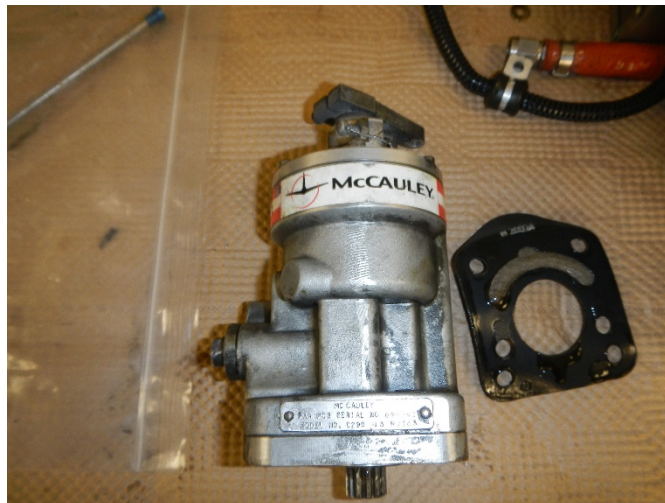
The propeller governor remained attached to the front left side of the engine with no pre-accident anomalies noted. The governor was removed and the inlet screen was clear. Manual rotation of the drive shaft resulted in free rotation of the pump with residual oil observed in the housing.
