# Continental Motors

## Component Examination Report

| Aircraft Make/Model: | Robinson R44 II | Aircraft S/N: | 12538 |
| Occurrence Date: | 07/02/2017 | NTSB Accident # | WPR17LA140 |

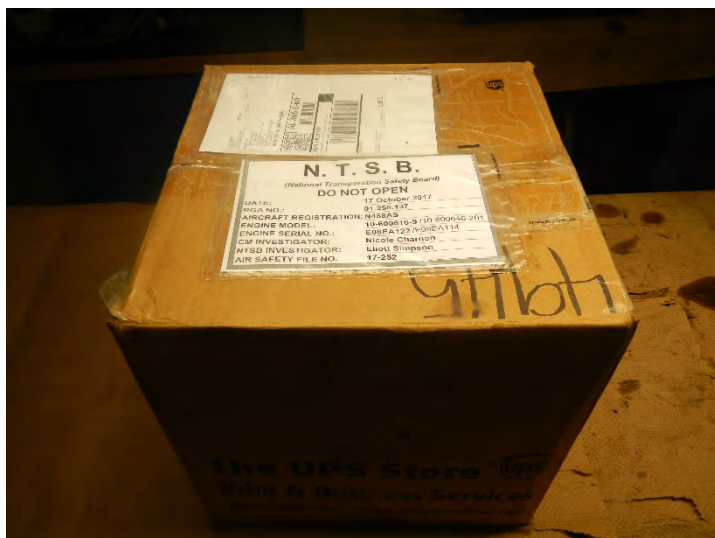
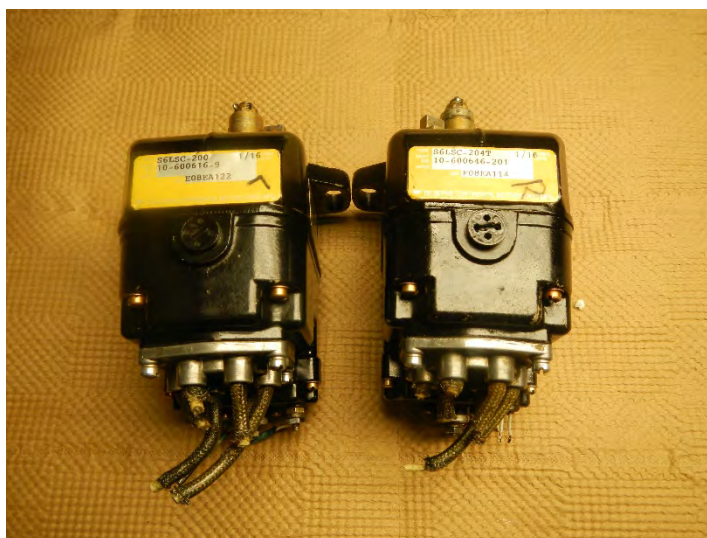
## LEFT MAGNETO

The magnetos were removed from the shipping box. The left magneto's point cap was removed and both sets of points were found loose (they had been removed and reinstalled during the previous NTSB exam). The point gap was re-established and the screw was tightened. The magneto was placed on the test stand with intermittent results. The magneto point cap was again removed. The capacitor was removed from the magneto and was replaced with an exemplar unit taken of a reclamation magneto. The magneto was placed on the test bench for a second time and it produced a spark across a 4mm gap from each terminal in firing order throughout normal test ranges. The left magneto's capacitor was tested in accordance with Continental Motors' Quality Work Instructions. Corrosion on the flag connector prevented the capacitor from testing within specifications. The insulation inboard of the flag connector was cut open and the test was repeated with satisfactory results using the exposed wire.
