# Continental Motors

## ENGINE EXAMINATION REPORT

| ENGINE MODEL | O300D (6) |
| CMI FILE NUMBER | 17-076 |

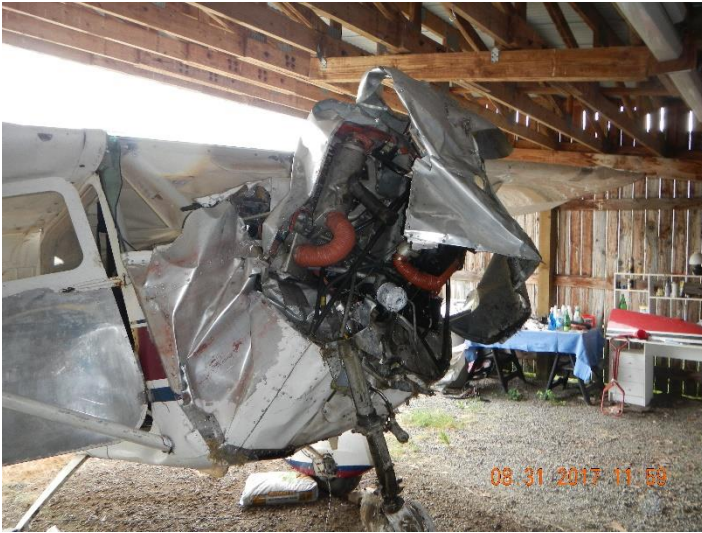
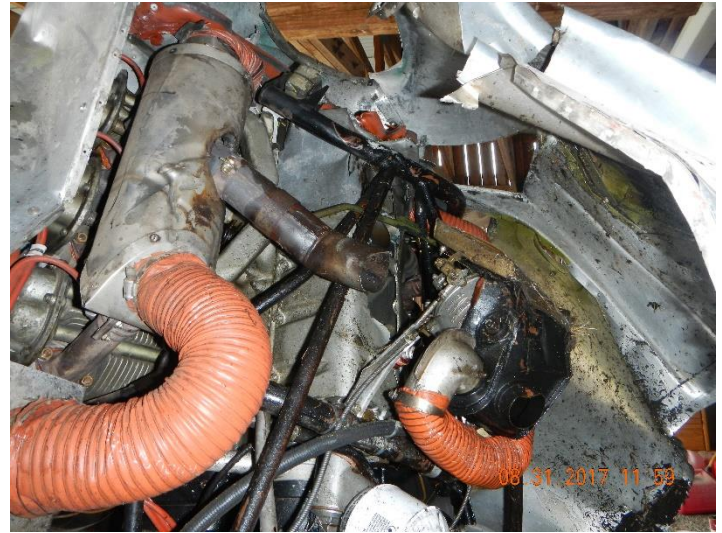
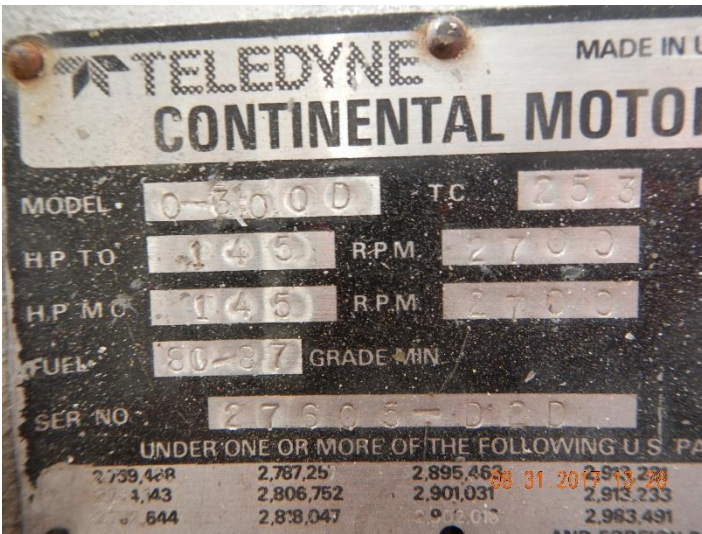
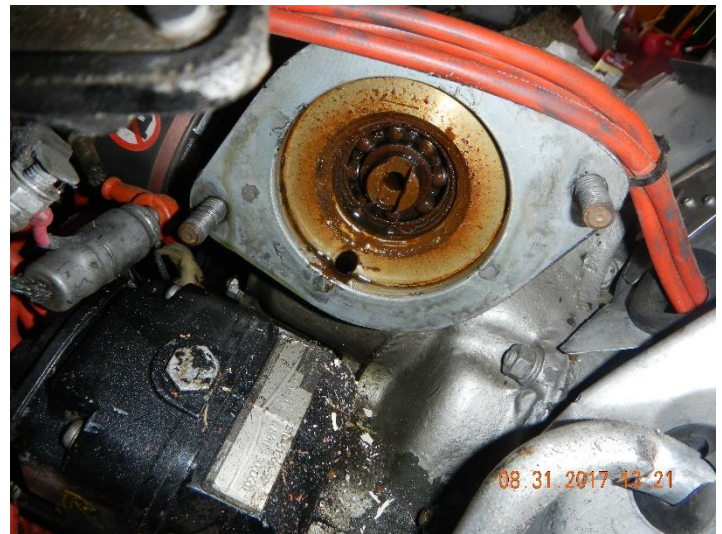
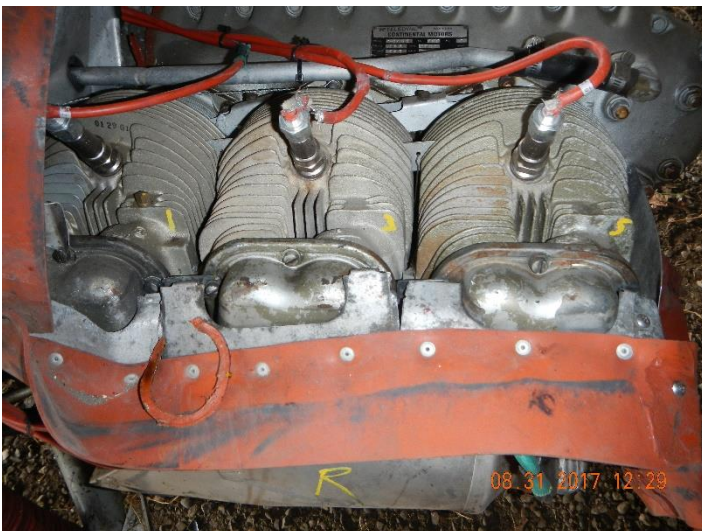
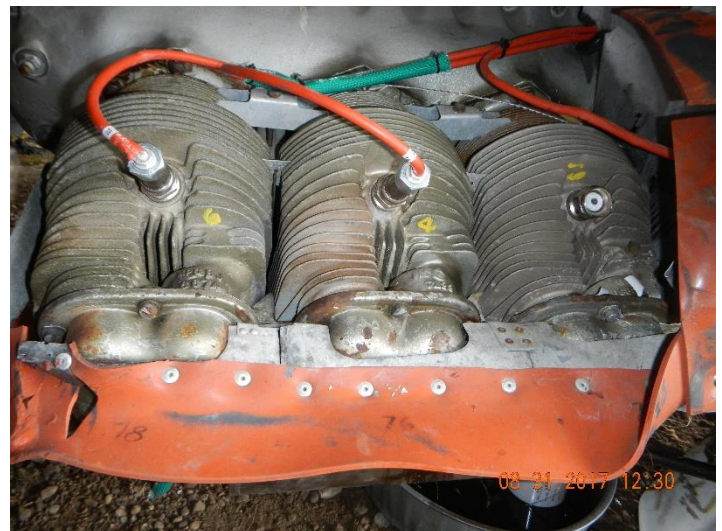
The two-blade metal, fixed pitch propeller separated from the engine at the crankshaft propeller flange. The propeller flange remained attached to the propeller with what appeared to be improper hardware. The propeller mounting bolt lengths were too short. Threads must protrude two-three threads outboard of the nut in order for the nylon locking feature to operate correctly. The propeller mounting bolt threads were flush with the outer portion of the self-locking nuts with no threads protruding. The fracture surface of the exposed portion of the damaged crankshaft exhibited 45-degree shear lips and diagonal ladder cracks across the radius.

The engine oil sump was impact damaged allowing most of the engine oil to escape. The carburetor separated and was secured to the engine only by the control cables and fuel hoses. The carburetor mounting flange had separated due to impact forces. The engine accessory case was damaged at the aftermarket oil filter adapter mount. A red-colored gasket protruded from the oil filter adapter at the damaged mount. The instrument dry-air pump remained attached to the accessory case mount but the inlet and outlet fittings separated. The exhaust components remained attached and the muffler tailpipes received impact damage.

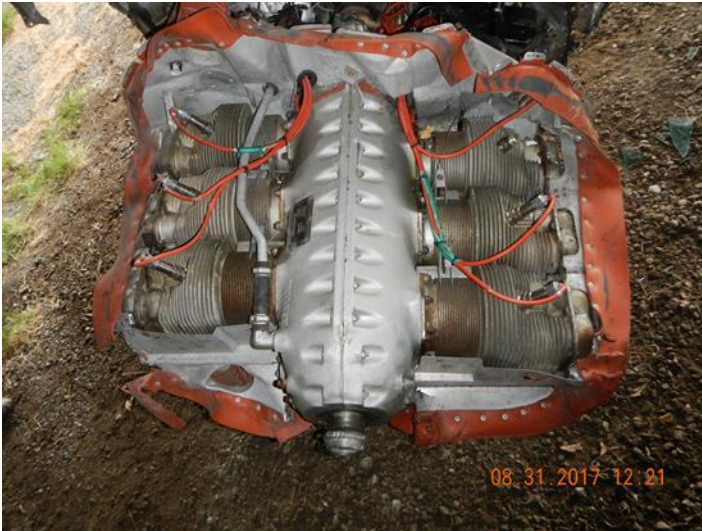
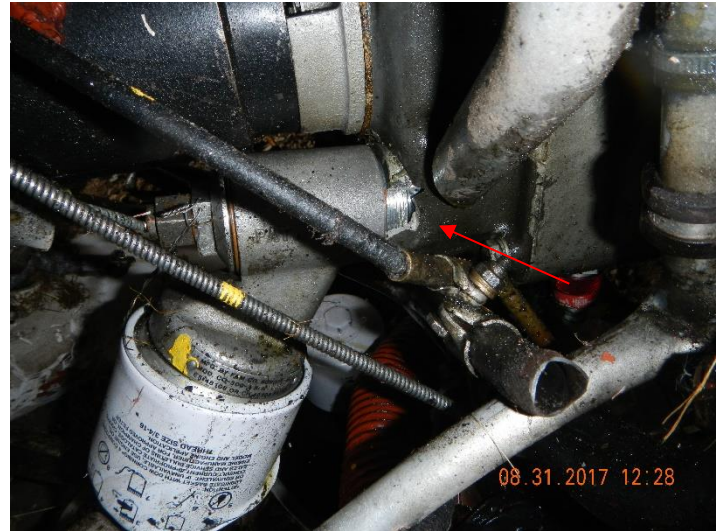
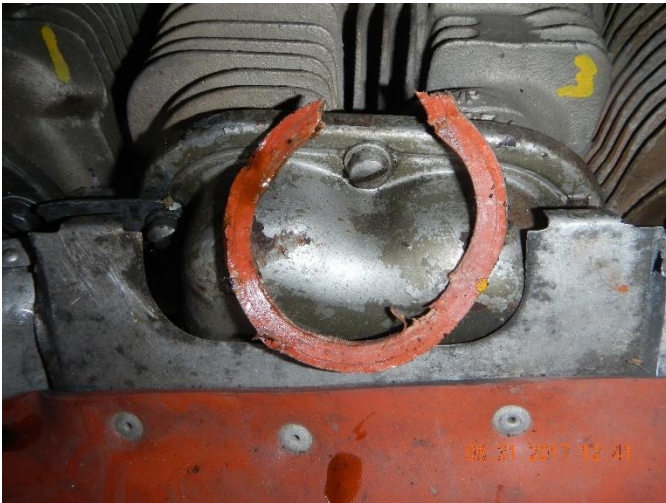
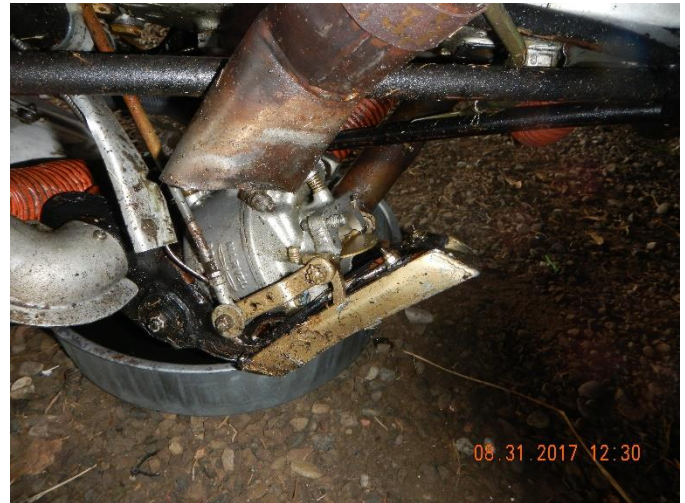
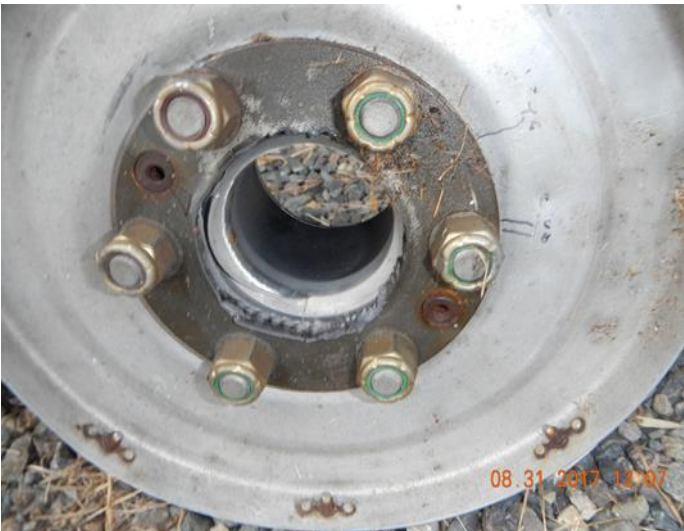
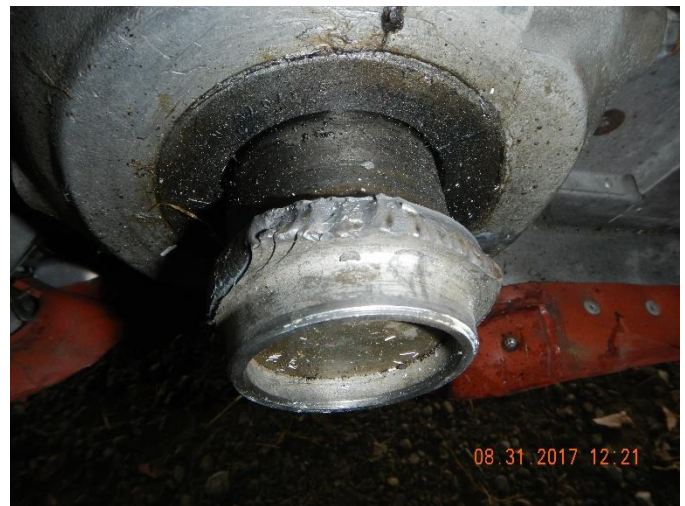
Condition: The left and right muffler remained attached. The tailpipes received impact damage.

Condition: The induction system remained intact except the carburetor mounting flange. See *Carburetor*. The induction filter was contaminated with dirt and grass.

Condition: The ignition harness exhibited impact damage at sparkplug connections on cylinders one, three and five.
