## **NATIONAL TRANSPORTATION SAFETY BOARD**

### **ENGINE EXAMINATION**

**WPR17LA172**

Location: Llano, California  
Date: July 31, 2017  
Aircraft: Cessna T-210F, N6109R, Serial # T210-0009  
NTSB IIC: Michael Huhn

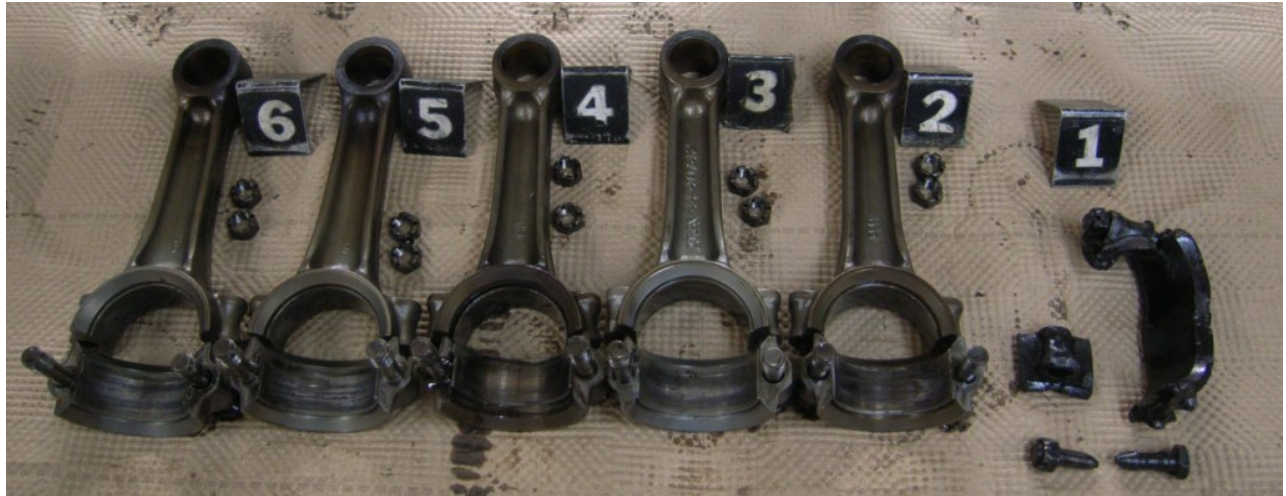
Figure 9 - Connecting Rods

- None of the accessory gears exhibited any damage, and all were properly safetied
- The lower cap for the No. 1 connecting rod was found separated in the oil sump

- The cap was blackened and severely damaged
  - The blackening was attributed by the CMG personnel to thermal distress
- One of the two cap bolt/nut assemblies was found in the oil sump

- The bolt was fractured in two, and retained its cotter-pin safetied nut
  - The bolt exhibited severe elongation and necking
  - The bolt was also blackened

- The No. 1 connecting rod remained attached to its wrist pin and piston
  - The rod moved freely on the wrist pin
- The crankcase bores/housings for the two hydraulic lifters for the No. 1 cylinder were partially fractured, with their liberated sections found in the oil sump

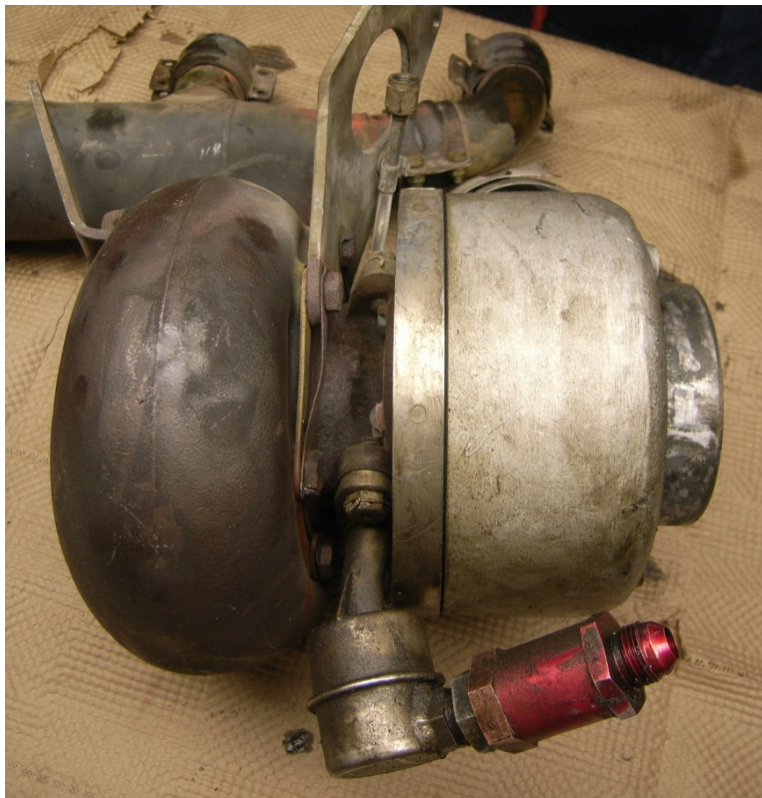
**Figure 14 - Turbocharger with Oil System Components**

When the engine was disassembled, multiple indications of oil starvation/depletion became evident. These included near-absence of oil in the sump, thermally-distressed internal components, failed/disintegrated components, and numerous metallic chips in the oil sump and filter element. The primary failed component was the connecting rod bearing/cap for the No. 1 cylinder. The apparent source of the oil depletion was traced to the turbocharger bearing assembly/housing.
