## **EXAMINATION REPORT & COMPANY INTERVIEWS**

**WPR17LA180**

**Pocatello, Idaho**

**Lockheed P2V-5; N410NA**

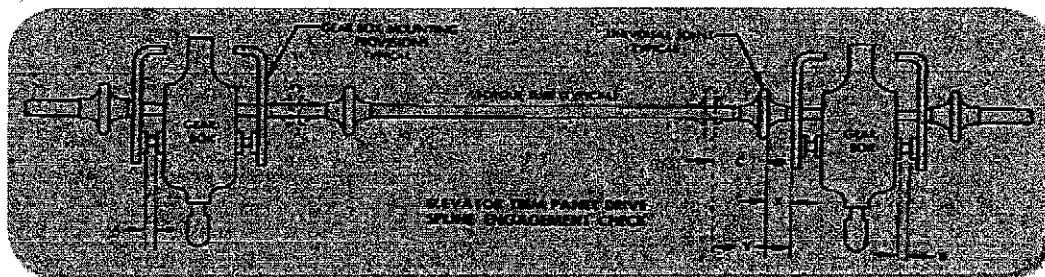
ANNUAL INSPECTION CARD 10-4 VARICAM

A AND B DIMENSION - GEAR BOX CLEARANCE TO MOUNT  
X DIMENSION - UNIVERSAL BOTTOMED AGAINST  
GEAR BOX SHAFT  
Y DIMENSION - UNIVERSAL PUSHED MAXIMUM  
DISTANCE AWAY FROM GEAR  
BOX SHAFT  
C DIMENSION = Y - X MAXIMUM LATERAL SHAFT  
MOVEMENT  
THE SUM OF DIMENSION A + B + C  
MUST EQUAL 0.450 OR LESS
