## **NATIONAL TRANSPORTATION SAFETY BOARD**

### **SUMMARY OF AIRCRAFT EXAMINATION**

**(WPR18FA016)**

Location: Arlington, Washington  
Date: October 24, 2017  
Aircraft: Robinson R22, N8537J  
NTSB IIC: Thomas M. Little

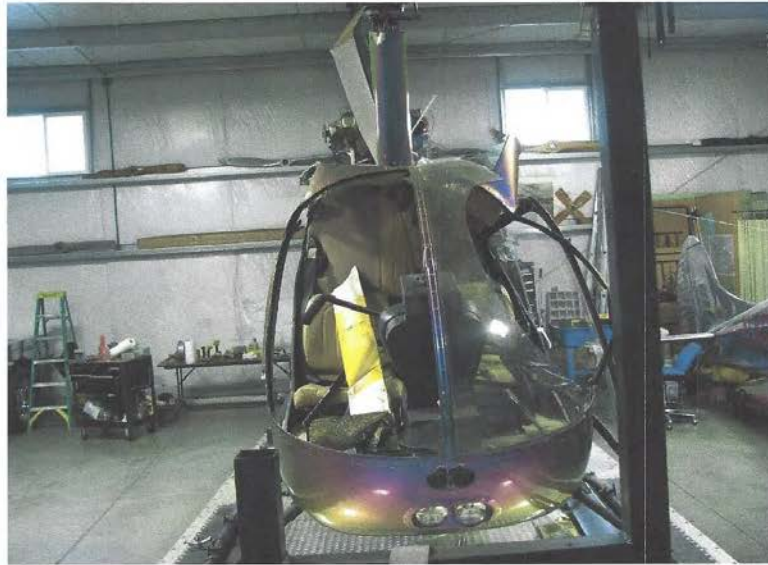
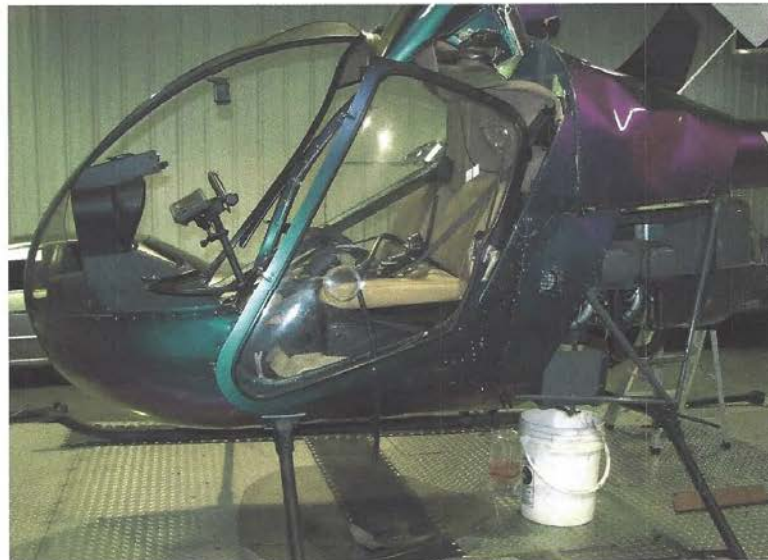
13.2

The airframe was mostly intact but exhibited extensive damage on the upper fuselage area. The cabin roof, windshield, and door frames and fuel tanks were damaged. However, photos of the

aircraft being recovered from the lake indicate that most of the damage to the cabin roof occurred during aircraft recovery. The fuel tanks were buckled in some areas, and the mast fairing was damaged. Both windshields were fractured, and the pilot door was broken and detached from the aircraft. The tailcone was separated at the aft end of the third bay, and at the forward end of the fifth bay. The fourth bay was not present for the examination. There was scoring, some which penetrated the tailcone skin from the inside, visible in several areas of the tailcone. There was a tear in the tailcone skin on the right side, on the third and fifth bays. The empennage was intact, but there was damage on the upper vertical stabilizer. The tail rotor visual guard and tail skid did not appear to be damaged.

Airframe from the front

Aircraft from the left side

**Figure 2 - Photos of front and left side of helicopter**

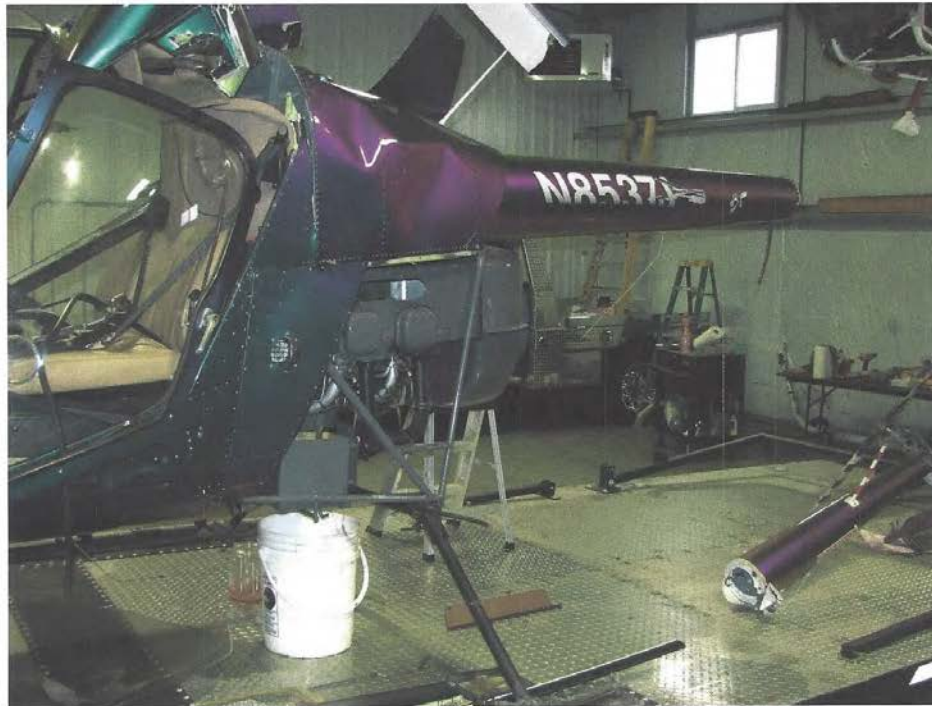
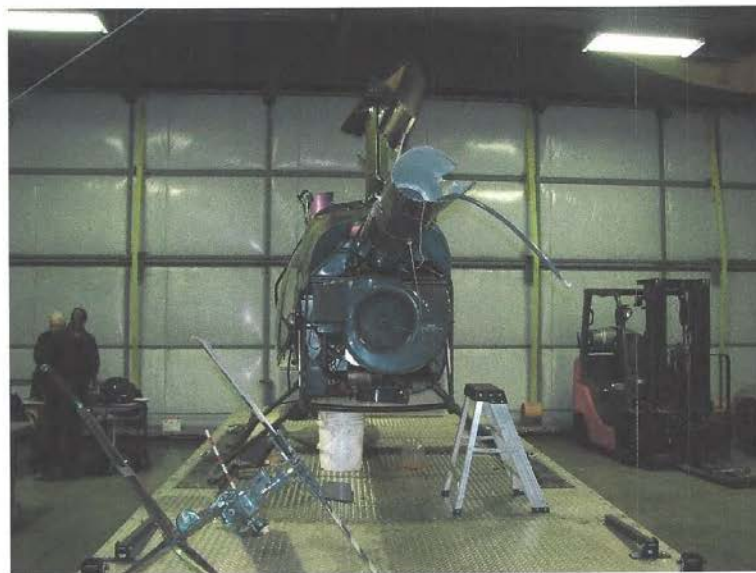
13.3

Aircraft from the left side

Aircraft from the rear

Figure 3 - Photos from left side and rear of helicopter

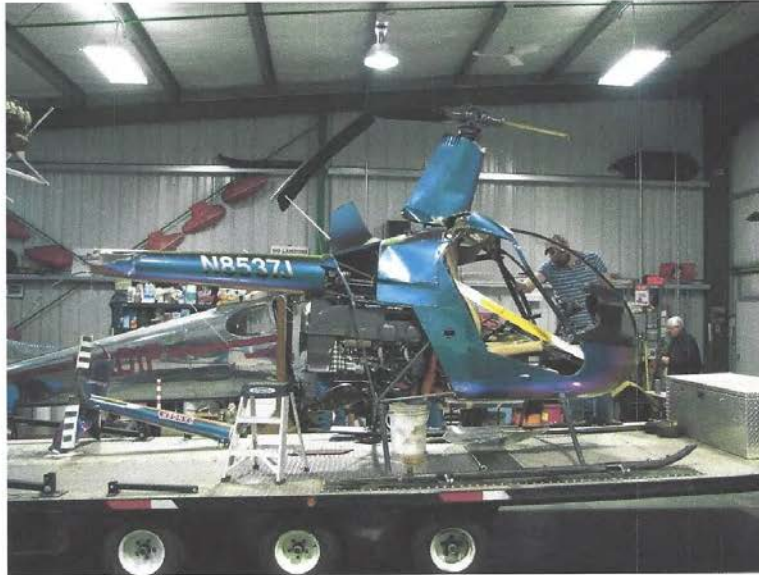
Aircraft from the right side

**Figure 4 - Photos of right side of helicopter and damage to cabin roof**

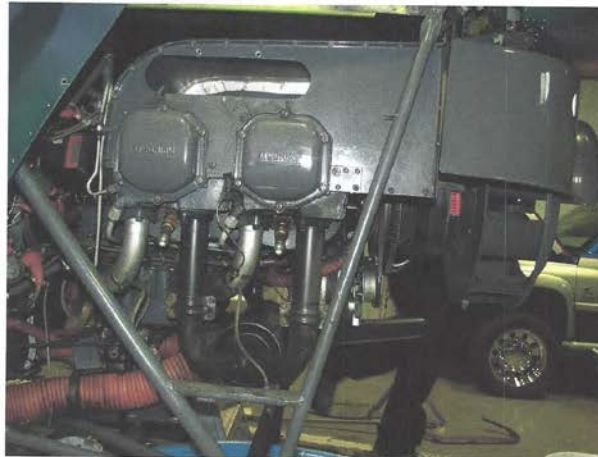
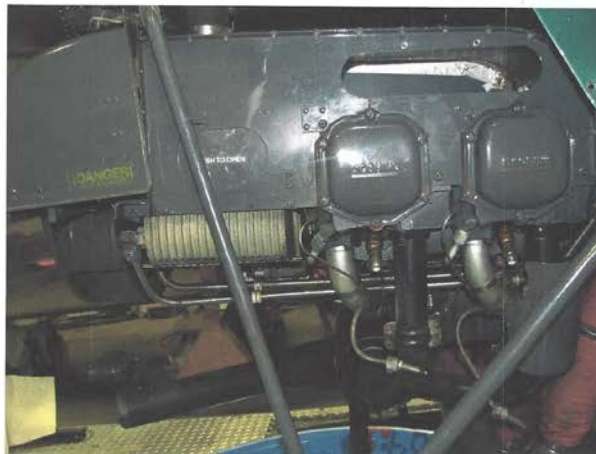
10.2

The engine, which had been submerged in about 31 ft of fresh water until it was recovered 6 days after the accident, exhibited very little visible damage. After the aircraft was delivered to Av-Tech Services, Av-Tech preserved the engine by removing the spark plugs and filling the cylinders and crankcase with diesel fuel. The engine was free to rotate at that time, according to Av-Tech representatives. The post-recovery examination of the engine failed to reveal any anomalies that would have precluded normal operation.

Engine right (aircraft left) side

Engine left (aircraft right) side

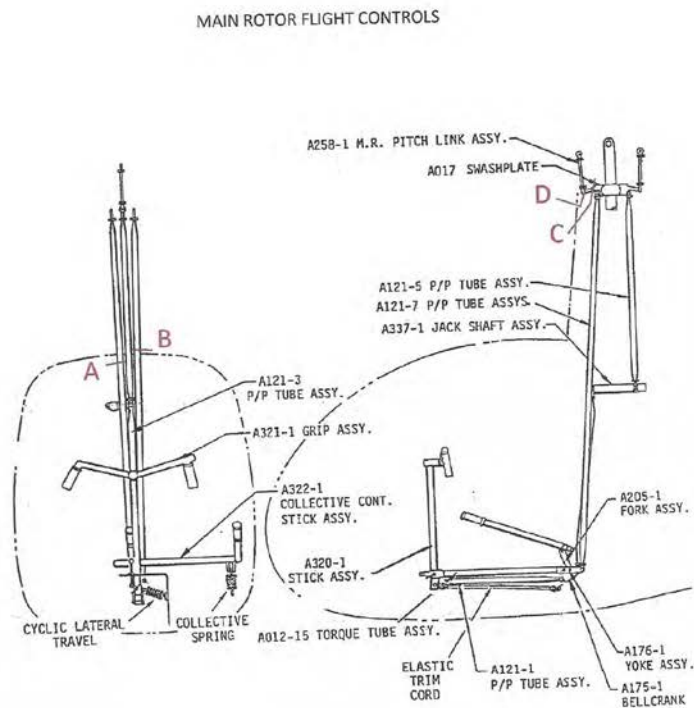
12.2

The flight control system had disconnects at the locations indicated on the following diagrams:

**Figure 7 - flight control disconnects located at positions A, B, C & D**  
**(courtesy of Robinson Helicopters)**

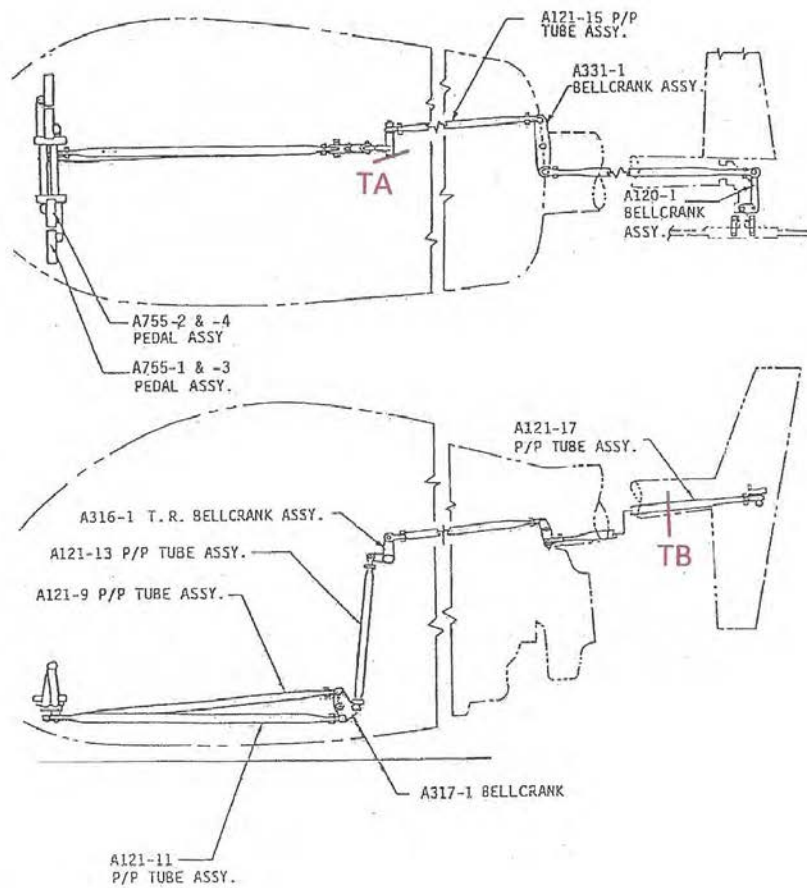
12.3

Figure 8 - flight control disconnects located at positions TA & TB  
(courtesy of Robinson Helicopters)

The upper swashplate arm that the drive scissor assembly attached to was fractured and was not present for the examination. (Disconnects C and D). Photos of the mating fracture surface were sent to the NTSB laboratory for examination. The lab concluded that the fractures were overstress, or impact related.
