## **NATIONAL TRANSPORTATION SAFETY BOARD**

### **SITE and ON-SCENE INFORMATION**

**NTSB Accident: WPR18FA035  
Accident Date: November 19, 2017**

Location: Tehachapi, California  
Date: November 19, 2017  
Aircraft: Cessna 152, N24987, Serial # 15280496  
NTSB IIC: Michael Huhn

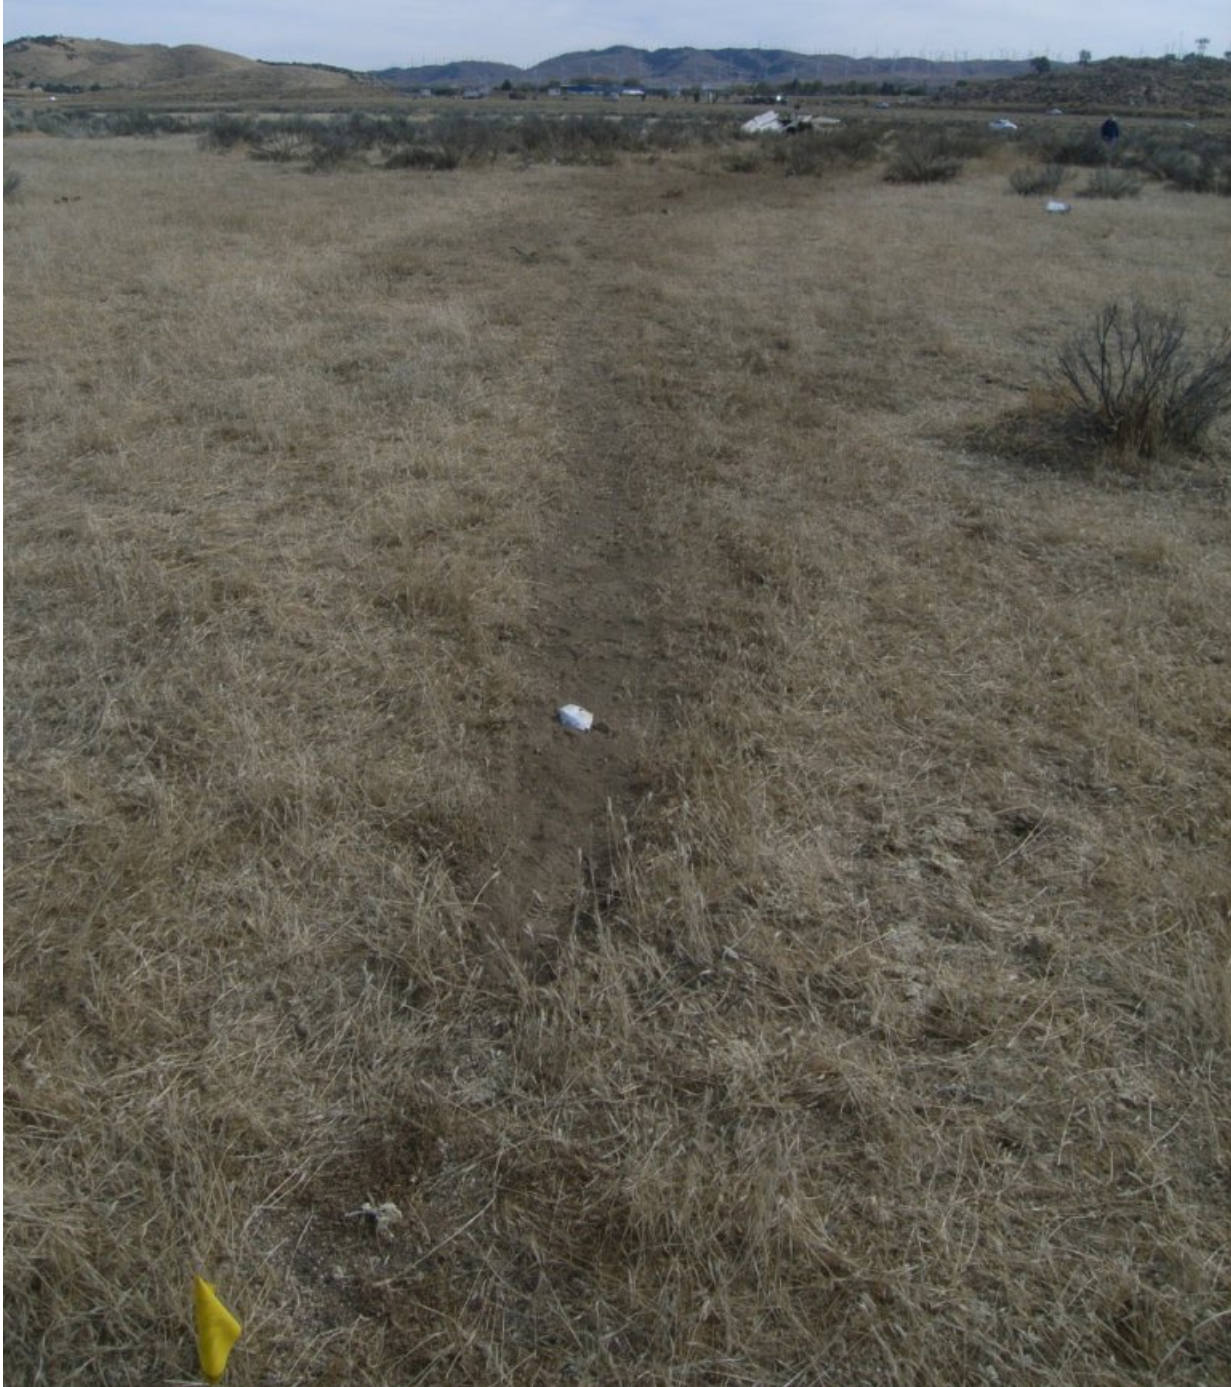
**Figure 2 - View Towards Wreckage from Initial Impact Point**

- Ground scars were consistent with the airplane striking the ground in a nose and right wing low attitude
- The right wingtip strike was beginning of the ground scars
  - The earliest identifiable piece of wreckage was an outboard fragment of the right aileron
- A ground scar consistent with the RMLG was located about 20 feet beyond the right wingtip strike
- The nose impact (NLG and/or propeller) was situated about 10 feet beyond the RMLG strike
- The ground scars and airplane damage were consistent with the wreckage tumbling and sliding
- About 26 key components in the debris field were mapped to enable development of a wreckage/debris field diagram (documented separately)

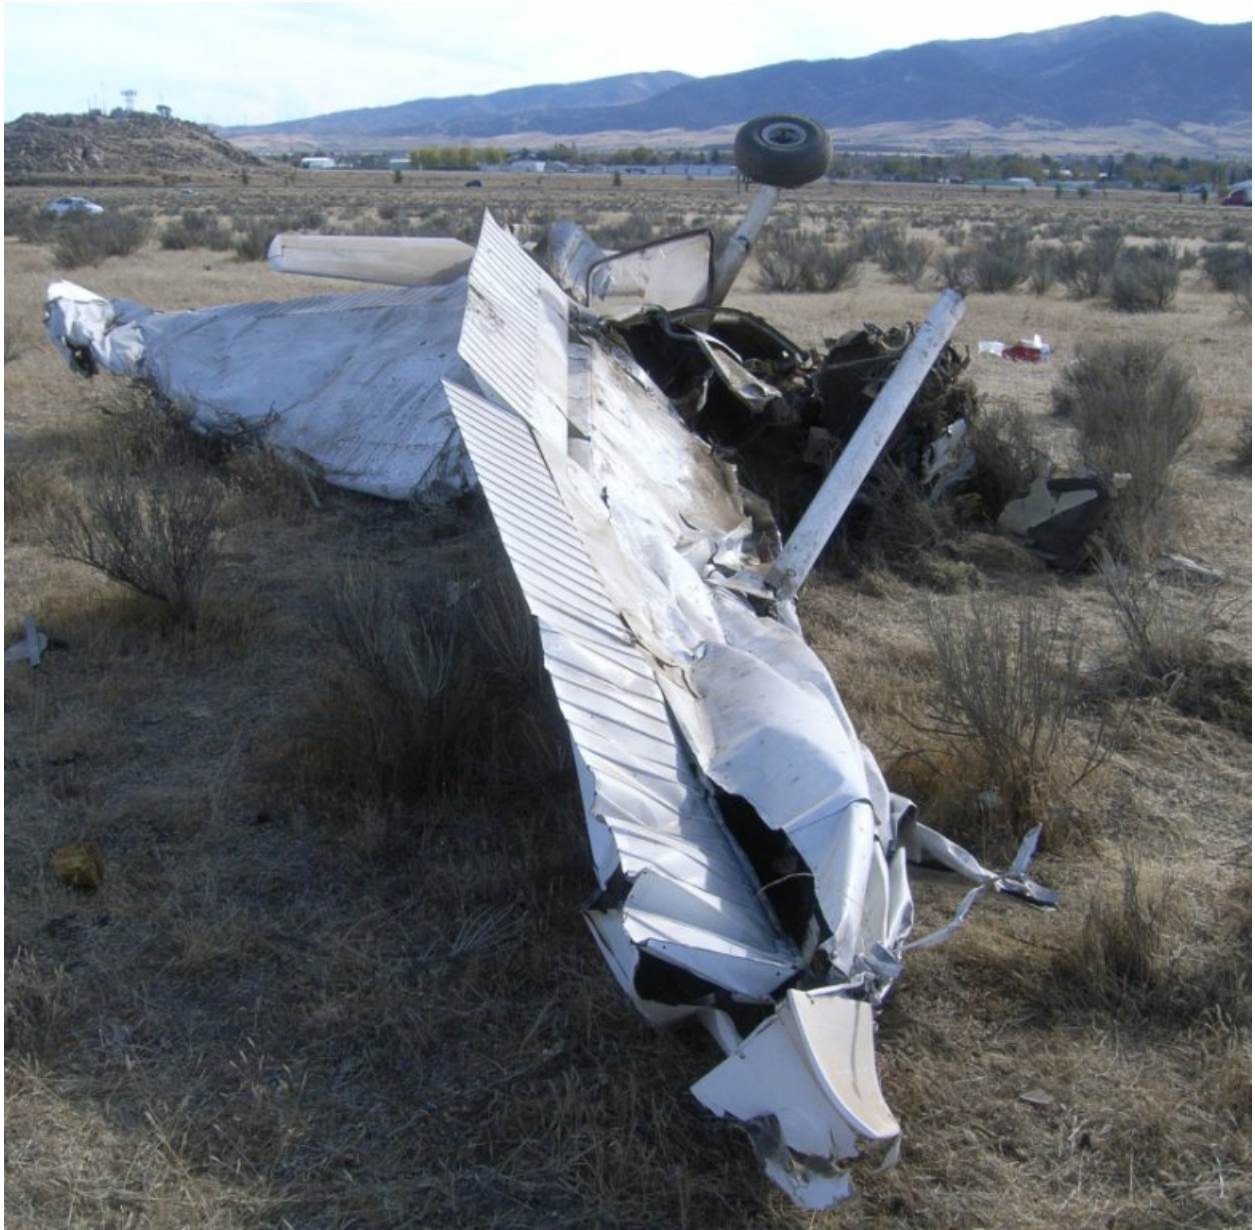
**Figure 6 - Main Wreckage from Left Wingtip**

- The wings came to rest approximately leading edge (LE) down, with the lateral axis oriented along a magnetic line of about 120°/300°
- Both wings exhibited full-span, aft-direction crush damage along their LEs; the damage was more significant outboard of each wing's lift strut attach point

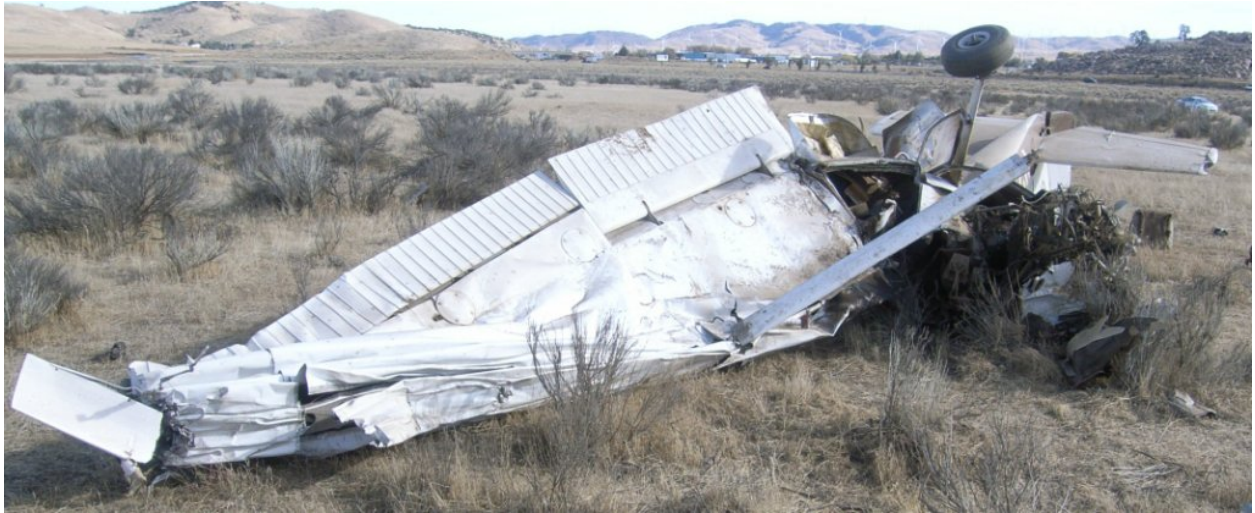
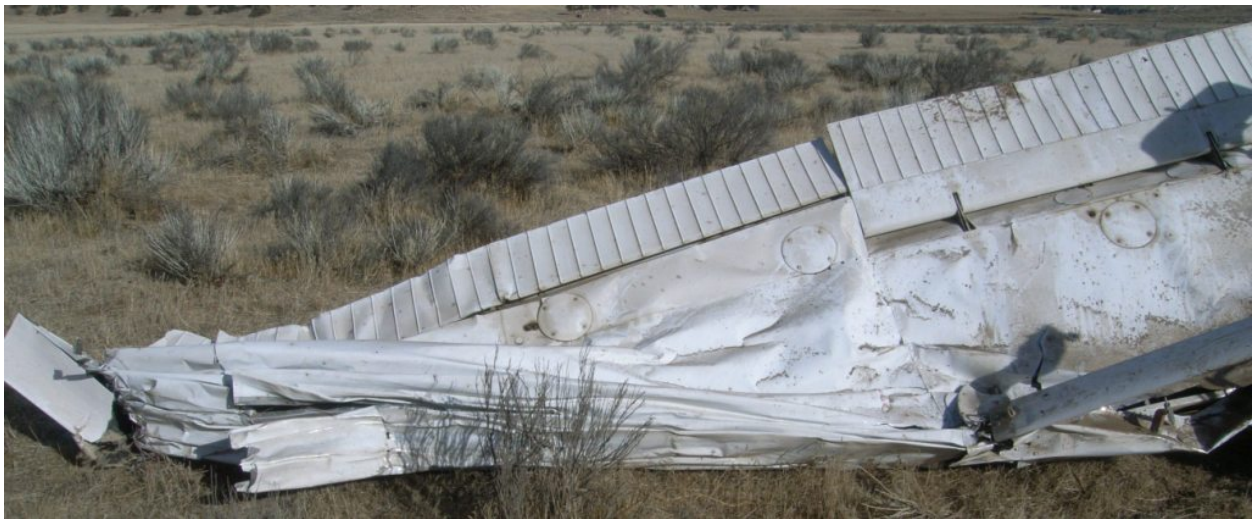
- Both lift struts remained attached to their respective wings, but separated from the fuselage
- Both wings retained their respective fuel tank caps
  - The left tank cap gasket was in good condition and flexible

**Figure 7 - Left Wing**

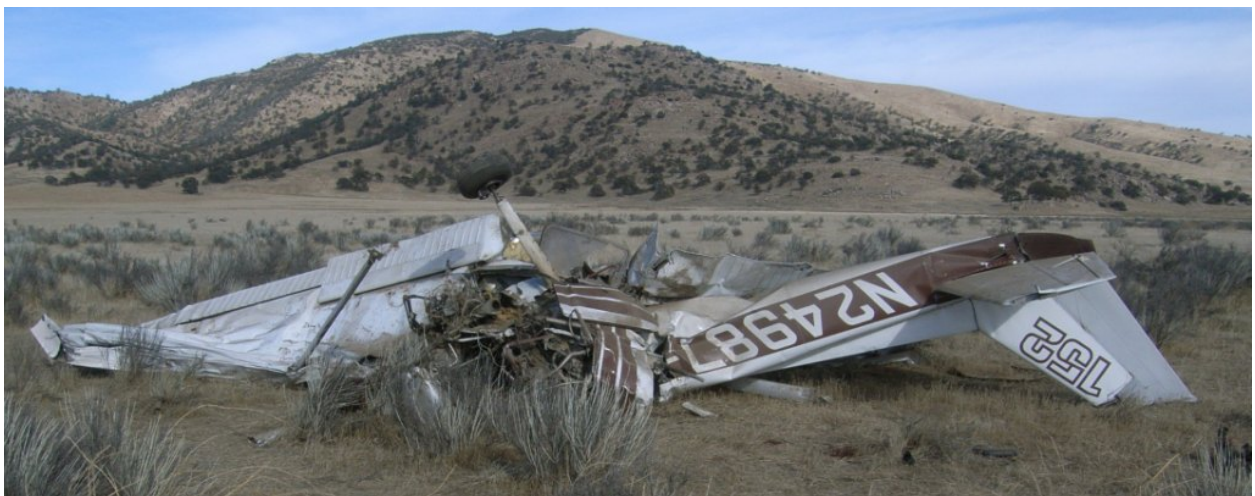
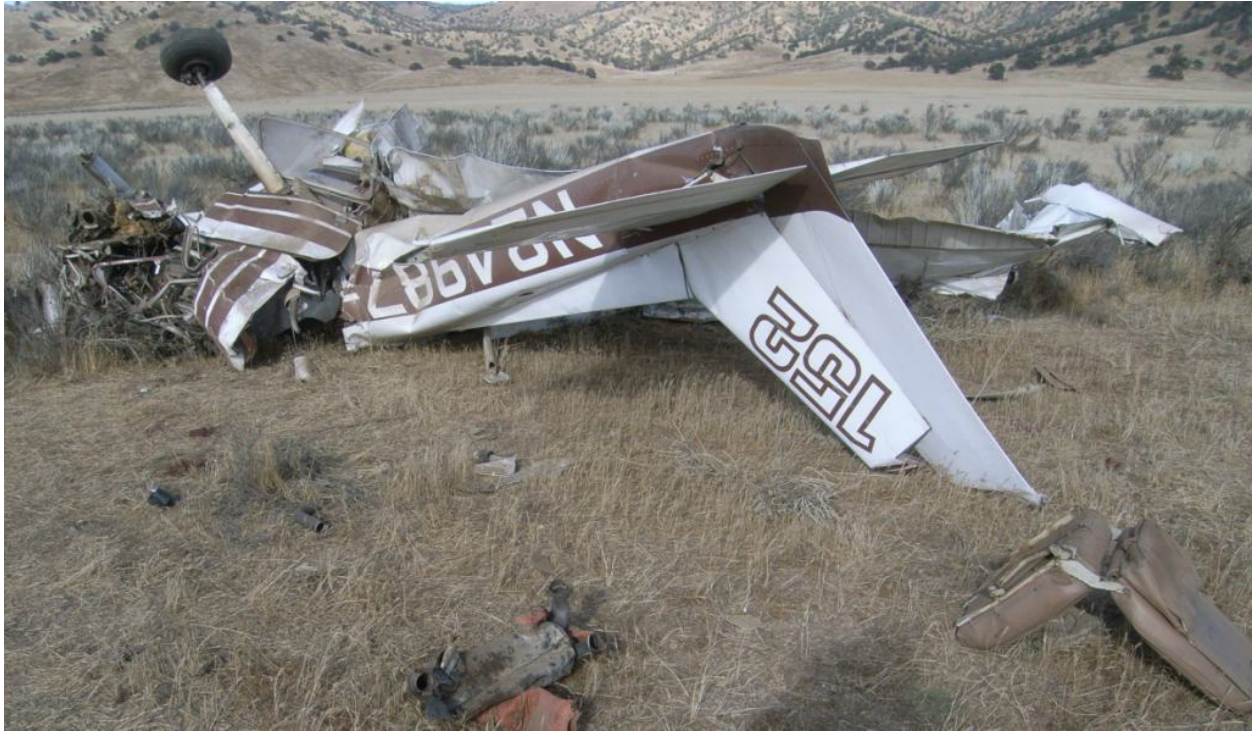
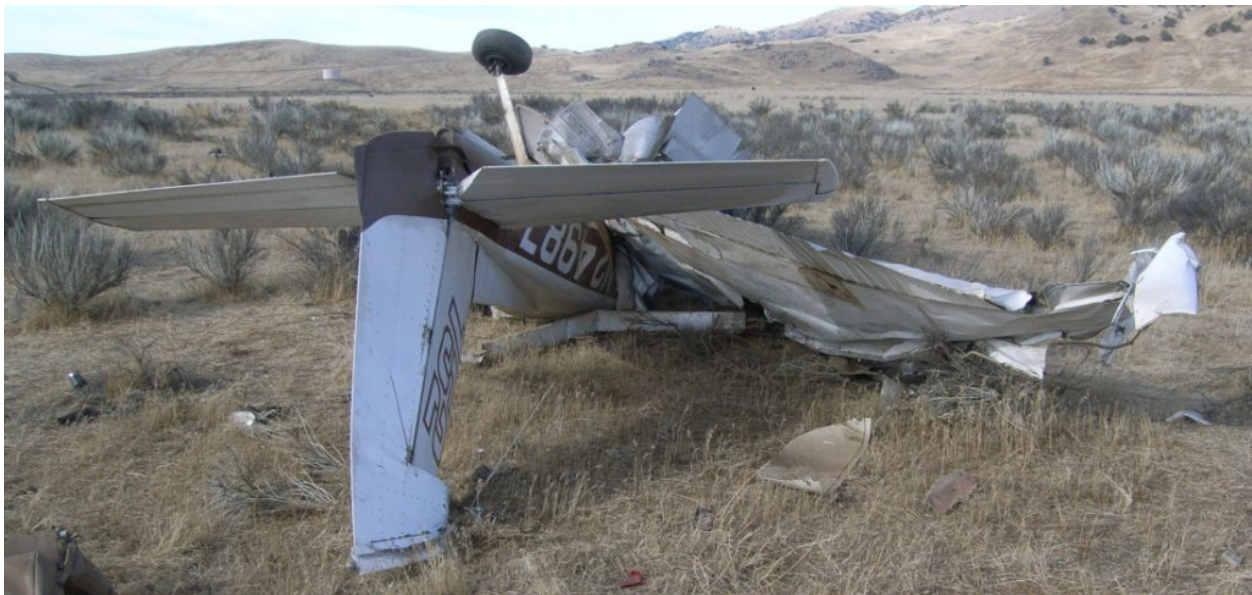
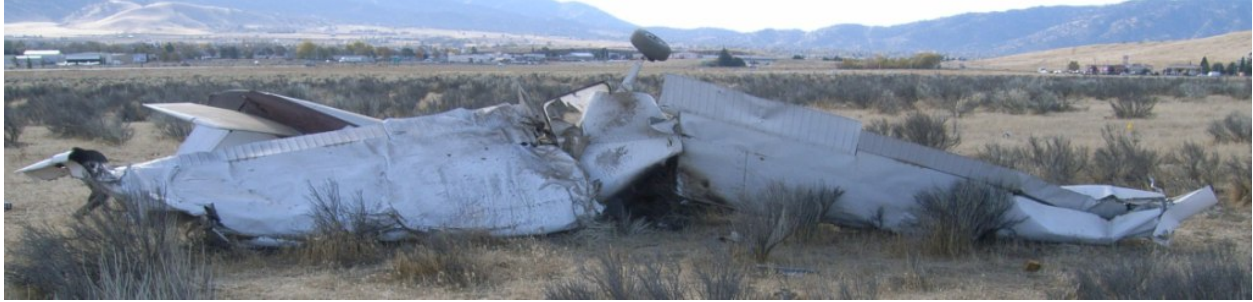
**Figure 9 - Main Wreckage**

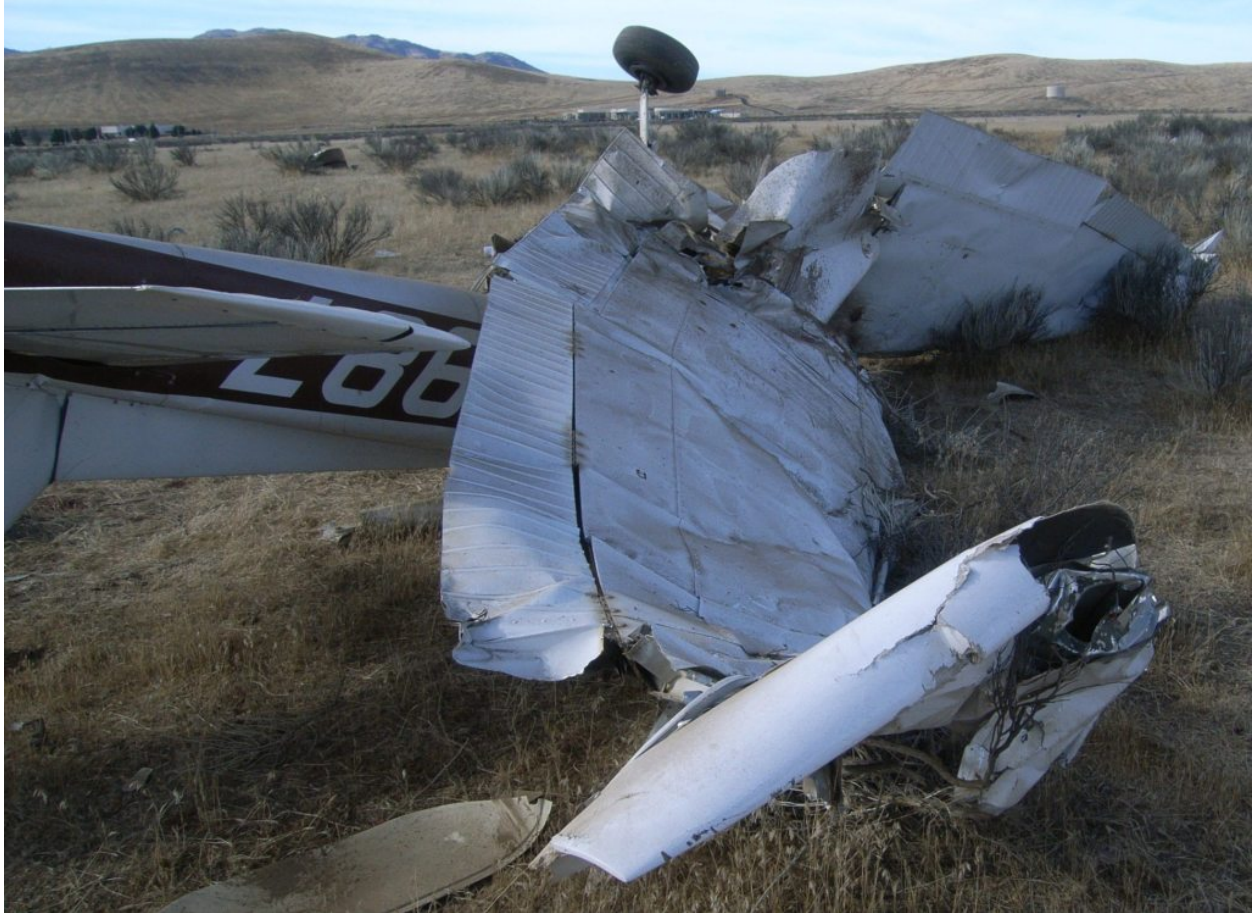
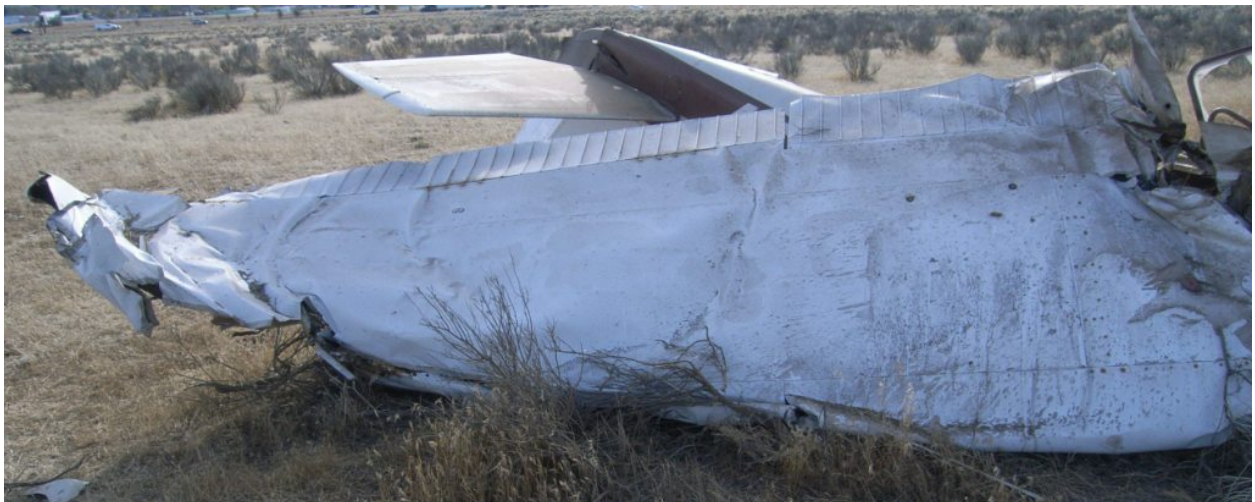
- Examination of the flap actuator indicated that the flaps were in the retracted position at impact
- Ailerons
  - Both ailerons remained attached to their respective wings. The left aileron was relatively undamaged, while the right one was missing about a 1-foot spanwise section at the outboard end. That section was the first identifiable item in the debris field

**Figure 12 - Right Wing**

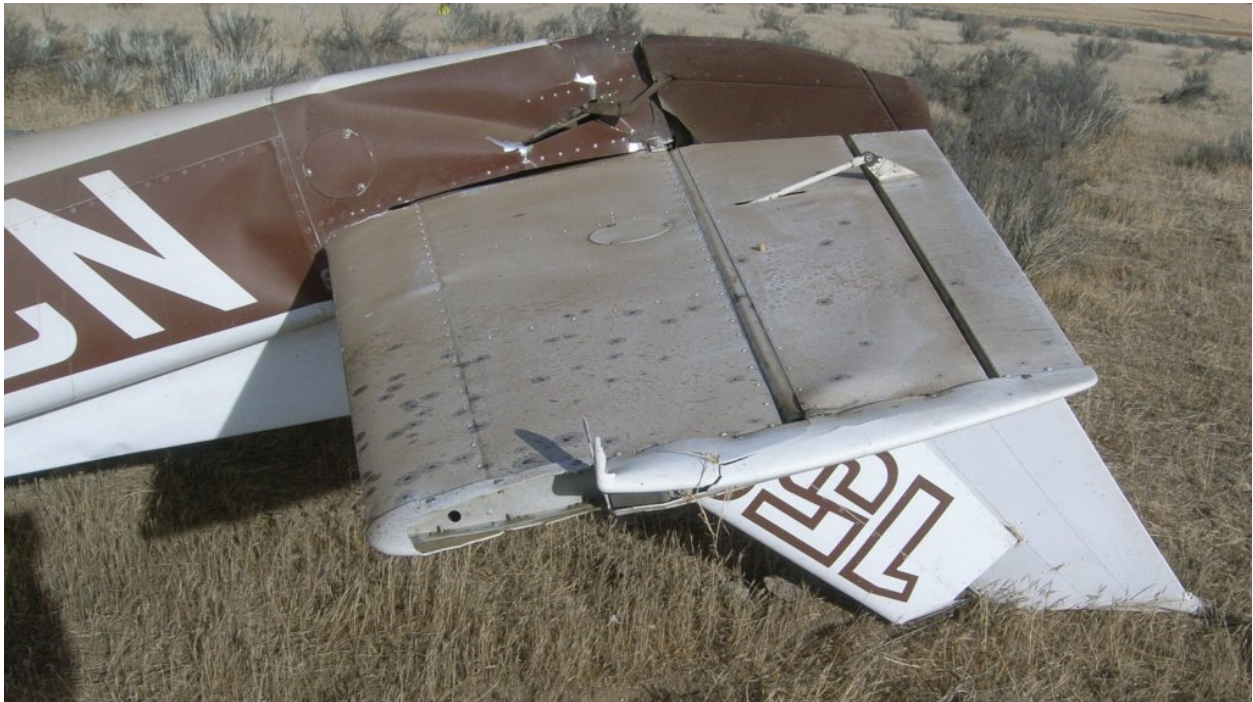
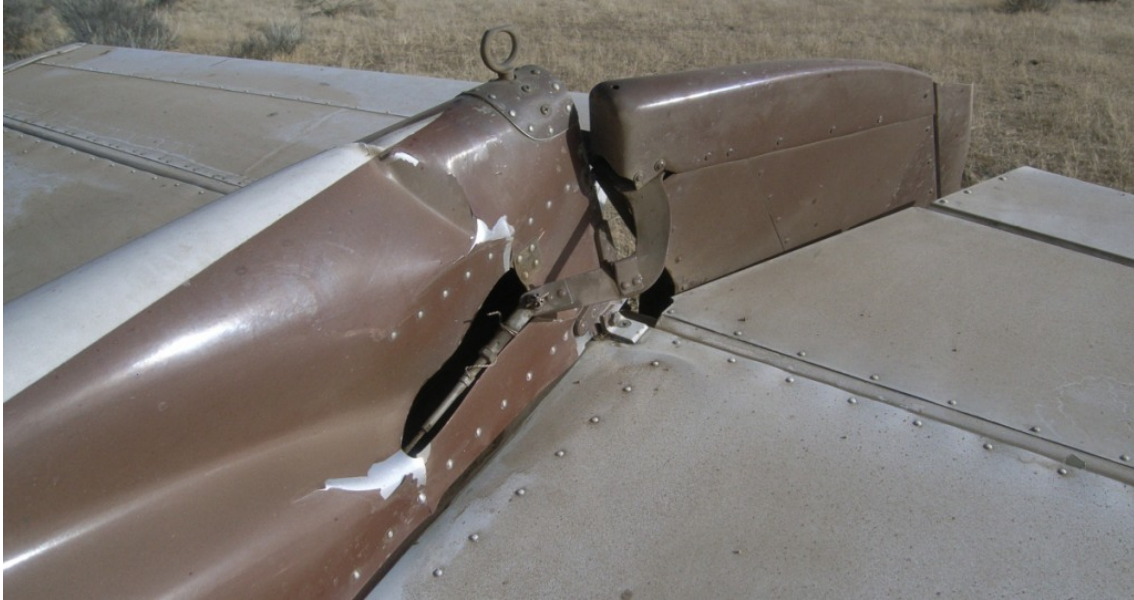
- All wing and empennage control surfaces retained their respective balance weights
- Control continuity was established from both elevators, the pitch trim tab, and the rudder to the fuselage break in the cockpit
- Control continuity was established from both ailerons to the fuselage break in the cockpit
- Aileron Cables
  - All aileron cables were still attached to their respective aileron bellcranks in the wings, and were continuous to the door post and cockpit area
- Flap Cables
  - All flap cables were separated in tensile overload

**Figure 15 - Empennage**

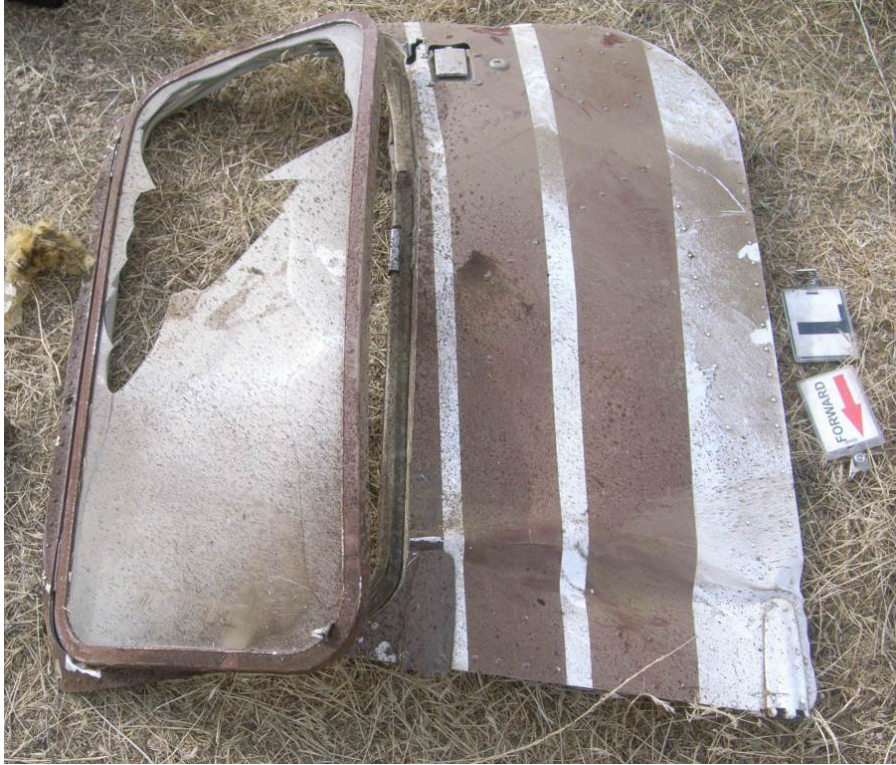
**Figure 19 - Left Door**

- The windshield was reduced to numerous small fragments, mostly 2-5" in size
- Both doors were completely fracture-separated from the airplane
- The cabin ceiling was deformed and partially fracture-separated from the two wings

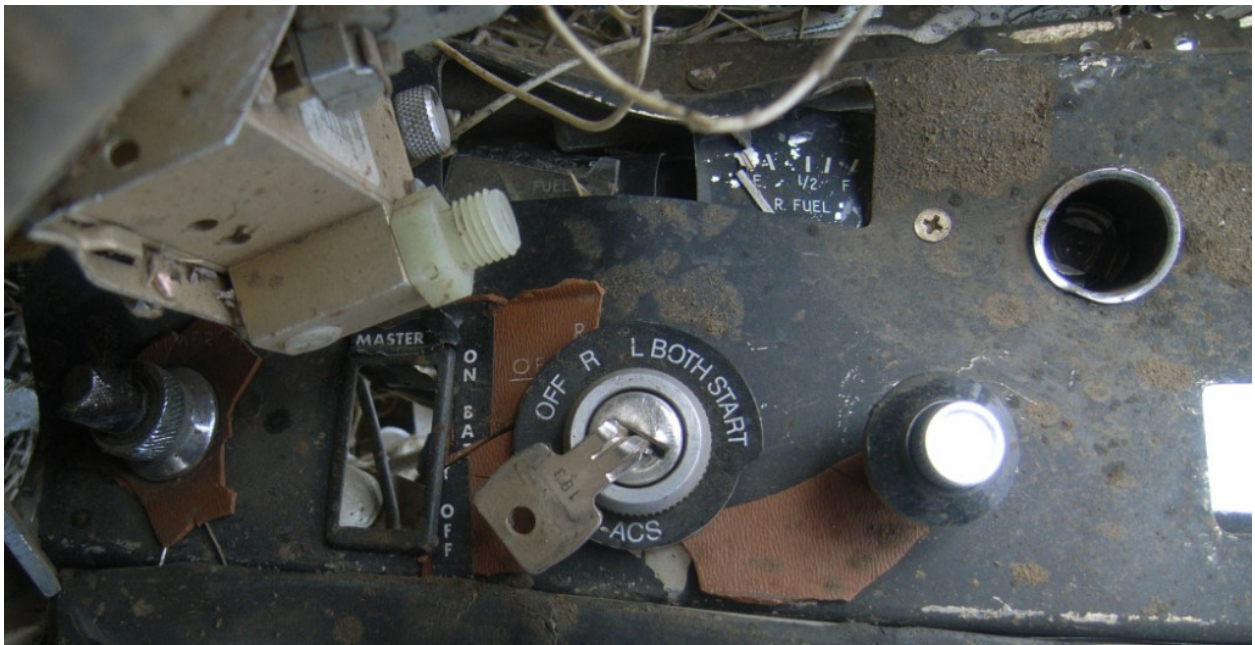
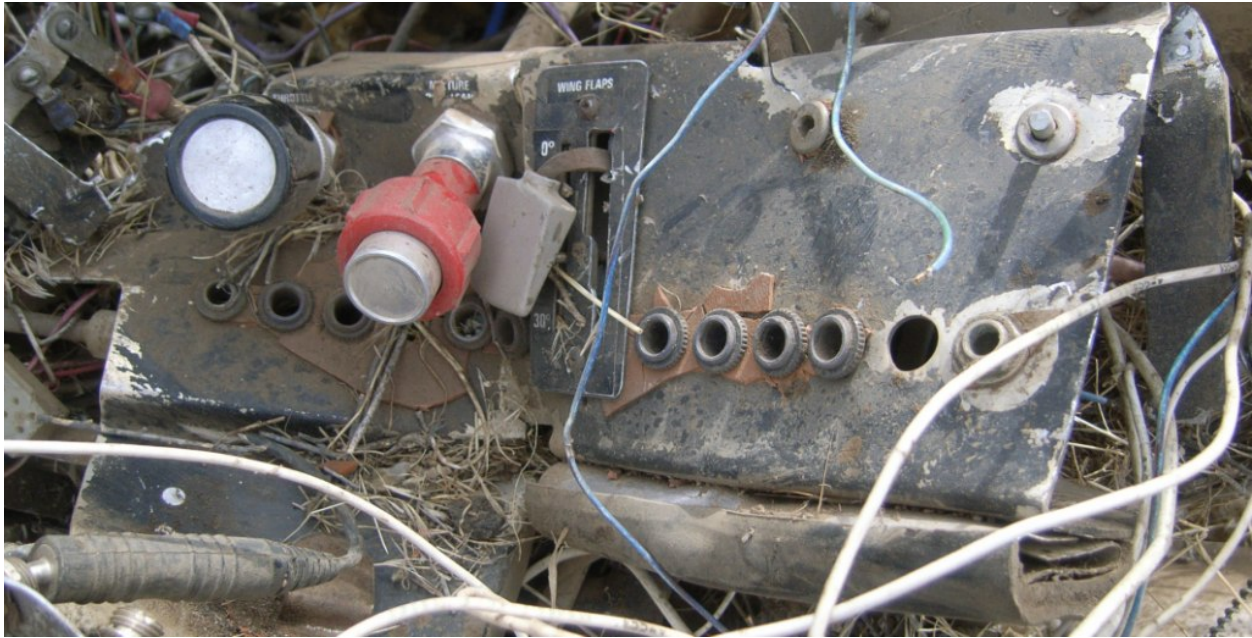
**Figure 20 - Instrument Subpanel Segment**

**Figure 21 - Instrument Subpanel Segment**

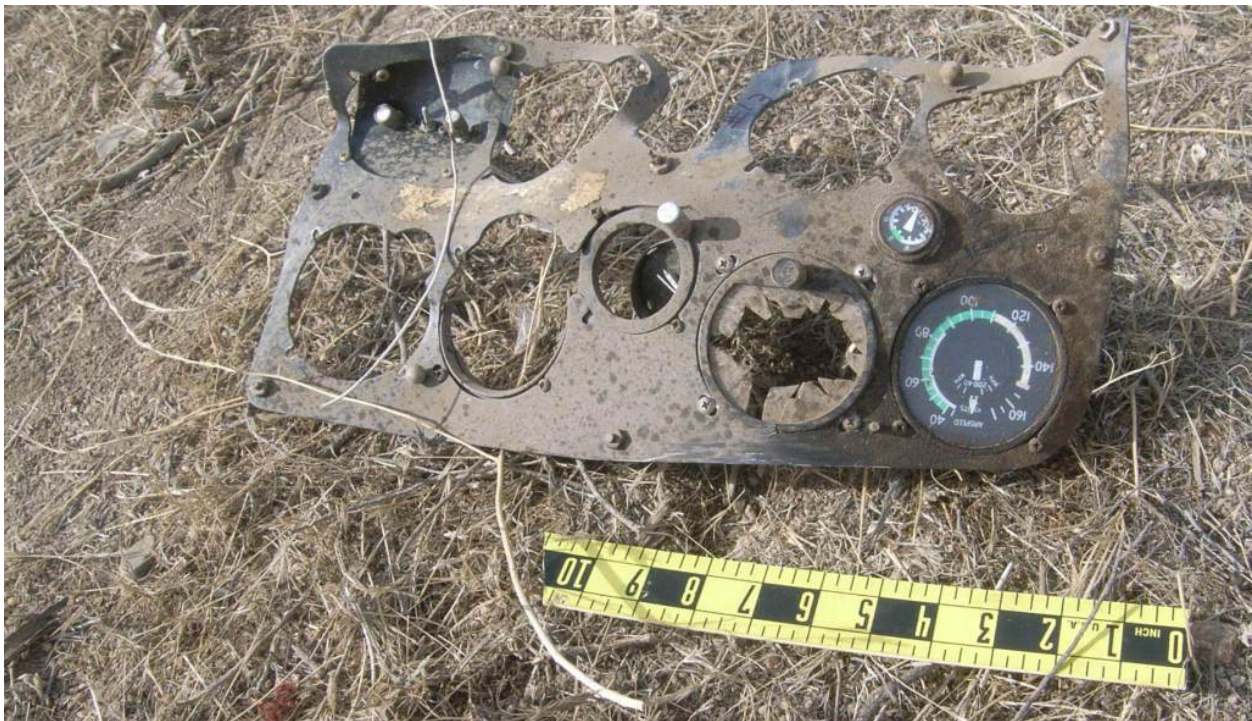
**Figure 22 - Instrument Panel Fragment**

- The following instrument readings were observed
  - Airspeed: In fracture-separated panel segment, 0 kts
  - Artificial Horizon: Fracture-separated from panel, crushed, no display information

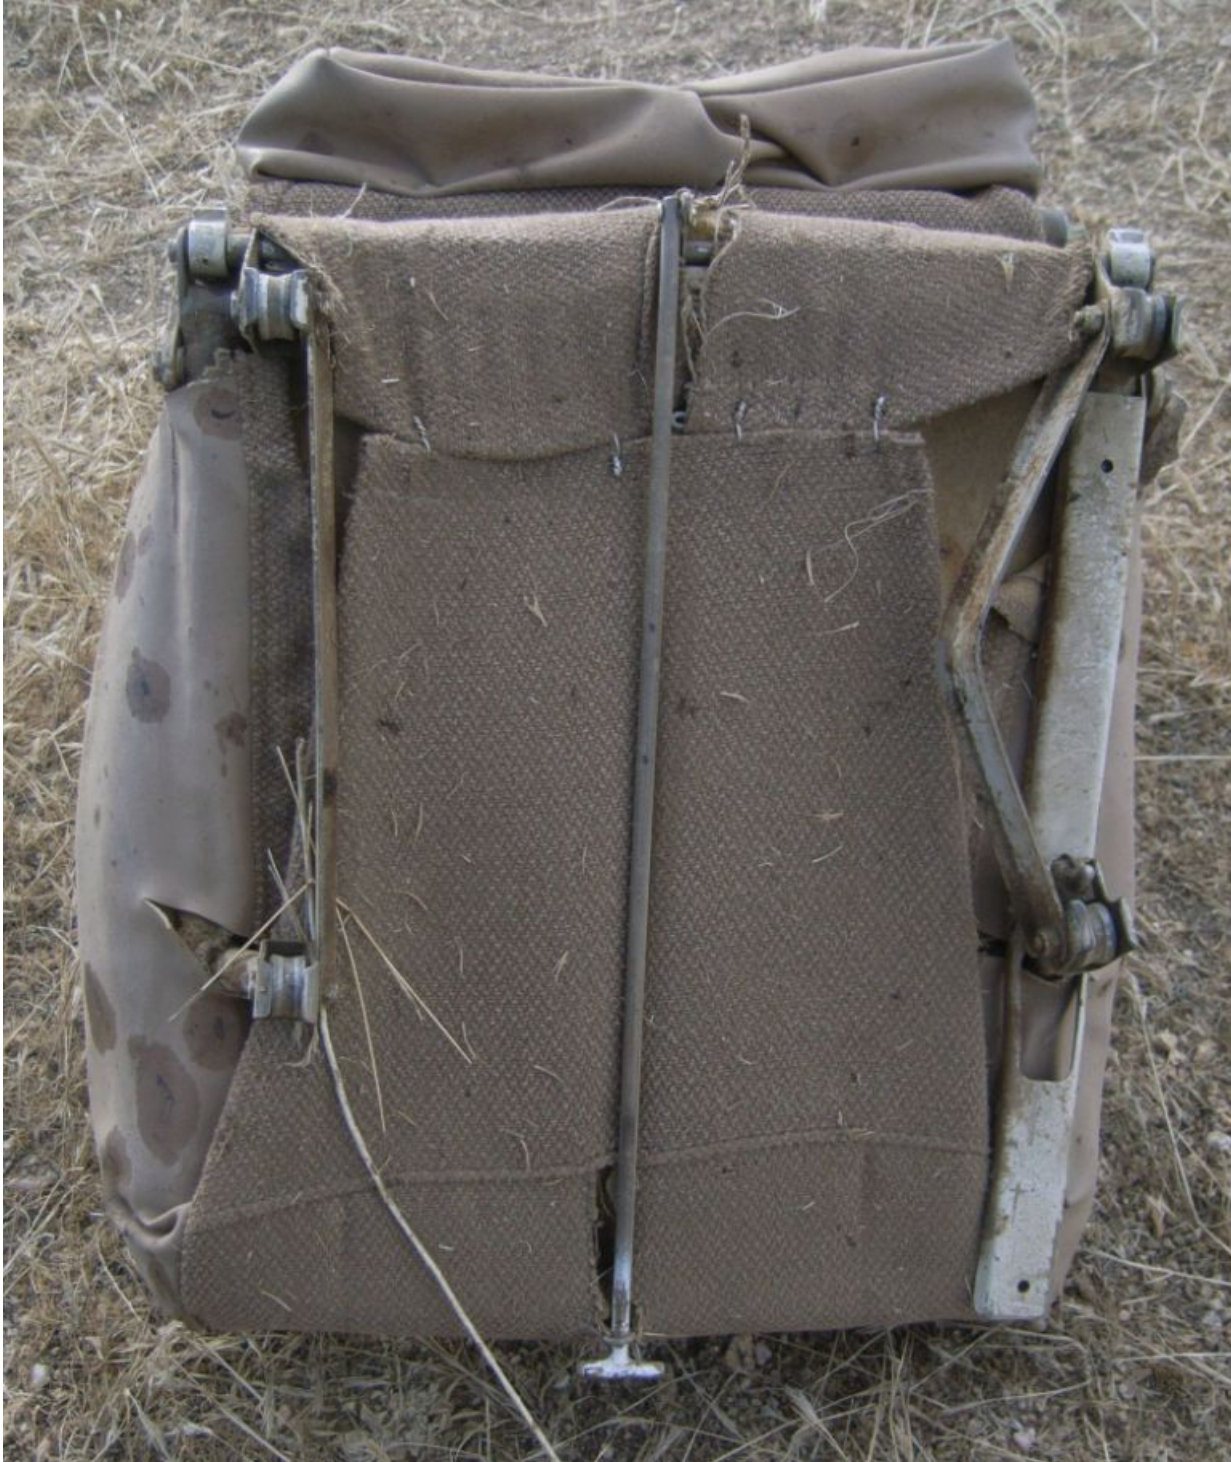
**Figure 30 – Underside of Left Seat**

- o L Fuel Qty: Off scale low (impact-damaged)
  - o R Fuel Qty: Off scale low (impact-damaged)
  - o Oil pressure: Undetermined due to impact damage
- The cockpit floor and attached seat rails were buckled
- The left seat was found fully detached from the cockpit floor, several feet from the main wreckage
- The right seat remained partially attached to the cockpit floor
- The airplane was equipped with 3-point (lap and single shoulder) occupant restraint harnesses
  - o The left harness lap and shoulder harness were buckled; the inboard lap belt stitching failed at its floor bracket attach wrap, which liberated the pilot
  - o The right seat harness components were all intact and remained attached to the fuselage
- The following cockpit/cabin items were recovered from the wreckage

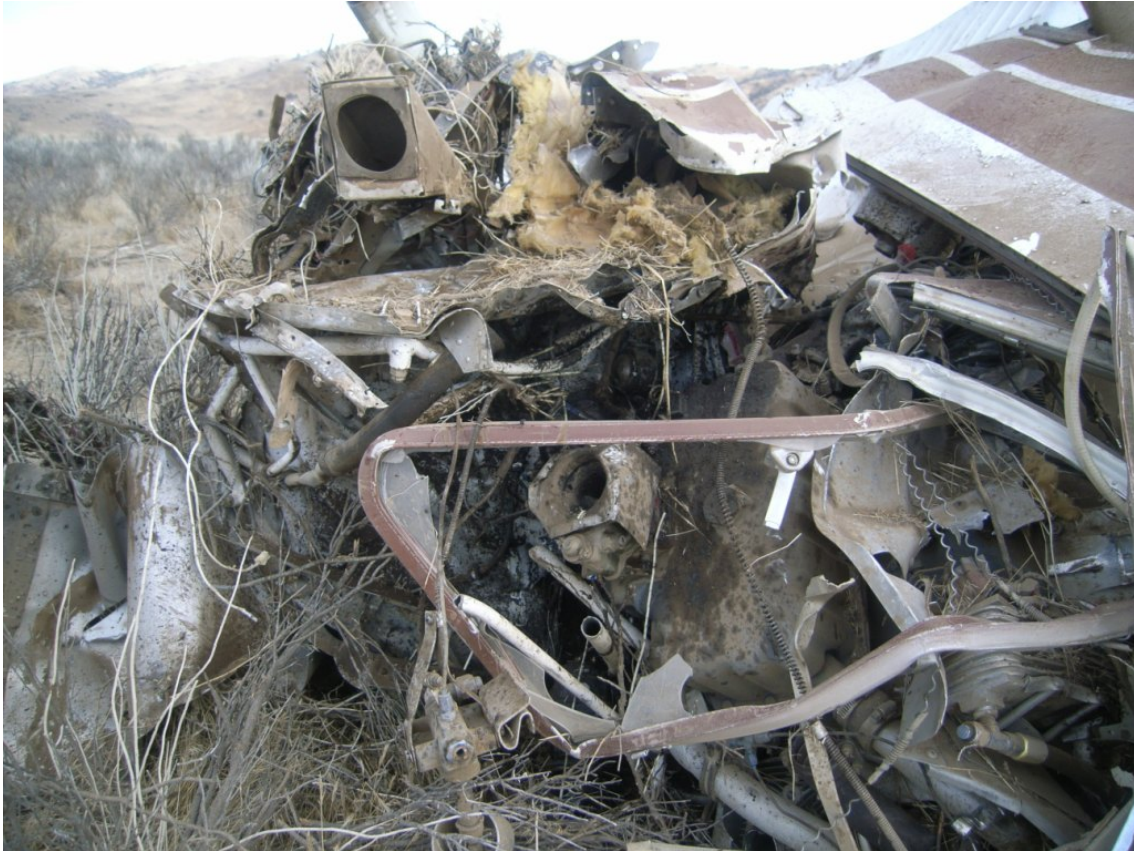
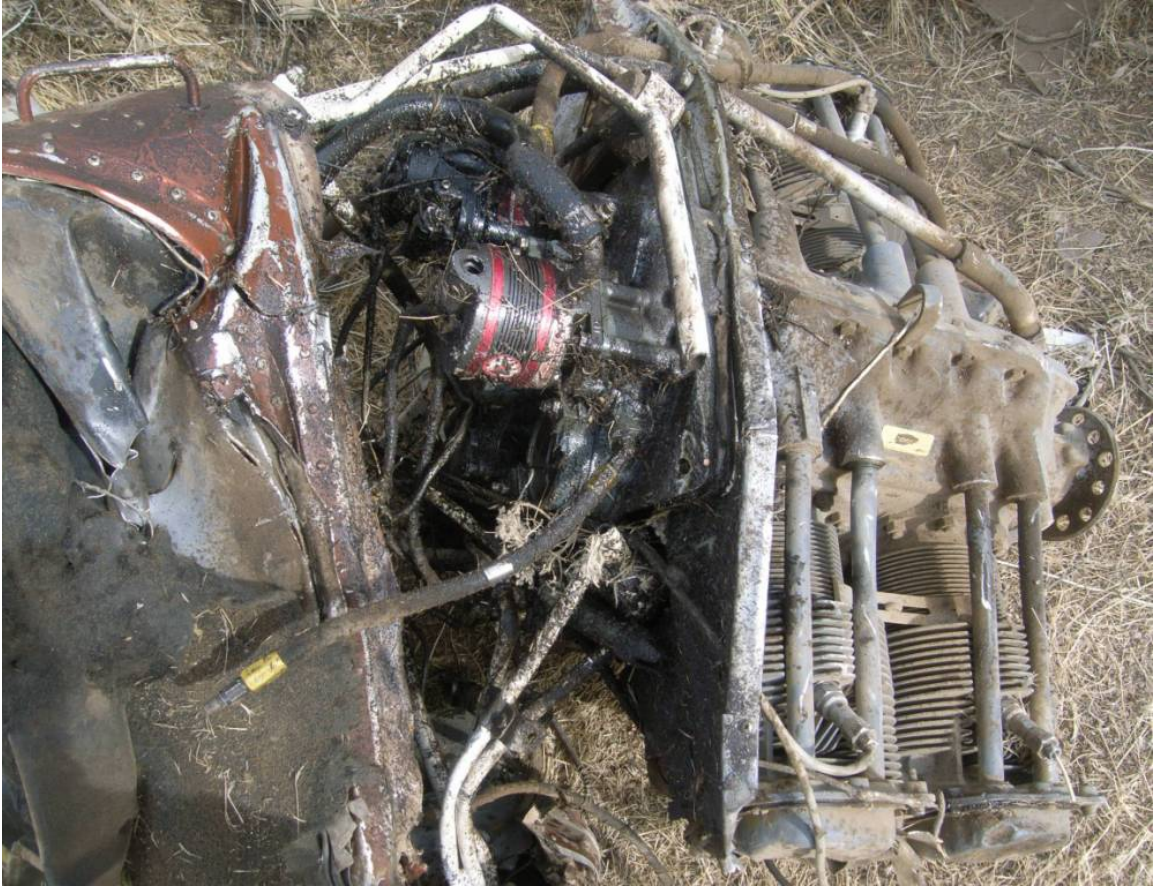
- The engine remained partially attached to the engine mount and forward fuselage
- The engine was essentially intact, but had sustained crush/impact damage in the aft and up directions
  - No evidence of any pre-impact catastrophic failures were observed
  - All four cylinders remained attached
  - The crankcase was not fractured
  - The carburetor remained attached and nearly intact
  - 7 spark plugs remained installed
- Several engine accessories or external components were fracture-separated from the engine
  - Starter
  - Right magneto
  - Alternator
  - No. 1 bottom (front right) spark plug
  - Muffler

**Figure 36 - Engine in Main Wreckage**

**Figure 37 - Engine**

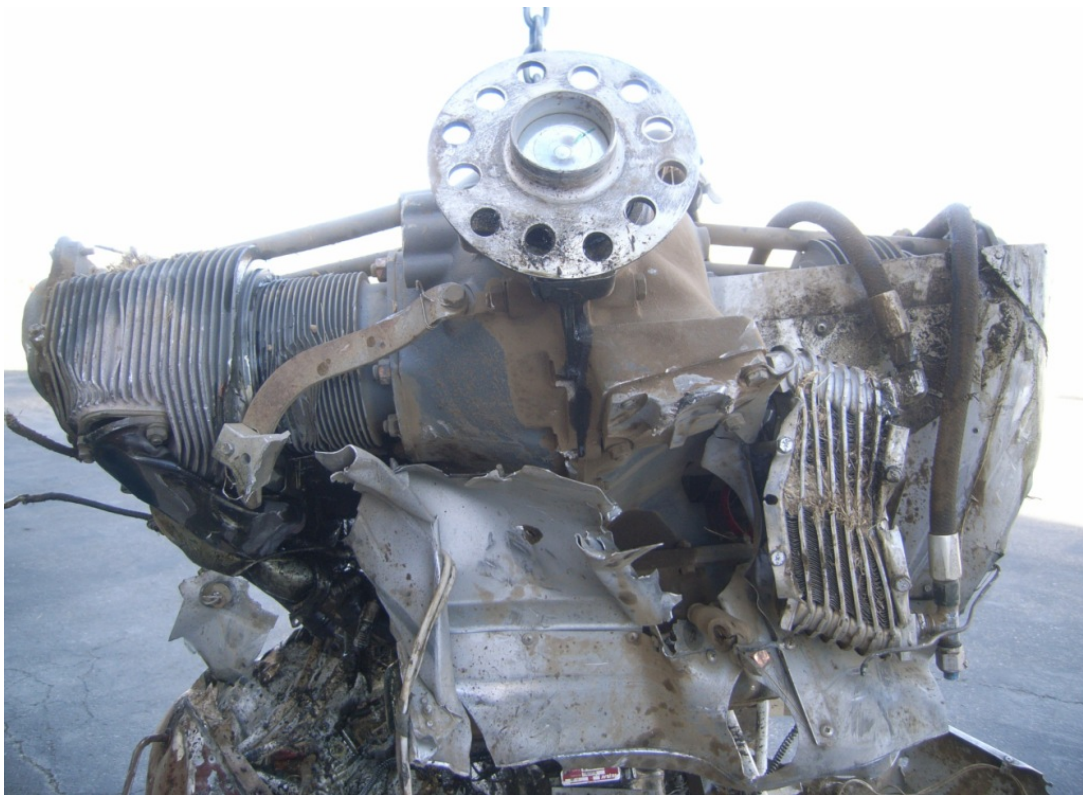
- The propeller was fracture-separated from the engine
  - The starter ring gear was separated from its attach flange
  - That flange was fracture separated from the engine and propeller, and fractured into multiple fragments

**Figure 38 – Engine and Propeller Flange**
