**Aircraft:** Beechcraft C90 King Air

**Registration No.:** N19LW

**Written by:** Les Doud  
Air Safety Investigator – Hartzell Propeller Inc.

**PROPELLER TEARDOWN REPORT**

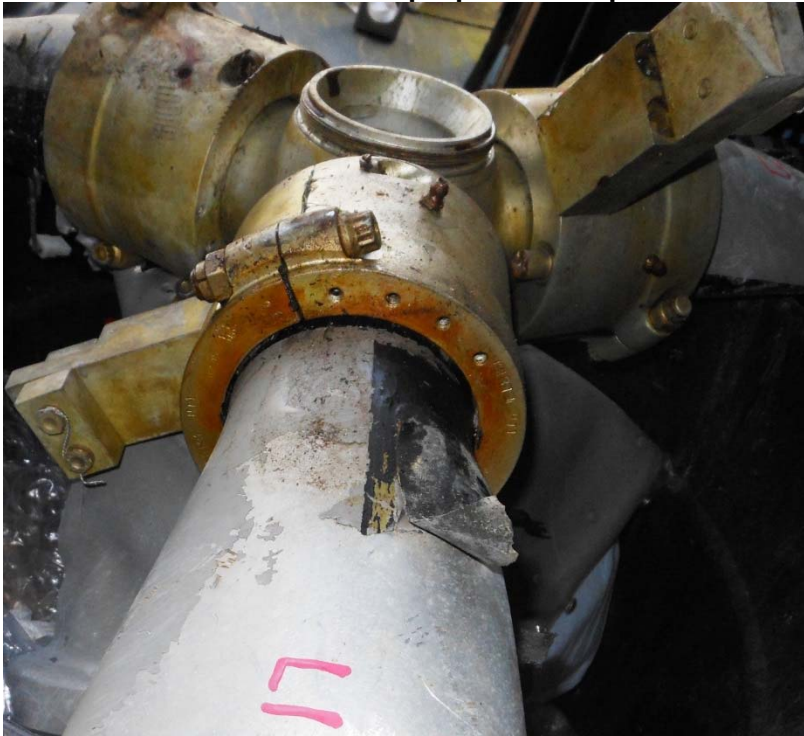
Photo #17 – Left propeller clamps

**Clamps and Counterweights:** (Photo #17). All the clamps appeared to be coated with a brownish-yellow substance that was not identified.
