# Continental Motors

## ENGINE EXAMINATION REPORT

| ENGINE MODEL | IO-550-B |
| FILE NUMBER | 17-337 |

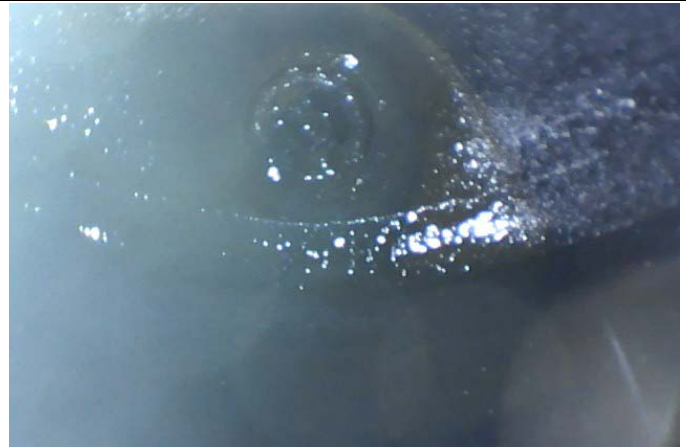
#1 Bottom

All of the spark plugs remained installed in their cylinders and displayed varying amounts of thermal damage signatures. The top spark plugs were removed and visually inspected and the bottom spark plugs were inspected using a lighted borescope. The electrodes displayed normal operating and wear signatures when compared with Champion Aviation Service Manual AV6-R. There were no anomalies noted.

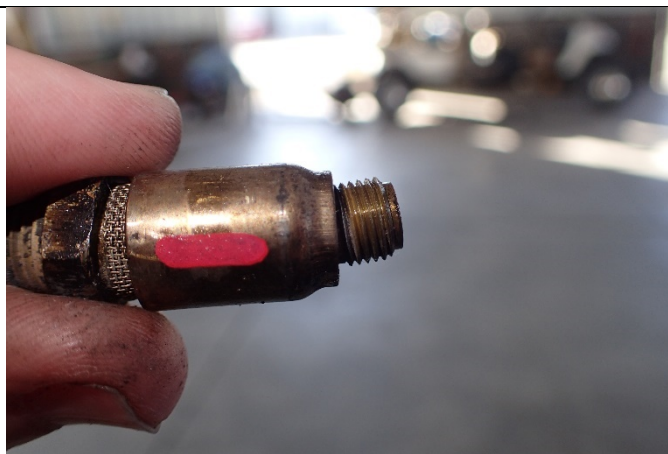
Bend in the #1 Nozzle

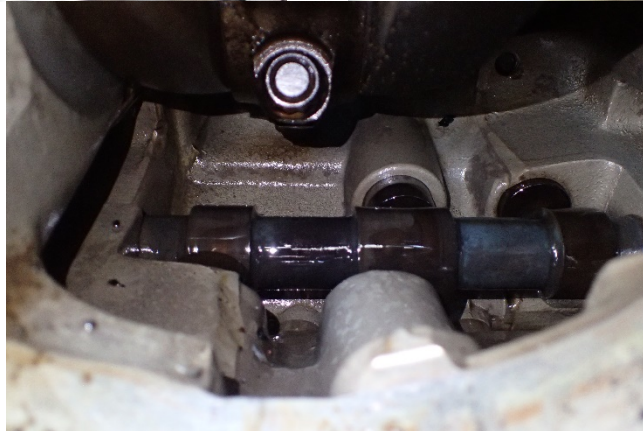
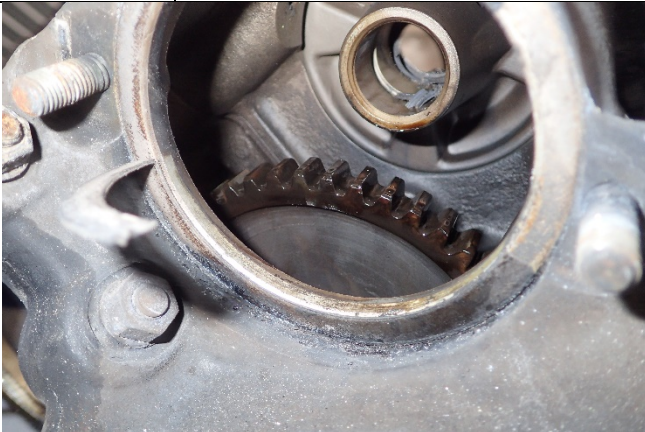
### ACCESSORY GEARS

The accessory gears displayed normal operating signatures. There were no anomalies noted with any of the gears.
