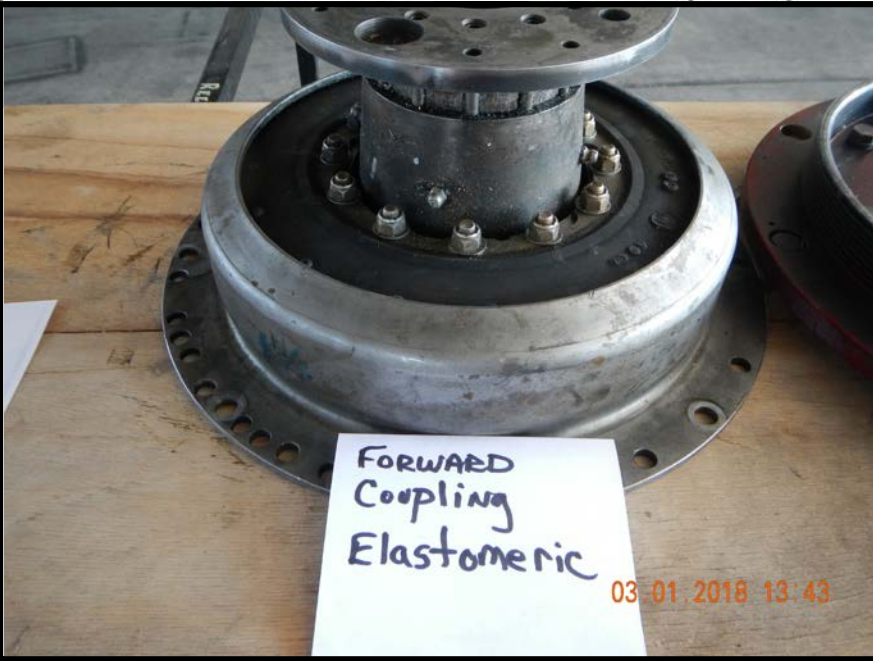
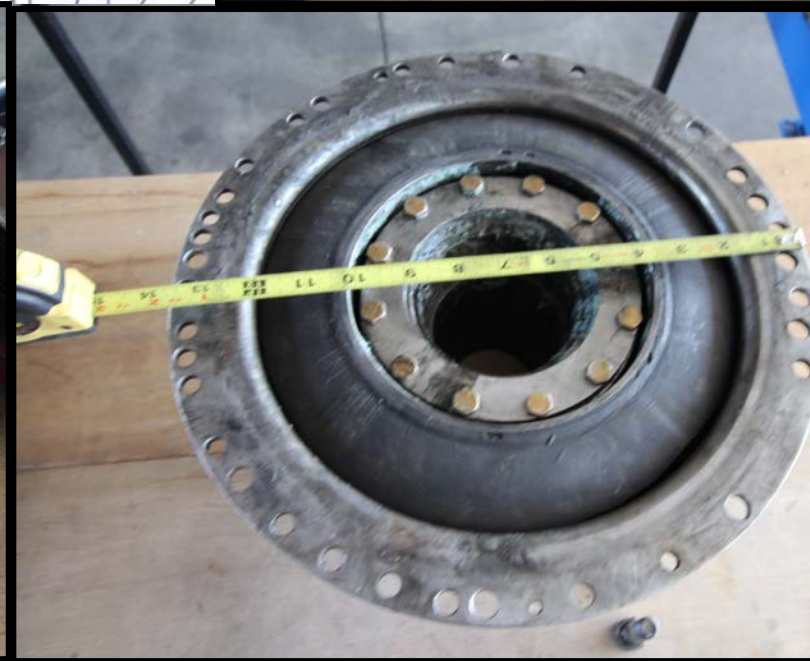
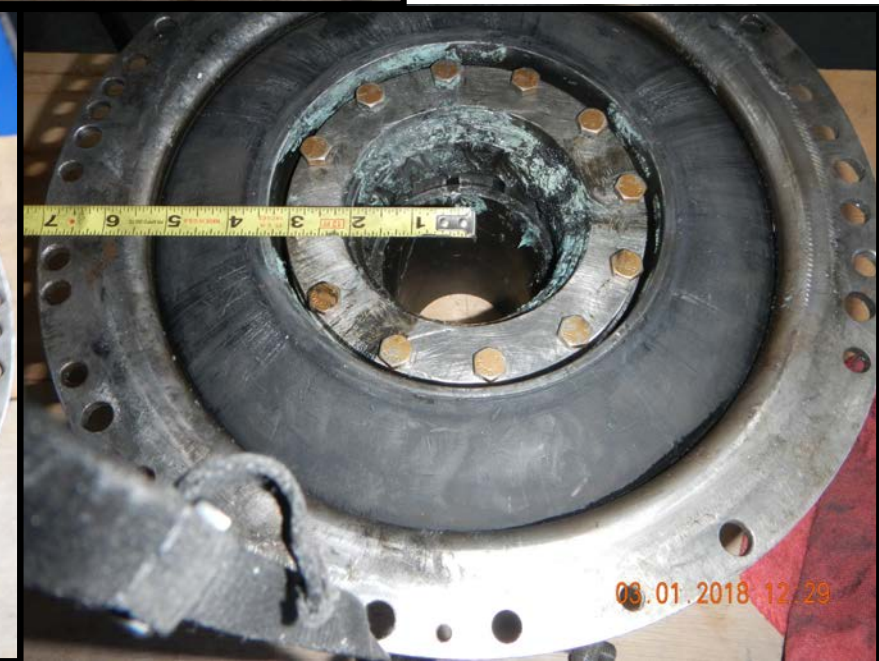
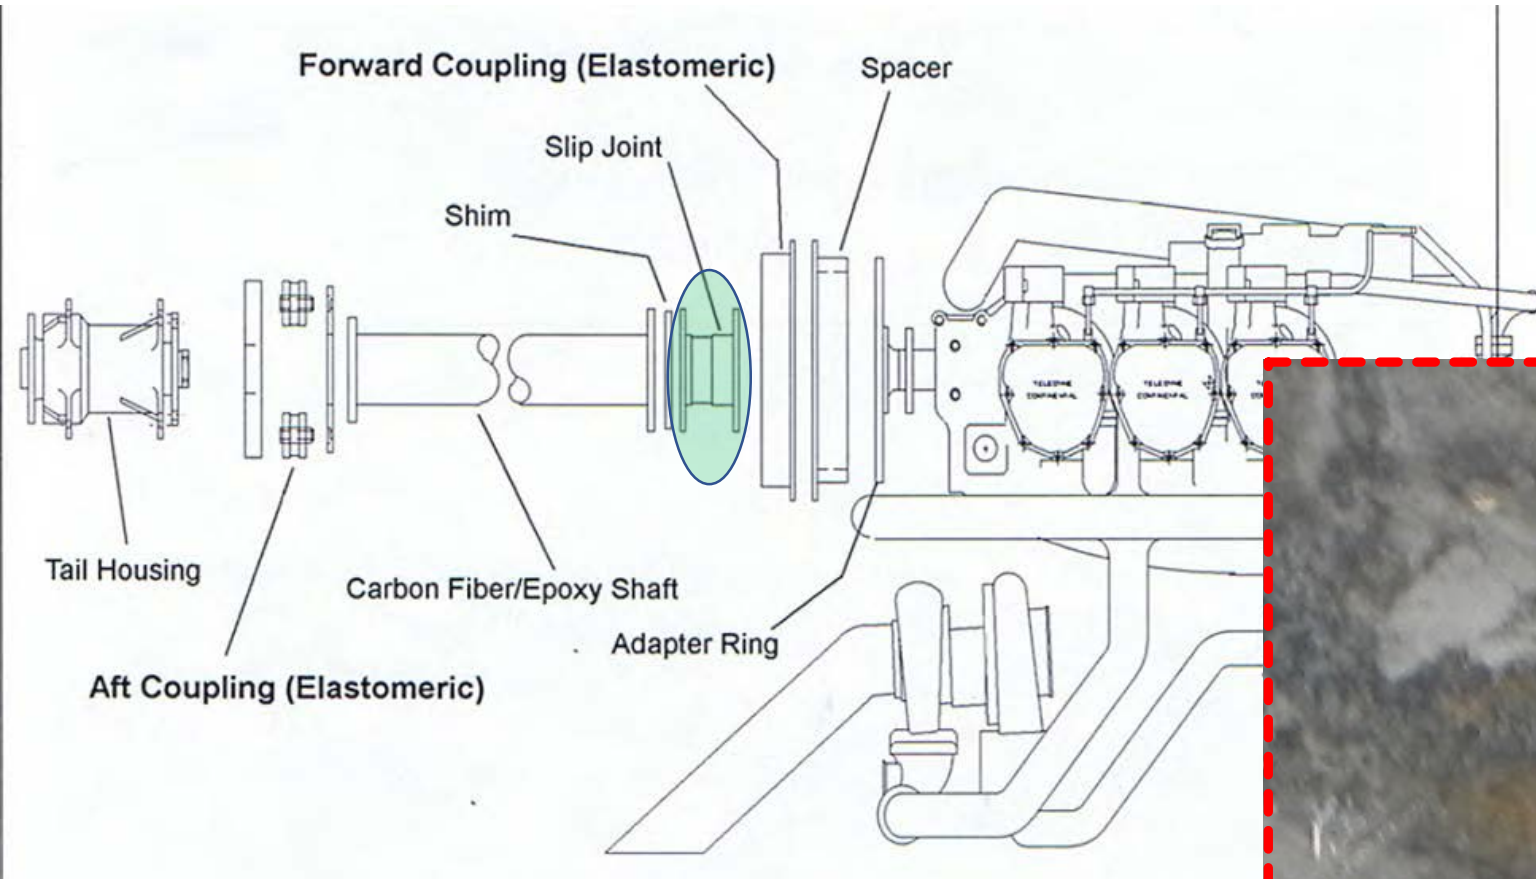
- Forward Coupling (Elastomeric)
- Dynaflex LCD Series Coupling
  - The forward bolts are about 3 inches from center.

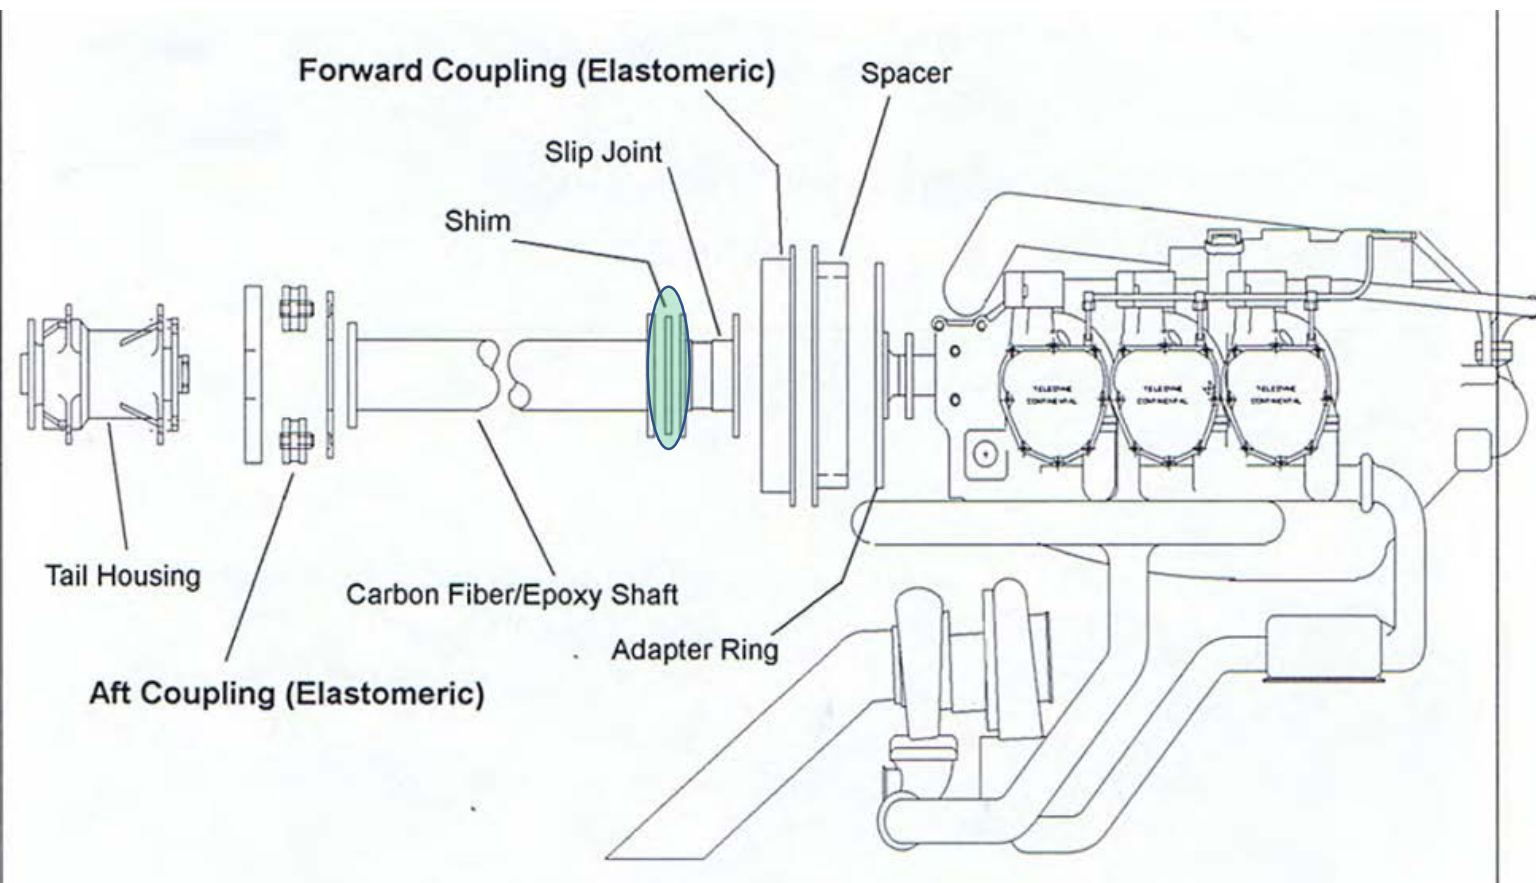
No shim was found between slip joint and drive shaft.

- According to the Cirrus Builders Association-Builders Newsletter, 10-CBA Nov. 1995, a shim was required between the drive shaft flange and the slip joint.
- There was not a shim present at the time of the exam.

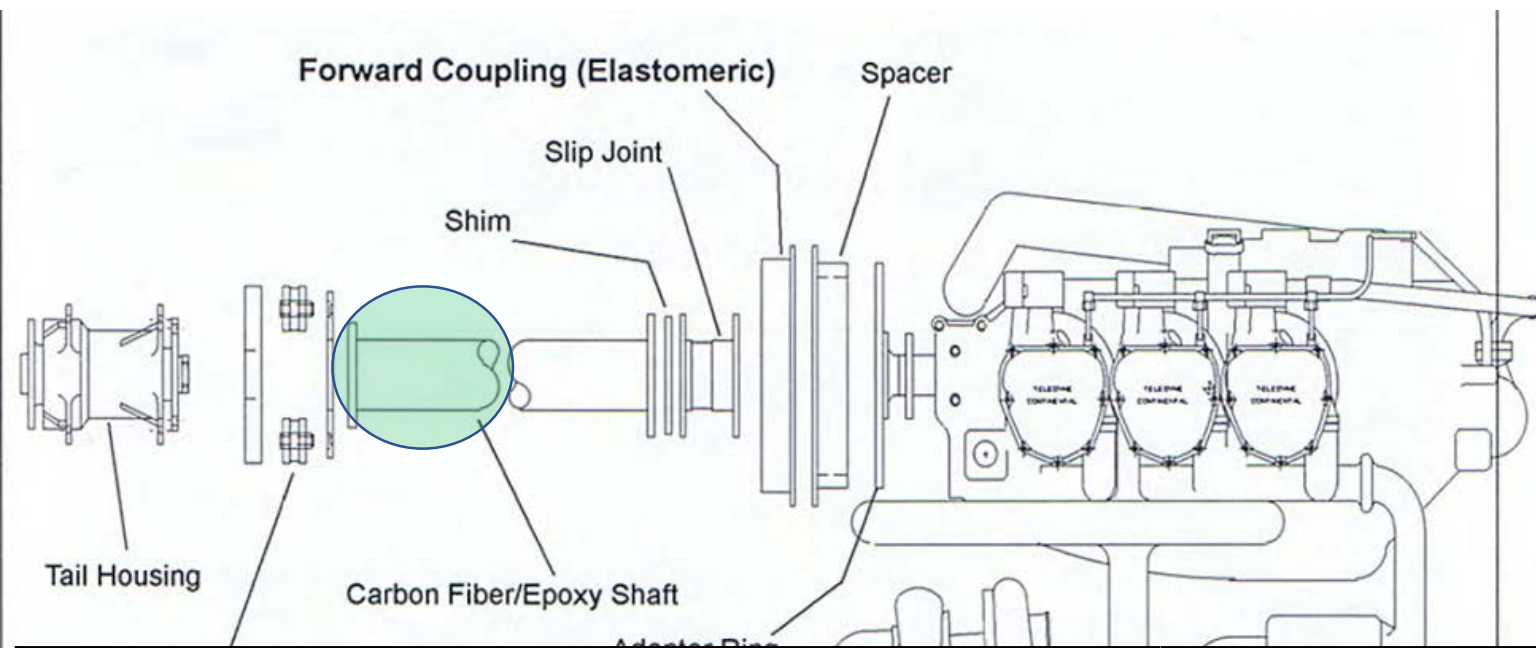
About 23 inches of the drive shaft was removed from the drive shaft and the remaining drive shaft was shipped to DC for further examination.

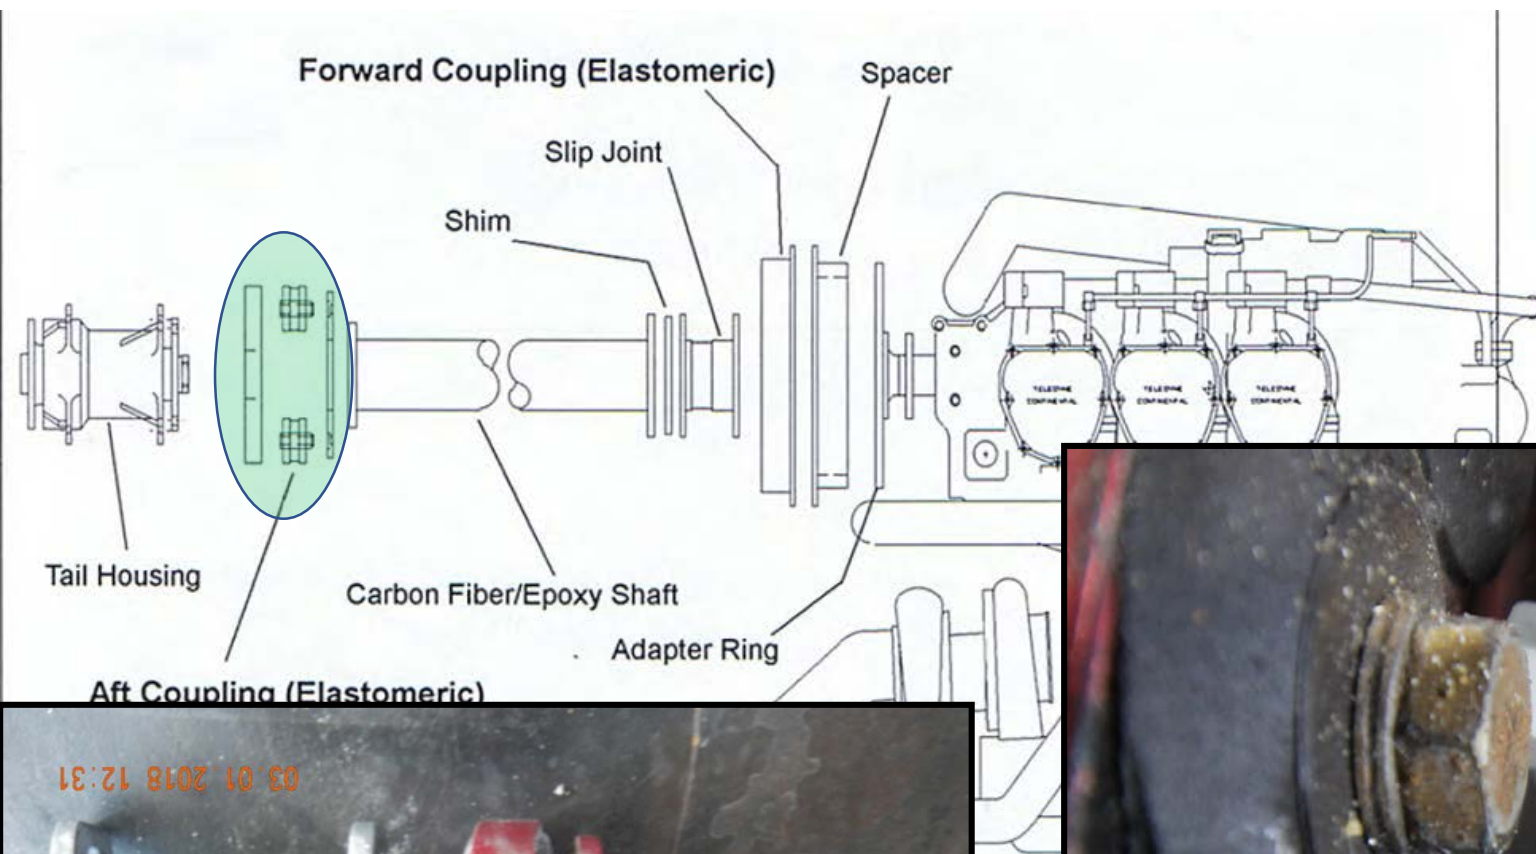
About 18 inches of the drive shaft remained attached to the aft coupling. The drive shaft was shipped to DC for further examination.

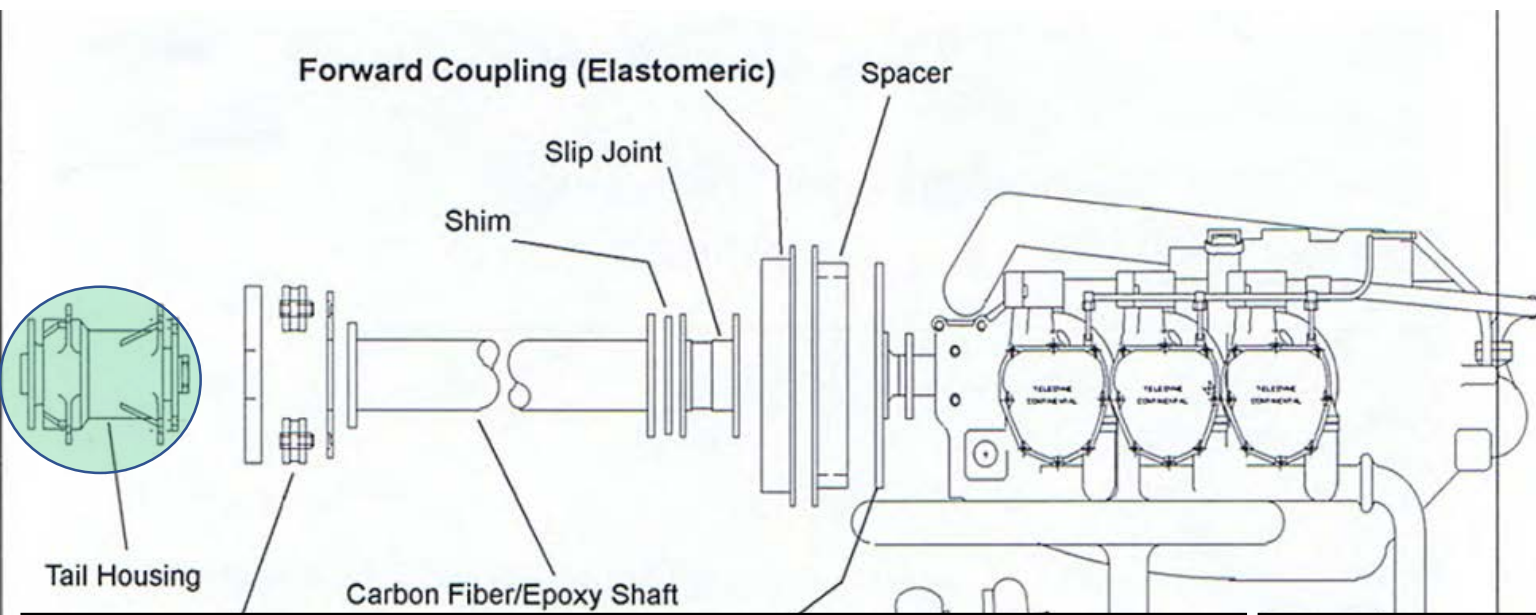
- The aft coupling remained attached to the tail housing and about 18 inches of the drive shaft.
- All three components were removed from the tail section as they were found. There were two bolts that connected the aft coupling to the tail housing, and one of those two bolts was backed off about 2.11mm.
- The aft coupling, tail housing, and drive shaft were shipped to DC for further examination.
