**National Transportation Safety Board**  
Office of Research and Engineering  
Washington, D.C. 20594

## Airplane Performance Study

| Airplane: | Piper PA-34-200T “Seneca II”, Registration N14GQ |
| NTSB Number: | WPR18FA091 |

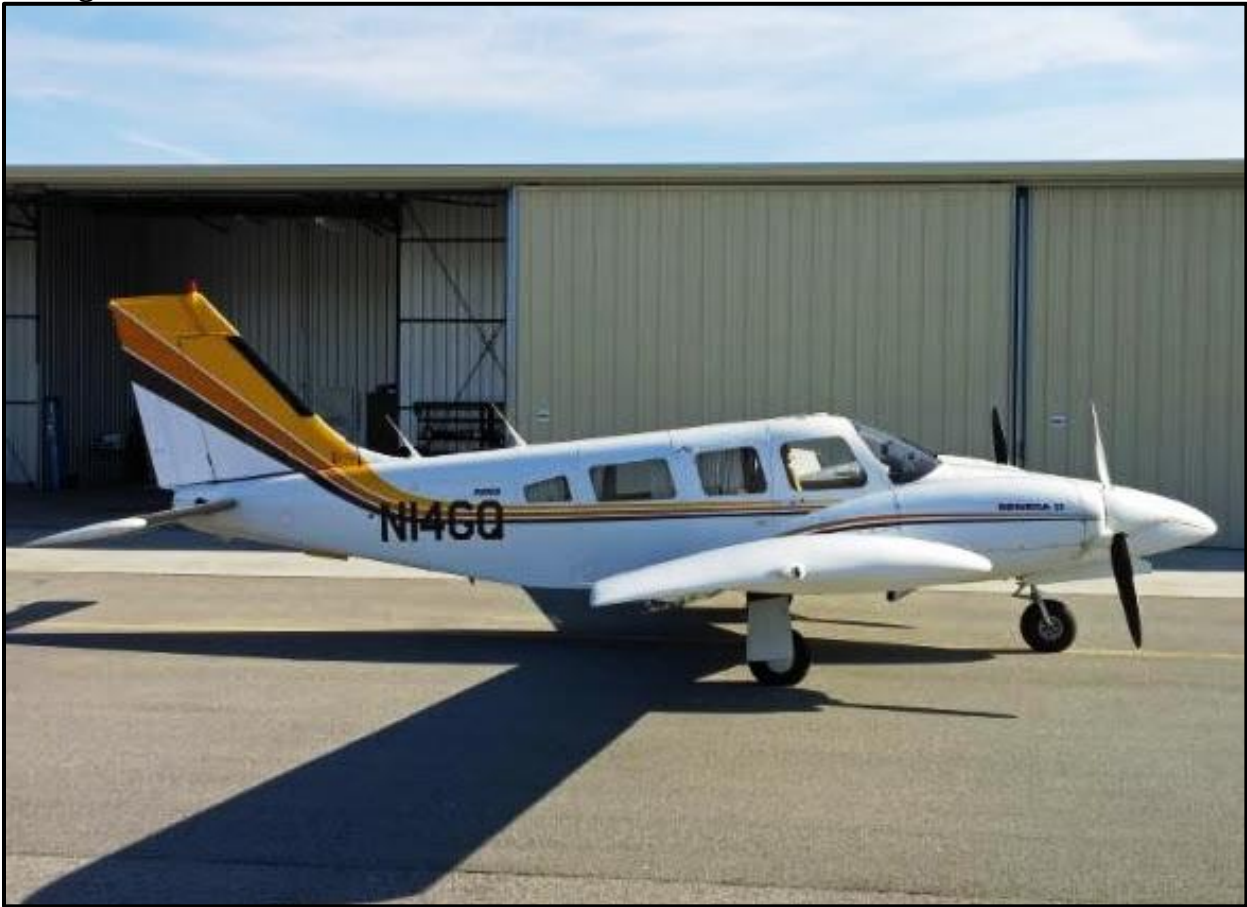
**Figure 1: Accident Airplane N14GQ, a Piper PA-34-200T “Seneca II”**

On February 19, 2018, about 1125 Pacific Standard Time (PST), a Piper PA-34-200T airplane, N14GQ, collided with the ground about 3.5 nautical miles (NM) northwest of the Minden-Tahoe Airport (MEV), Minden, Nevada (NV). The commercial pilot was fatally injured, and the airplane was destroyed. The airplane was registered to Stunad, LLC, and operated by the pilot under the provisions of Title 14 Code of Federal Regulations (CFR) Part 91 as a personal flight. Visual meteorological conditions prevailed. The one-hour, fifty-one minute flight originated from Meadows Field Airport (BFL), Bakersfield, California, about 0935 PST with an intended destination of MEV. See Figure 1 for a picture of the accident airplane.

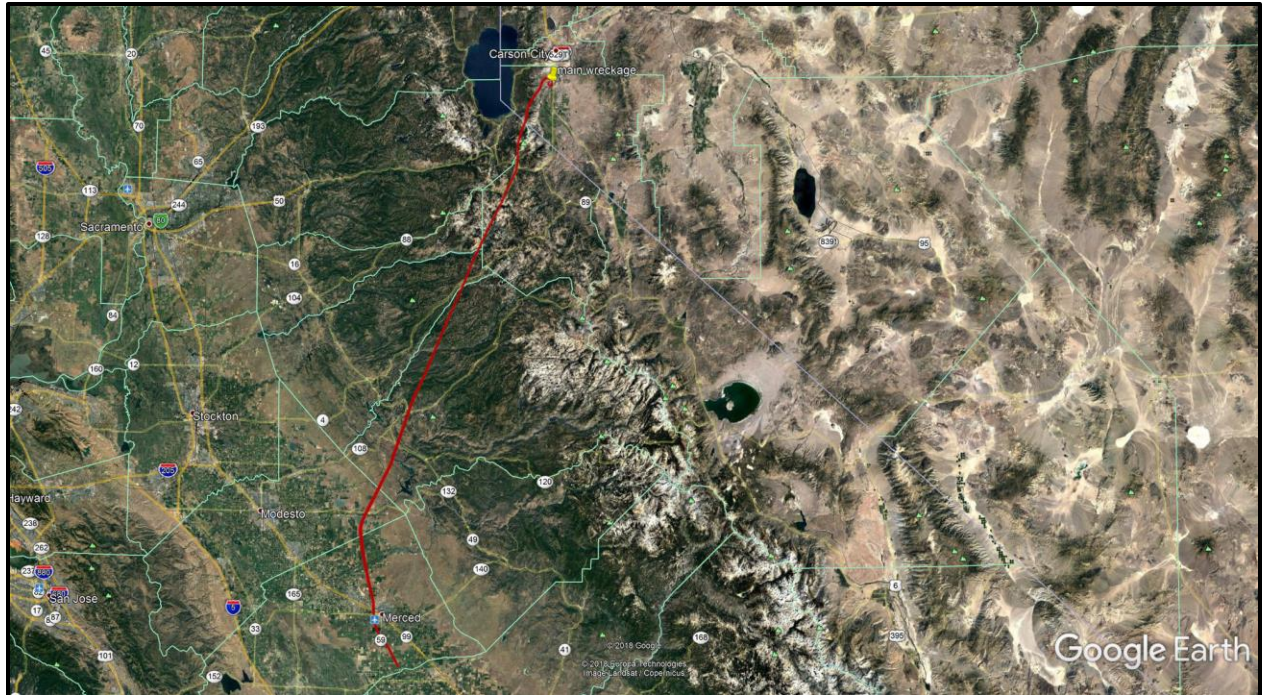
**Figure 3: Appareo Stratus Ground Track for the Flight**

Figure 3 highlights the ground track for the entire flight from BFL to the accident site recovered from the Appareo Stratus receiver. Figure 4 shows approximately the last five minutes of the flight and the main wreckage site in more detail.
