# **National Transportation Safety Board**

## **Airplane Performance Study with Air Traffic Control Communications**

| Airplane: | PIPER PA34, N14GQ |
| NTSB Number: | WPR18FA091 |

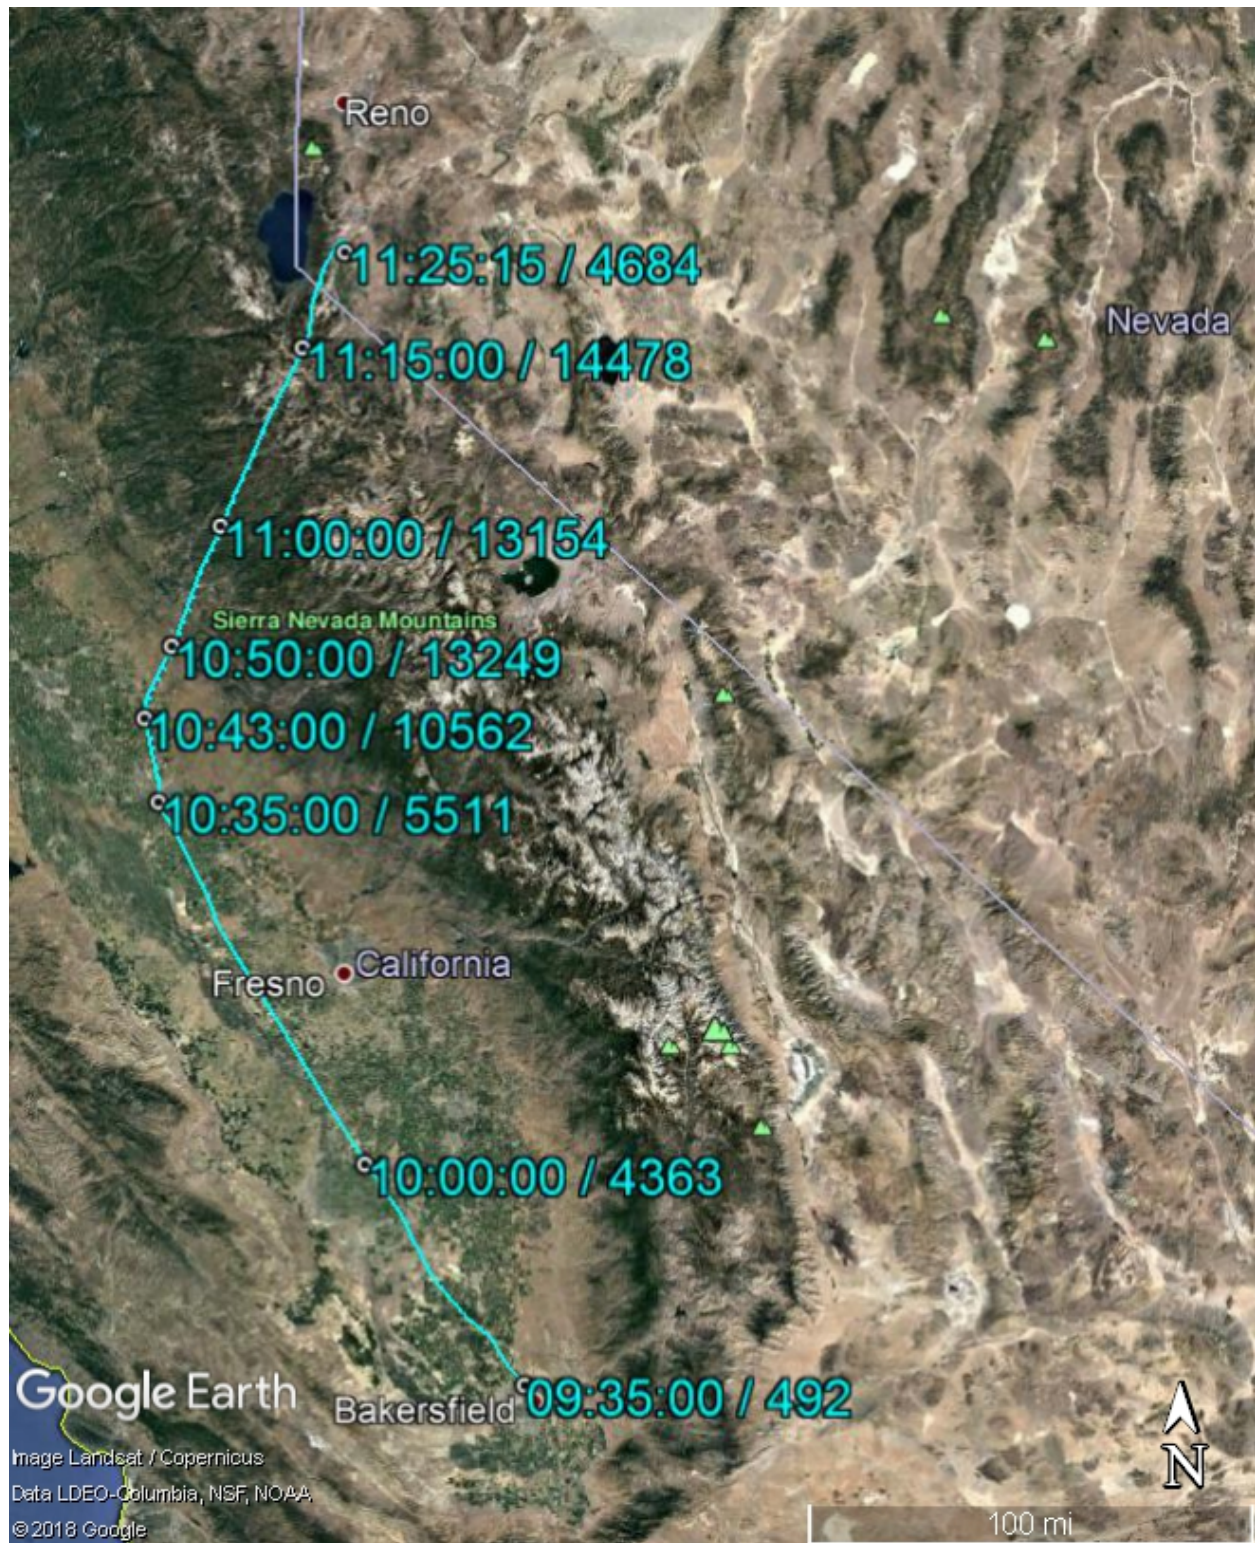
The aircraft took off from Meadows Field Airport in Bakersfield, California at about 09:35 (Figure 1). The airplane flew up the Central Valley of California at an altitude of about 4,300 ft and a groundspeed between 130 and 150 kts (Figure 2). Just after 10:30 the airplane began turning right and climbing. By 10:50 the airplane was above 13,000 ft and on a track of 23° over the Sierra Nevada Mountains. Its groundspeed was between 140 and 150 kts. By 11:15 the airplane's altitude was above 14,000 ft and it was near the California-Nevada border.

Figure 1. Airplane flight path with time and altitude annotated.

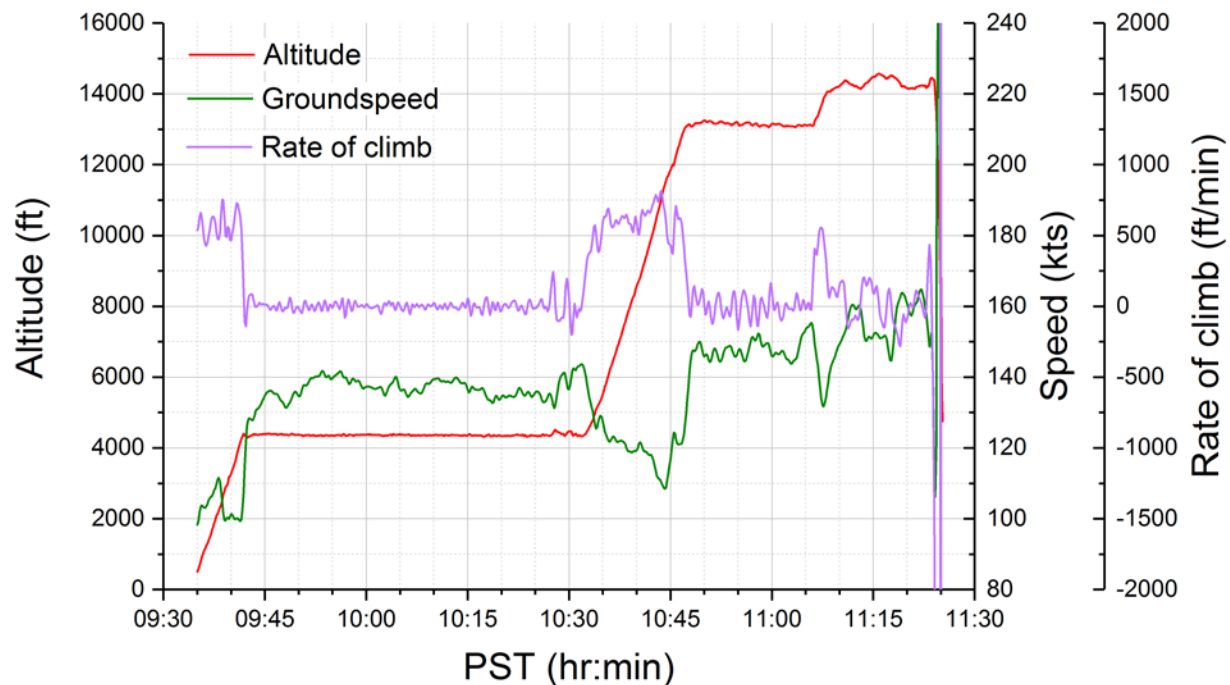
**Figure 2.** Altitude, groundspeed, and rate of climb for whole flight.

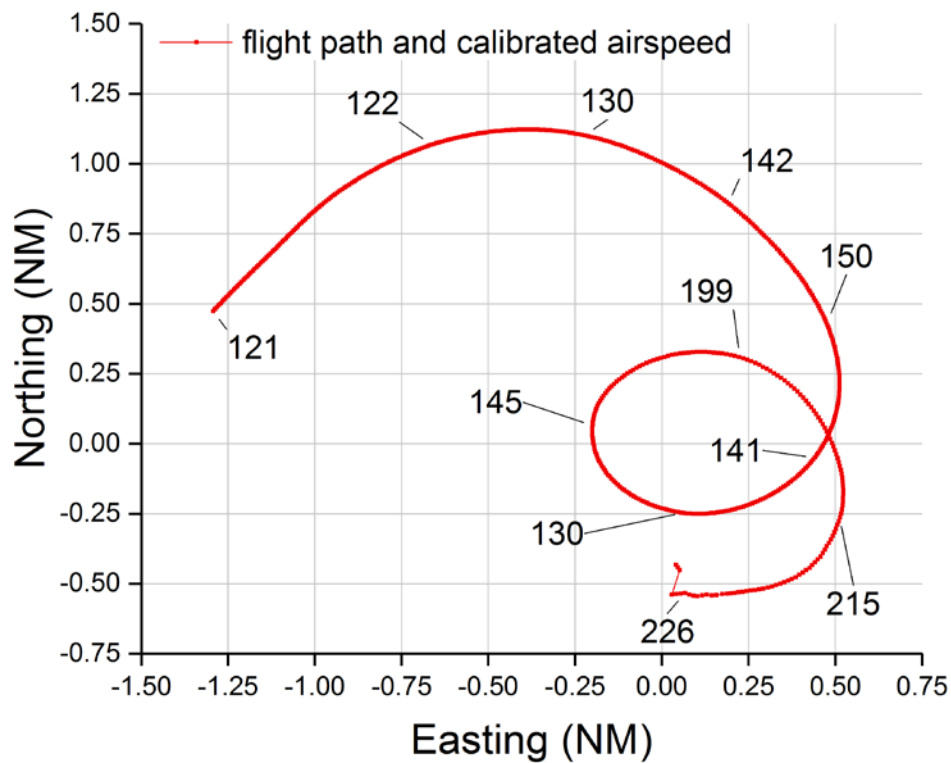
**Figure 5.** Airplane flight path with airspeeds.

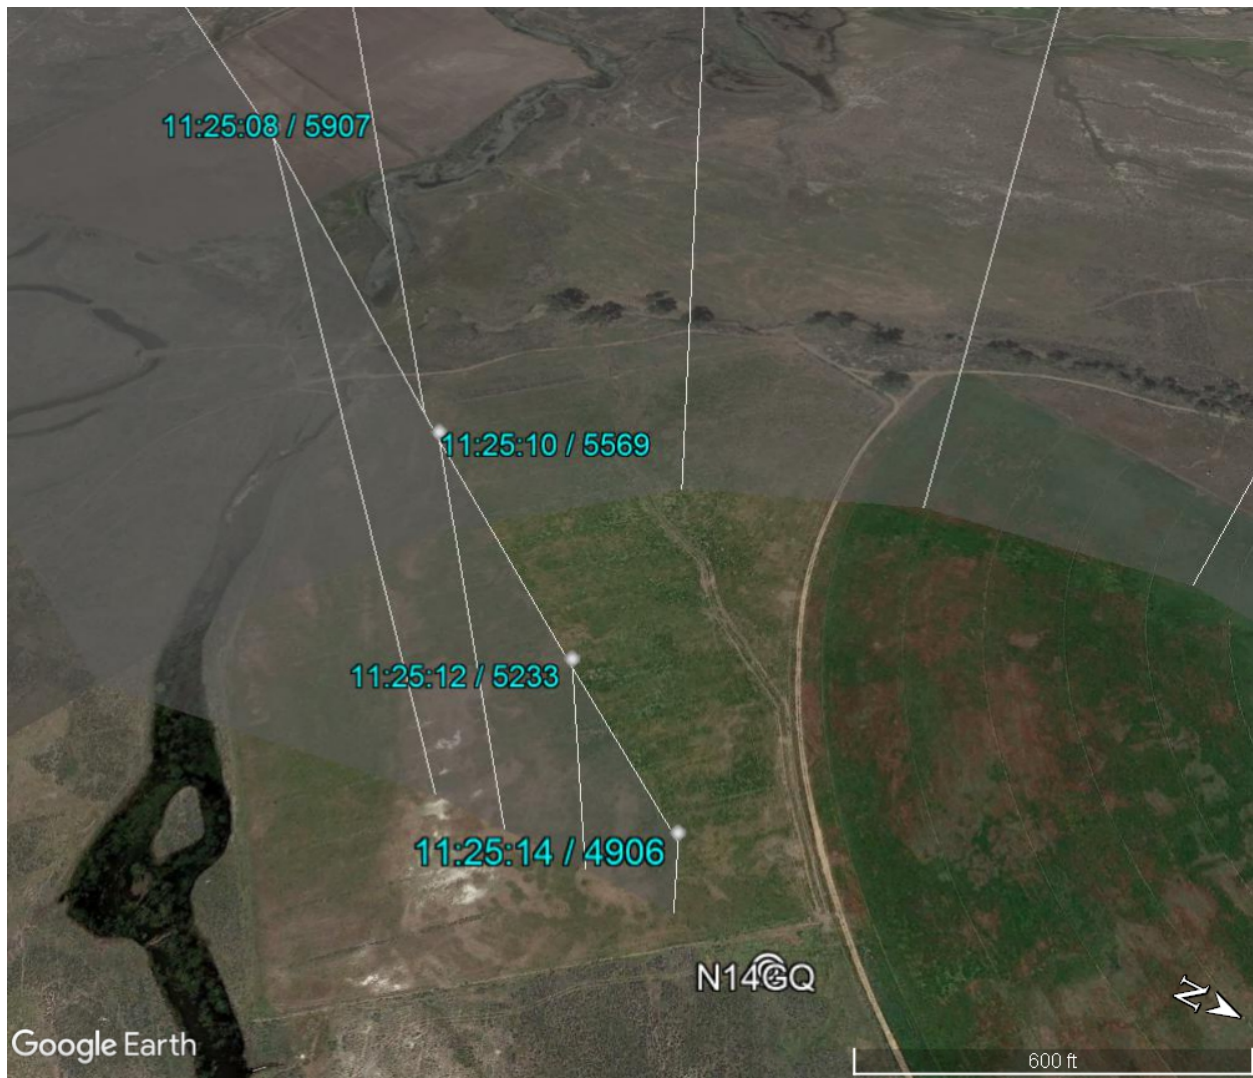
Figure 7 shows the recorded flight path with data points between 11:24:50 and 11:25:08 removed. The final six seconds of data from 11:25:08 until 11:25:15 did show a flight path and altitude consistent with the airplane fuselage's final resting point (Figure 8). The elevation of the debris field was about 4,600 ft above sea level. The wreckage lay along a heading of 345° from the southern-most stabilator trim tab to the fuselage, which was a mile away.

**Figure 8.** Airplane flight path and fuselage, marked as N14GQ.
