## **NATIONAL TRANSPORTATION SAFETY BOARD**

# **AIRFRAME AND ENGINE EXAMINATION**

**WPR18FA095**

Location: Monticello, Utah  
Date: February 22, 2018  
Aircraft: Piper PA-32R-300, C-GYGY, Serial # 32R-7680182  
NTSB IIC: Michael Huhn

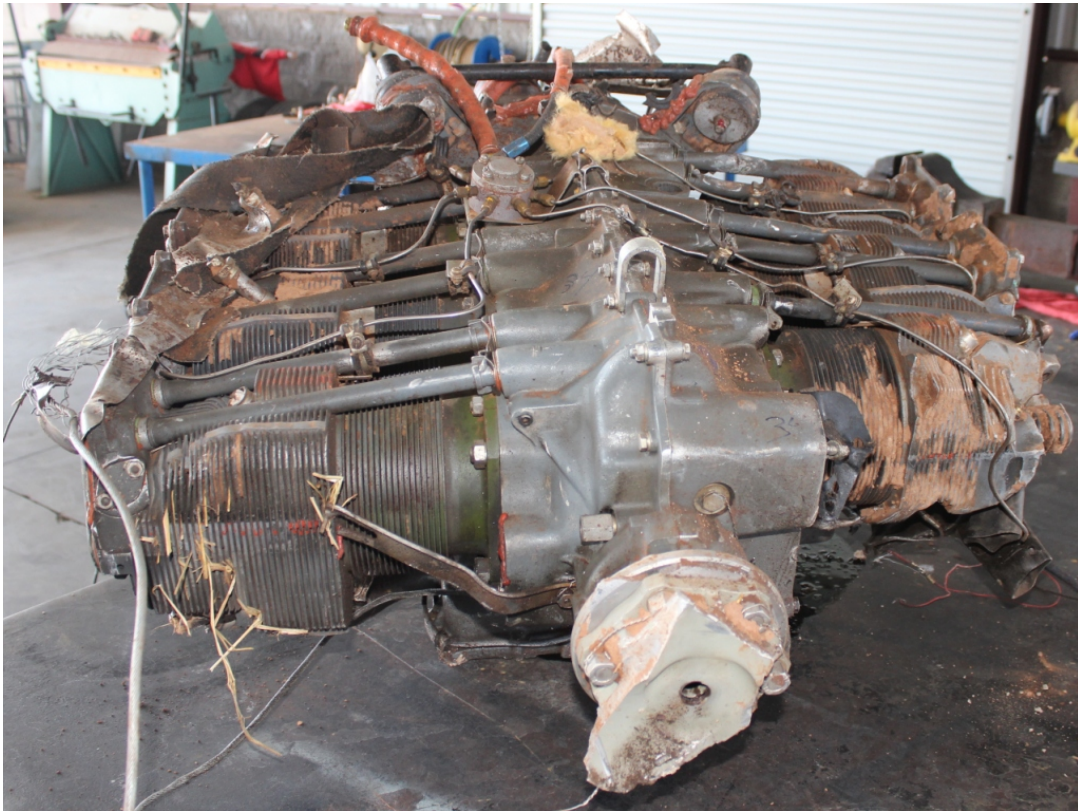
**Figure 18 - Engine Front**

The engine had been liberated from the airframe at the engine mount during the accident sequence. The engine had sustained significant impact damage, which separated the propeller assembly, starter, alternator, propeller governor, exhaust system, single drive-dual magneto, fuel pump, fuel injection servo and oil filter. The number two cylinder head had sustained significant impact damage that separated most of the rocker box casting and intake valve rocker assembly.
