## **NATIONAL TRANSPORTATION SAFETY BOARD**

# **ACCIDENT SITE EXAMINATION SUMMARY**

**WPR18FA104**

Location: La Center, WA  
Date: March 11, 2018  
Aircraft: Piper PA-18-150, N4511Y  
NTSB Investigator-in-Charge: Maja Smith

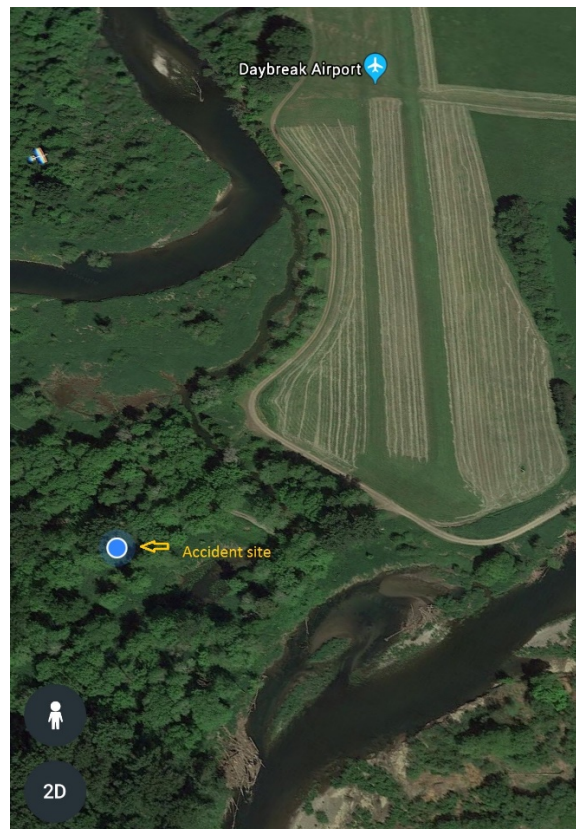
Image 1-Satellite View

The accident site was located in the wooded terrain field near privately owned Daybreak Airport (WA46), Le Center, WA. The wreckage was positioned about 530 ft from the approach end of runway 31 on a 228° bearing from the runway.
