## **NATIONAL TRANSPORTATION SAFETY BOARD**

# **ACCIDENT SITE EXAMINATION SUMMARY**

**WPR18FA155**

Location: Melville, New York  
Date: May 30, 2018  
Aircraft: N62382; North American SNJ-2  
NTSB Investigator-in-Charge: Andrew Swick

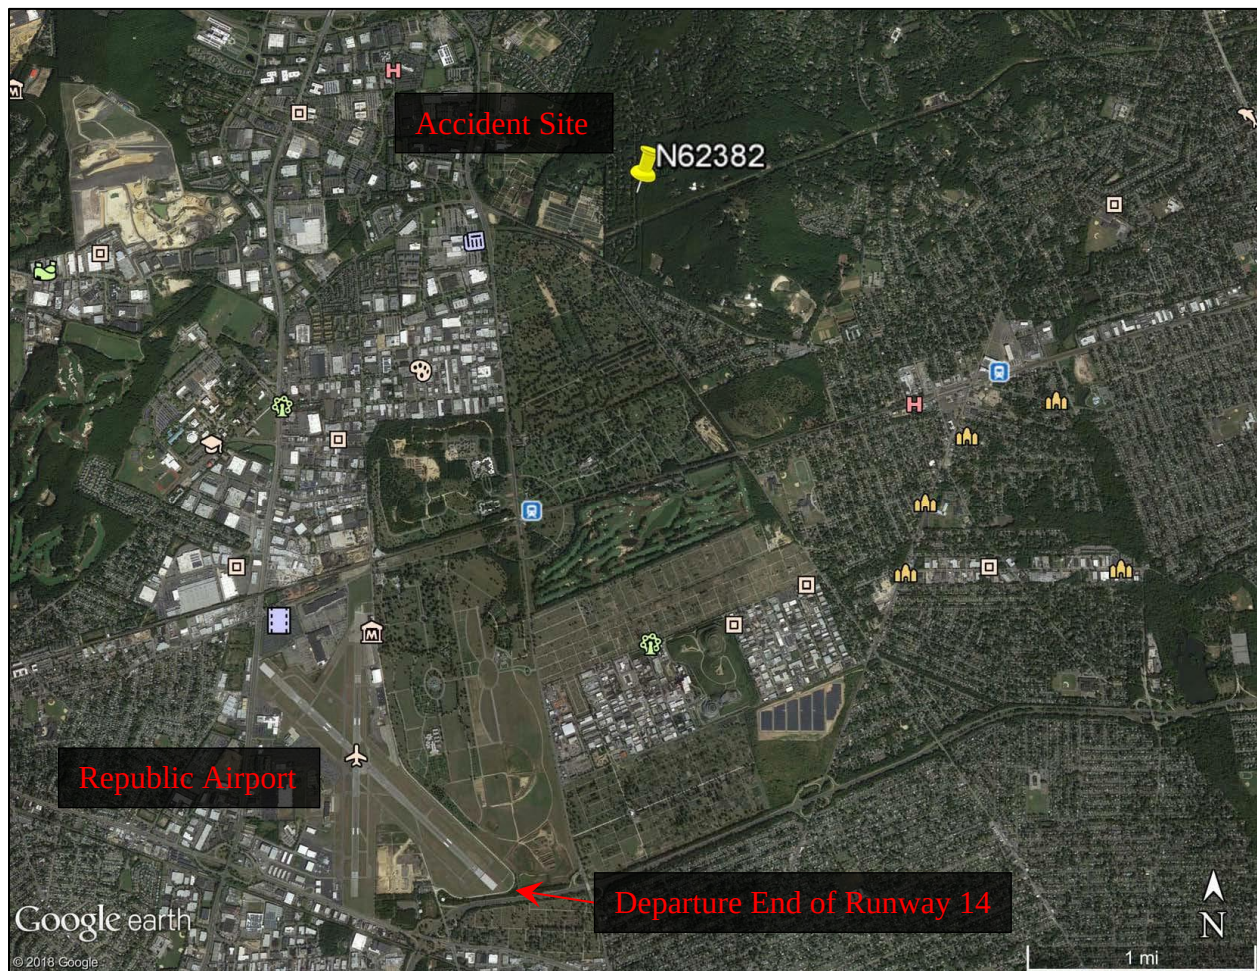
Main Wreckage: N 40° 46.050', W-073° 23.423' – Elevation: 155 feet  
Accident site was about 2.5 miles north of the departure end of runway 14 at FRG.

Figure 1-Aerial View of FRG and the Accident Site
