# WPR18FA188 - Examination Notes

## National Transportation Safety Board Office of Aviation Safety Washington, D.C. 20594

| Aircraft: | N8648F / MDHI 369D |

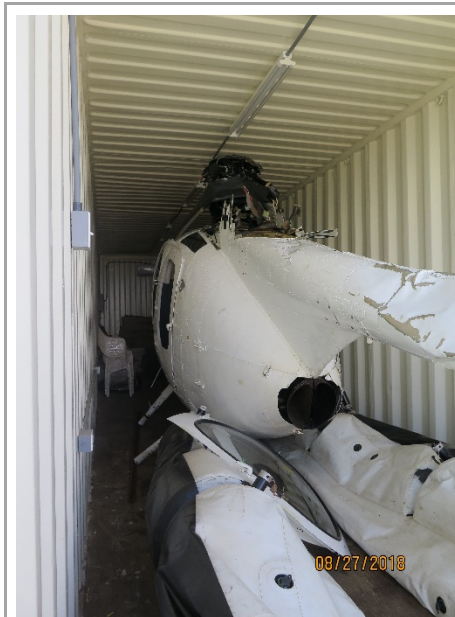
Figure 2 - In Conex

The helicopter was stored in a temperature and humidity controlled conex box and secured with a lock on the conex doors. The skids and floats had been removed and the rear landing gear struts depressurized to facilitate placement of the helicopter in the conex.
