## **NATIONAL TRANSPORTATION SAFETY BOARD**

### **AIRFRAME EXAMINATION**

**WPR18FA232**

Location: Granger, Texas  
Date: August 21, 2018  
Aircraft: Hughes 369FF, Registration: N530FU  
NTSB IIC: Elliott Simpson

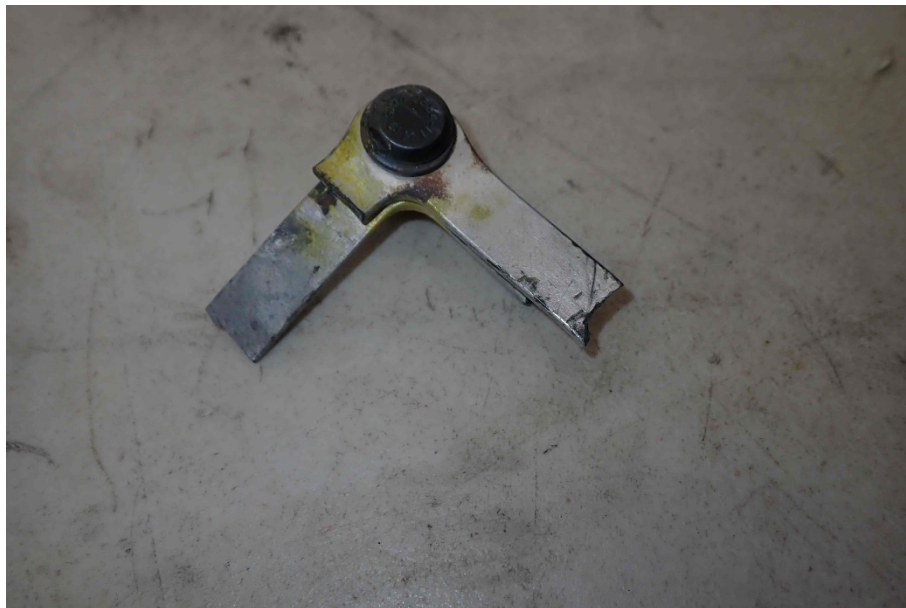
**Photo 11 – Flexible Coupling Fractures**

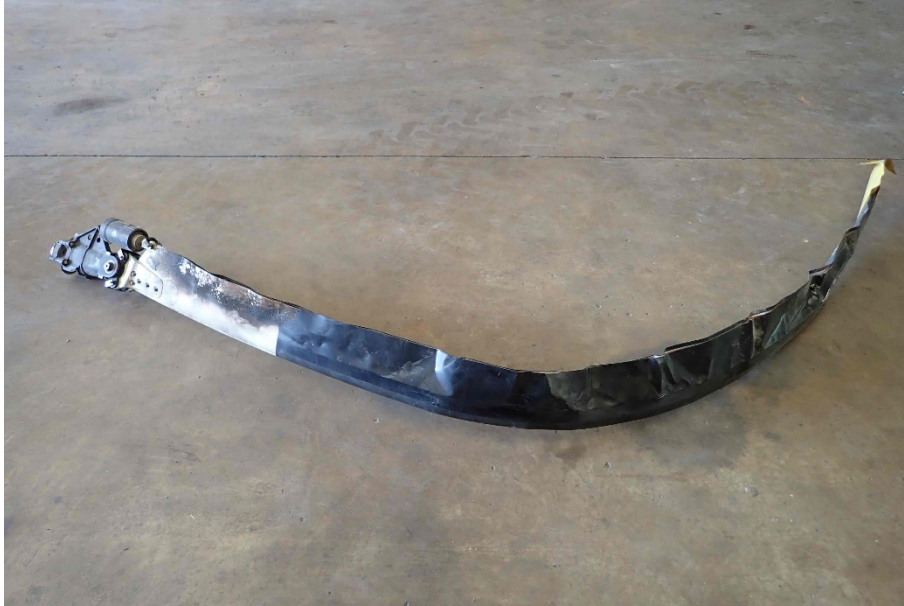
The entire red blade pitch housing had pulled away from the upper hub, revealing remnants of the strap pack assembly (Photo 14). The blade remained attached to the pitch housing, and the lead lag bolt was intact along with the damper (Photo 15). The entire blade was bent 90 ° opposite the direction of travel in a progressive curve (Photo 16). The tip was still attached, and the trailing edges had opened exposing the core. The inboard 30-inch trailing edge section of the blade was coated in soot.

**Photo 16 – Red Blade**

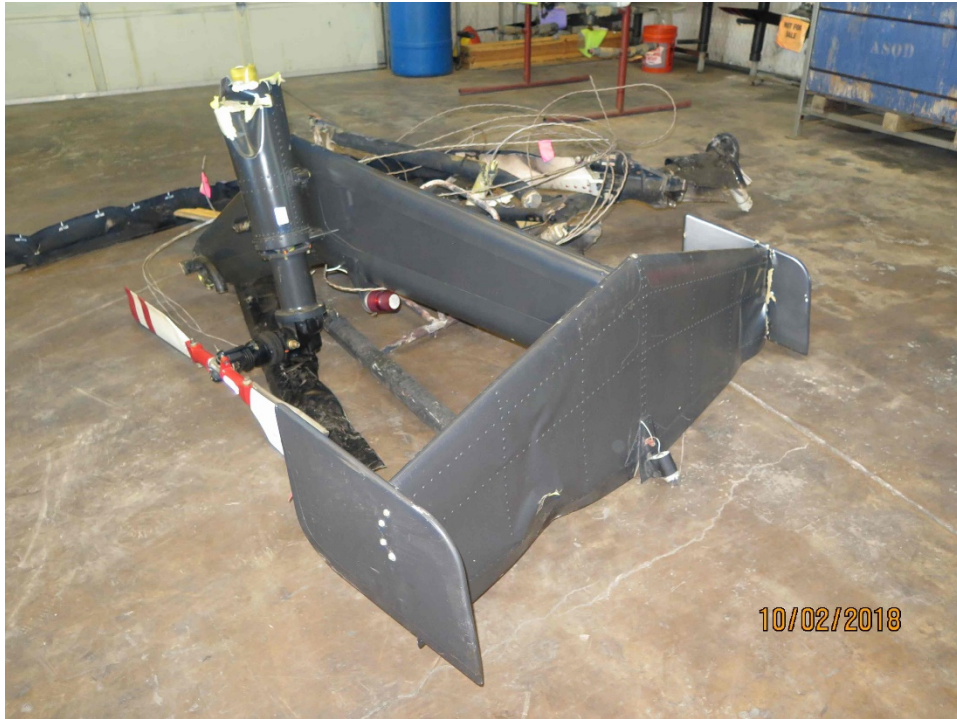
The aft boom fairing sustained thermal damage just above the engine and remained partially attached to the aft fuselage section (Photo 26). The remaining section of the tailboom sustained less thermal damage, limited to bubbling paint and soot deposits. The aft end of the tailboom had detached about 10 inches forward of the horizontal stabilizer attachment fittings (Photo 27). Both the tail rotor driveshaft and tailboom control rod were continuous within the tailboom, and the aft section of the driveshaft was impacted with mud. The tail rotor gearbox, along with the upper

and lower sections of the vertical stabilizer remained attached to the aft end of the tailboom. The assembly was located about 20 ft beyond and to the east of the main wreckage and did not exhibit any thermal damage. The stinger was still attached to the lower vertical stabilizer and had bent 180 ° upwards and against the left stabilizer surface. The horizontal stabilizer was attached to the vertical stabilizer.

**Photo 27 – Tail Section**

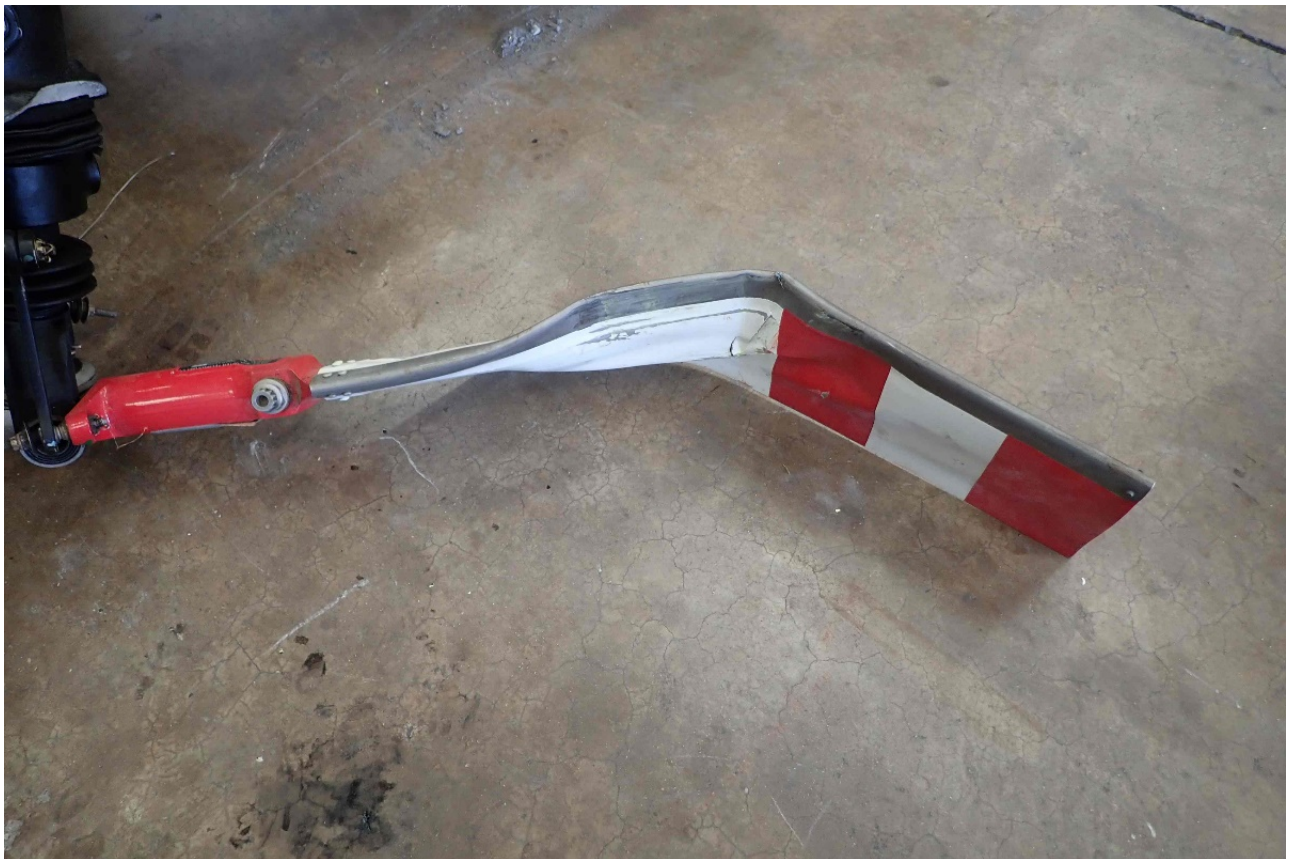
The tail rotor gearbox remained attached to the aft tailboom through its extension tube. The tail rotor control bellcrank at station 284 had fractured from the tail rotor transmission housing. The swashplate bearing could be moved and rotated smoothly. One blade was attached to the tail rotor hub assembly, and its pitch link, which was intact, was connected to the swashplate. The tail rotor blade exhibited a square-shaped 4-inch-wide indentation to its outer surface about midspan (Photo 28). The indentation contained yellow transfer marks, similar in shade to the yellow paint on the main rotor blade tips (Photo 29). The main rotor blade tip weight section was about 4 inches wide (Photo 29). The other tail rotor blade remained partially attached to the hub and had broken away from its pitch link (Photo 30).

**Photo 28 – Tail Rotor Blade**

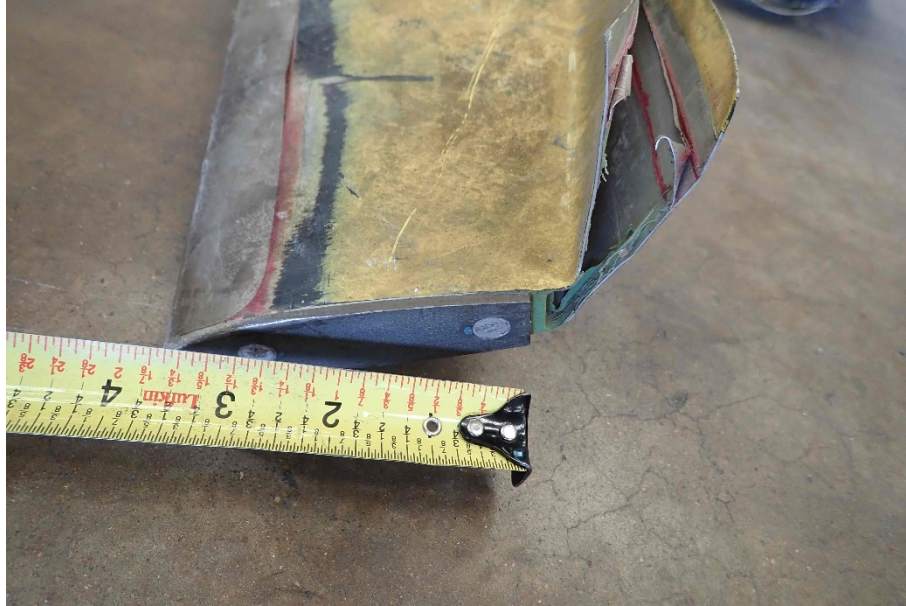
**Photo 29 – Main Rotor Blade Tip**
