## EXAMINATION NOTES

### HISTORY OF FLIGHT

On August 29, 2018, about 2035 mountain standard time, a Cessna P210, N6500W, impacted terrain short of the runway in Prescott, Arizona. The pilot, who was the registered owner, was operating the airplane under the provisions of 14 *Code of Federal Regulations* (CFR) Part 91. The airline transport pilot, the sole occupant, sustained fatal injuries; the airplane sustained substantial damage. The personal local flight departed from Ernest A Love Field Airport, Prescott, Arizona, about five minutes prior to the accident. Visual meteorological conditions prevailed and no flight plan had been filed.

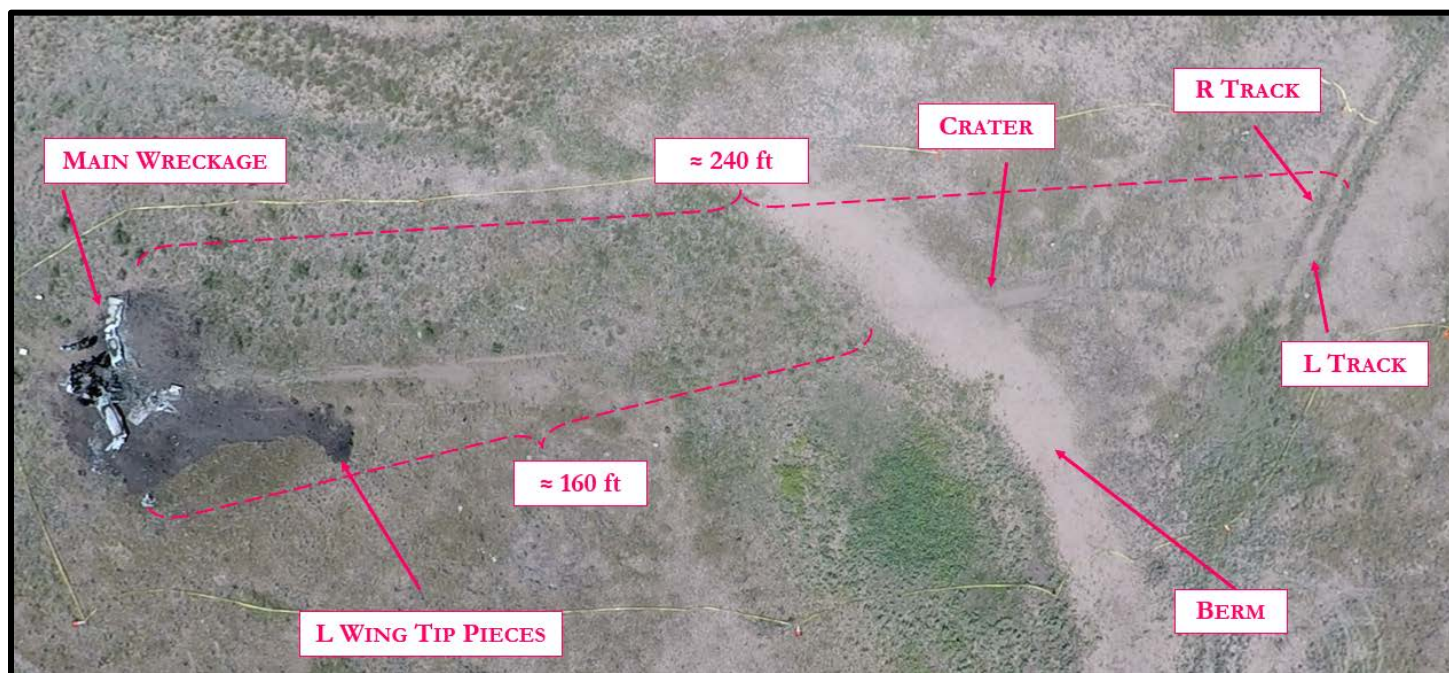
Figure 5: Debris Field Overview

The accident site was located in the desert terrain about 1,890 ft from the approach end of runway 21R. In character, the terrain was composed of dry, soft dirt and prairie grass. The wreckage was found distributed over a 240 ft distance on a median magnetic bearing of about 222°.

The main wreckage consisted of a majority of the airframe and engine, which had been consumed by fire. The main wreckage came to rest on a heading of about 270°. The remaining wreckage was found in the debris field and adjacent to the main wreckage and principally consisted of the outboard left wing, the nose landing gear doors, a propeller blade, and nose cowlings pieces.

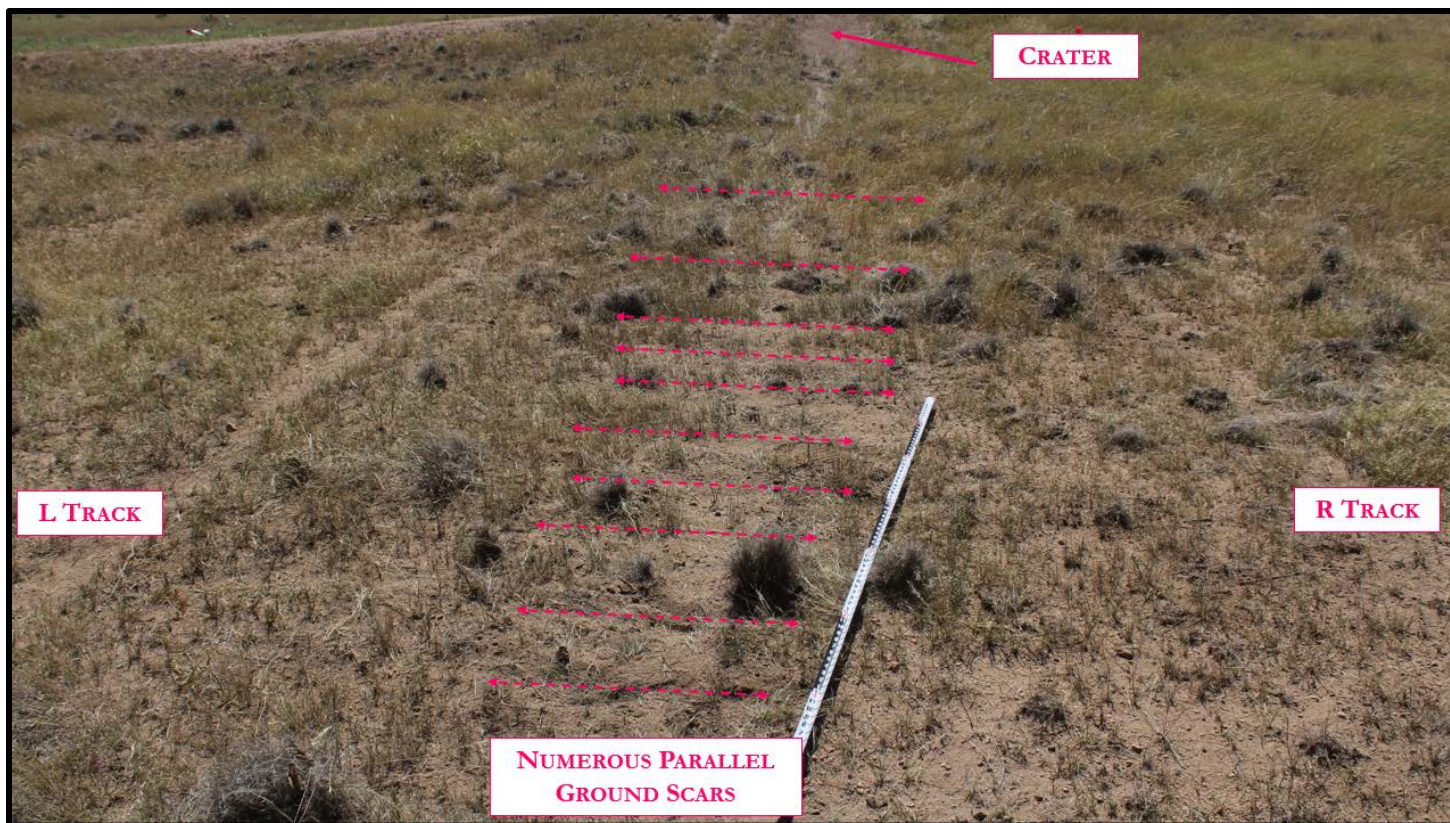
Figure 10: Ground Scars Leading Up to the Berm

The indentations were continuous about 60 ft until reaching a northwest-southeast oriented berm that was about 2 feet higher than the surrounding terrain. There were numerous parallel ground scars that were located perpendicular to the direction of the center indentation and immediately over it. The size and location was consistent with propeller slashes.

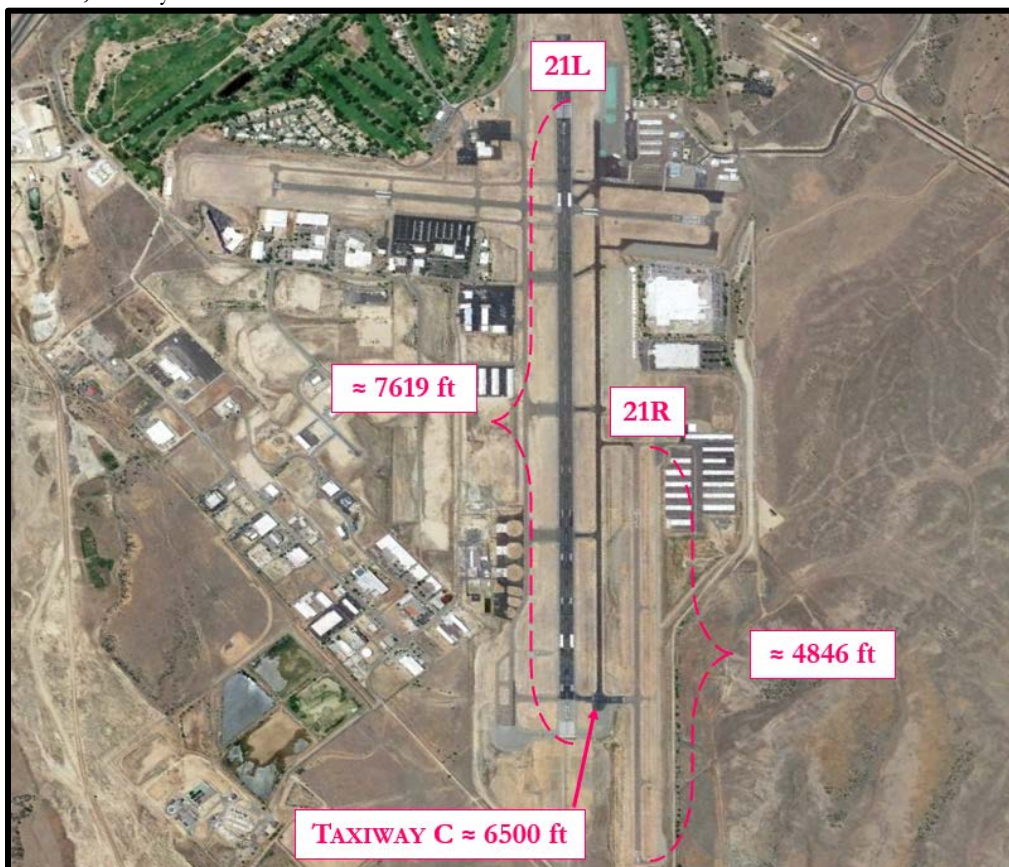
Figure 20: Airport Highlighting Runway Distances

Runway 21R/3L that is 4,846 by 60 feet

Runway 30/12 that is 4,408 by 75 feet

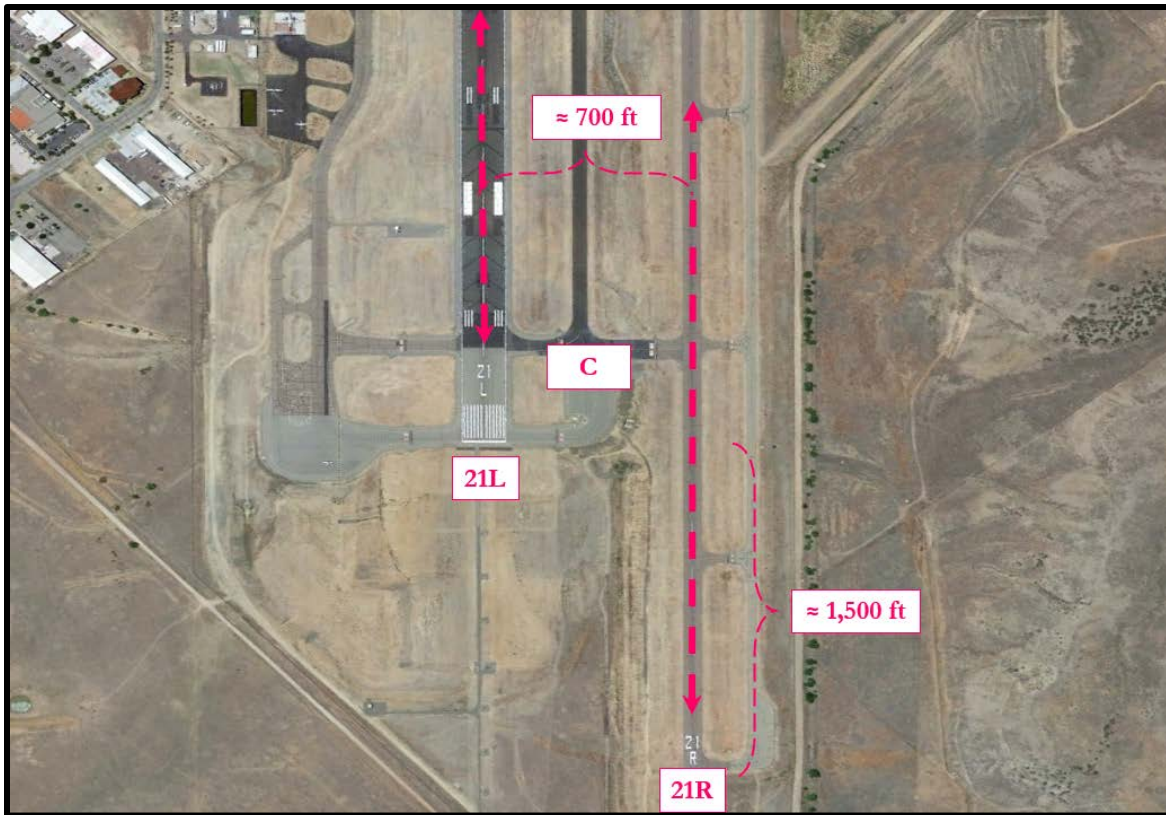
Figure 21: Runway 21L and 21R (showing lengths)

The centerlines of runways 16R and 16L were separated by 700 ft. The paved approach (northeast) end of runway 21R began about 1,5000 feet before 21L.
