## **NATIONAL TRANSPORTATION SAFETY BOARD**

### **ON SCENE OBSERVATIONS**

**WPR18FA249**

Location: Pacoima, California  
Date: September 3, 2018  
Aircraft: Cessna 150L, Registration N10789, Serial #15075041  
NTSB IIC: Samantha Link

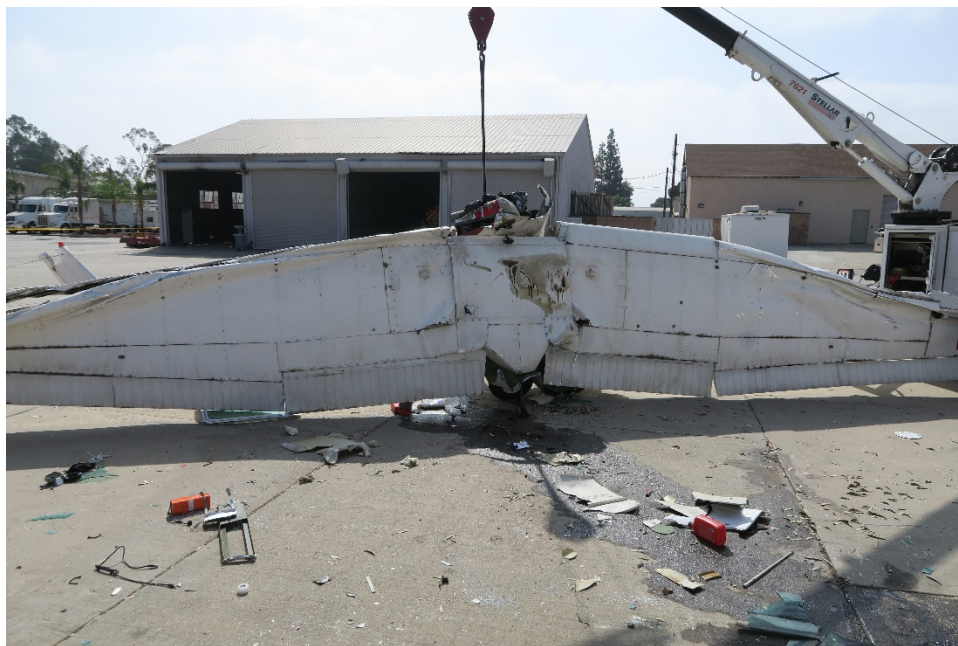
Figure 6: Top of the Wings

- The fuel tanks were damaged, however, they were not breached
  - The total fuel removed from the airplane was less than one full gallon
    - About 3 quarts of fuel was drained from the left fuel tank

- Both fuel caps remained secured at fuel tanks
    - No evidence of fuel leakage was observed around the fuel caps
    - The left fuel cap was a non-vented cap, and the right fuel cap was a vented cap.
