## **NATIONAL TRANSPORTATION SAFETY BOARD**

### **SITE and ON-SCENE INFORMATION (Rev A)**

**NTSB Accident: WPR18FA251  
Accident Date: September 4, 2018**

Location: Palo Alto, California  
Date: September 4, 2018  
Aircraft: Mooney M20J, N701JM, Serial # 24-3281  
NTSB IIC: Michael Huhn

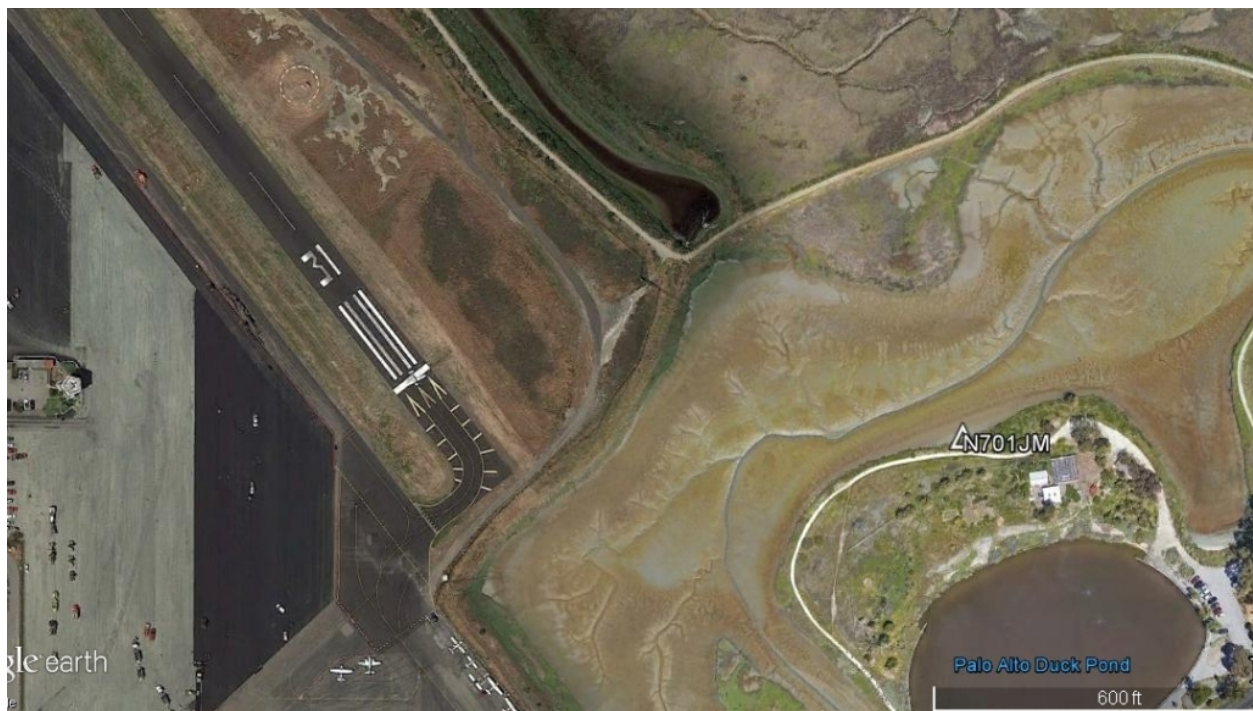
- At 1230, the water level appeared to be about 2 -3 feet lower than the high tide line, and was about 1 ft deep at the airplane
- When plotted using Google Earth, the final resting location was about 890 feet from the center of the threshold of runway 31, on a True bearing of 096° from that runway location

- This location was offset about 600 ft NE of the runway centerline, and about 600 feet SE of the runway 31 threshold
- Ground scars included a broken fence, ground gouges between the fence and the shoreline, and slices/gouges in the tidal flat mud

**Figure 1 - KPAO and Wreckage Location**

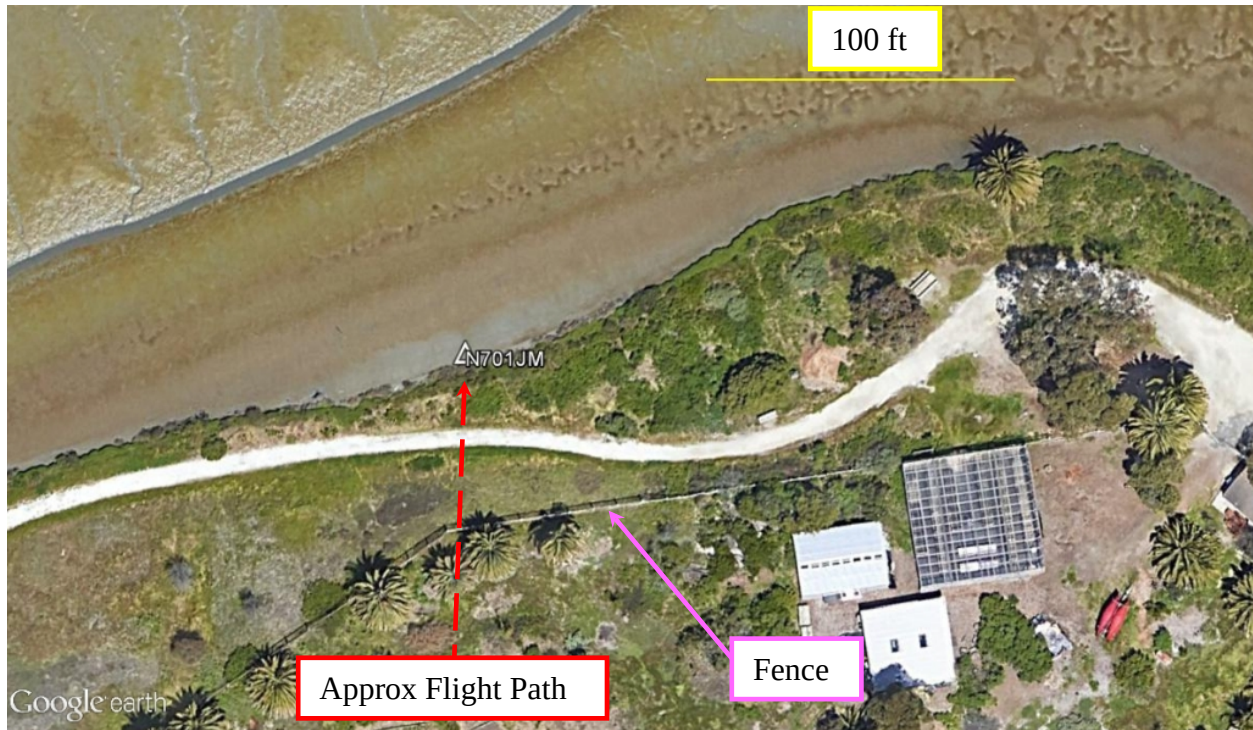
- The airplane was upright, pointed on a heading of approximately 340° magnetic
- The airplane was approximately 20 feet from shore, in a tidal flat.
  - The tide was receding at the time of the accident

**Figure 2 - Accident Location**

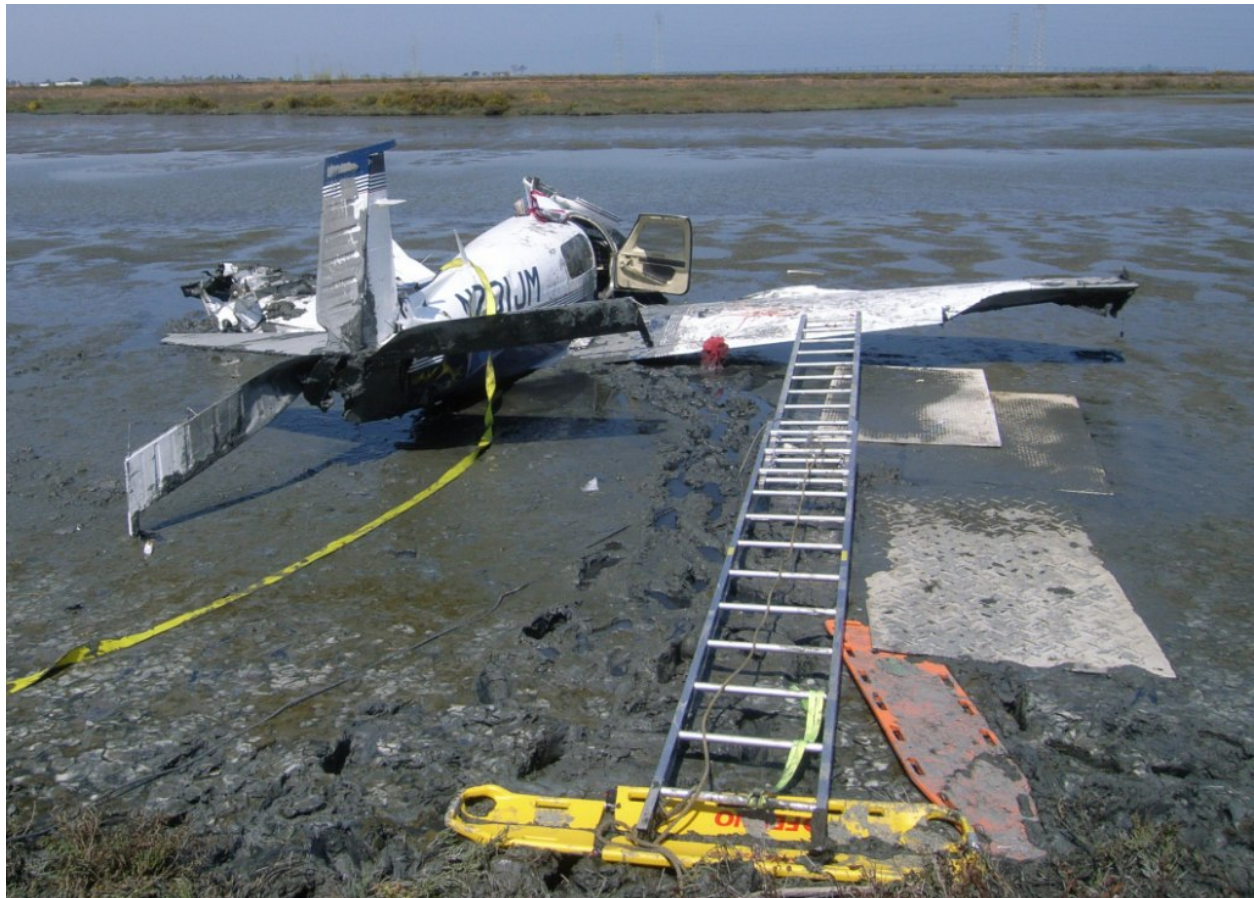
- The leading edges of both wings displayed multiple impacts
- The outboard end of the right wing displayed significant impact damage
- The engine was partially fracture-separated from the fuselage, and buried in the mud

- All other components remained attached to the airplane
- The left elevator was partially torn from its hinges
- The forward fuselage/cockpit was moderately crushed/deformed

- The instrument panel was severely disrupted
- The aft cabin/seating area retained its normal occupiable volume
- The fuselage aft of the cabin displayed light to moderate crumpling

**Figure 5 - Right Aft View**

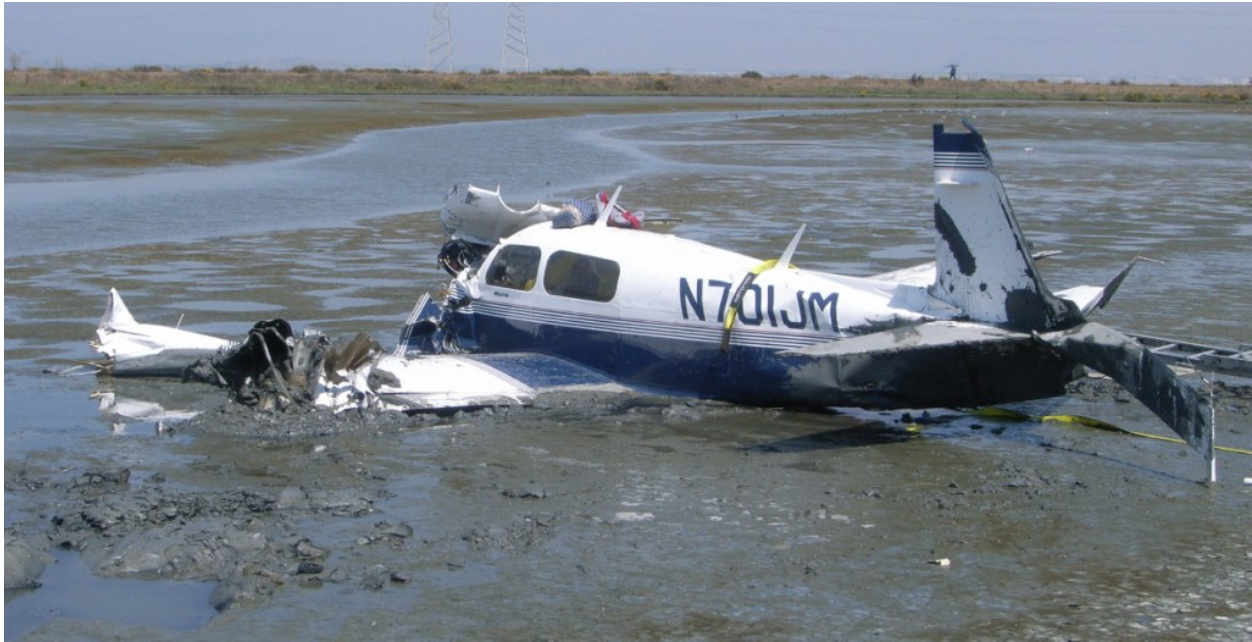
**Figure 6 - Left View**

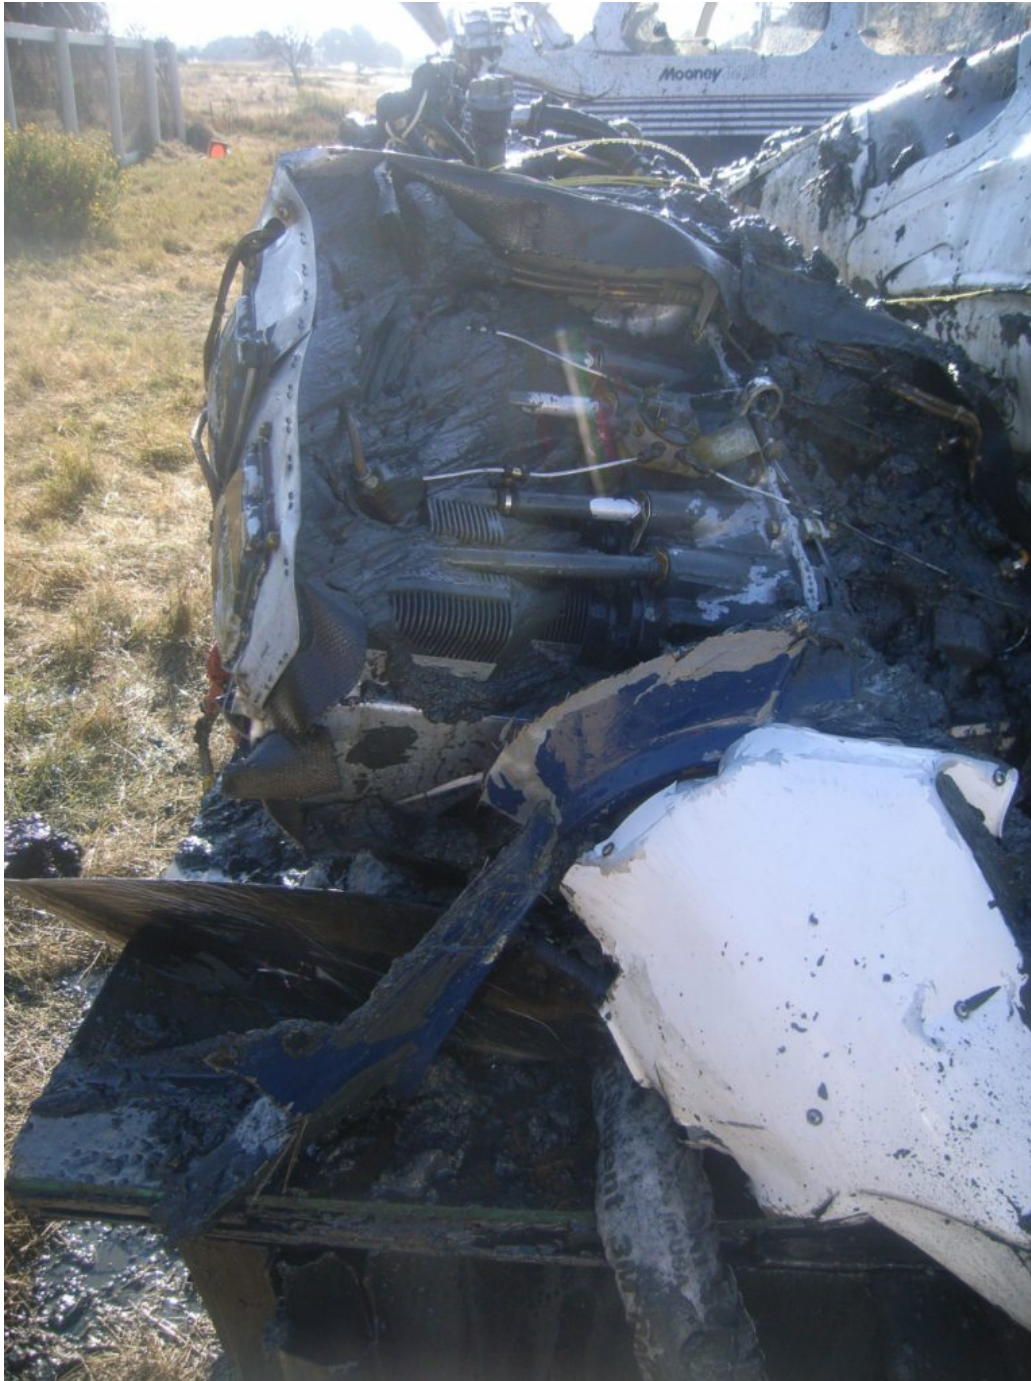
- The 2 blade propeller remained attached to the engine
  - Both blades exhibited moderate deformation
  - Neither blade tip exhibited any damage indicative of a runway strike
  - The propeller blades were caked with mud and were not examined in detail; that will be accomplished at the recovery facility
- The engine was rinsed with water to attempt to remove the mud, but was only partly successful due to a lack of water and the tenacity of the mud
  - The upper right forward portion of the engine was cleansed enough to reveal that that portion of the engine did not exhibit any indications of catastrophic internal failure
  - The remainder of the engine will be examined at the recovery facility
- The aft fuselage and empennage were then cut (as a single unit) from the forward fuselage to facilitate loading and transport

**Figure 18 - Engine After Partial Washdown**

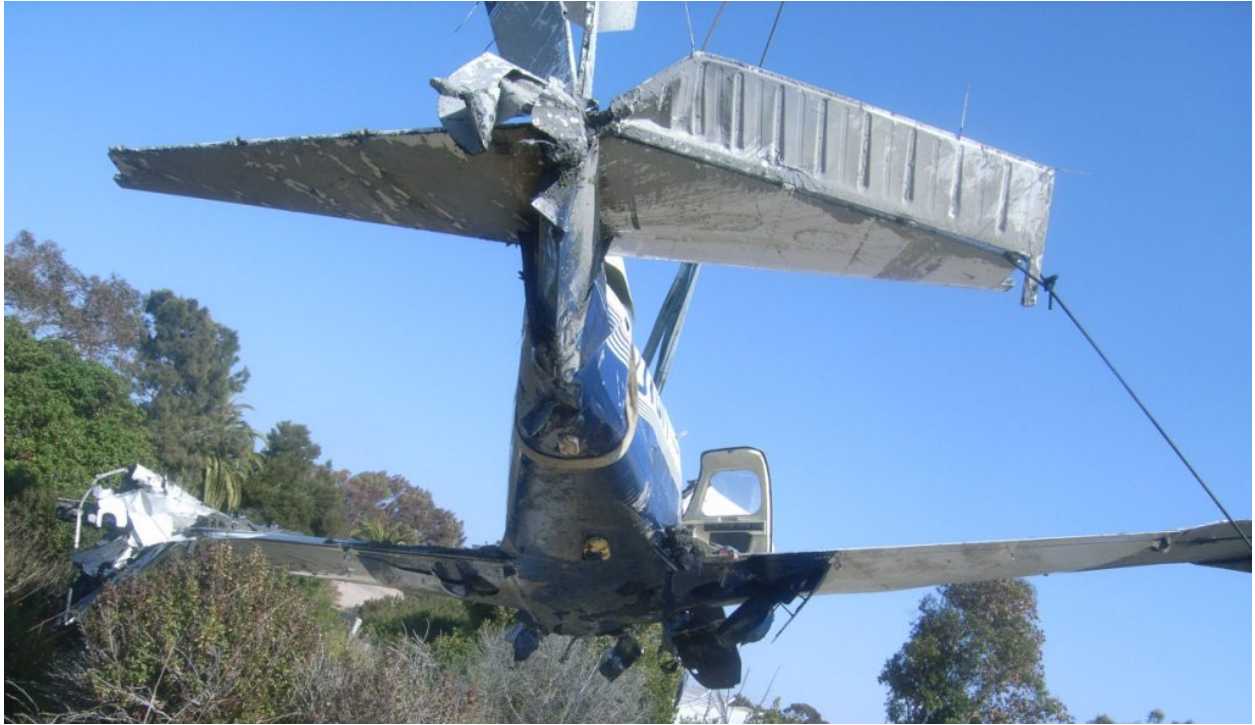
**Figure 19 - Aft Underside View**
