# Continental Motors

## ENGINE EXAMINATION REPORT

| ENGINE MODEL | IO-550-N (Turbo normalized by Tornado Alley) |
| FILE NUMBER | 17-227 |

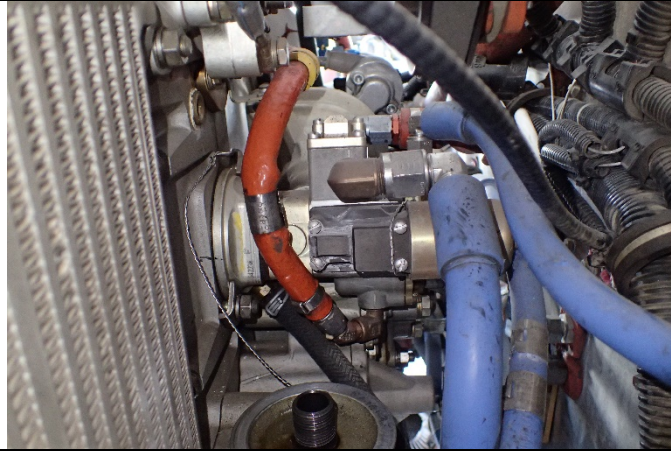
The fuel pump remained attached to its installation point and was undamaged. All of the fuel lines remained secured to the fuel pump and there were no signs of fuel leaks. There were no signs of oil leaks around the fuel pump installation flange. There were no anomalies noted with the fuel pump.

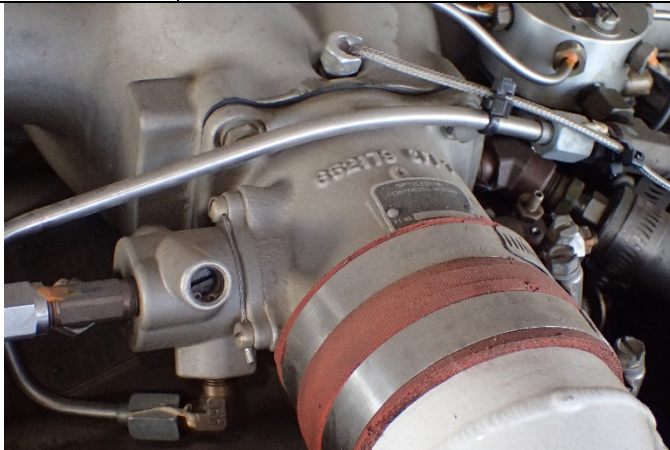
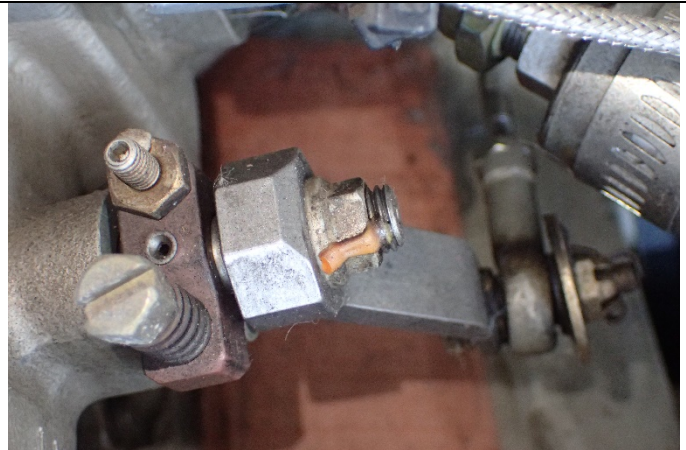
The throttle and metering assembly remained attached to its installation point and was undamaged. The throttle control arm remained secured to the control shaft and the throttle cable rod end remained secured to the control arm. There were no anomalies noted with the throttle and metering assembly.

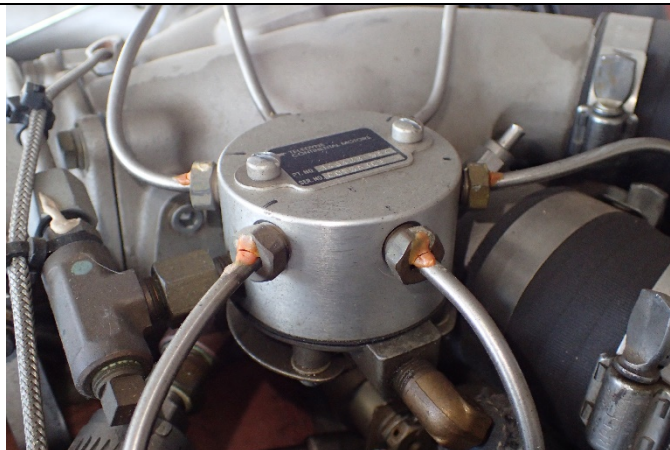
The fuel manifold valve remained attached to its installation point and was undamaged. There were no signs of fuel leaks or other anomalies noted with the manifold valve.

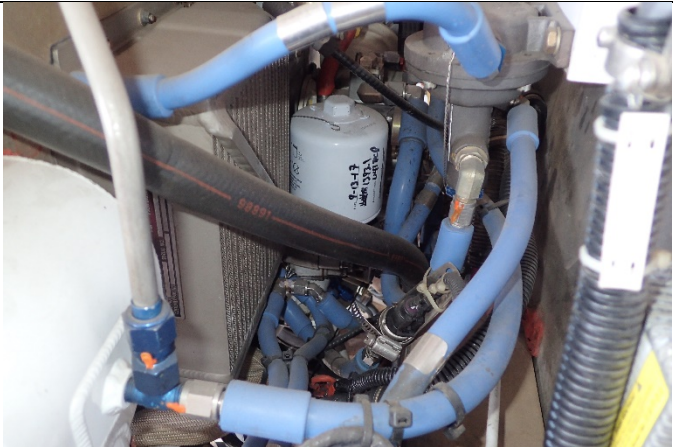
| Condition: | The oil cooler remained attached to its installation point and was undamaged. There were no signs of oil leaks around the oil cooler or the attaching oil lines. | | |

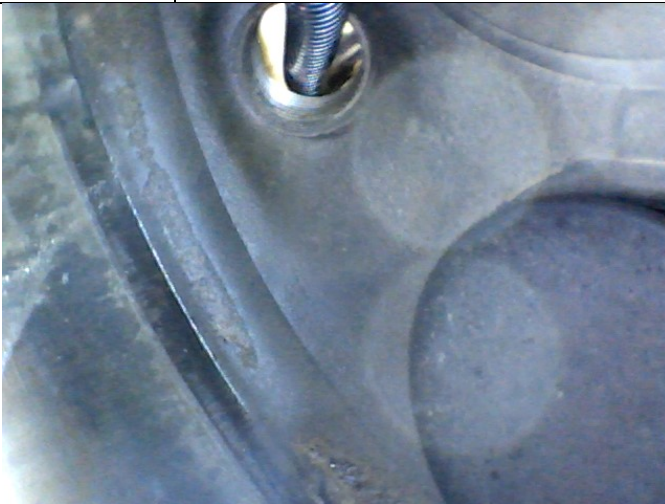
#1 Exhaust Valve

**Condition:** All of the valve heads were inspected using a lighted borescope; the #3 intake and exhaust valve were only partially visible due to the position of the #3 piston. All of the visible valve heads displayed normal operating and combustion signatures.

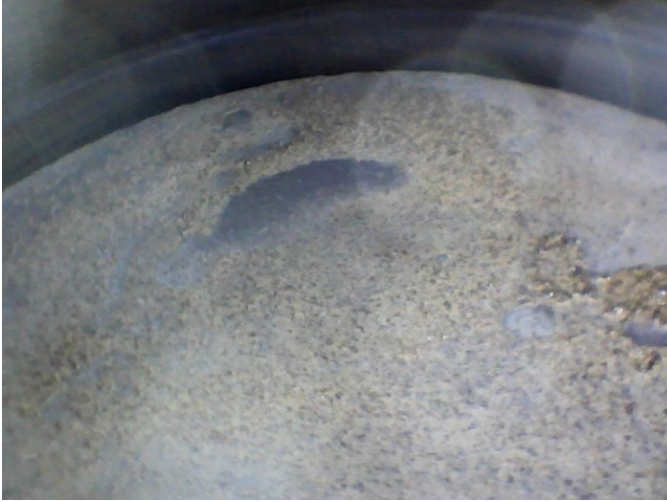
#1 Piston

The piston faces were inspected using a lighted borescope. The piston faces displayed normal operating and combustion signatures; there were no signs of detonation noted. It was noted that during crankshaft rotation the #3 and the #4 pistons would not move consistent with the #3 and #4 connecting rods releasing from the crankshaft. The rest of the pistons moved normally during crankshaft rotation.

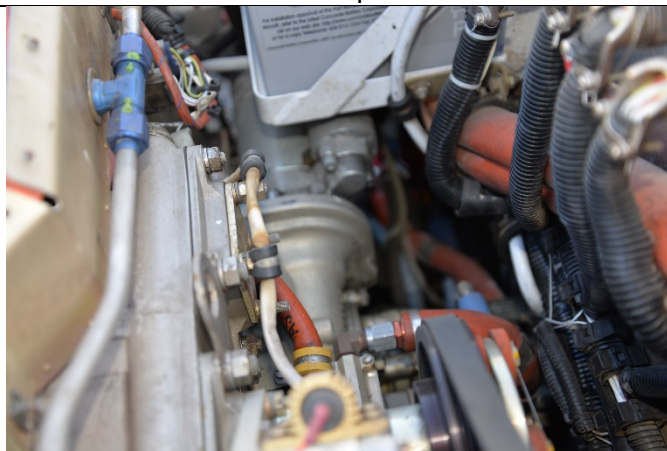
| Condition: | The starter adapter remained attached to the engine and was undamaged. There were no signs of oil leaks around the starter adapter. There were no anomalies noted. | | |

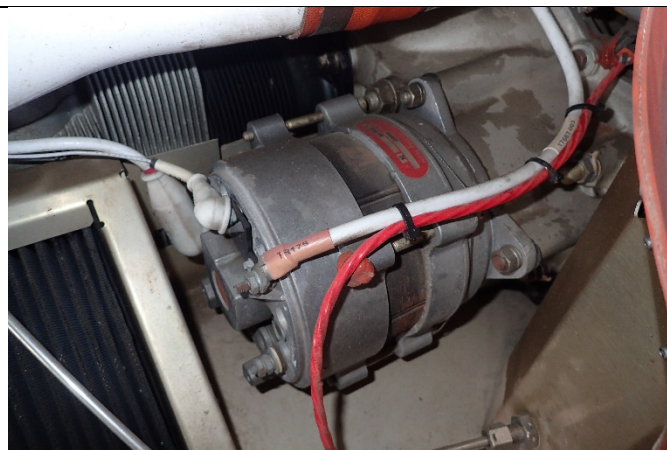
| Condition: | The alternator remained attached to its installation point and was undamaged. There were no signs of oil leaks around the alternator installation point. There were no anomalies noted. | | |

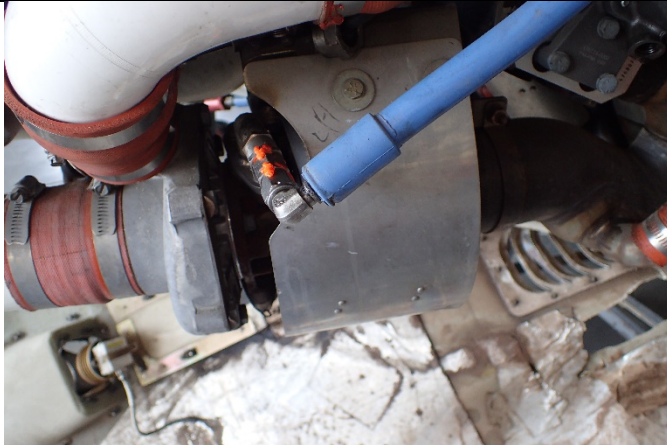
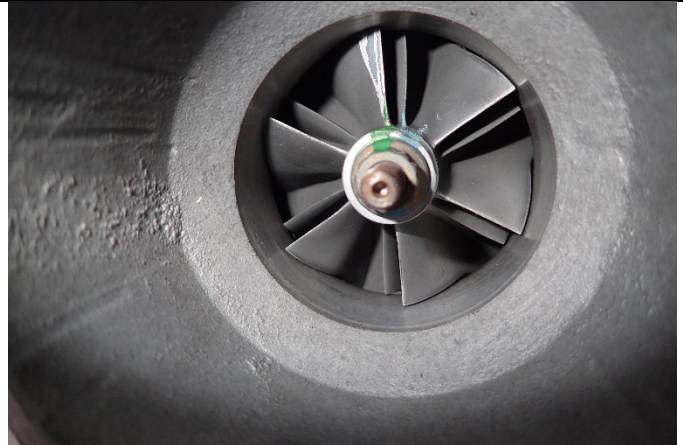
The turbocharger remained attached to its installation point and was undamaged. The oil lines going to the turbocharger were noted to be secure and there were no signs of an oil leak. The induction hose going to the compressor was removed and the compressor was visually inspected; the compressor blades displayed normal operating signatures and the compressor was capable of normal rotation. There were no anomalies noted with the left turbocharger.

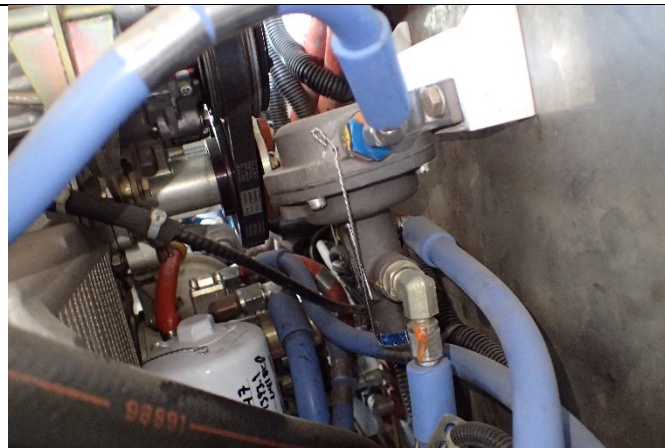
The controller remained attached to its installation point and was undamaged. All of the oil lines remained secure to the controller. There were no anomalies noted.

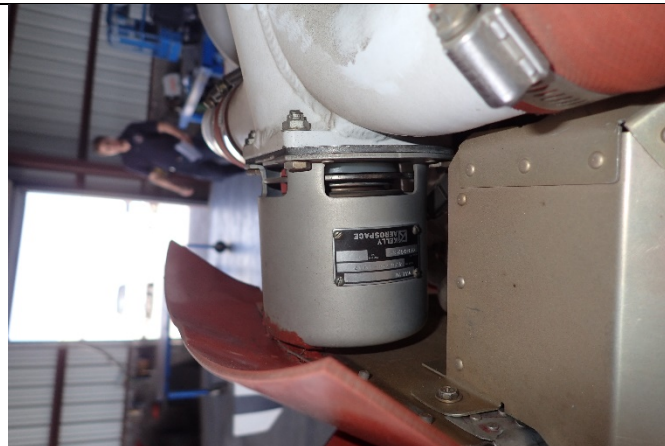
The overboost valve remained attached to its installation point and was undamaged. There were no anomalies noted with the overboost valve.

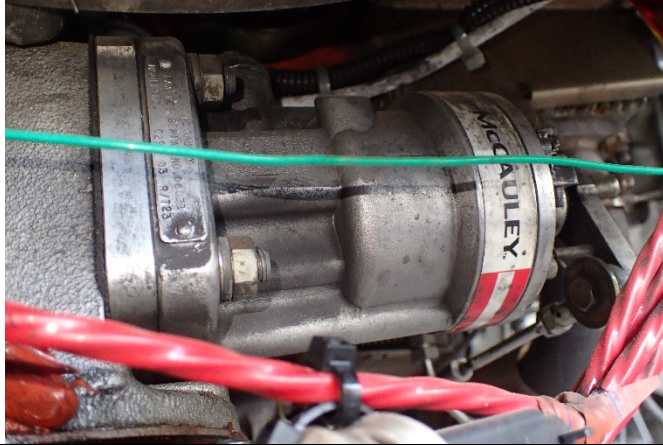
The governor remained attached to its installation point and was undamaged. There were no signs of oil leaks around the propeller governor.
