## ***Quicksilver GT-500 Preliminary Engine Tear-down Inspection Summary***

Date of accident: 11-25-2017

N Number: N599RA

Engine: Type Rotax 582 Blue Head (2 cylinder water cooled two stroke)

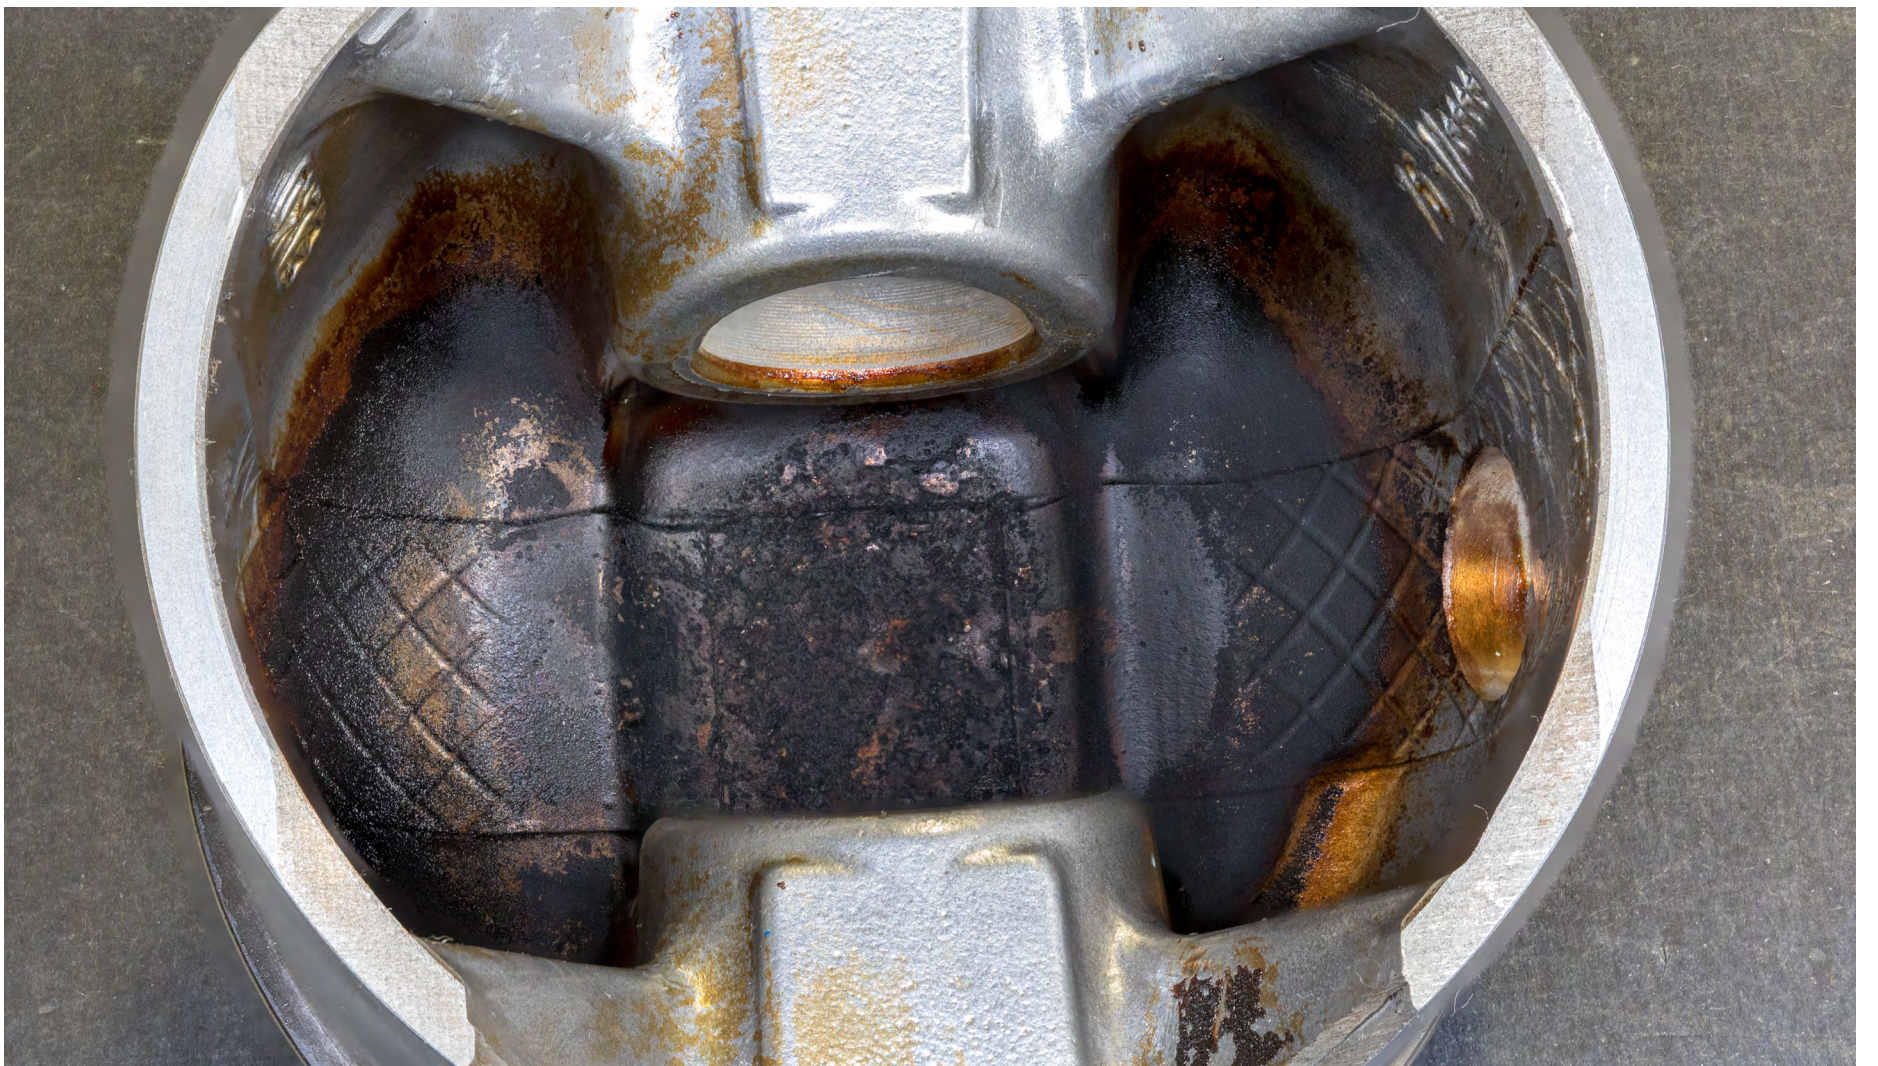
*Figure: 13 Magneto Side Piston (Bottom)*

bon deposits most often occurs at the hottest spot on the piston which would be the exhaust side. Based on the shock-wave disruption of the carbon deposits on the top of the piston, they appear to be fairly well distributed and originating from the center of the piston outward. In addition, the burning away of the cylinder head in the area of the upper ring (Dykes ring) (Figure: 12) at the pin and ring end gap is consistent

with pre-ignition/detonation high-pressure/temperature gases escaping between the ring end gap and burning away the aluminum portion of the piston. It appears as though this area was most likely subject to secondary end gas detonation. This can be identified by the area of clean metal exposed as a result of the localized shock-wave pattern that removed the combustion deposits from this area. As this localized area of extremely high temperature/pressure exits between the ring end gap the velocity and temperature act much like a cutting torch. This melts away the aluminum and the embedding of the aluminum into the cylinder wall begins the cascading effect which results in seizure of the piston. If we compare the discoloration around the perimeter of the PTO side piston with the discoloration around the perimeter of the magneto (failed side) piston, you can see that the discoloration has been worn away by the tight piston to cylinder wall clearances. Both pistons, most likely, looked identical just prior to the engine failure. If we look at the bottom side of the piston, (Figure: 13) we can see the signs of overheating. The discoloration in the aluminum is a sign that the piston has been running at excessive temperatures. The indication of discoloration on the wrist pin is also another indication that the piston has been exposed to excessive temperatures for longer than just the period of time from the last takeoff power application to engine failure. This supports the hypothesis that the engine may have been losing coolant prior to the landing at the Willows airport. In addition, the carbon buildup on the bottom of the piston is also an indication of prolonged operation at above normal temperatures. On a normally operating engine no discoloration or carbon deposits will be evident.

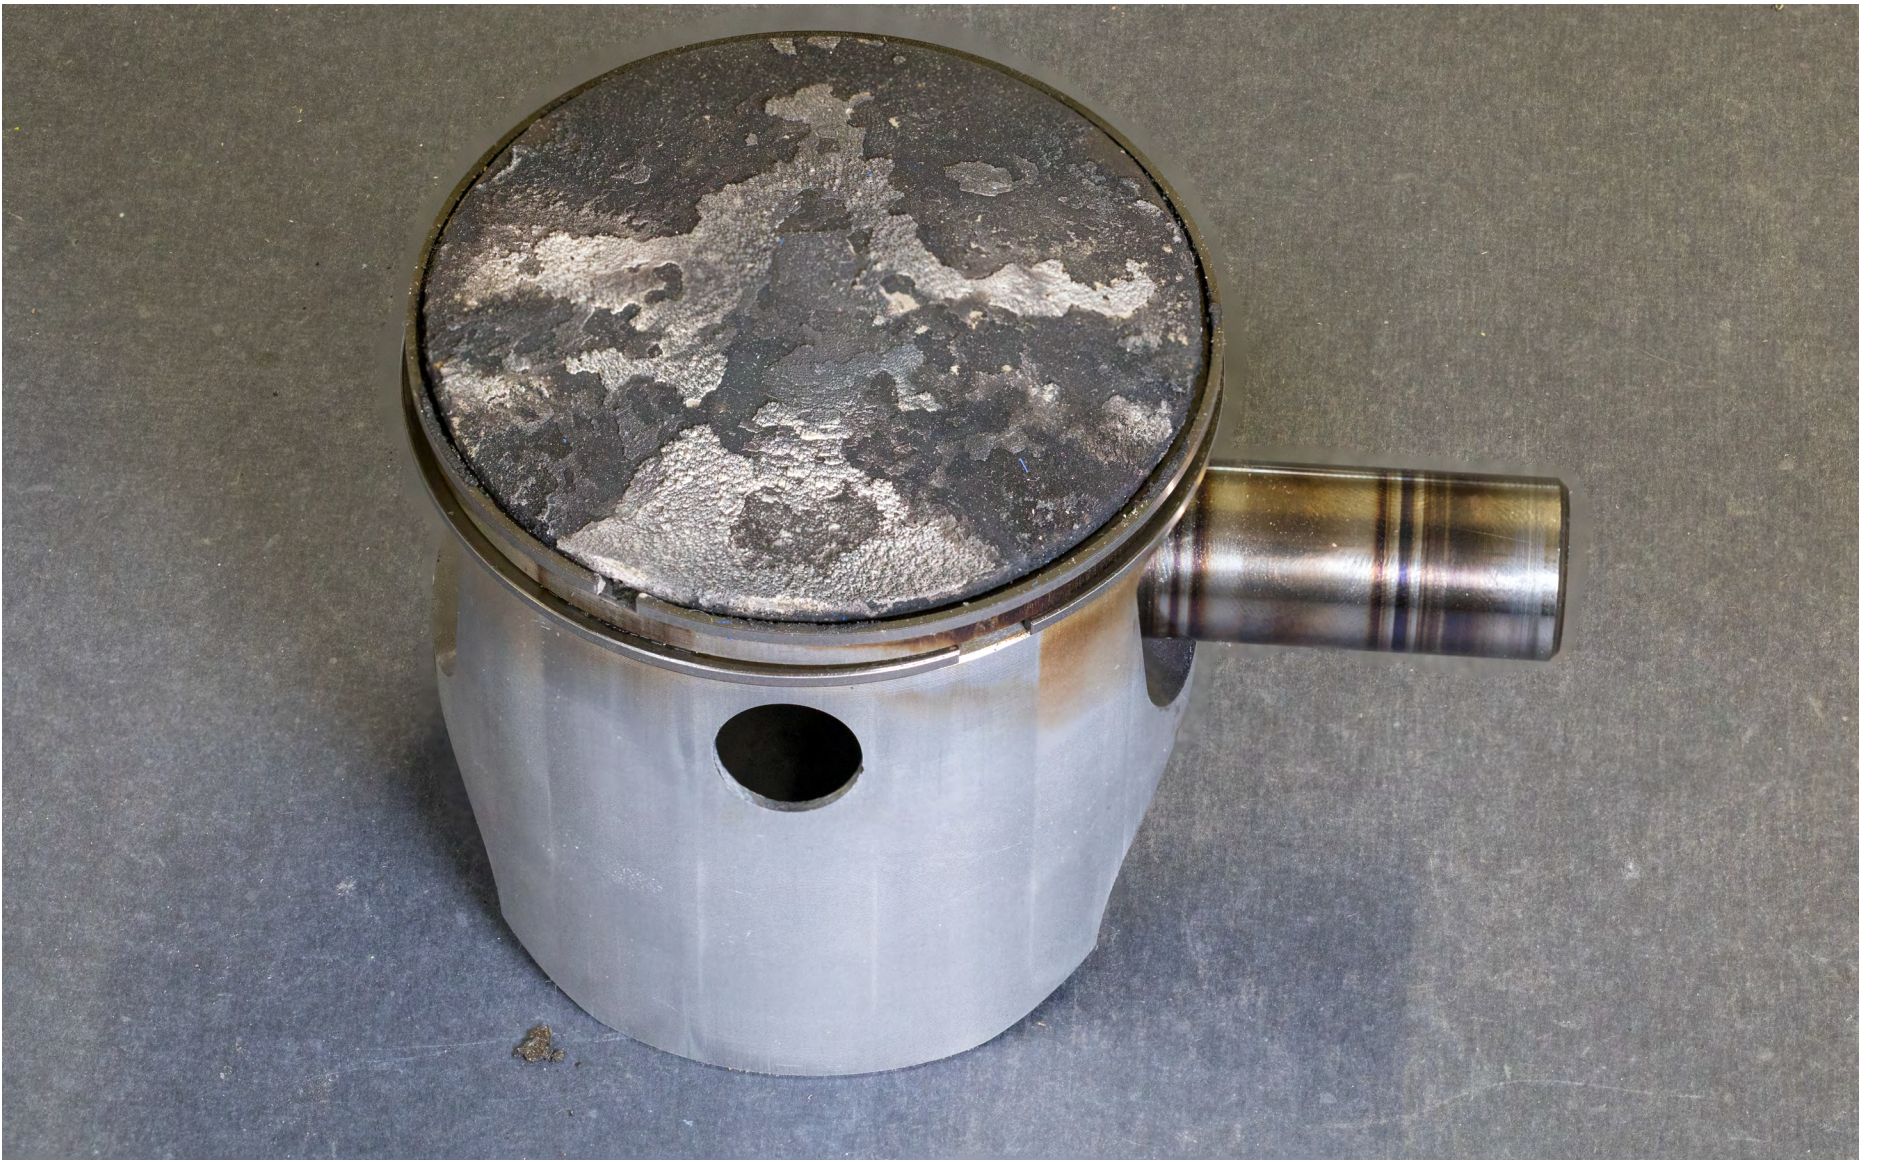
*Figure: 16 PTO Side Piston (Intake Side)*

10. PTO side Piston: (Figure: 15) The PTO side piston also shows signs that the cylinder/piston had been overheating for some period of time. Both the discoloration and the presence of burnt on carbon deposits are evidentiary of this phenomenon. Both rings are floating and free from sticking. This would indicate that the overheating was a fairly recent event. Engines that run at a higher than normal temperature have a tendency to build these carbon deposits also within the ring groove causing the rings to “stick”. At the Dykes ring (top ring) end gap location, there is evidence of the very first signs of melting of the piston. (Figure: 16) On the intake side of the piston there are two vertical striations showing not a visible seizure, but an area of extremely high pressure very similar to what we would refer to as “sympathetic seizure marks” that we would see on the exhaust side of an engine suffering from lubrication injection pump failure, or even as a result of conditions similar to that related to a cold seizure. These are indications that the piston is overheating and has expanded to reduce the cylinder to piston wall clearance to below tolerances. This pressure was sufficient enough to burnish away the machining marks which are normally visible around the perimeter of the entire piston. On the opposite side of the piston there are also two points of high-pressure opposing the pressure points on the intake side of the piston. These will invariably be the first points of failure on the piston and cylinder wall if the engine continued to run in this configuration. The discoloration that encompasses the circumference of the top portion of the piston has been worn away in the high pressure area of the striations. This indicates that the discoloration and overheating occurred prior to the actual failure of the engine. The machining marks around the perimeter of the piston, which we mentioned previously, are one of the most useful tools in determining the quality of the engine overhaul and the subsequent operating conditions. Both of the pistons show extremely low wear. And indicates that the engine was operating correctly up until the subsequent incident.

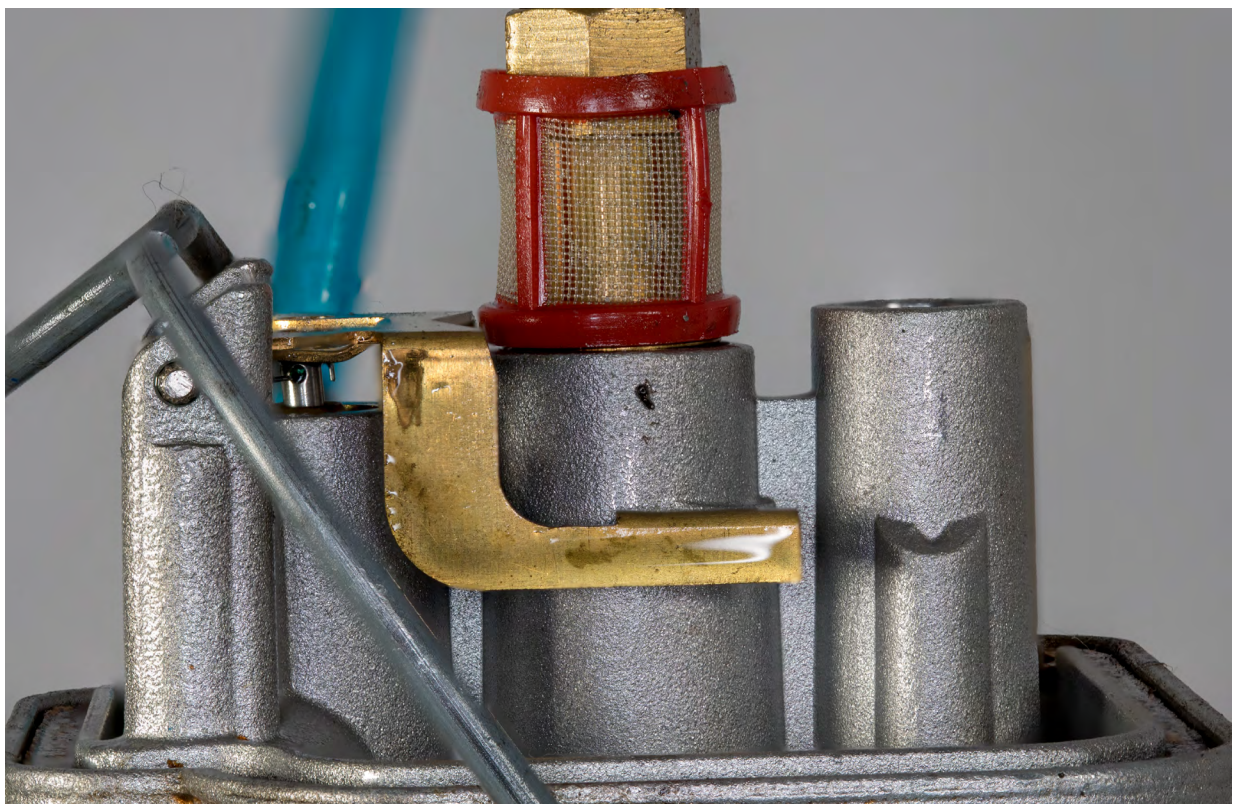
*Figure: 24 Float Level (Mag Side Carb)*

resistance around the perimeter of the needle. This, in turn, accelerates the wear on the clip, needle jet, and jet needle. In addition, the o-ring on top of the circlip was missing from the mag side carburetors. The purpose for this o-ring is to help stabilize the needle and reduce the amount of vibration and subsequent wear on the needle jet and jet needle. Running rich in the midrange has correlative importance in this case inasmuch as excessive carbon buildup can be a source of pre-ignition in many scenarios. But more importantly, it may contribute to the reason for the engine failure occurring at the particular point in the mission profile. In the cruise, approach, and landing profile the reduced manifold pressure accompanied by the excessively rich mixture may have prevented the engine from reaching temperatures conducive to pre-ignition. The needle jet/jet needle provide the mixture setting that correlates with the 1/4 - 3/4 throttle setting. Once above the 3/4 throttle setting the primary controller of the mixture is the main jet. At full throttle, as in the case of this engine failure, the needle jet and jet needle have no effect upon the mixture. Upon inspection, the main jet is the proper jet and appears to be in proper operating condition, and free from contamination or corrosion. The float level (Figure: 24) is also set up correctly. The wear on the carburetor slide is indicative of a carburetor that has been in service longer than the last ~300 hours of operation since the estimated of the last engine overhaul. In addition, the overall condition of the carburetor looks as though the engine overhaul at ~300 hours ago may have been the last time that the carburetors were also overhauled. This is supported by the amount of wear on the needle jet and jet needle, condition of O-rings (Figure: 25), and age and deterioration of gaskets.

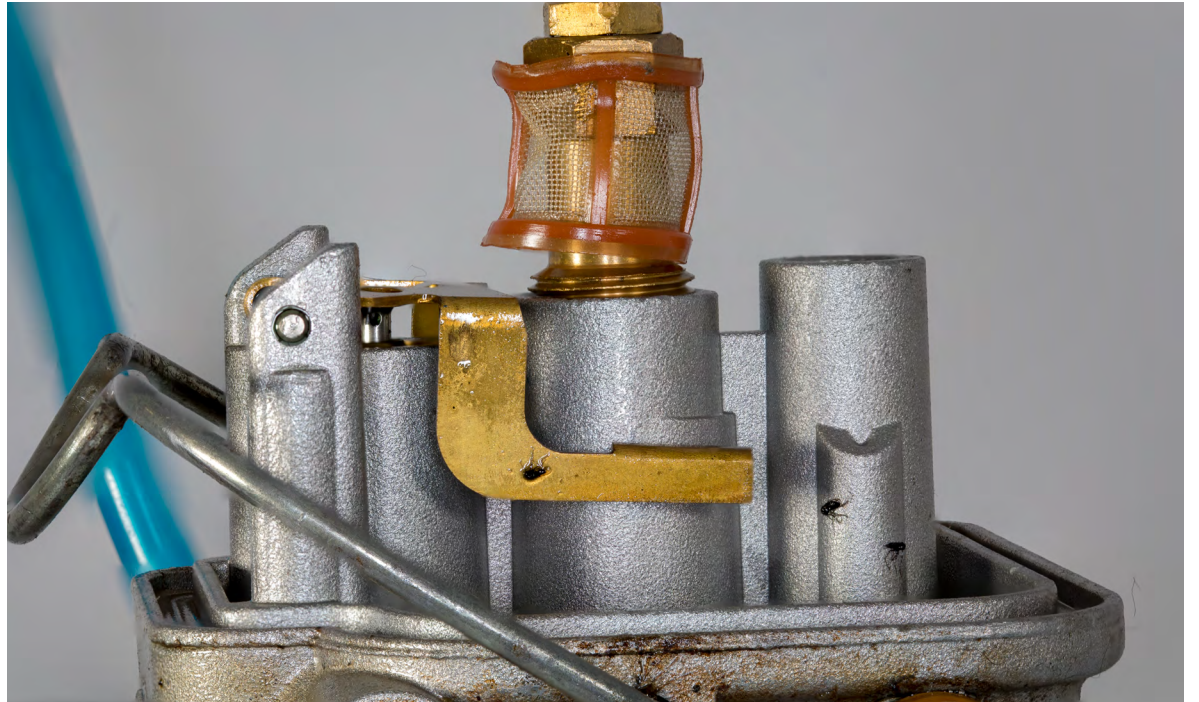
*Figure: 26 Float Level (PTO Side Carb)*

15. PTO Side Carburetor: Tear-down inspection observations. [{Main jet, 165} --- {Idle jet, 55} --- {Needle Jet, 2.72} --- {Jet needle, 11K2} --- {Clip position, 4} --- {Air Screw, .5}] (Figure: 21) several anomalies were found on this carburetors well. (1) The clip position was in groove # 4 instead of groove # 3 as recommended. This would cause the mixture to be enriched in the midrange. (2) the idle air screw was set at .5 turns instead of 1 turn out from the seated position. (3) The o-ring was missing from the idle jet. (4) The float level was improperly adjusted. (Figure: 26) In this case, the float level was set higher than normal. This would increase the mixture throughout the entire range of power settings. This would also support the hypotheses that the PTO cylinder was running richer and as a result cooler, this causing the failure of this cylinder to lag behind slightly in its failure in comparison to the magneto side cylinder. (5) The jet needle (Figure: 27) was an 11K2 instead of 11G2. The higher code letters will produce a richer mixture below at the half throttle setting and below. One of the primary indicators of excessive wear on the needle is a visual inspection of the area with the needle part number stamped into the body of the needle. In this case, you can see an excessive amount of wear to the point that the numeral 2 is completely worn away. This is the area where the needle makes contact with the carburetor slide. And although this clip is tight against the needle groove and has the o-ring intact, based on the amount of wear an inspection of the clip reveals
