Here is our statement for the events that occurred on the night of December 5th, 2017 to N47536, a 1977 Piper Seneca II, aircraft total time since new was approximately 1,700 hours. Our comments at the end of the statement are to bring light on what the statements and comments are from the other parties involved and from what the evidence shows in the pictures. This is supplemented with the extensive experience we have operating these specific type of aircraft in the flight training environment.

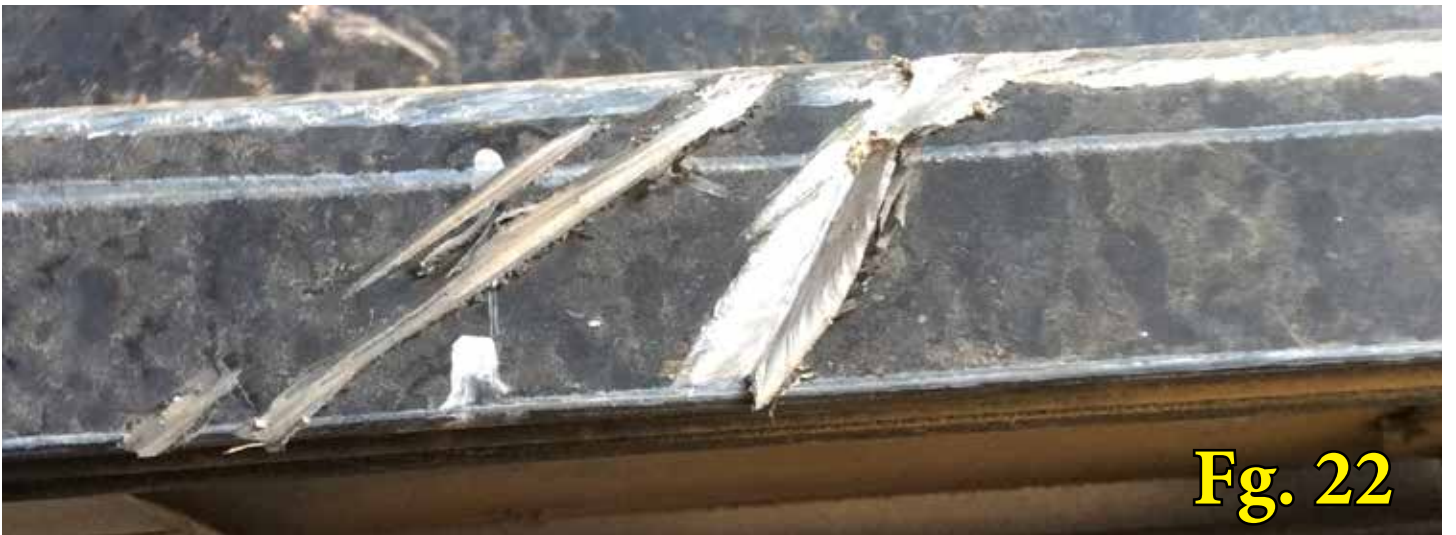
Prop strike damage to the runway sign which clearly shows that there was not gear failure at this point of the incident.
