# Continental Motors

## ENGINE EXAMINATION REPORT

| ENGINE MODEL | IO-550-B (converted by Tornado Alley Turbo for turbo normalized) |
| FILE NUMBER | 17-440 |

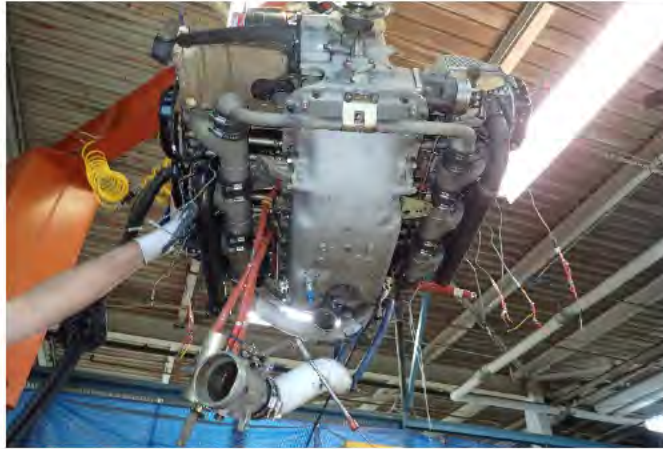
#### EXHAUST SYSTEM

**Condition:** The exhaust risers remained attached to the engine and were undamaged. The exhaust tailpipe had been removed from the turbocharger and displayed impact damage signatures; the V-band clamp had been removed from the tailpipe and remained intact.

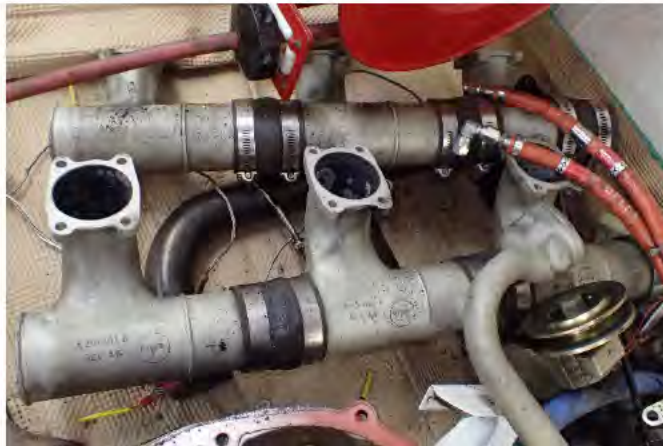
#### INDUCTION SYSTEM

**Condition:** The induction system displayed impact damage signatures concentrated at the induction Y-tube. There were no signs of induction leaks noted around any of the attached induction tubes and risers. Some of the induction system was not shipped with the engine by the recovery personnel.

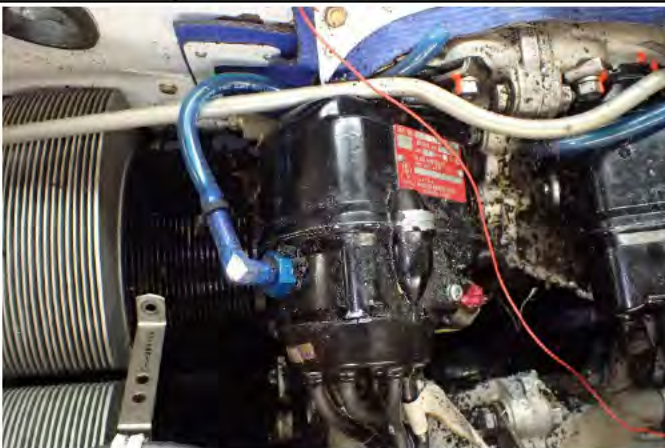
**Condition:** The magneto remained attached to its installation point and displayed minor mechanical damage. The magneto was removed and it was noted that the drive was capable of normal rotation. The magneto was placed on a test bench and it was noted that the magneto was capable of producing a spark on all six posts. The top housing was removed and the visible internal components displayed normal operating signatures. There were no anomalies noted with the magneto.

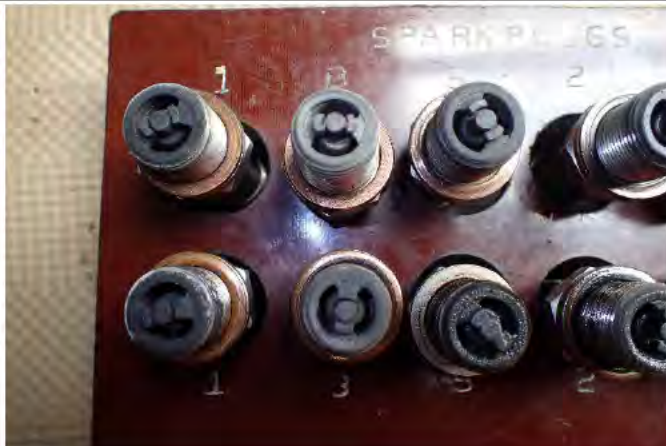
All of the spark plugs remained installed in their cylinders and were undamaged. The spark plugs were removed and the electrodes were visually inspected. The electrodes displayed normal wear signatures. The #1 electrodes displayed sooting consistent with a rich mixture and the #2 and the #6 bottom spark plugs were oil soaked consistent with post-accident accumulation.

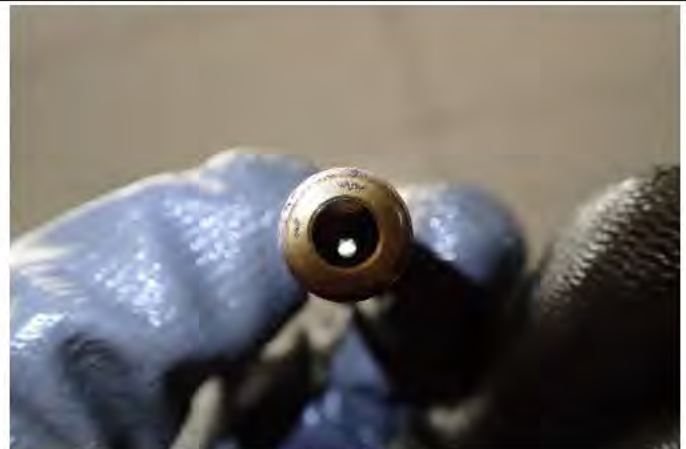
#3 Nozzle

Condition: The fuel nozzles remained intact and were undamaged. The nozzles were removed and it was noted that all of the nozzles were clear of any blockages. There were no anomalies noted with the nozzles.

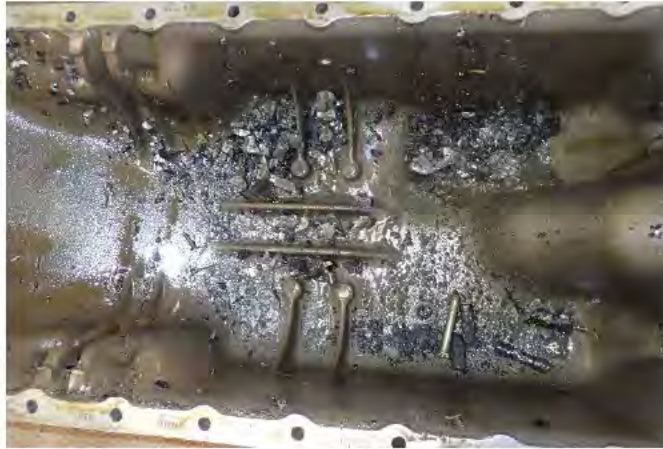
#### OIL SUMP

Condition: The oil sump remained attached and displayed some impact damage signatures. The oil sump was removed and it was noted that there was a significant amounts of metallic material within the sump.

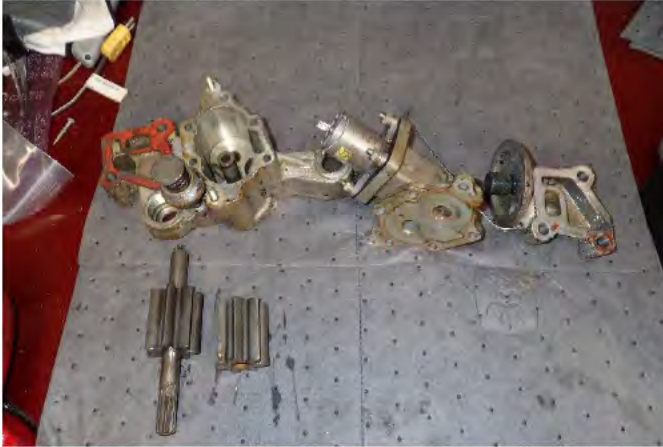
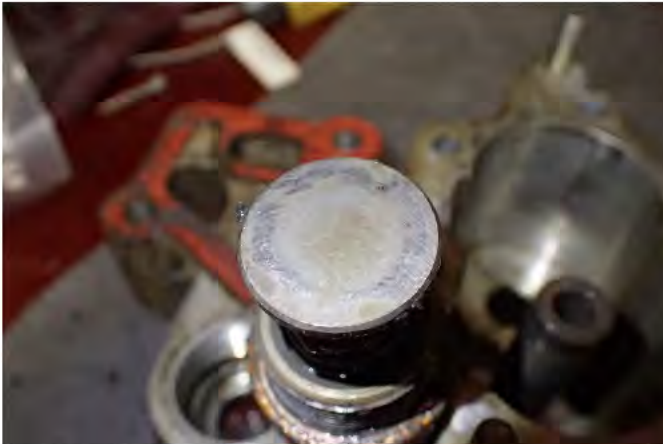
The oil pump remained attached to its installation point and was undamaged. The oil pump was removed and disassembled. The internal portion of the oil pump housing displayed scoring consistent with hard particle passage. The oil pump gears and oil pressure relief valve remained intact and displayed normal operating signatures.

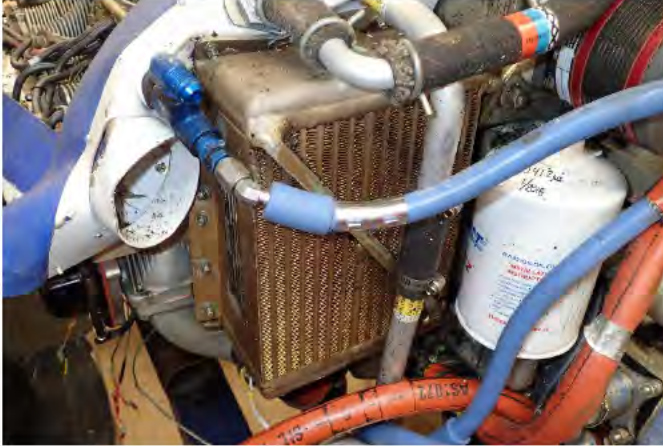
The oil filter remained attached to the oil filter adapter and was undamaged. The oil filter housing was cut open and the filter pleats were visually inspected; there was a significant amount of metallic material within the filter pleats.

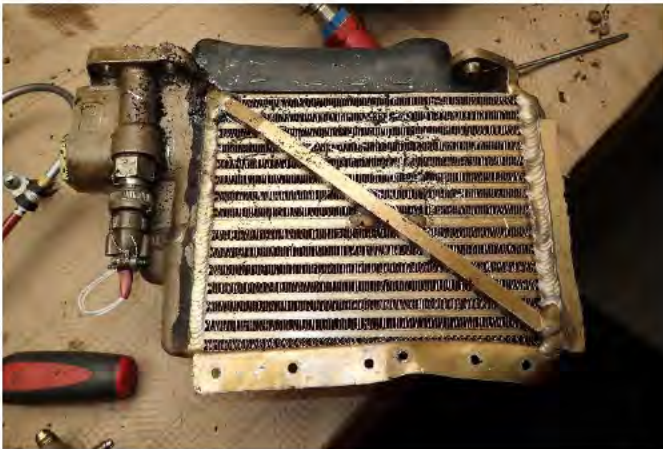
## OIL COOLER

The oil cooler remained attached to its installation point and displayed impact damage signatures. There were no anomalies noted with the oil cooler.

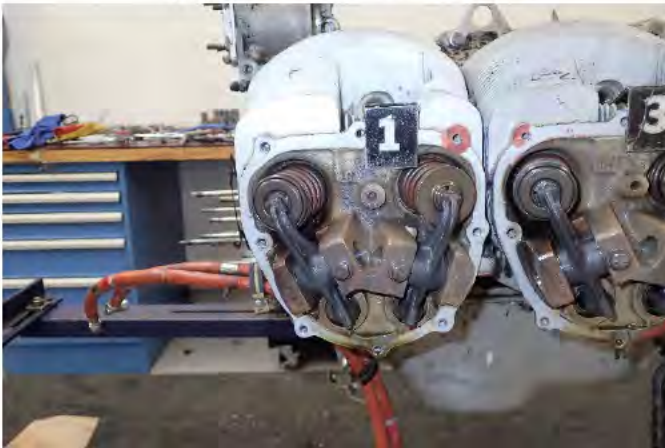
The cylinder remained attached to its cylinder bay and there wasn't any noticeable impact damage. The cylinder was removed and it was noted that the cylinder skirt displayed mechanical damage signatures. The cylinder bore and valve heads displayed normal operating and combustions signatures. The overhead components (valves, valve springs, and rocker arms) displayed normal operating and lubrication signatures.

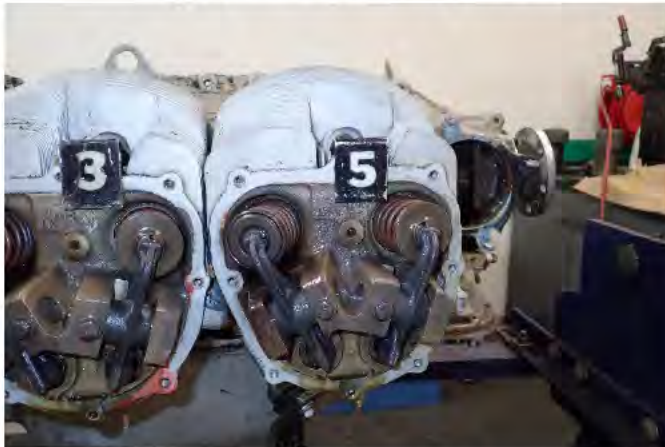
Condition: The cylinder remained attached to its cylinder bay and there wasn't any noticeable impact damage. The cylinder was removed and it was noted that the cylinder skirt displayed mechanical damage signatures. The cylinder bore and valve heads displayed normal operating and combustions signatures. The overhead components (valves, valve springs, and rocker arms) displayed normal operating and lubrication signatures.

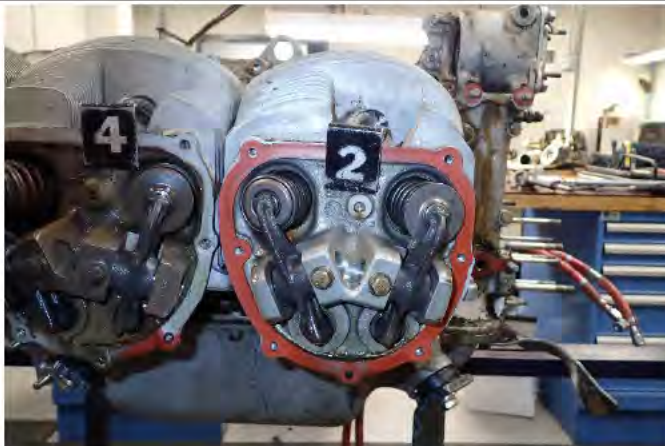
## CYLINDER #2

Condition: The cylinder remained attached to its cylinder bay and there wasn't any noticeable impact damage. The cylinder was removed and it was noted that the cylinder skirt displayed mechanical damage signatures. The cylinder bore and valve heads displayed normal operating and combustions signatures. The overhead components (valves, valve springs, and rocker arms) displayed normal operating and lubrication signatures.

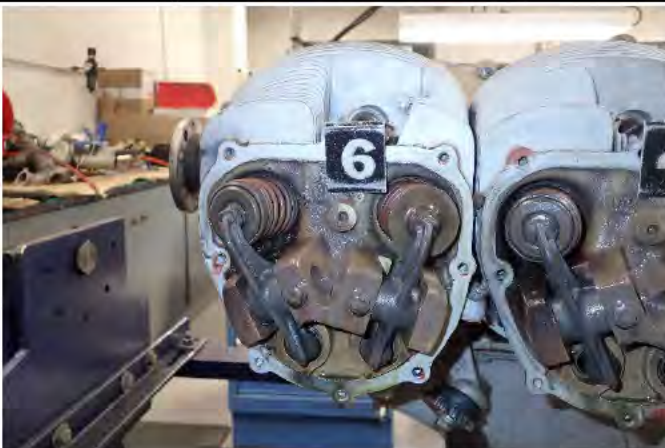
**Condition:** The cylinder remained attached to its cylinder bay and there wasn't any noticeable impact damage. The cylinder was removed and it was noted that the cylinder skirt displayed mechanical damage signatures. The cylinder bore and valve heads displayed normal operating and combustions signatures. The overhead components (valves, valve springs, and rocker arms) displayed normal operating and lubrication signatures.

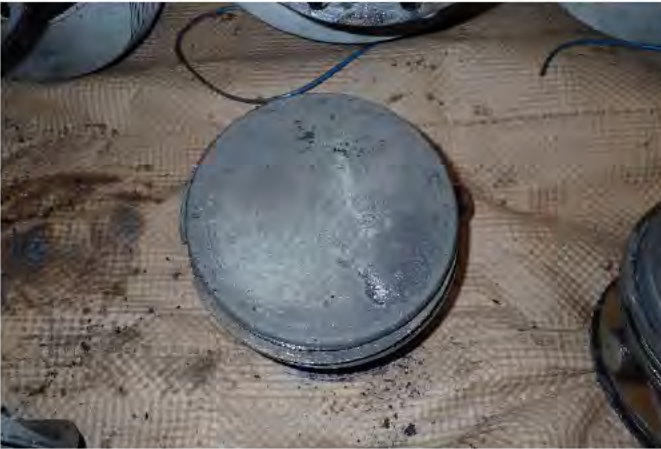
The piston remained attached to its connecting rod and displayed a significant amount of mechanical damage to the rear of the piston. The piston face displayed semicircular indentations consistent with valve strikes; there were no signs of detonation or preignition. The rear piston ring displayed mechanical damage and was broken; the rest of the piston rings remained within their grooves and were undamaged. There were no anomalies noted with the piston.

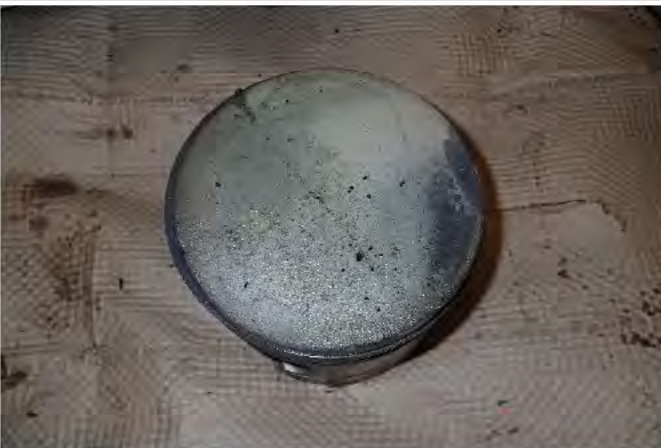
**#6 PISTON,  
RINGS AND PIN**

The piston remained attached to its connecting rod and displayed a significant amount of mechanical damage to the rear of the piston. The piston face displayed normal operating and combustion signatures. The rear piston ring displayed mechanical damage and was broken; the rest of the piston rings remained within their grooves and were undamaged. There were no anomalies noted with the piston.

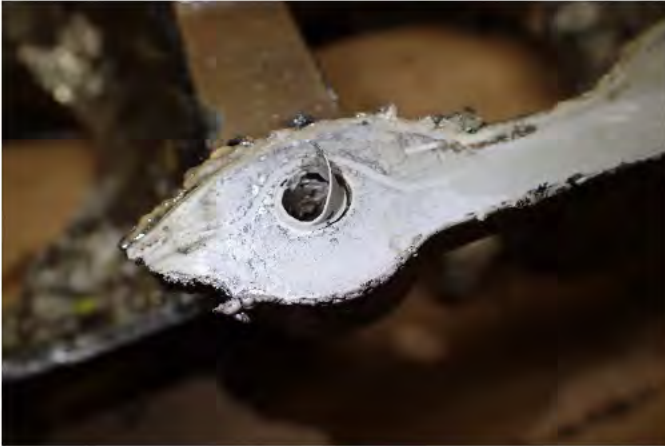
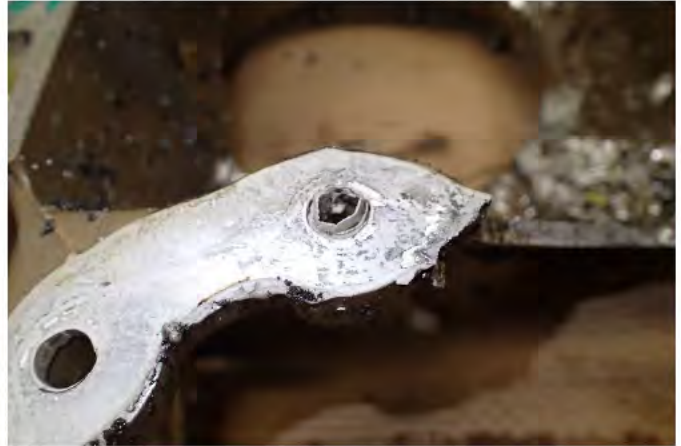
The crankcase displayed two large holes in the top of the crankcase consistent with an internal engine failure. The crankcase halves were removed and the internal portions of the crankcase were visually inspected. The internal crankcase displayed mechanical damage to several locations. The bearing supports displayed normal operating signatures and there were no signs of fretting or bearing shift. It was noted that there was a coating of grey sealant material consistent with silicon sealant applied to the crankcase backbone mating surfaces.

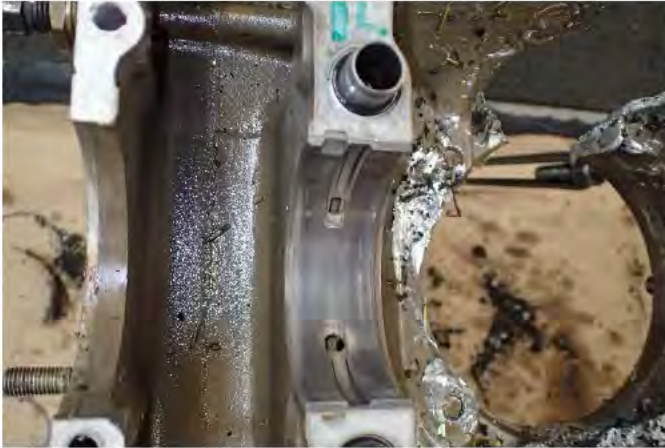
The bearings remained within the bearing supports and there were no signs of bearing shift. The bearings displayed normal operating and lubrication signatures.

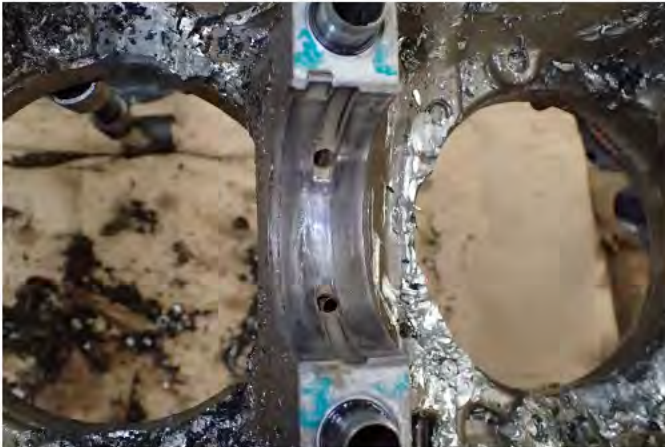
The bearings remained within the bearing supports and there were no signs of bearing shift. The bearings displayed smearing and damage consistent with lubrication distress.

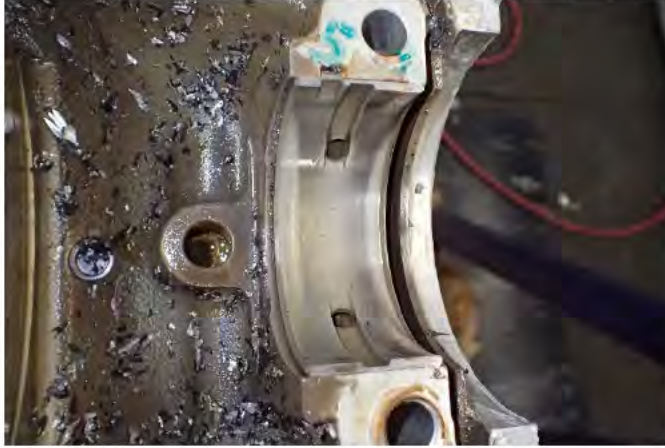
The bearings remained within the bearing supports and there were no signs of bearing shift. The bearings displayed normal operating and lubrication signatures.

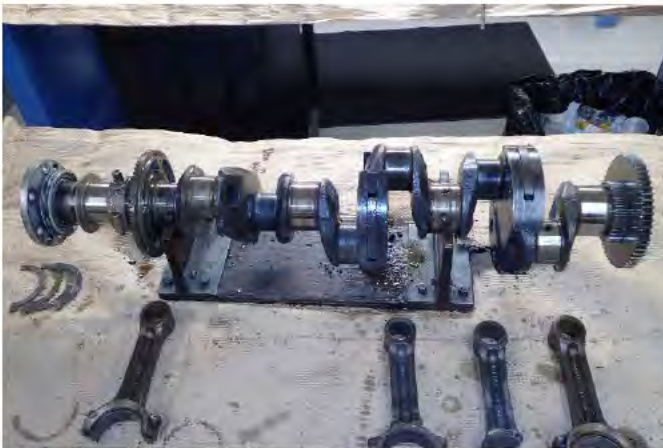
The crankshaft remained intact and there were no signs of impact damage signatures. The main bearing journals displayed normal operating signatures. The #1 and the #6 connecting rod journals displayed normal operating signatures. The #2, #3, #4, and the #5 connecting rod journals displayed thermal damage signatures consistent with lack of lubrication; the #4 and the #5 connecting rod journals displayed mechanical damage. The #4 connecting rod oil galley was blocked with redeposited metal. The rest of the oil galleries were clear of any blockages. The crankshaft gear remained intact and was undamaged.

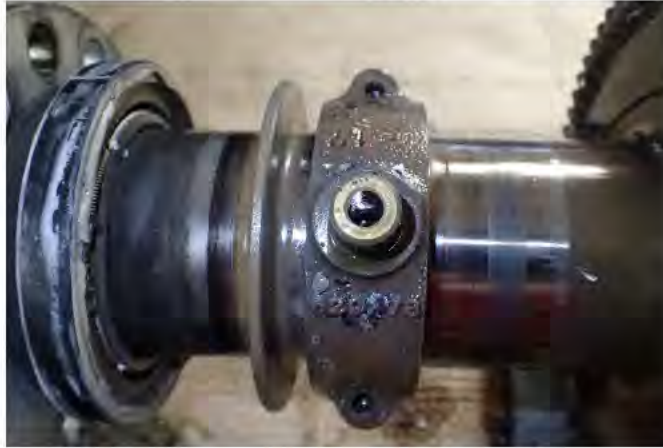
The transfer collar remained attached to its installation point and was undamaged. There were no anomalies noted with the transfer collar.

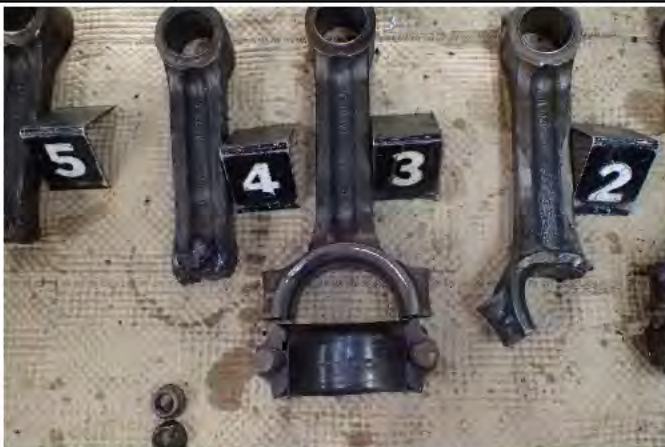
Condition: The connecting rod remained attached to its connecting rod journal and to its piston pin. The connecting rod displayed thermal discoloration consistent with lubrication distress.

Condition: The bearings remained within the bearing supports and displayed significant amount of damage consistent with lack of lubrication; the bearing surfaces were smeared and the bearings were slightly extruded.

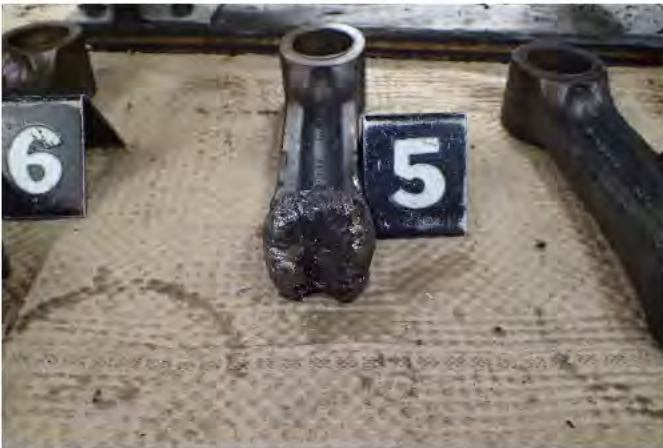
Condition: The connecting rod had released from its journal and remained attached to its piston pin. The connecting rod displayed a significant amount of thermal damage consistent with lubrication distress as well as mechanical damage.

Condition: Small portions of bearing material were located within the oil sump. The located bearing material displayed significant thermal damage signatures consistent with lubrication distress.

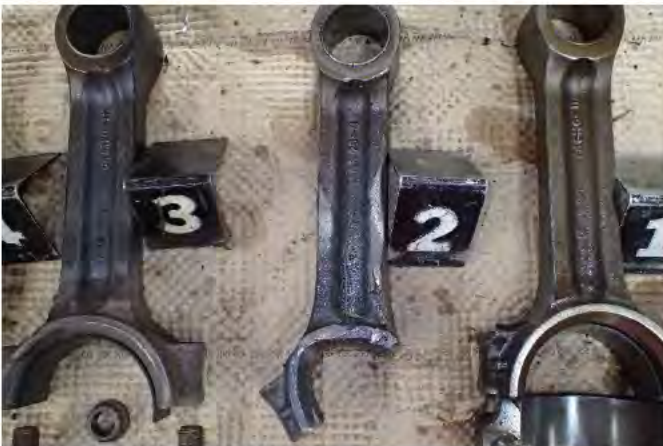
## #2 CONNECTING ROD

Condition: The connecting rod had released from its journal and remained attached to its piston pin. The connecting rod displayed a significant amount of thermal damage consistent with lubrication distress as well as mechanical damage.

Condition: Small portions of bearing material were located within the oil sump. The located bearing material displayed significant thermal damage signatures consistent with lubrication distress.

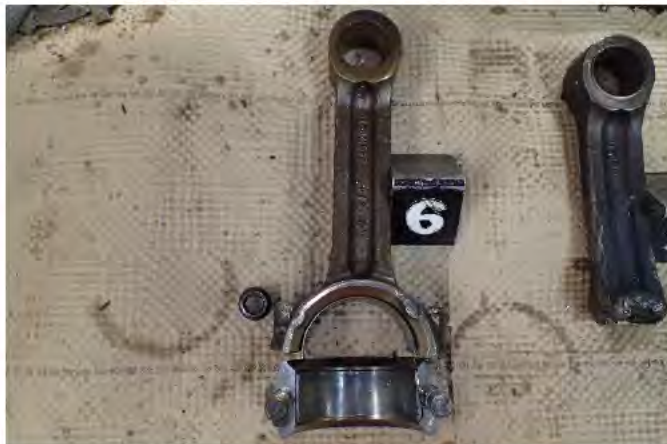
The connecting rod remained attached to its journal and to its piston pin. The connecting rod displayed mechanical damage signatures as well as normal operating signatures. There were no anomalies noted with the connecting rod.

The bearings remained within the bearing supports and displayed minor mechanical damage signatures. The bearings displayed the initial stages of lubrication distress.

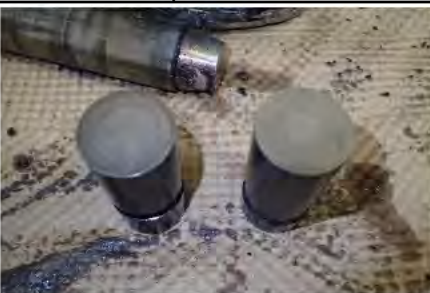
#1 Lifters

| LIFTERS | #1 | #3 | #5 | #2 | #4 | #6 |
|---|---|---|---|---|---|---|
| Condition: | The lifters remained installed in their installation points and displayed varying amounts of mechanical damage. There were no anomalies noted with the lifters. | | | | | |

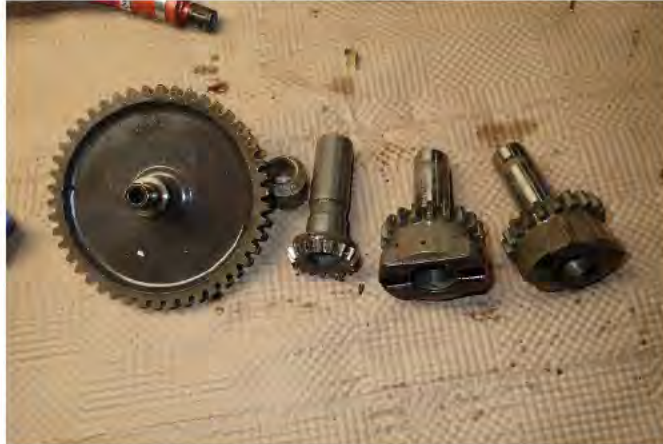
All of the accessory gears remained installed in their installation points and displayed normal operating and lubrication signatures. There were no anomalies noted with the gears.
