# Continental Motors

## ENGINE EXAMINATION REPORT

| ENGINE MODEL | TSIO-360-KB |
| FILE NUMBER | 17-513 |

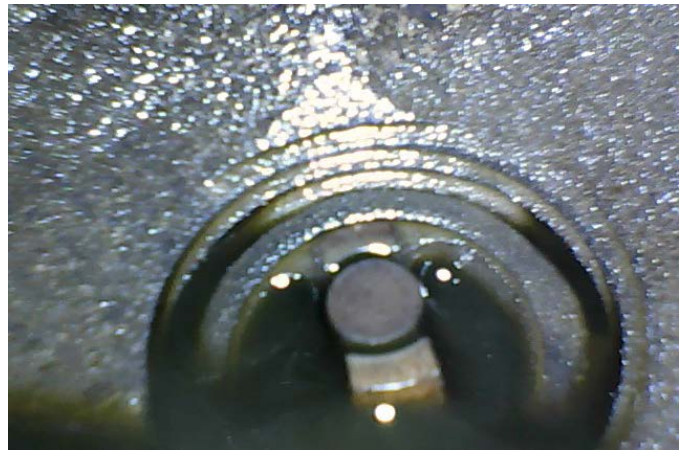
#1 Bottom Spark Plug

All of the spark plugs remained installed in their cylinders and were undamaged. The top spark plugs were removed and the electrodes were visually inspected. The electrodes displayed normal operating and wear signatures when compared with Champion Aviation Service Manual AV6-R. The bottom spark plugs were inspected using a lighted borescope. It was noted that the #1, #3, and the #5 bottom spark plugs were oil soaked consistent with post-accident accumulation. The bottom spark plugs displayed normal operating and combustion signatures. There were no anomalies noted.

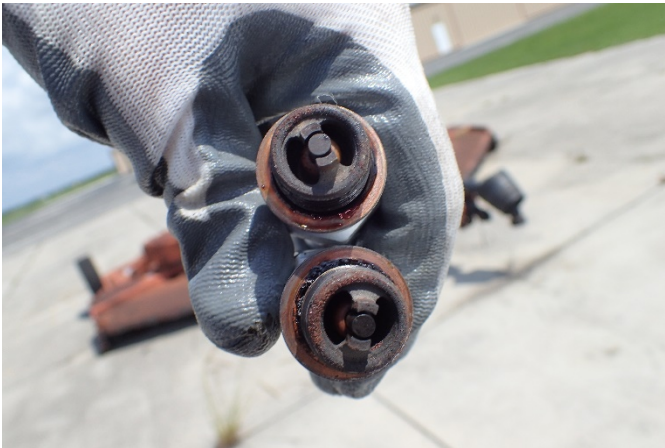
#4 Spark Plugs

All of the spark plugs remained installed in their cylinders and were undamaged. The spark plugs were removed and visually inspected. The electrodes displayed normal operating and wear signatures when compared with Champion Aviation Service Manual AV6-R. There were no anomalies noted.

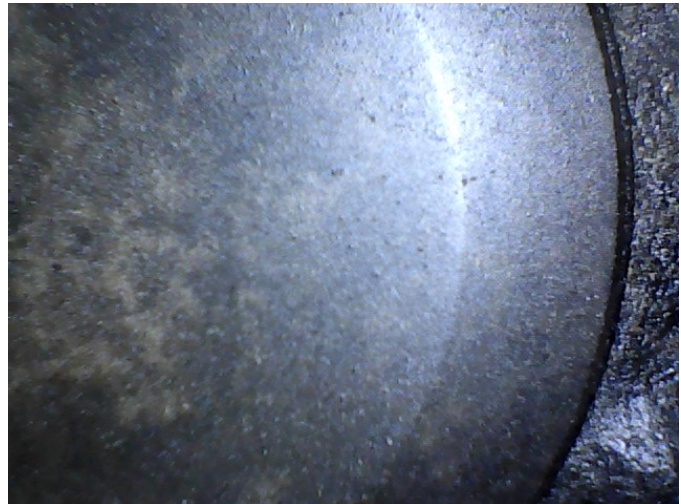
#1 Intake

**Condition:** The valve heads were inspected using a lighted borescope. The valve heads displayed normal operating and combustion signatures.

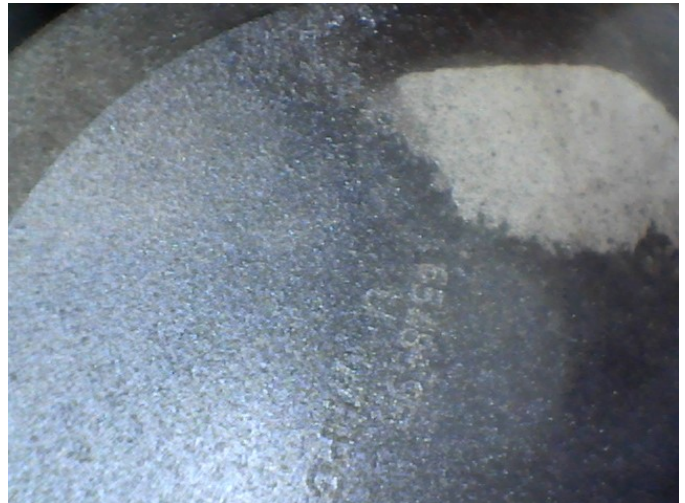
#3 Piston

The piston faces were inspected using a lighted borescope; the piston face displayed normal operating and combustion signatures. It was noted there was very little combustion deposits on the piston faces which is consistent with an engine that has been recently overhauled.
