**TEARDOWN REPORT  
OF ONE MODEL TPE331-10-511M  
TURBOPROP ENGINE  
SERIAL NUMBER P36075C**

**August 29, 2019**

This report, prepared by Honeywell Aerospace, presents the findings of a teardown and inspection conducted on one Honeywell Model TPE331-10-511M engine, Serial Number P36075C. The inspection took place at the Honeywell Investigation Laboratory in Phoenix, Arizona, on October 16 – 18, 2018.

On April 29, 2018, at 15:30 pm local time, a Grumman / Schweizer G-164C/C, single engine agricultural airplane, N6674K, was substantially damaged following a forced landing due to a loss of engine power near Maxwell, CA. The commercial pilot was not injured. The pilot reported, while flying at 200 feet altitude, that the engine surged three times, followed by what he believed was a total engine failure. The aircraft was recovered to a secure facility where the engine was removed and shipped to Honeywell for teardown.

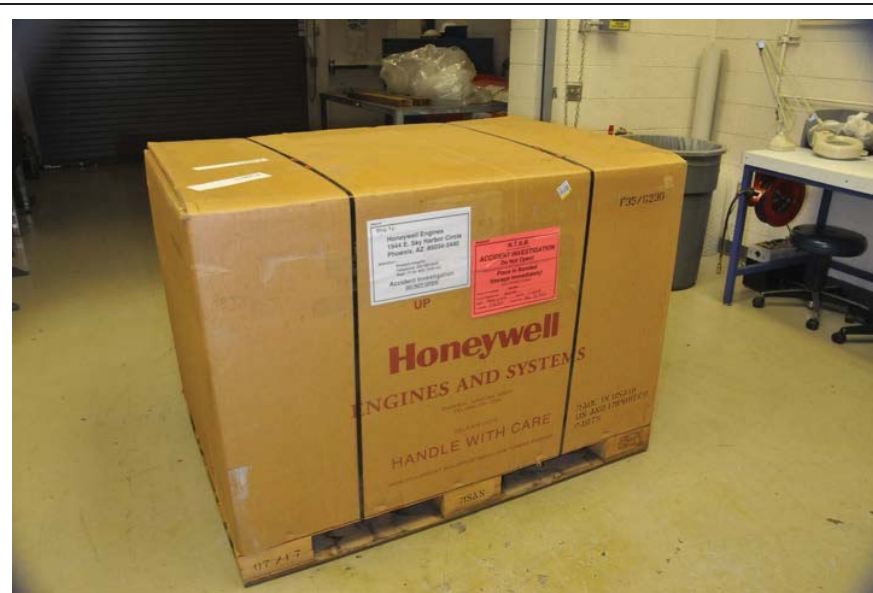
**Figure 1. Engine S/N P36075C, As Received**

- (a) The engine was received in a standard wooden shipping container, in an open vacuum bag (Figure 1 and Figure 2).
- (b) The engine logbook was returned separate from the engine.

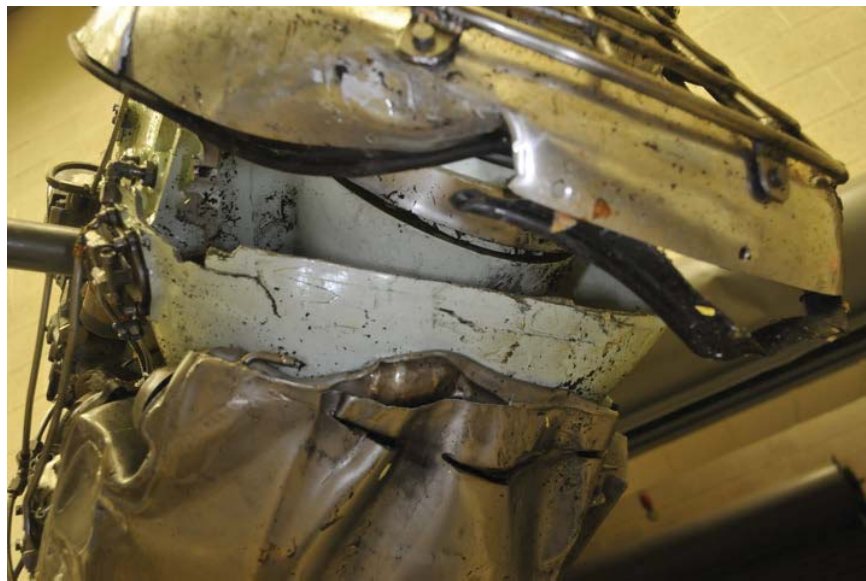
Figure 12. Engine S/N P36075C, As Received

- Exhaust duct (Figure 10).
  - Common drain plumbing (Figure 11).
- (f) The following engine damage was noted:
  - There was impact damage to the inlet (Figure 12)

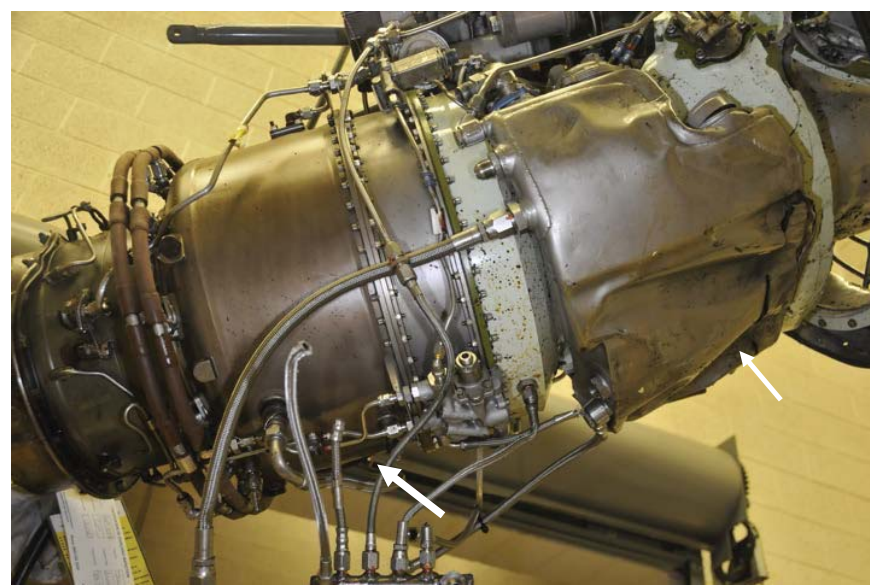
Figure 13. Engine S/N P36075C, As Received

- The oil tank was crushed (Figure 13).
  - The oil bypass indicator was not popped (Figure 14).
  - There was a small amount of earthen debris in the inlet area (Figure 15).

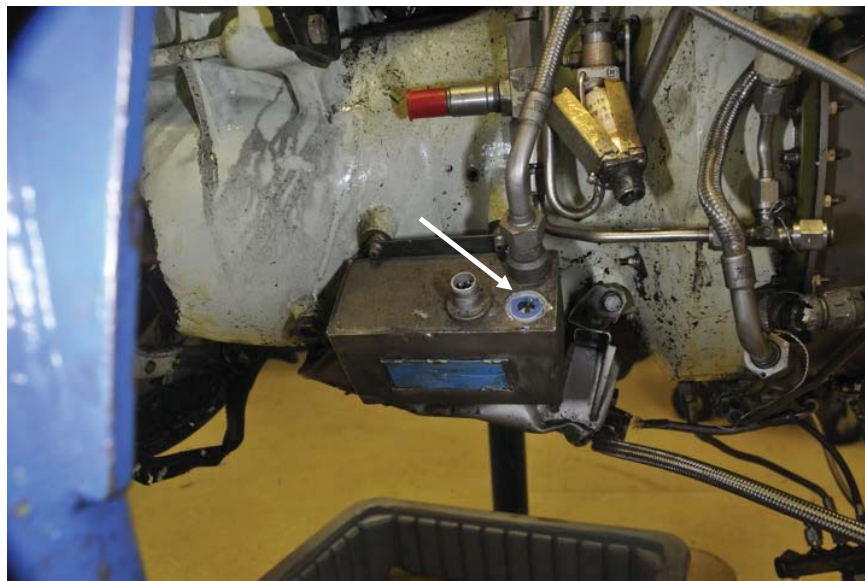
Figure 16. Engine S/N P36075C, As Received

- One lead on the exciter box was damaged (Figure 16).
  - There was damage to the right side aft exhaust duct (Figure 17).
    - The oil supply tube was crushed.

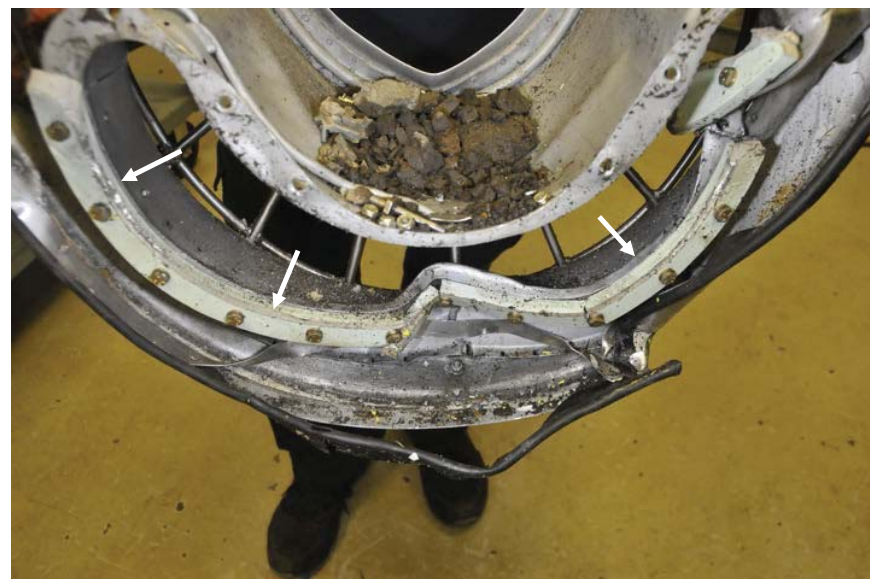
Figure 18. Engine S/N P36075C, As Received

- The inlet mount flange of the accessory gearbox housing was separated and remained attached to the aircraft inlet (Figure 18).

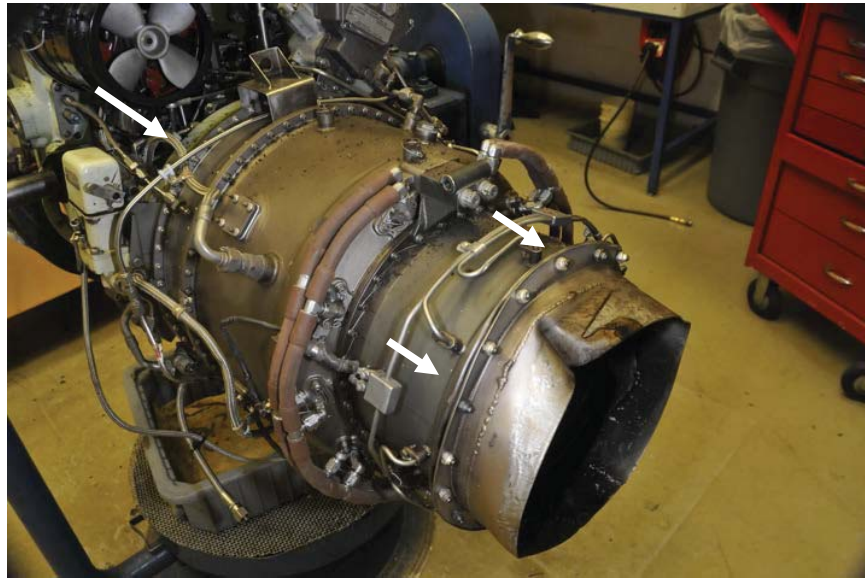
Figure 19. Engine S/N P36075C, As Received

- The exhaust flange was distorted ([Figure 19](#)).
- The fuel shutoff valve was in the AUTO position ([Figure 20](#)).
- (g) The engine propeller shaft would rotate, but the turbine did not rotate with the prop.
- (h) The engine's rotating group would rotate, but the prop did not rotate.
- (i) The FCU / PPC / Prop Governor rigging was verified to be correct.
- (j) The starter/generator was:
  - The starter shaft was intact and appeared undamaged ([Figure 21](#)).
  - The starter pad flange was intact and appeared undamaged ([Figure 22](#)).

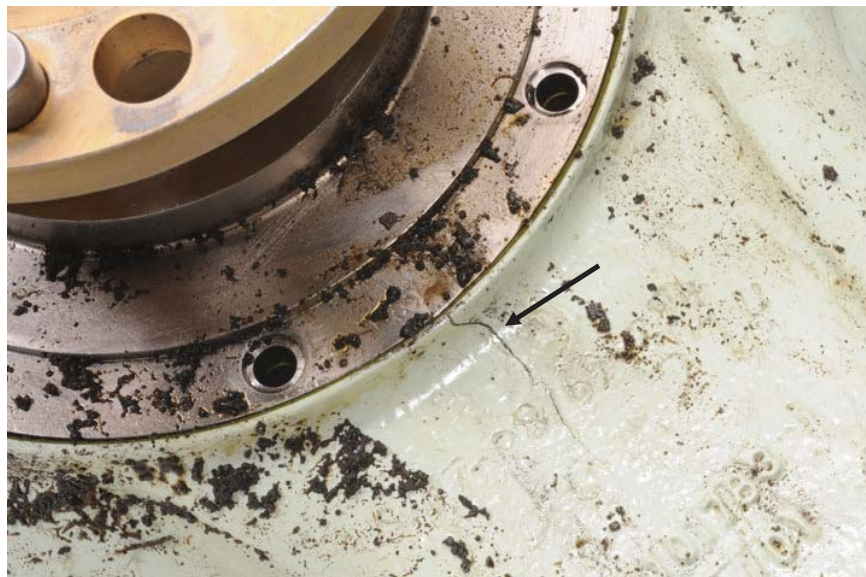
Figure 24. Nose Cone Housing

- (a) Nose Cone Housing
  - The nose cone housing was intact and appeared undamaged ([Figure 23](#)).
  - There was a crack on the forward side at the bottom of the nose cone housing that appears to have originated from bearing bore at 6 o'clock ([Figure 24](#)).

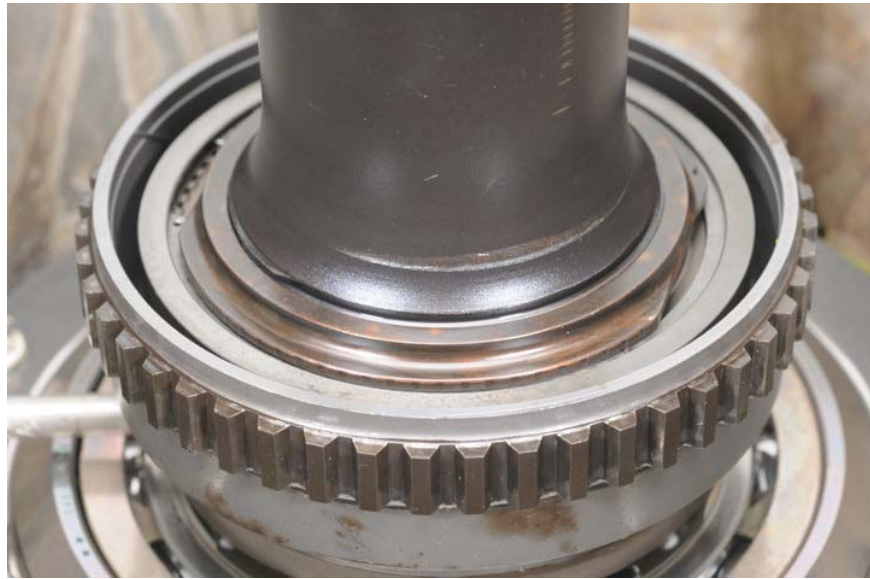
Figure 27. Propeller Shaft

- There was light rotational scoring over a 90-degree arc aft of the bearing retaining nut on the propeller shaft ([Figure 27](#)).
  - There was very light rotational scoring at the aft end of the propeller shaft over 180 degrees ([Figure 28](#)).

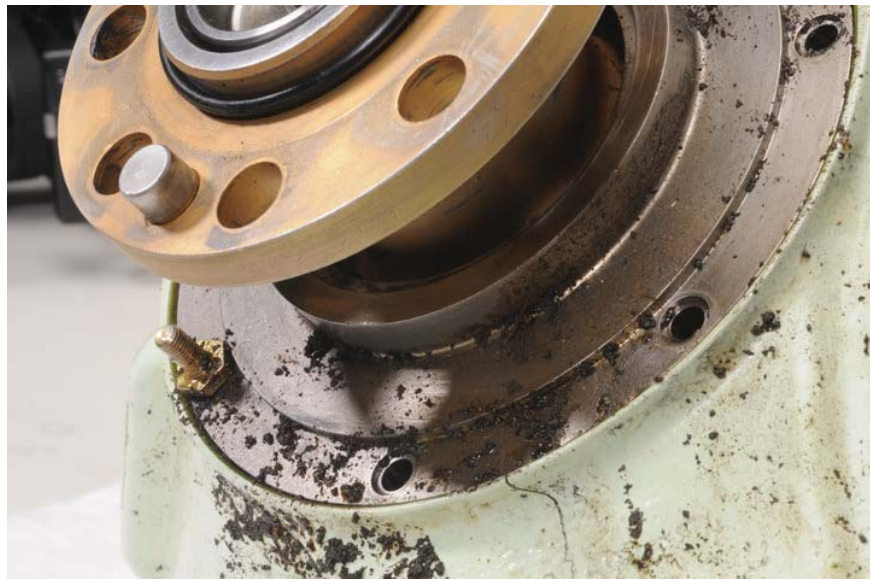
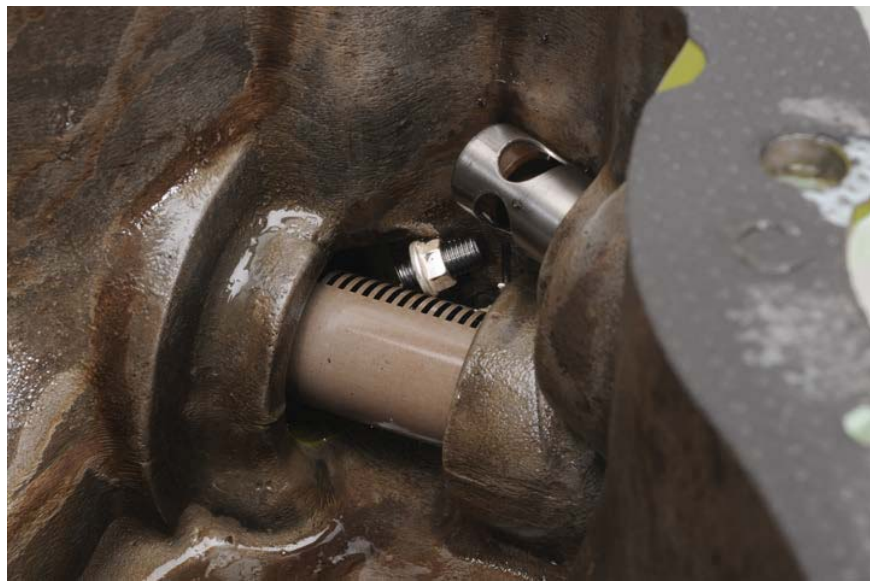
- (d) Forward Propeller Shaft Bearing Mount Bolts
  - Three forward propeller shaft bearing mount bolts were broken and found in the sump area of nose cone ([Figure 29](#) and [Figure 30](#)).

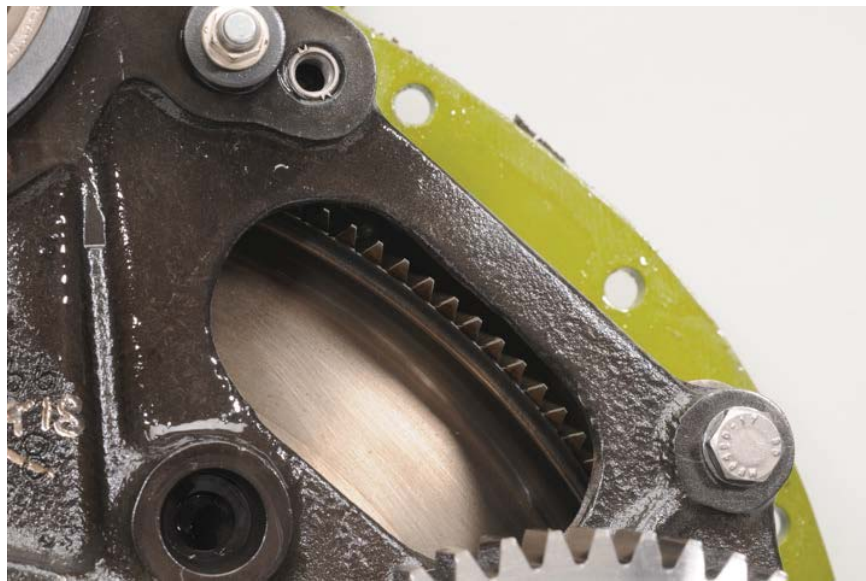
**Figure 46. Bull Gear**

- (g) Bull Gear
  - The bull gear was intact and appeared undamaged (Figure 46 and Figure 47).
- (h) Forward Bull-Gear Bearing
  - The forward bull gear bearing was intact and appeared undamaged (Figure 48).

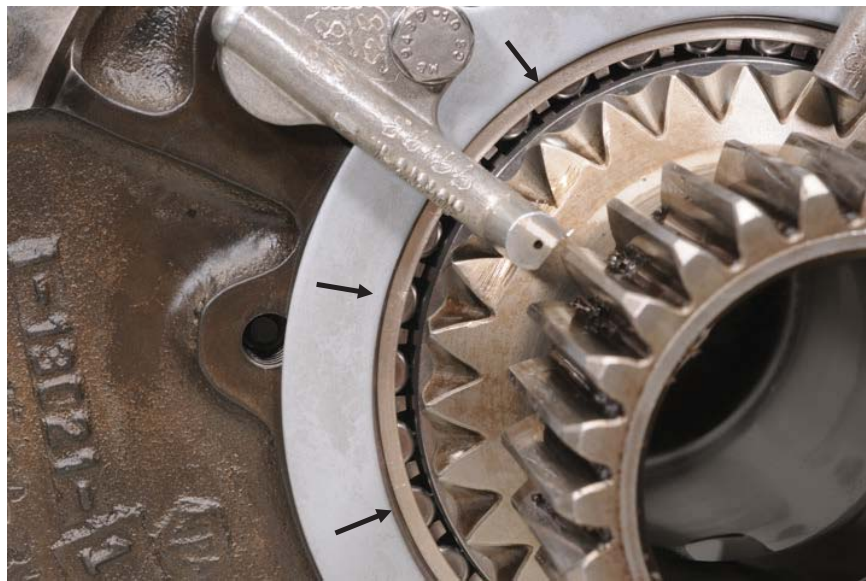
Figure 48. Forward Bull Gear Bearing

- The forward bull gear bearing was not removed for detailed inspection.
- (i) Aft Bull-Gear Bearing:
  - The aft bull gear bearing was intact and appeared undamaged (Figure 49).

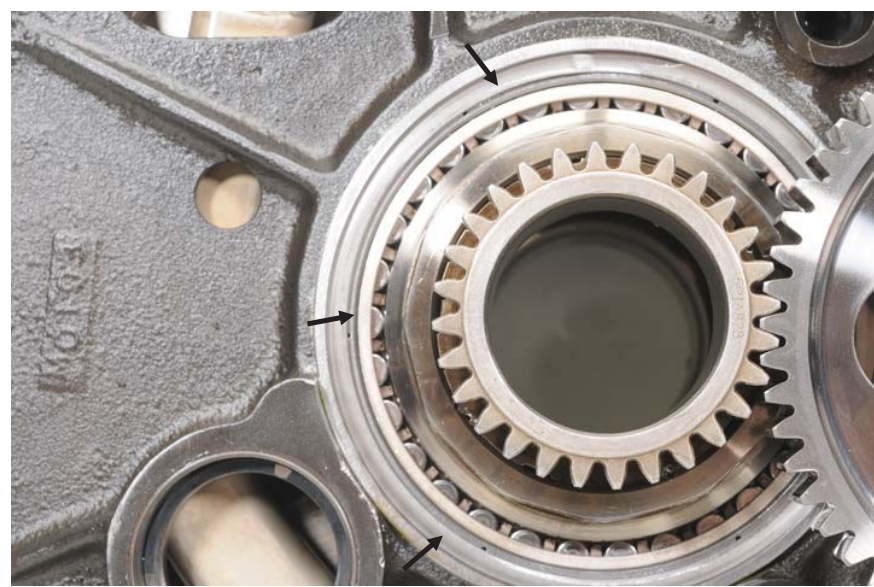
Figure 49. Aft Bull Gear Bearing

- The aft bull gear bearing was not removed for detailed inspection.
- (j) Sun Gear
  - The sun gear was intact and appeared undamaged (Figure 50).
  - The oil jets for the sun gear were intact and appeared undamaged.

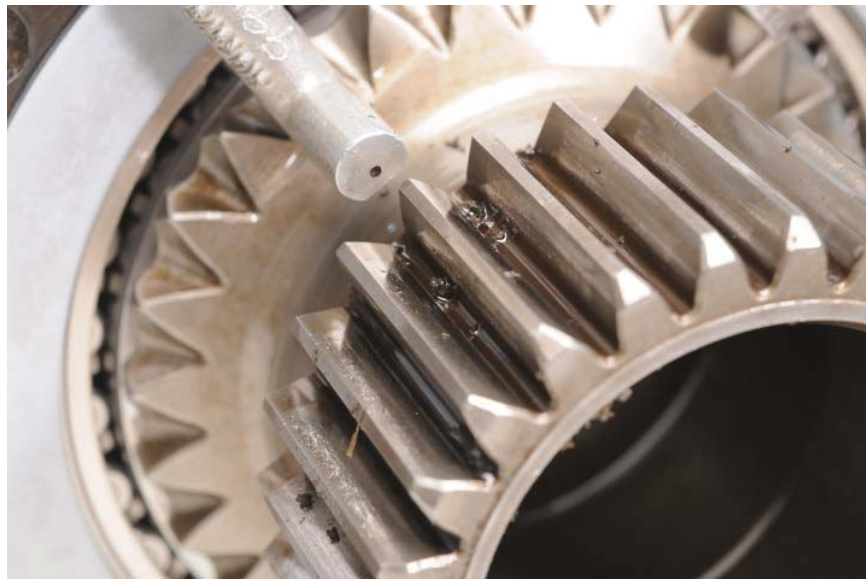
Figure 51. Sun Gear

- There was evidence of wear on the gear teeth with debris present between the gear teeth (Figure 51).
- (k) High-Speed Pinion HSP:
  - The high-speed pinion was intact and appeared undamaged (Figure 52).

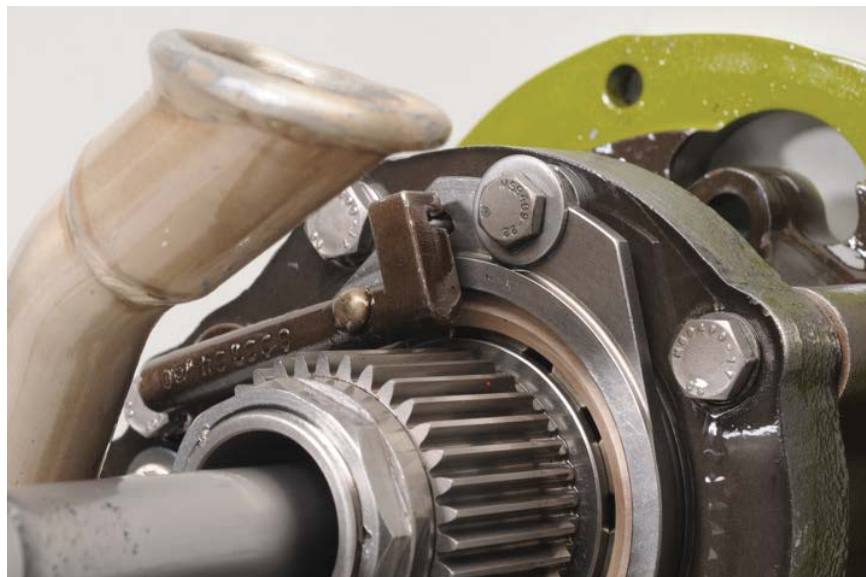
Figure 52. High-Speed Pinion (HSP)

- The high-speed pinion was not removed for detailed inspection.
- (l) Forward High-Speed Pinion Bearing:
  - The forward high-speed pinion bearing was intact and appeared undamaged (Figure 53).

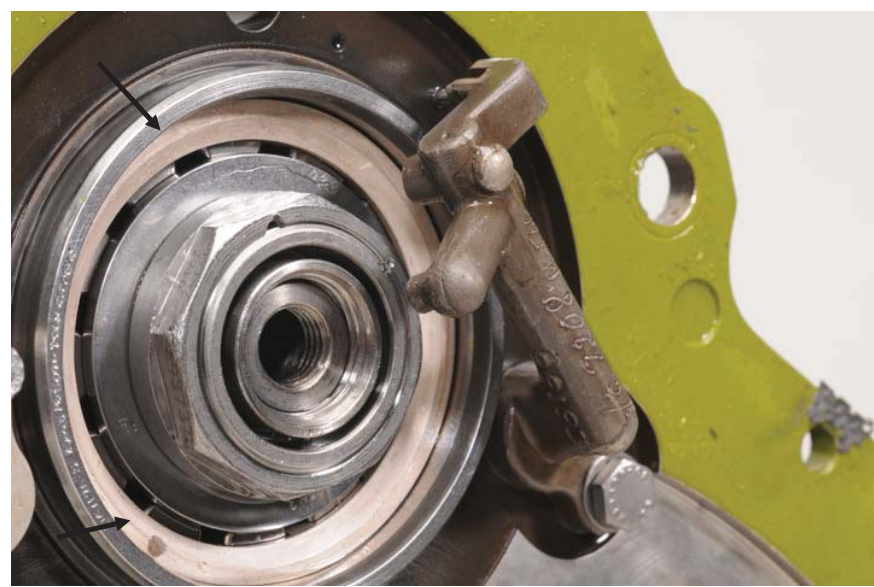
Figure 53. Forward High-Speed Pinion Bearing

- The forward high-speed bearing was not removed for detailed inspection.
- (m) Aft High-Speed Pinion Bearing:
  - The aft high-speed pinion bearing was intact and appeared undamaged (Figure 54).

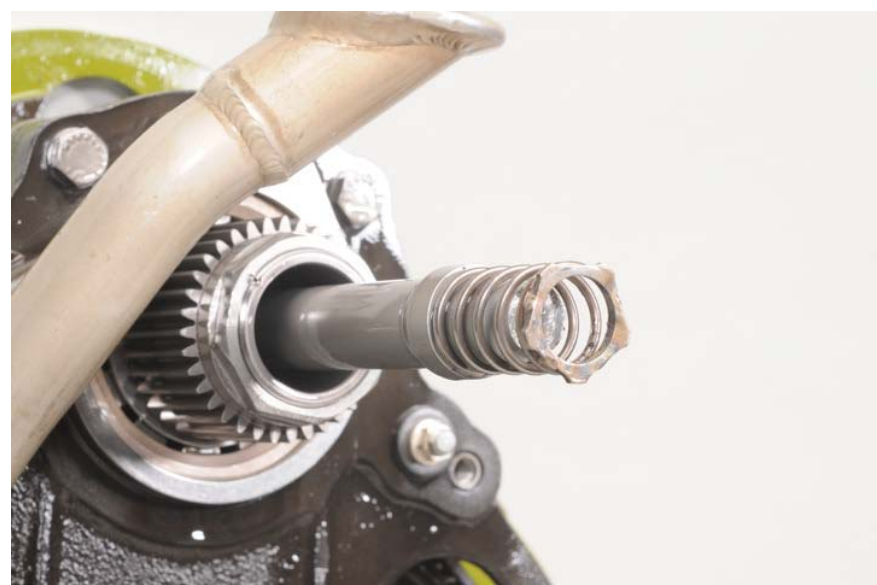
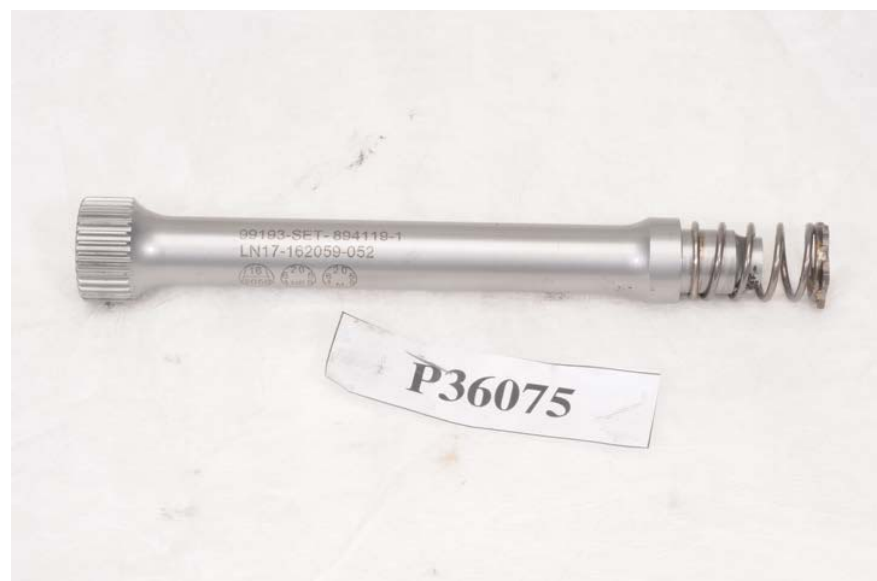
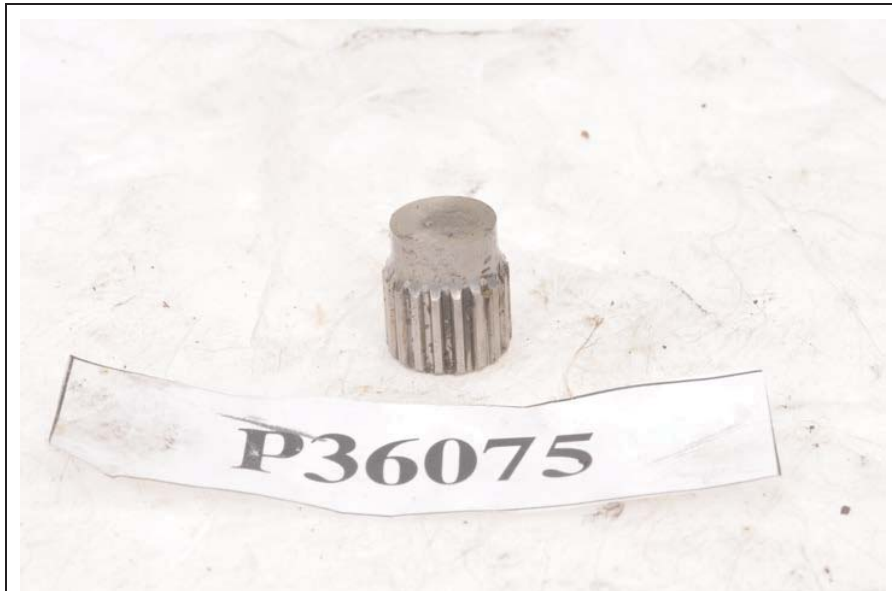
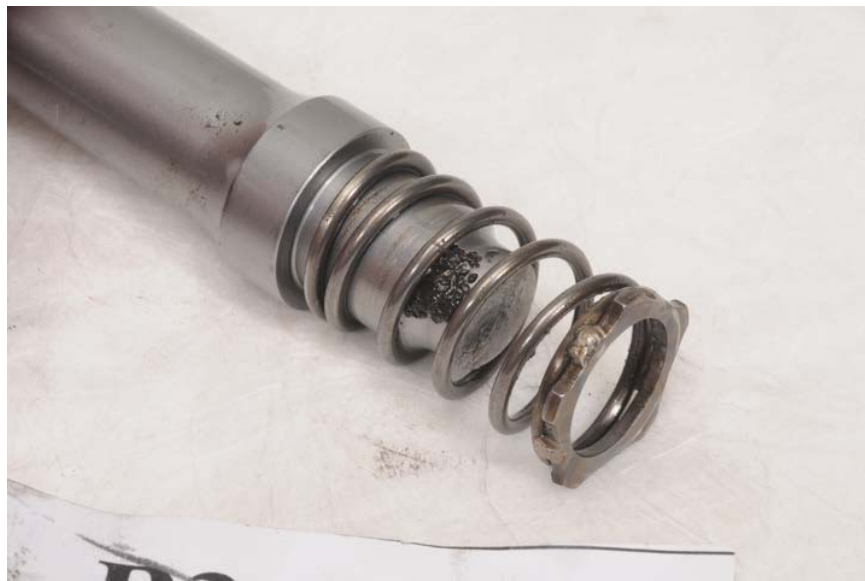
- (n) HSP-to-Power Section Coupling Shaft
  - The HSP-to-power section coupling shaft broke at the aft end ([Figure 55 - Figure 58](#)).
  - The HSP-to-power section coupling shaft was submitted for material analysis. The results are presented in [APPENDIX A](#).

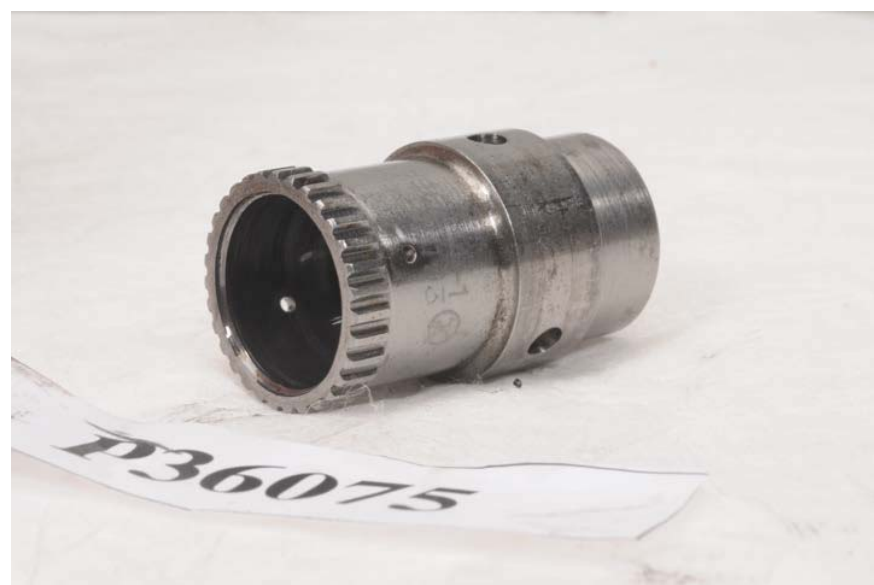
Figure 59. Shouldered Ball-Lock Shaft

- (o) Shouldered Ball-Lock Shaft
  - The shouldered ball-lock shaft was intact and appeared undamaged ([Figure 59](#)).
- (p) Negative Torque Sensor (NTS) Quill Shaft

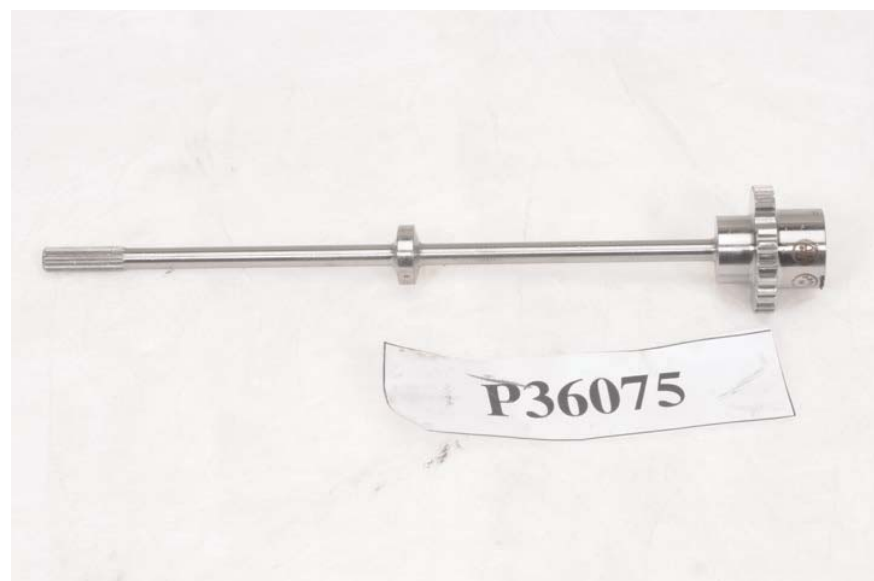
Figure 60. NTS Quill Shaft

- The NTS quill shaft was intact and appeared undamaged ([Figure 60](#)).
- (q) Hydraulic Pump Drive Gearshaft.
  - The hydraulic pump drive gearshaft was intact and appeared undamaged ([Figure 61](#)).

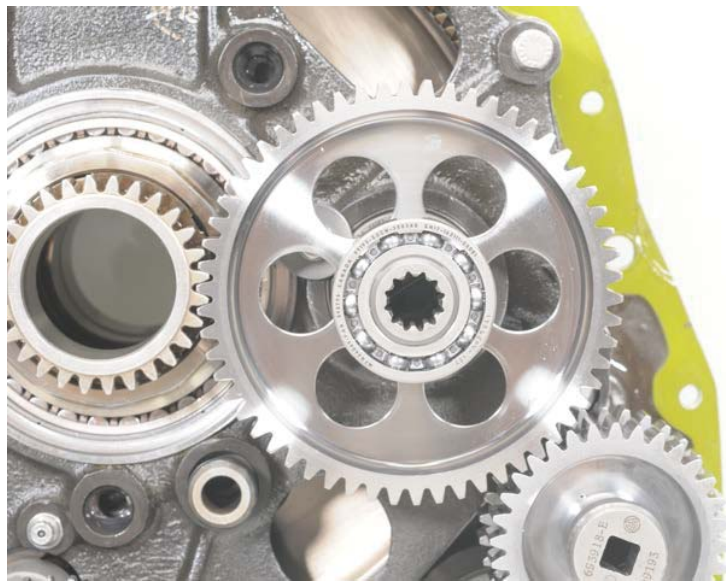
**Figure 62. Propeller Governor Drive Gear Assembly**

- (r) Propeller Governor Drive Gear Assembly:
  - The propeller governor drive gear assembly was intact and appeared undamaged ([Figure 62](#)).
- (s) Starter/Generator Drive Gearshaft Assembly:

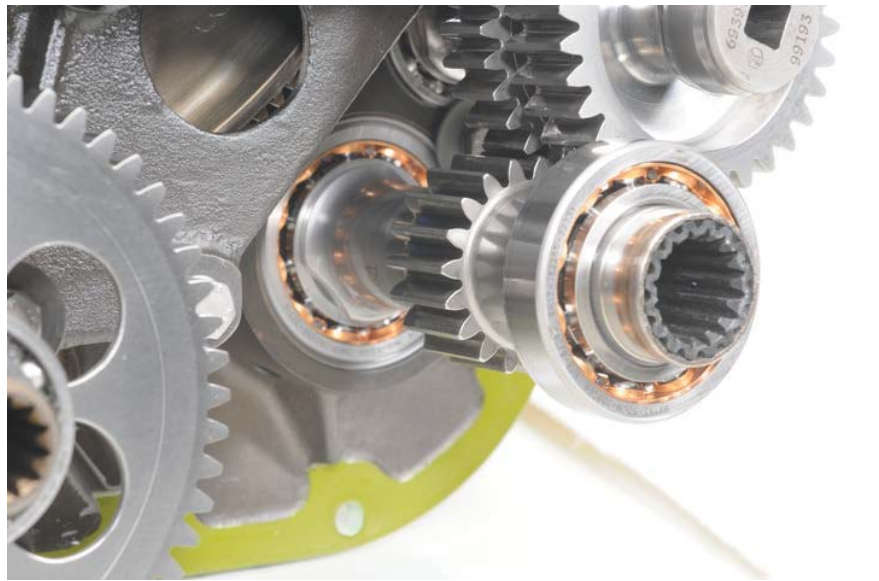
**Figure 63. Starter/Generator Drive Gearshaft Assembly**

- The starter/generator drive gearshaft assembly was intact and appeared undamaged ([Figure 63](#)).
- (t) Starter/Generator Idler Gears Assembly:
  - The starter/generator idler gears assembly was intact and appeared undamaged ([Figure 64](#)).

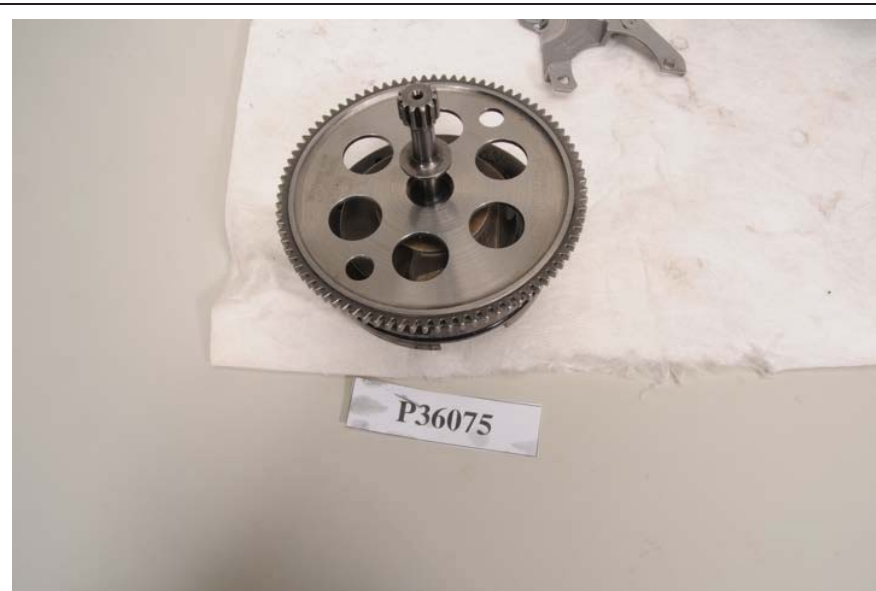
**Figure 65. Gearcase Oil-Scavenge Pump Drive Idler Gear and Drive Shaft**

- (u) Gearcase Oil-Scavenge Pump Drive Idler Gear
  - The gearcase oil-scavenge pump drive idler gear was intact and appeared undamaged ([Figure 65](#)).

- (v) Gearcase Oil-Scavenge Pump Drive Shaft
  - The gearcase oil-scavenge pump drive shaft was intact and appeared undamaged ([Figure 65 - Figure 66](#)).

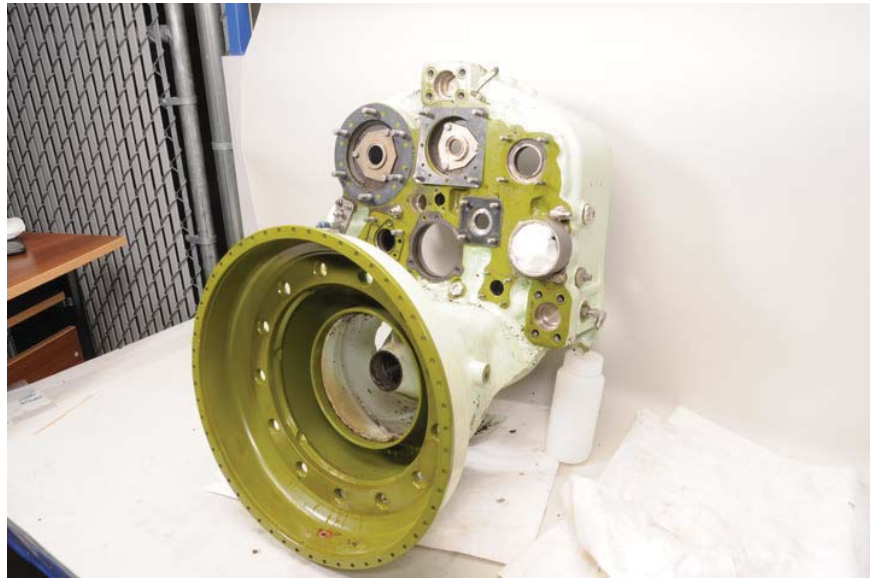
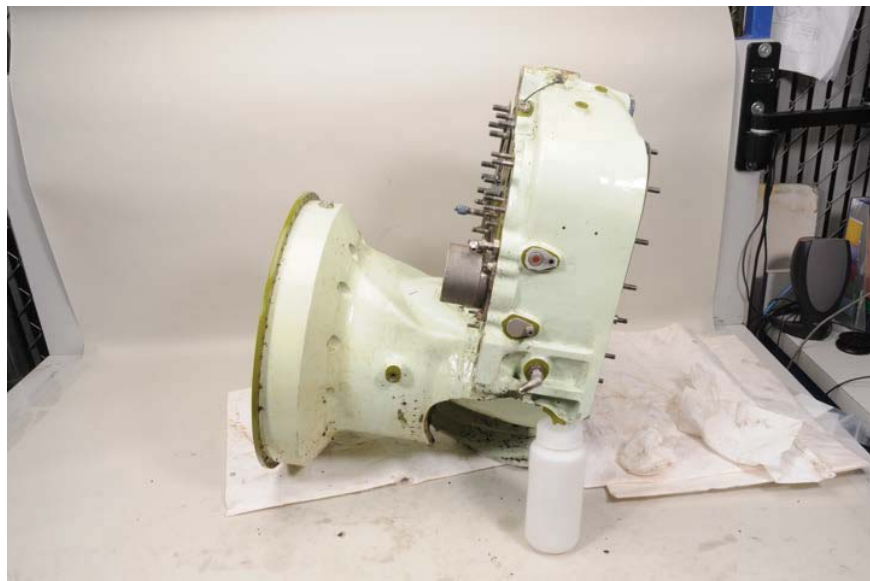
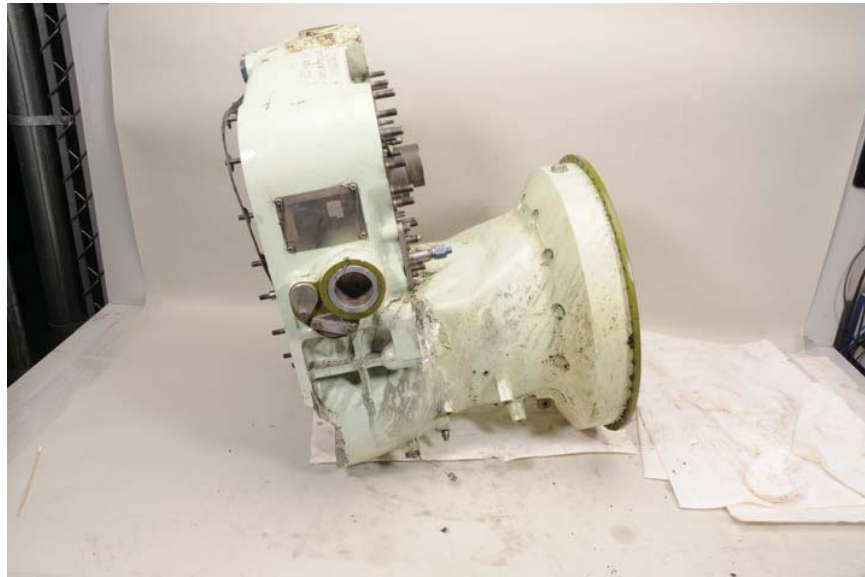
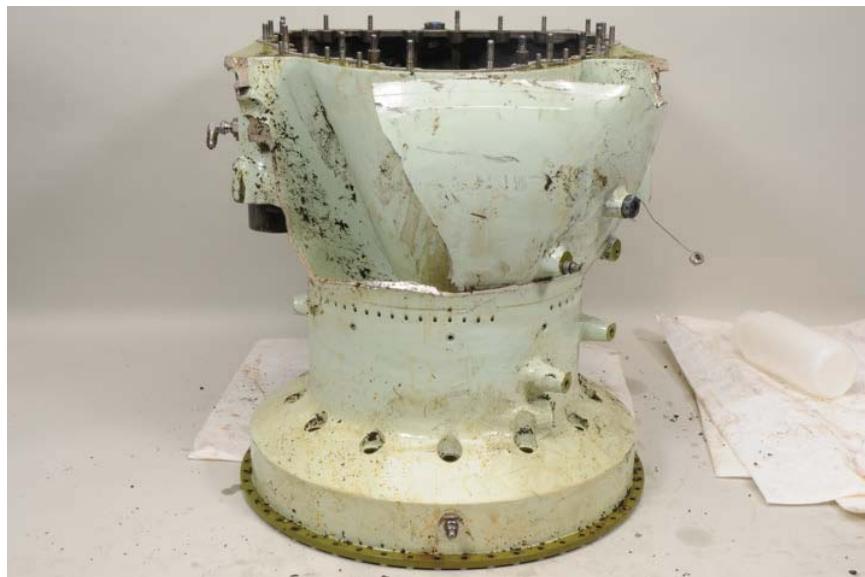
- (a) Exterior (Non Oil-Wetted) of the Gearcase Housing
  - The gearcase housing was intact ([Figure 67](#) - [Figure 70](#)).
  - A portion of the gearcase housing at the bottom of the inlet was damaged with the inlet flange and a portion of the inlet duct on the right side missing, but remained attached to the oil tank ([Figure 71](#)).

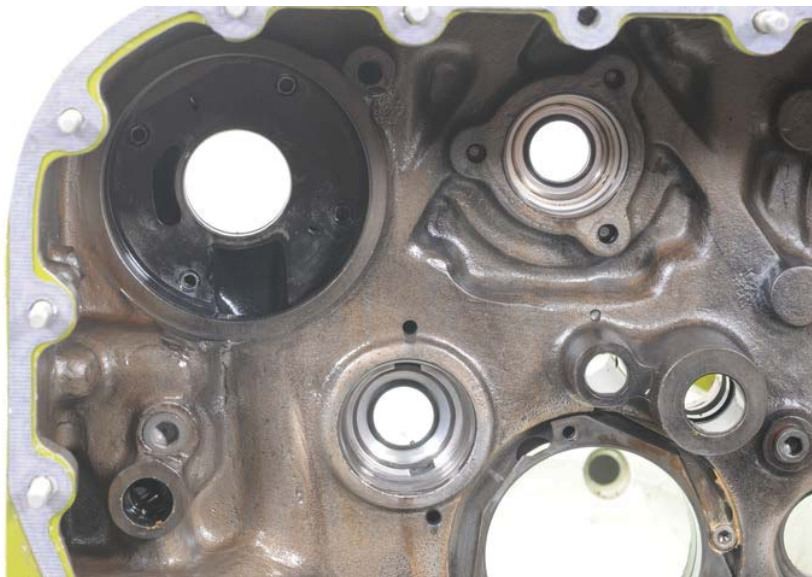
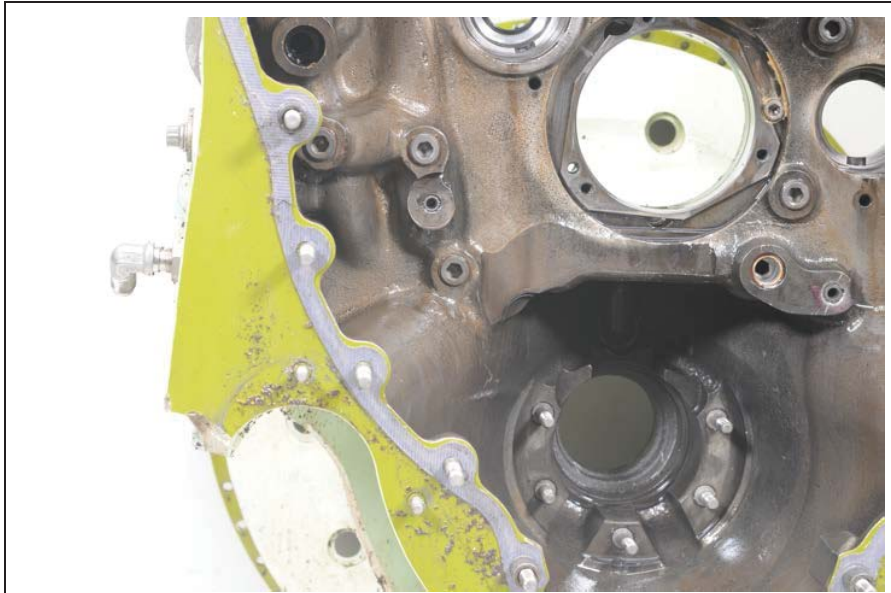
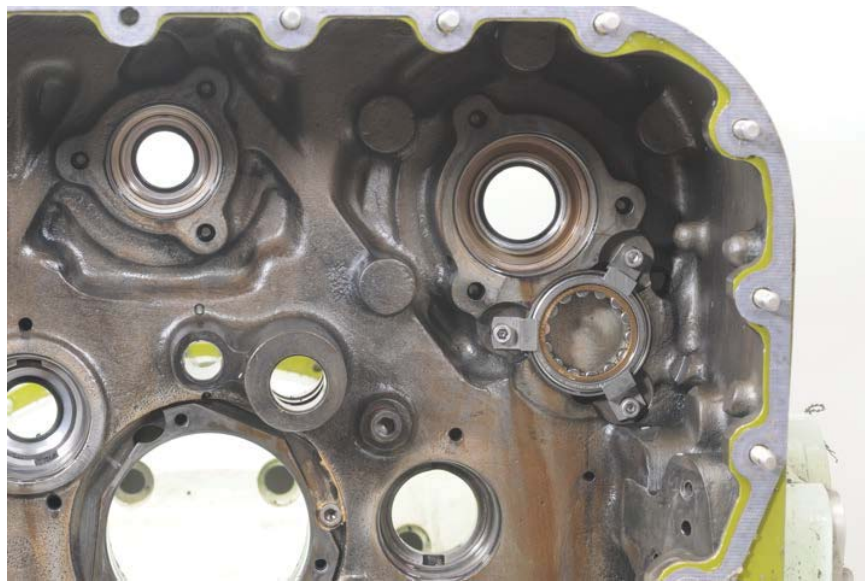
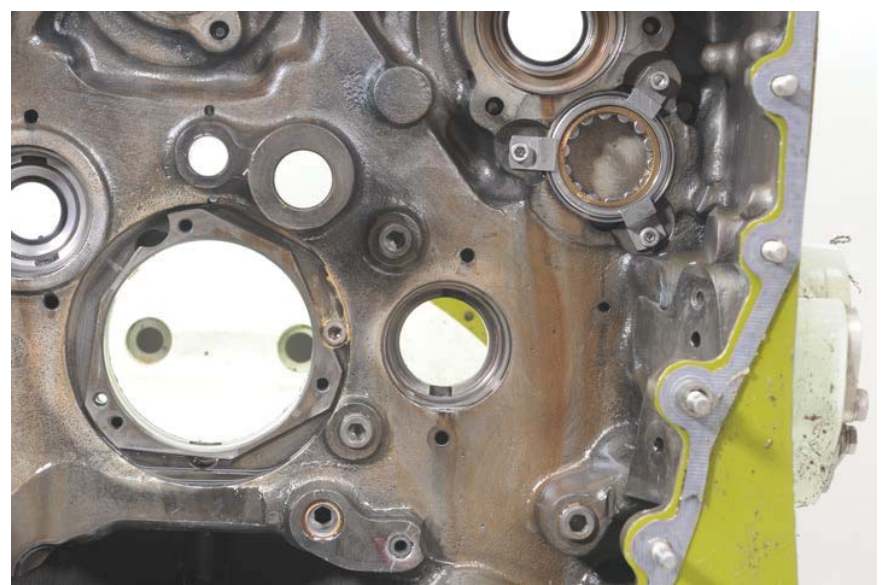
- (b) Interior (Oil-Wetted) of the Gearcase Housing
  - The interior (oil-wetted) of the gearcase housing was intact and appeared undamaged ([Figure 72](#) - [Figure 75](#)).

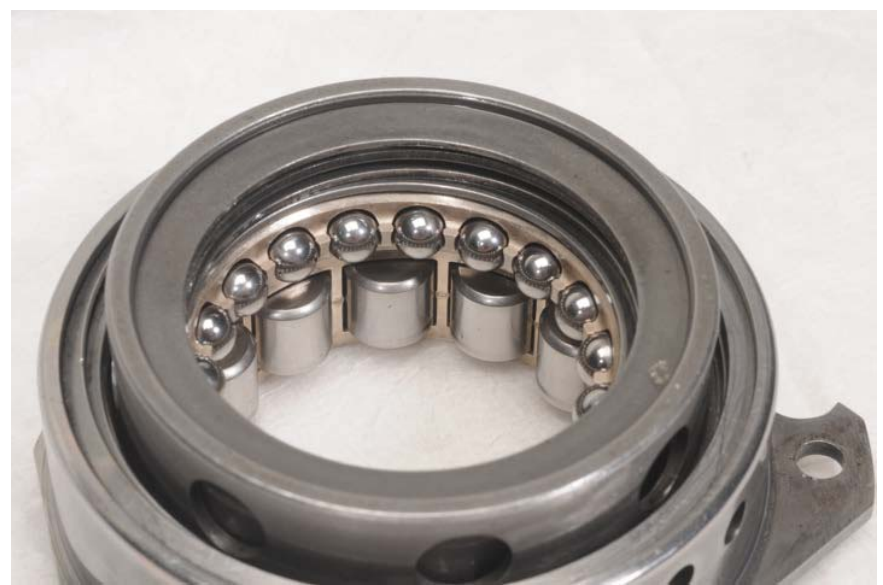
**Figure 76. Propeller Shaft Aft Ball Bearing**

- (c) Anti-Ice Shield
  - The anti-ice shield was not installed on the engine.
- (d) Propeller Shaft Aft Ball Bearing
  - The propeller shaft aft ball bearing was intact and appeared undamaged ([Figure 76](#)).

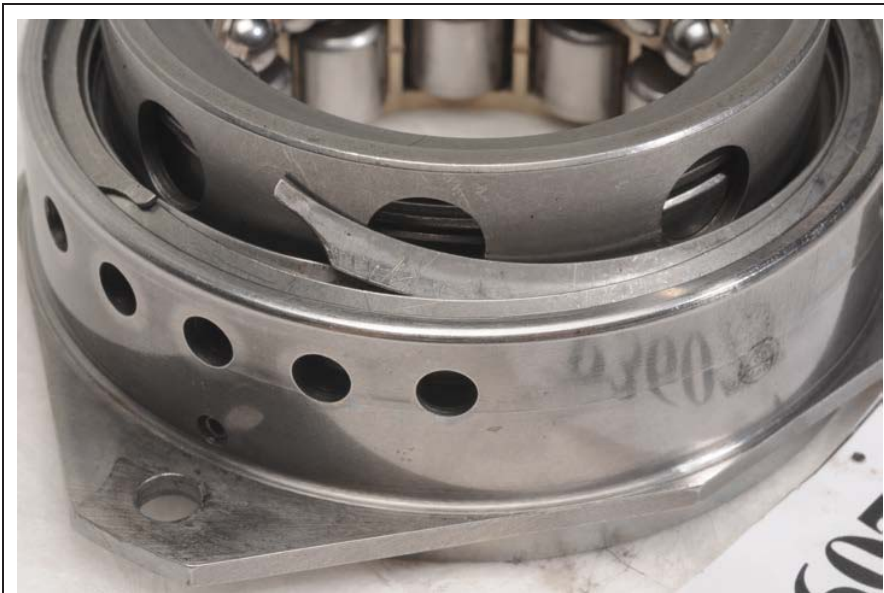
**Figure 77. Propeller Shaft Aft Ball Bearing**

- The propeller shaft aft ball bearing rotated freely.
  - The retainer on aft side of the propeller shaft aft ball bearing was partially out of the groove ([Figure 77](#)).

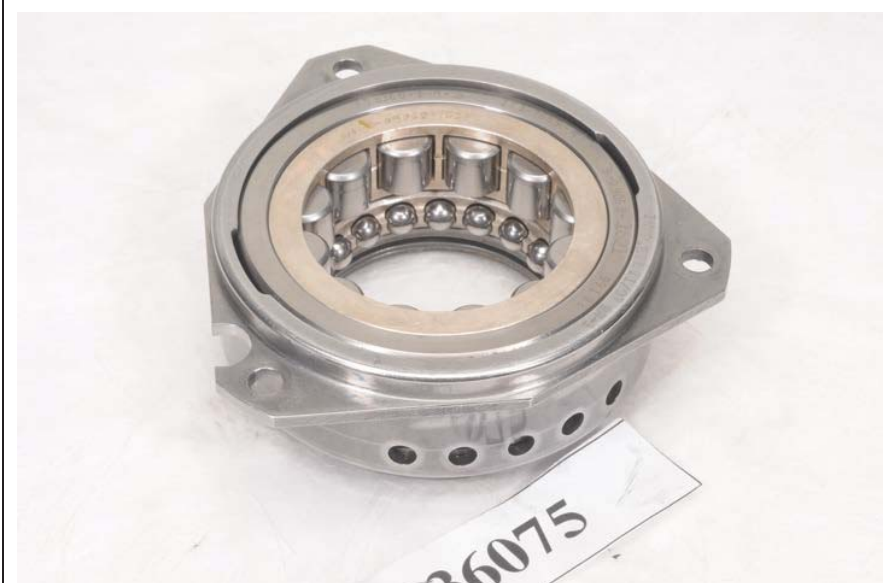
**Figure 78. Propeller Shaft Roller Bearing**

- (e) Propeller Shaft Roller Bearing
  - The propeller shaft roller bearing was intact and appeared undamaged ([Figure 78](#)).
  - The propeller shaft roller bearing rotated freely.

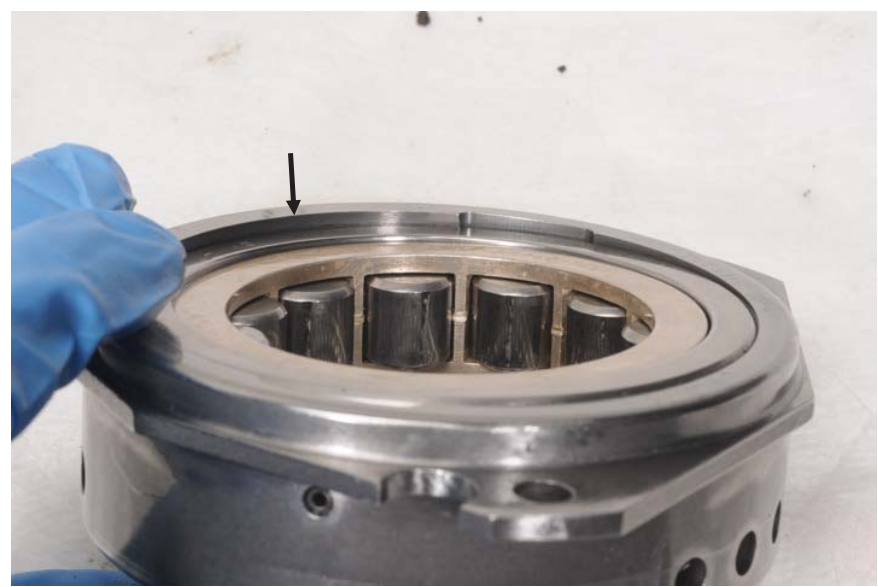
**Figure 79. Propeller Shaft Roller Bearing**

- The propeller shaft roller bearing was misaligned in the housing ([Figure 79](#)).
- (f) Forward (Compressor) Main-Shaft Nut
  - The forward compressor main-shaft nut was intact and appeared undamaged ([Figure 80](#)).

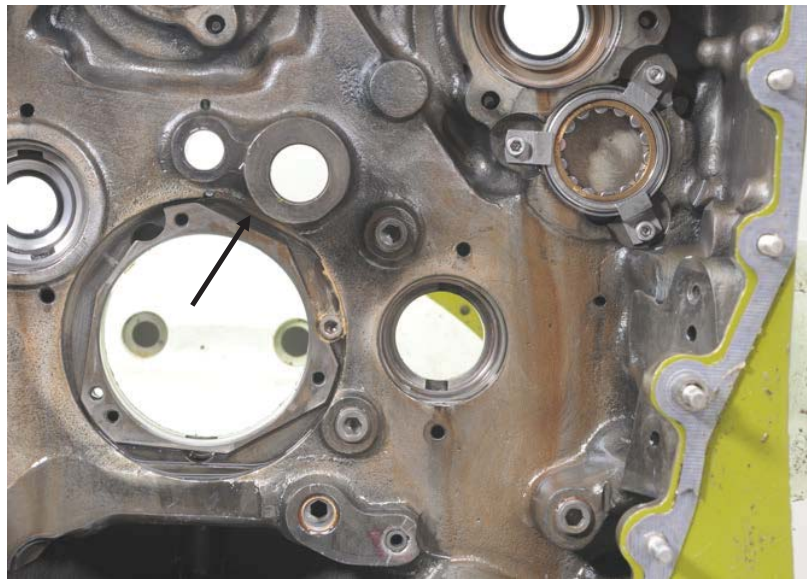
**Figure 91. Feather Valve Oil Transfer Tube Mount Boss**

- The feather valve oil transfer tube was intact and appeared undamaged.
- (p) Feather Valve Oil Transfer Tube Mount Boss
  - There were no impact or score marks on the feather valve oil transfer tube mount boss ([Figure 91](#)).

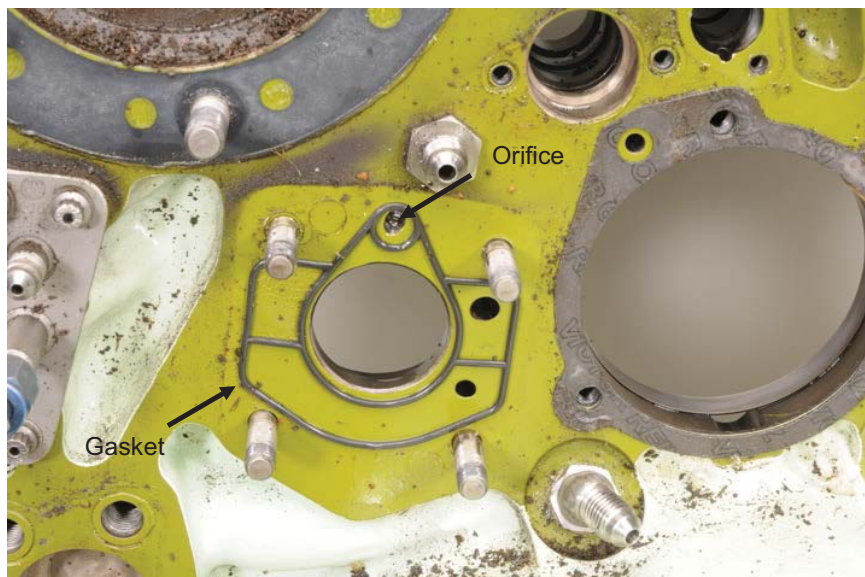
**Figure 92. Propeller Governor "Spider" Gasket and "Lee" Check Valve and Orifice Assembly**

- (q) Propeller Governor “Spider” gasket
  - The propeller governor “spider” gasket was intact and appeared undamaged ([Figure 92](#)).
- (r) “Lee” Check Valve & Orifice Assembly

- The “Lee” check valve orifice appeared free of debris ([Figure 92](#)).

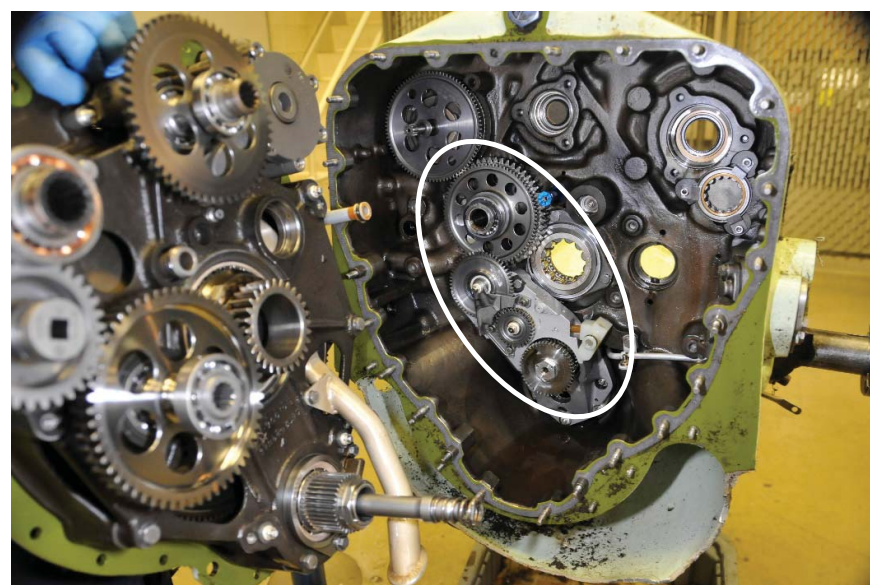
Figure 93. Torque Sensor and DDFC Gear Train

- The DDFC gear train was intact, undamaged and free to rotate ([Figure 93](#)).
- (b) Torque sensor:
  - The torque sensor was intact and appeared undamaged ([Figure 94](#)).

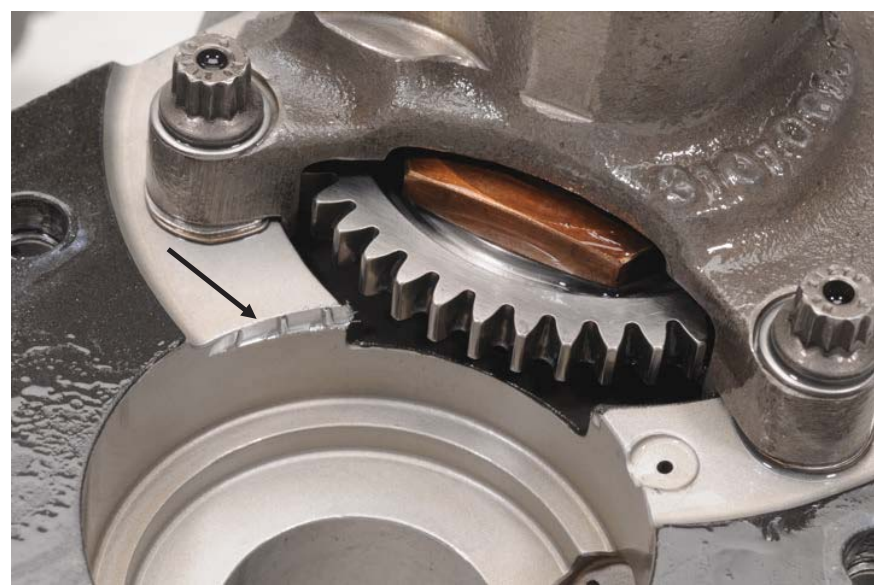
Figure 95. Torque Sensor

- There was an impact mark on the aft side ID bore of the torque sensor from contact with the main shaft gear ([Figure 95](#)).
- (c) First Direct Drive Fuel-Control (DDFC) Gear Assembly
