**TEARDOWN REPORT  
OF ONE MODEL TPE331-10-511M  
TURBOPROP ENGINE  
SERIAL NUMBER P36075C**

**August 29, 2019**

This report, prepared by Honeywell Aerospace, presents the findings of a teardown and inspection conducted on one Honeywell Model TPE331-10-511M engine, Serial Number P36075C. The inspection took place at the Honeywell Investigation Laboratory in Phoenix, Arizona, on October 16 – 18, 2018.

On April 29, 2018, at 15:30 pm local time, a Grumman / Schweizer G-164C/C, single engine agricultural airplane, N6674K, was substantially damaged following a forced landing due to a loss of engine power near Maxwell, CA. The commercial pilot was not injured. The pilot reported, while flying at 200 feet altitude, that the engine surged three times, followed by what he believed was a total engine failure. The aircraft was recovered to a secure facility where the engine was removed and shipped to Honeywell for teardown.

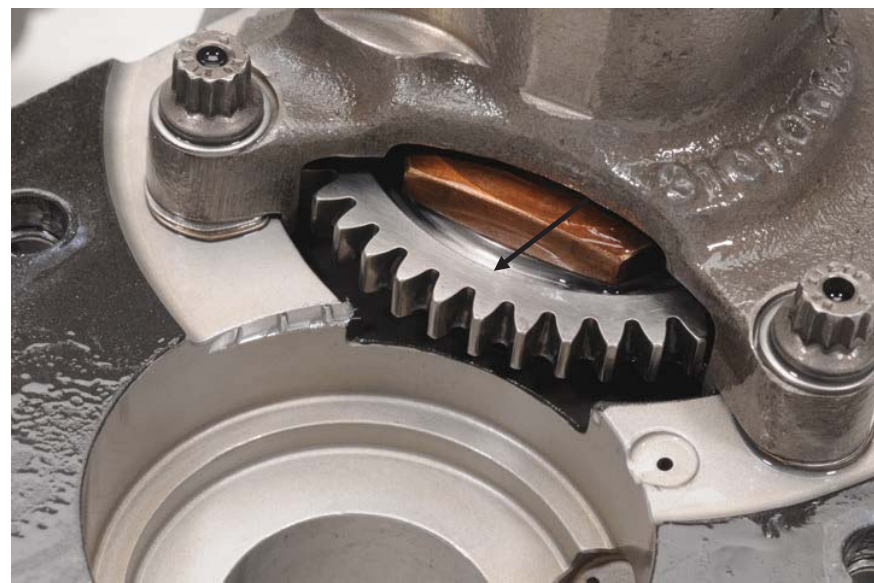
Figure 96. First DDFC Gear Assembly

- The first DDFC gear assembly was intact and appeared undamaged ([Figure 96](#)).
- (d) Second DDFC Gear
  - The second DDFC gear was intact and appeared undamaged ([Figure 97](#) and [Figure 98](#)).

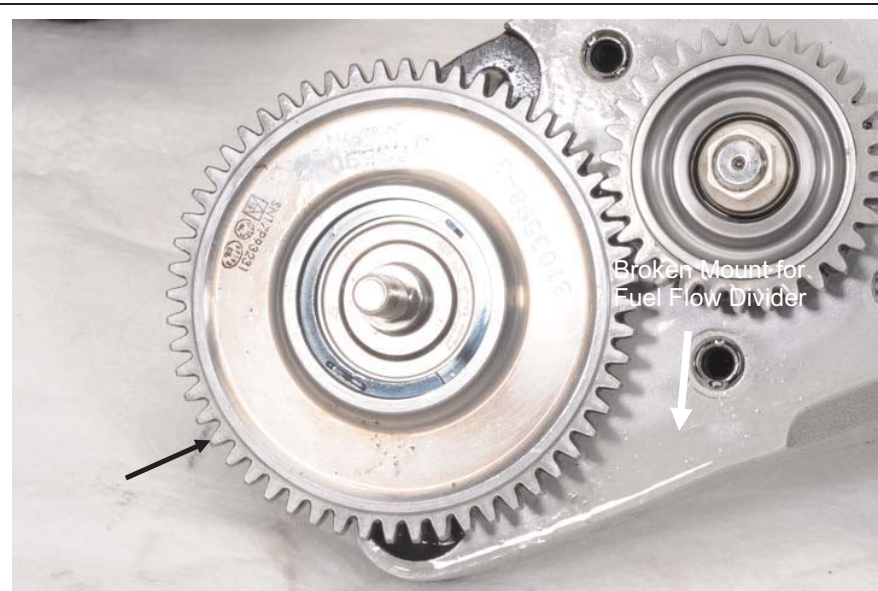
**Figure 99. Third DDFC Gear**

- (e) Third DDFC Gear
  - The third DDFC gear was intact and appeared undamaged ([Figure 99](#)).
- (f) Fourth DDFC, Tach/Generator Drive Gear and Shaft Assembly

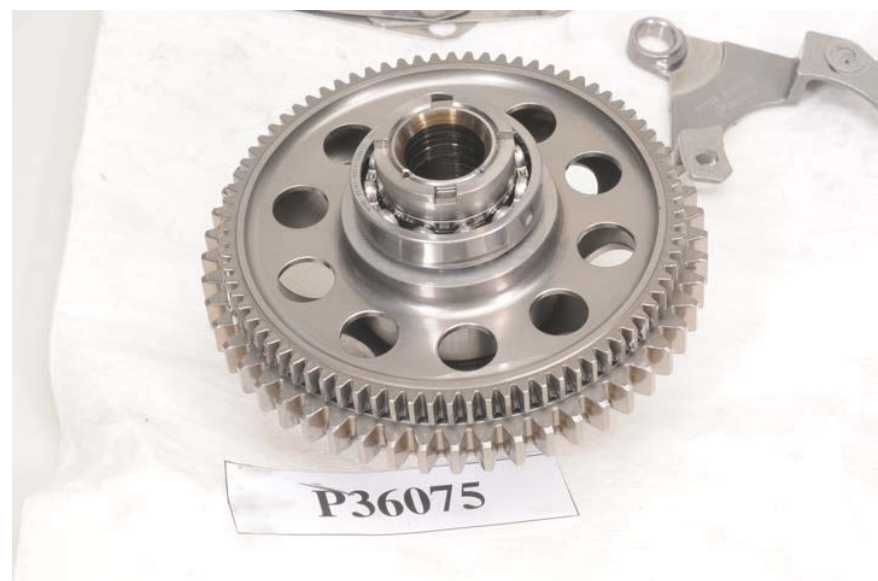
**Figure 100. Fourth DDFC Tach/Generator Drive Gear and Shaft Assembly**

- The fourth DDFC, tach/generator drive gear and shaft assembly was intact and appeared undamaged ([Figure 100](#)).
- (g) Hydraulic Oil Torque Sensor Output

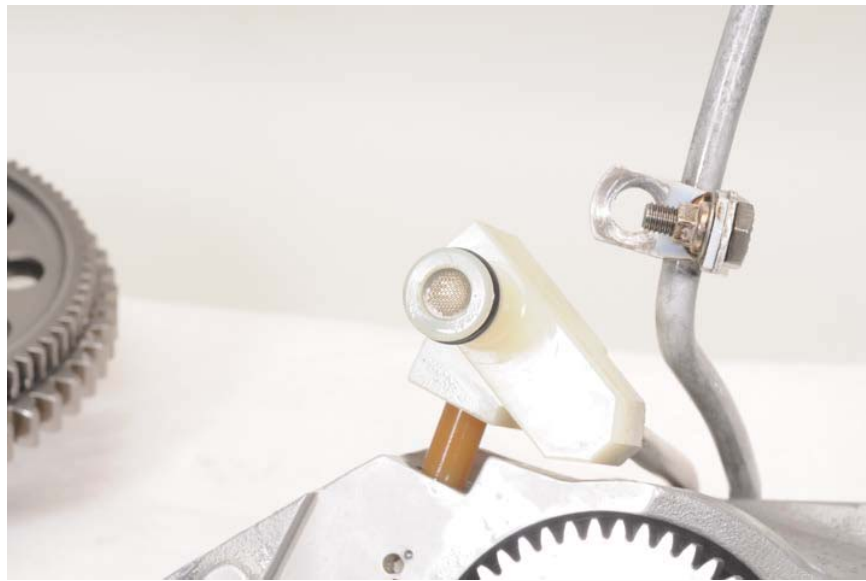
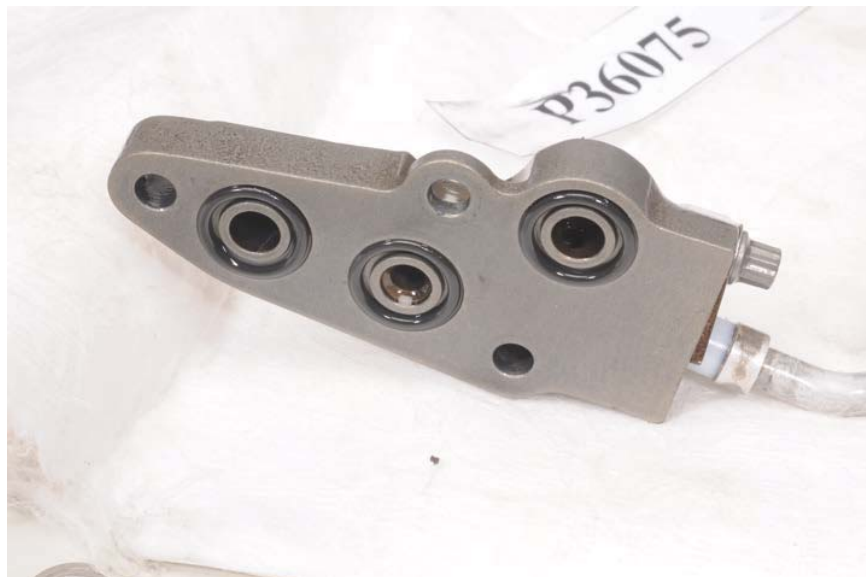
Figure 101. Hydraulic Oil Torque Sensor Output

- The hydraulic oil torque sensor output was intact and appeared undamaged ([Figure 101](#) and [Figure 102](#)).

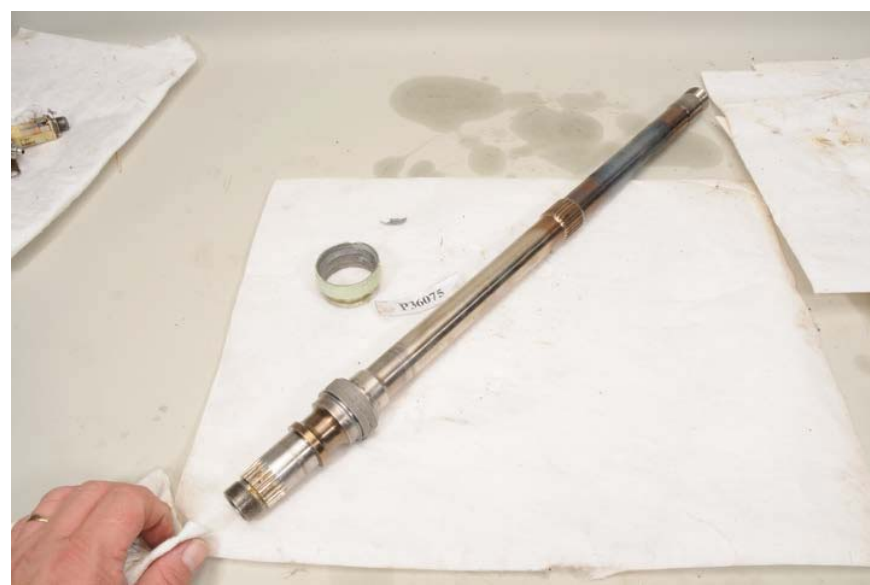
**Figure 103. Main Shaft**

- (a) Main Shaft
  - The main shaft was intact and appeared undamaged ([Figure 103](#)).
  - Debris was present in the knife seals at the compressor end of the main shaft ([Figure 104](#)).
- (b) Main Shaft Gear
  - The main shaft gear was intact and appeared undamaged ([Figure 105](#)).
  - Light contact marks were present on several gear teeth of the main shaft gear ([Figure 106](#)).
  - Debris remained between the gear teeth of the main shaft gear ([Figure 107](#)).

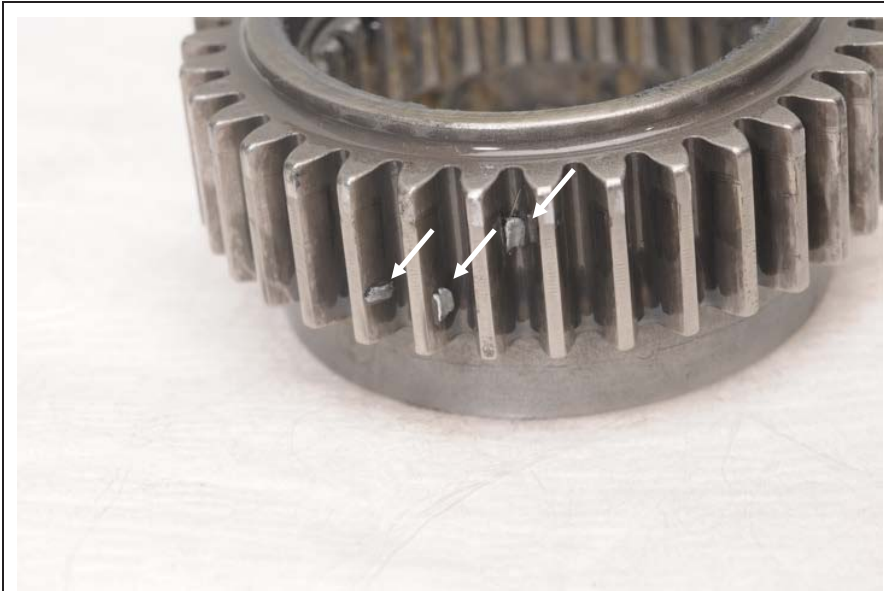
**Figure 107. Main Shaft Gear**

- The main shaft gear was submitted for material analysis. The results are presented in [APPENDIX A](#).
- (c) Torsion Shaft
- The torsion shaft was intact and appeared undamaged (Figure 108).

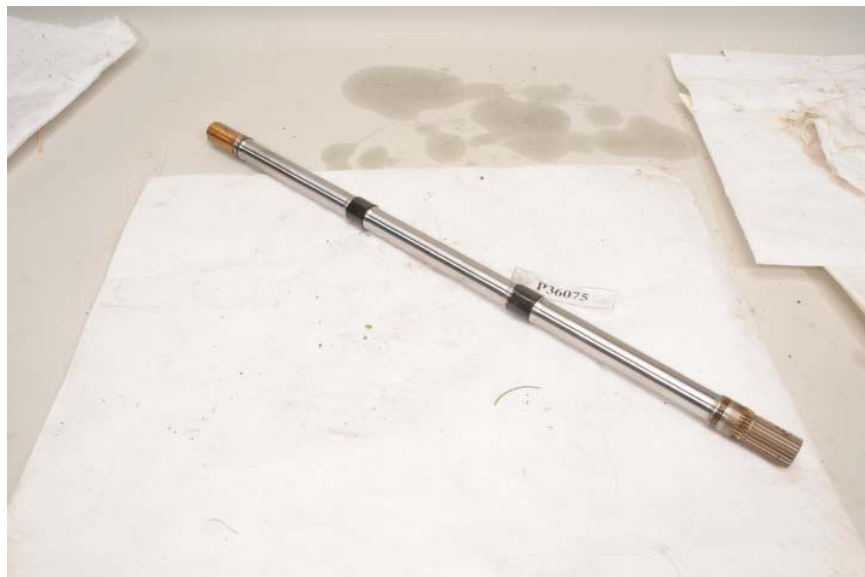
**Figure 108. Torsion Shaft**

- The torsion shaft was free of coking.
- (d) First-Stage Compressor Impeller Shroud
- The first-stage compressor impeller shroud was intact and appeared undamaged ([Figure 109](#) and [Figure 110](#)).

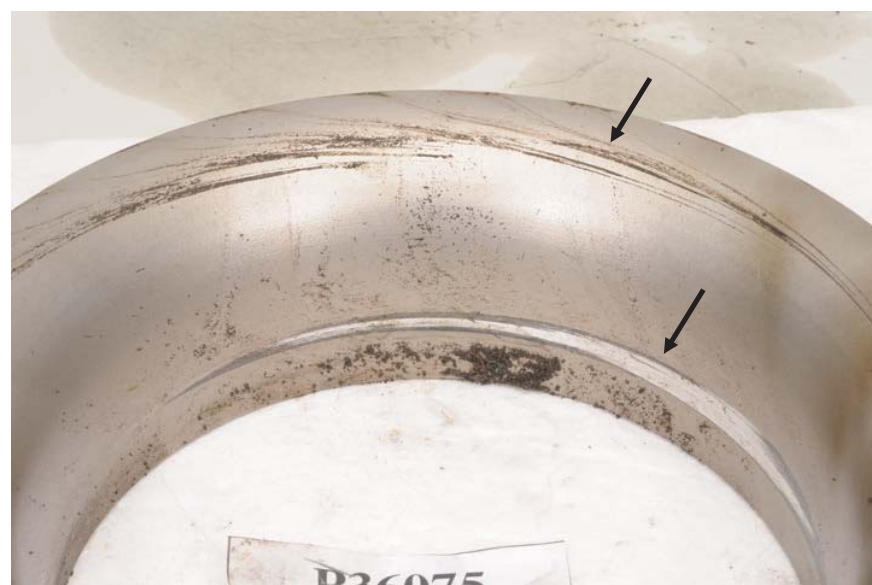
**Figure 111. First-Stage Compressor Impeller Shroud**

- There was a rub on the first-stage compressor impeller shroud from 11 to 3 o'clock at the inducer ([Figure 111](#)).
  - There was very light score mark at the exducer from 10 o'clock to 3 o'clock of the first-stage compressor impeller shroud ([Figure 111](#)).

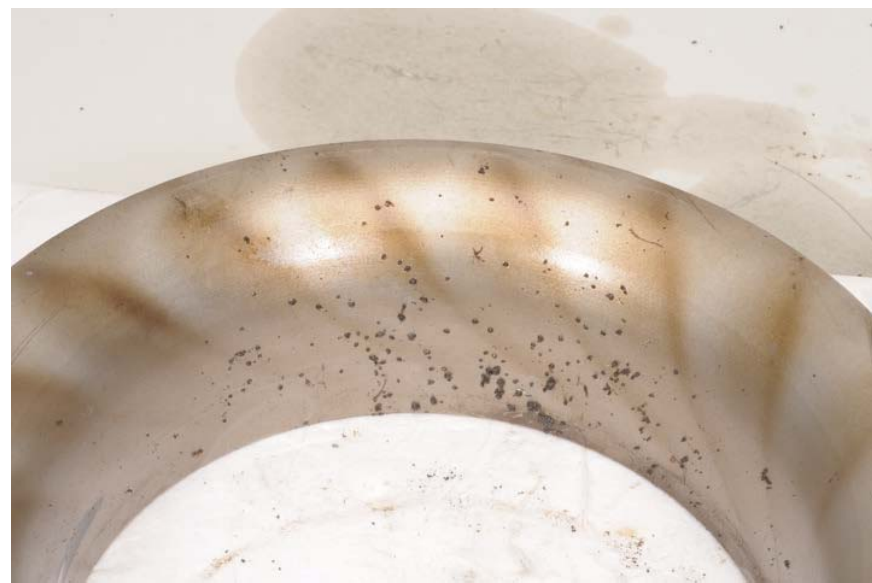
**Figure 112. First-Stage Compressor Impeller Shroud**

- There was discoloration on the first-stage compressor impeller shroud at 11 static blade positions from 1 to 9 o'clock ([Figure 112](#)).
  - Debris was present forward of the inducer on the first-stage compressor impeller shroud ([Figure 112](#)).

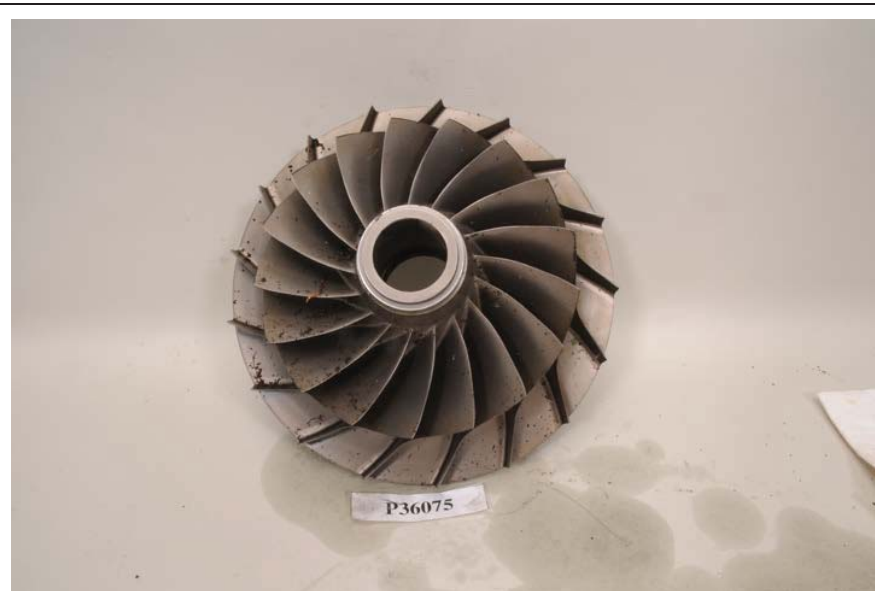
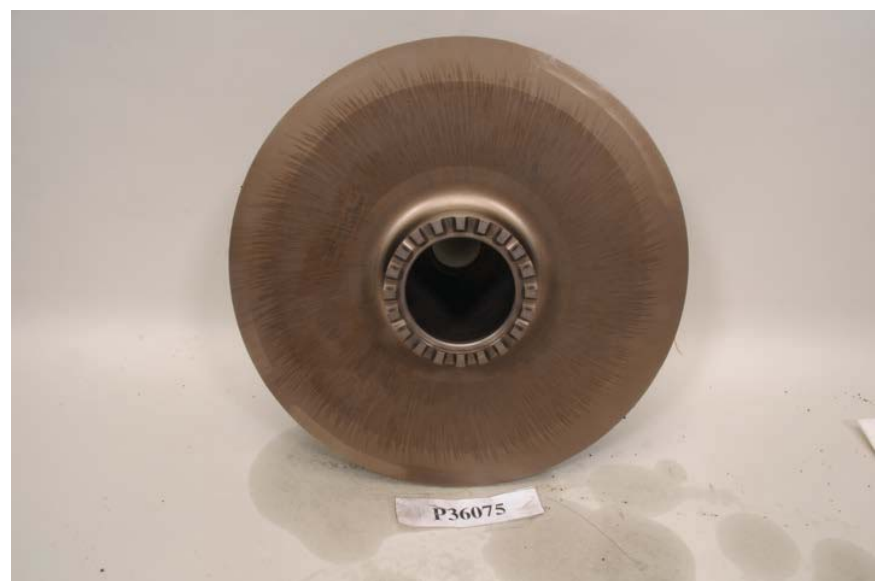
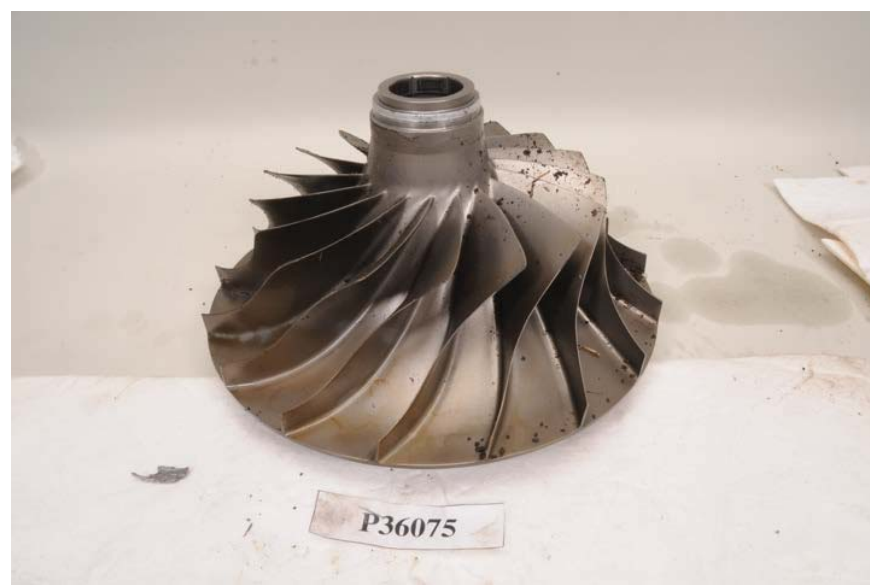
**Figure 113. First-Stage Compressor Impeller**

- Debris was present at the bottom of the first-stage compressor impeller shroud.
- (e) First-Stage Compressor Impeller
- The first-stage compressor impeller was intact and appeared undamaged ([Figure 113](#) - [Figure 115](#)).

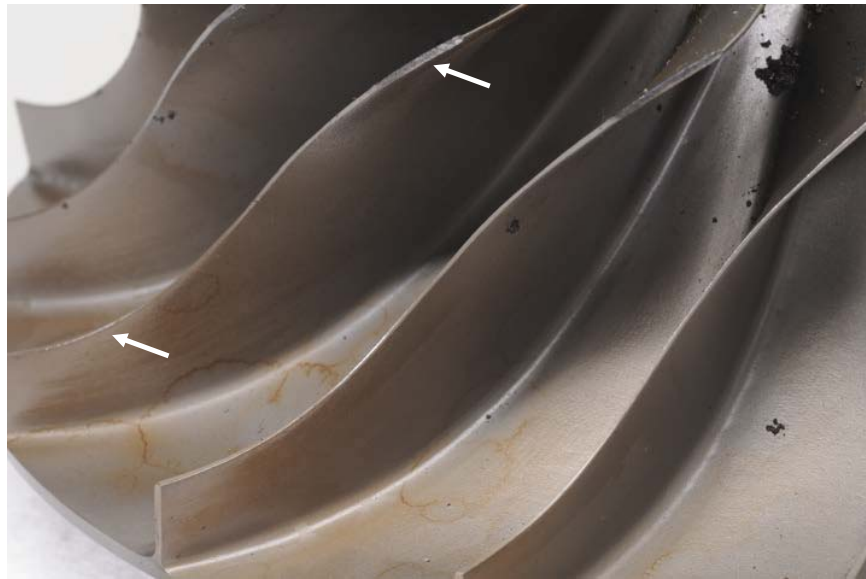
**Figure 116. First-Stage Compressor Impeller**

- There was light rotational scoring on the blades of the first-stage compressor impeller from the inducer to knee ([Figure 116](#)). The scoring was heavier at the inducer.

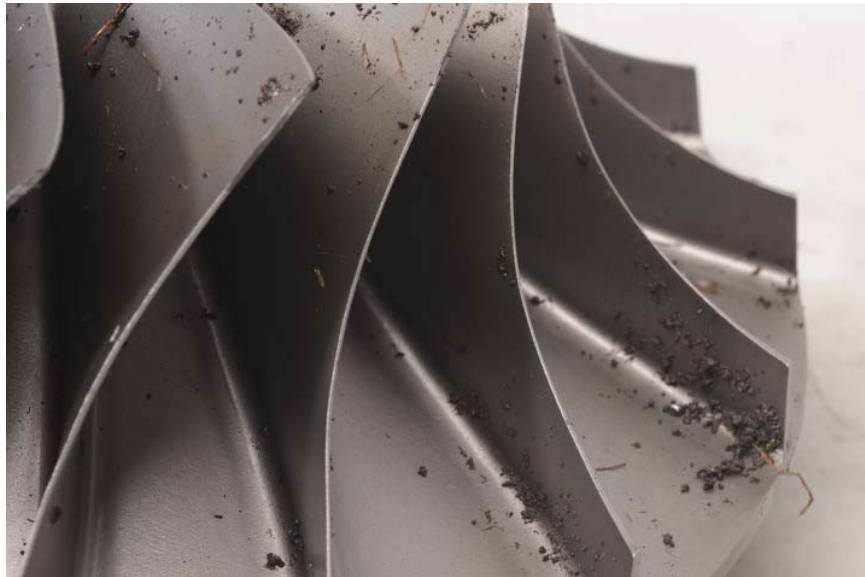
**Figure 117. First-Stage Compressor Impeller**

- There was debris adhering to blades at the tip near the inducer of the first-stage compressor impeller ([Figure 117](#)).
  - Debris was present on the hub of the first-stage compressor impeller ([Figure 117](#)).

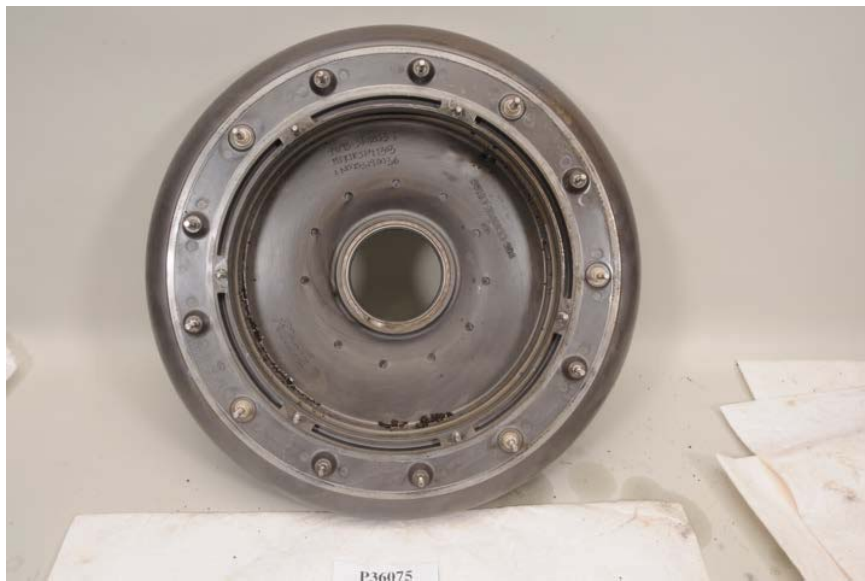
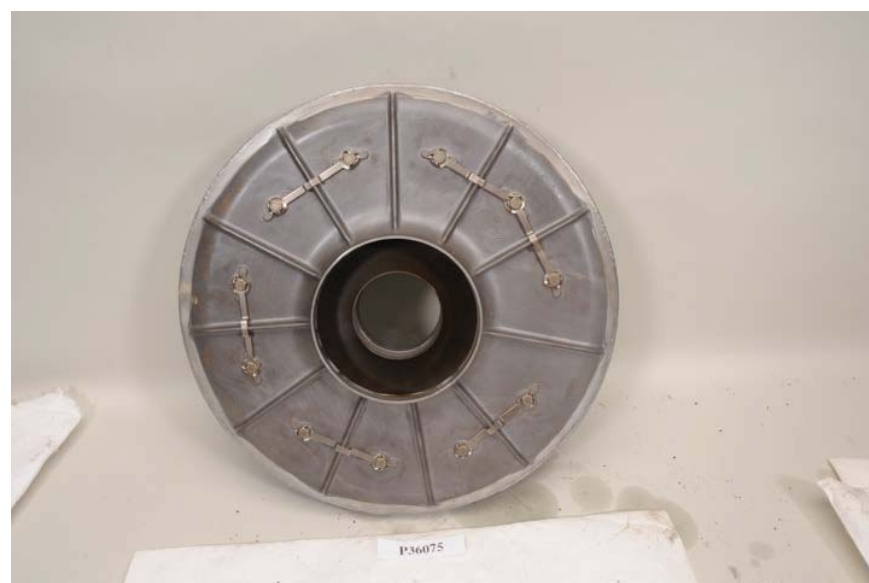
**Figure 118. First-Stage Compressor Diffuser (Crossover Duct)**

- (f) First-Stage Compressor Diffuser (Crossover Duct)
- The first-stage compressor diffuser was intact and appeared undamaged ([Figure 118](#) and [Figure 119](#)).

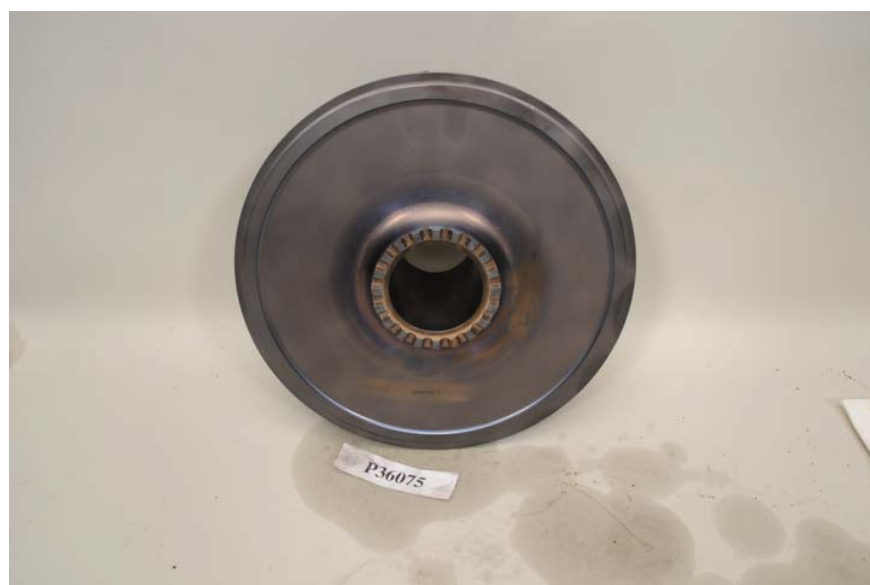
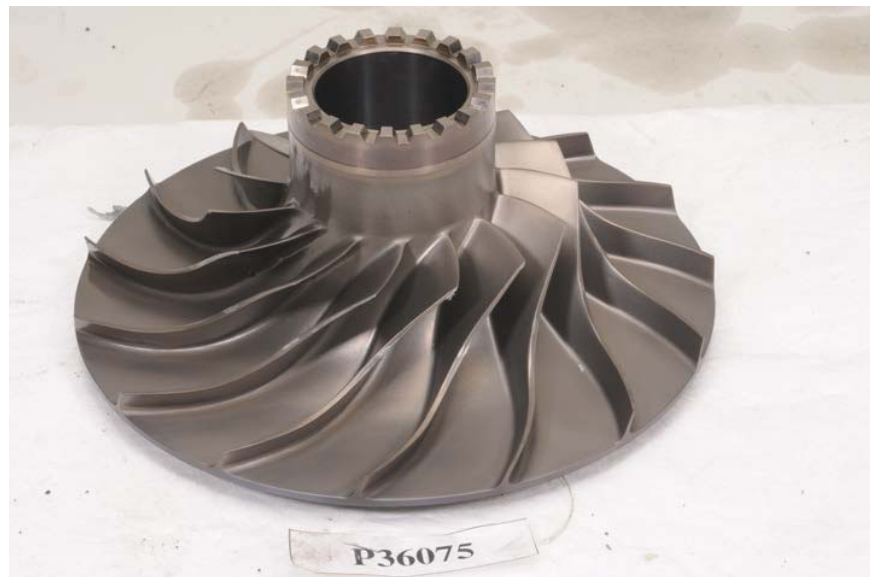
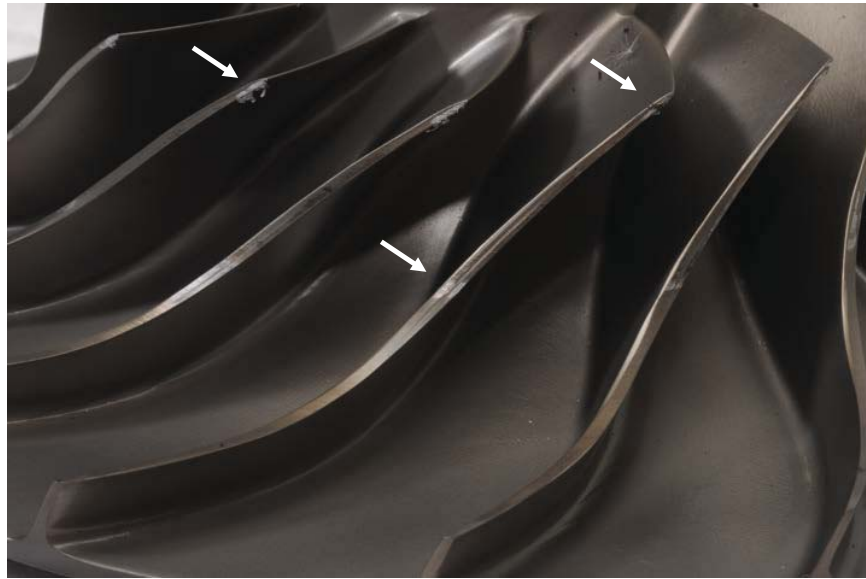
- The second-stage compressor impeller was intact and appeared undamaged ([Figure 124](#) - [Figure 126](#)).
- There was rotational scoring on the blade tip at the knee and inducer of the second-stage compressor impeller ([Figure 127](#)).
- Debris was adhering to the blades of the second-stage compressor impeller at the tip near the inducer ([Figure 127](#)).
- Debris was found on the hub between the blades of the second-stage compressor impeller ([Figure 128](#)).

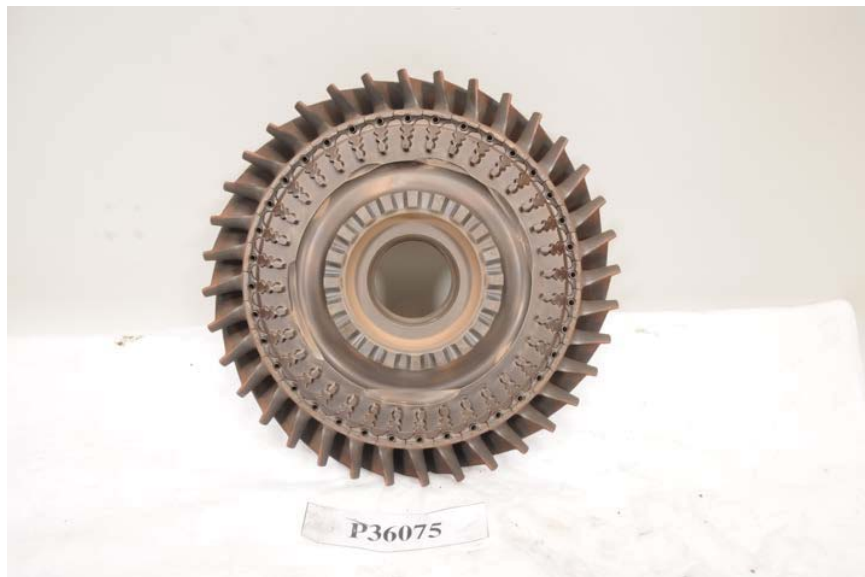
**Figure 143. First Stage Turbine Shroud**

- (d) First Stage Turbine Shroud
- The first-stage turbine shroud was intact and appeared undamaged ([Figure 142](#)).
  - There was localized rubbing at the end of four shroud segments of the first-stage turbine shroud ([Figure 143](#)).

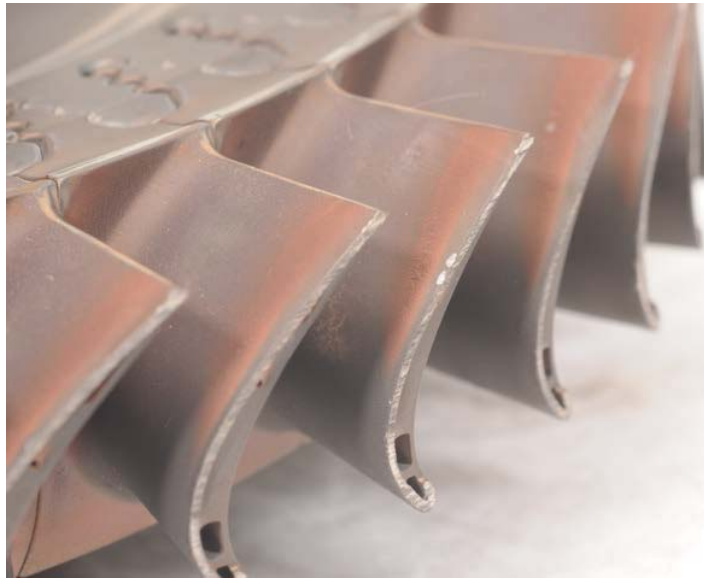
**Figure 146. First-Stage Turbine Rotor Assembly**

- The blades of the first-stage turbine rotor assembly were brownish in color.
  - There was rotational scoring on the aft blade platform of the first-stage turbine rotor assembly ([Figure 146](#)).

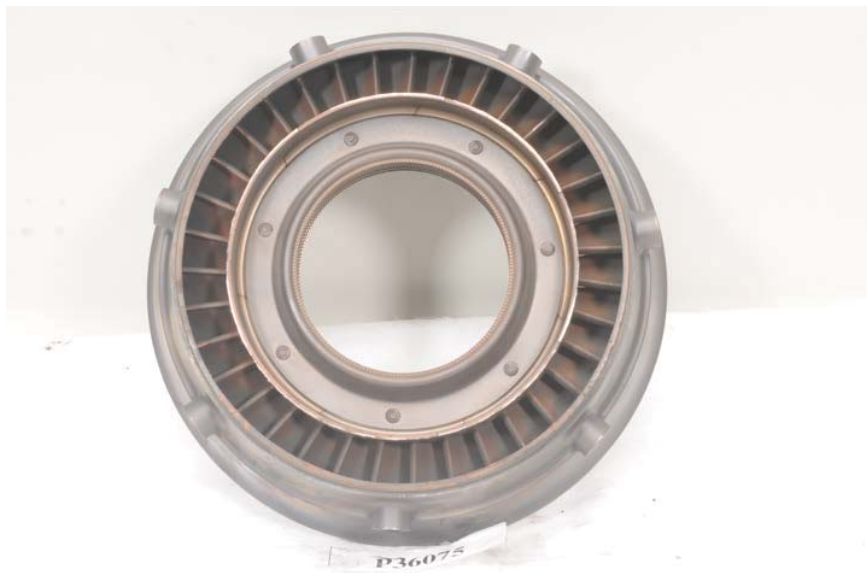
**Figure 147. First-Stage Turbine Rotor Assembly**

- There was light rotational scoring on the blade tips of the first-stage turbine rotor assembly with additional rub at the aft end of the blade tip ([Figure 147](#)).

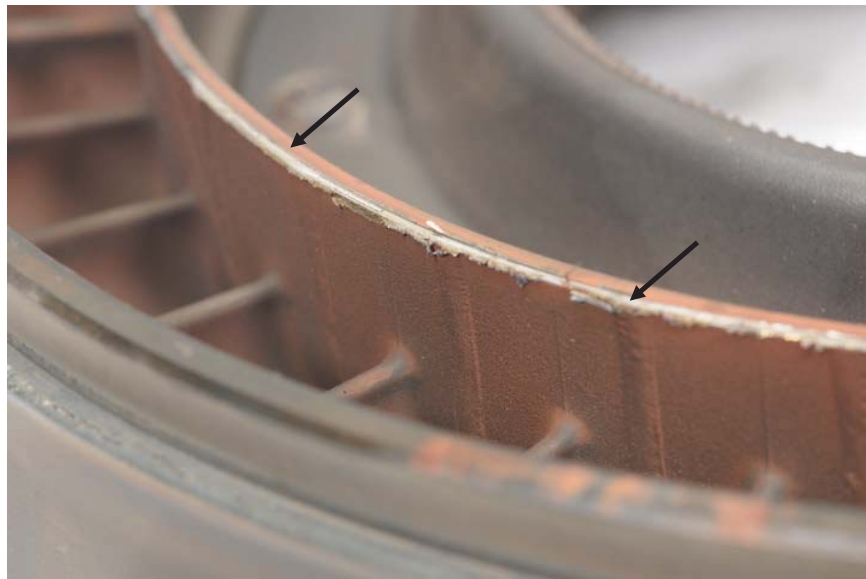
**Figure 150. Second-Stage Turbine Stator**

- (f) Second-Stage Turbine Stator
- The second-stage turbine stator was intact and appeared undamaged ([Figure 148](#) and [Figure 149](#)).
  - There was rotational scoring over a 45-degree arc on the shroud of the second -stage turbine stator ([Figure 150](#)).

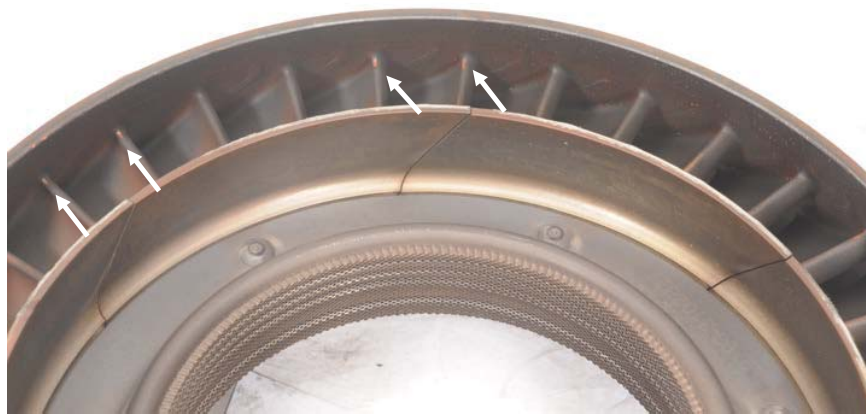
**Figure 151. Second-Stage Turbine Stator**

- There was rotational scoring on the forward side ID platform of the second-stage turbine stator over 360 degrees ([Figure 151](#)).
  - There were small earthen deposits on two adjacent vanes of the second-stage turbine stator.

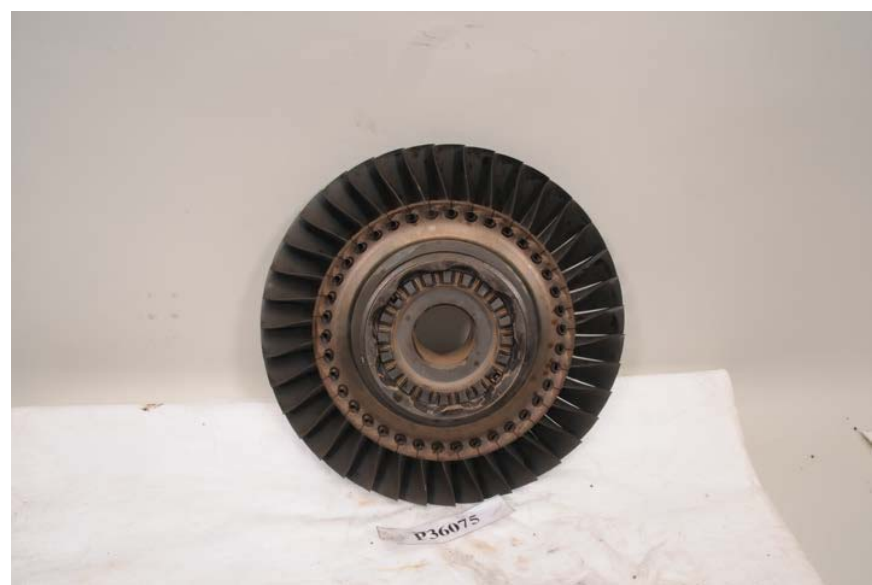
**Figure 152. Second-Stage Turbine Stator**

- There was discoloration at the outer vane leading edge of 20 vanes of the second-stage turbine stator ([Figure 152](#)).
- (g) Second-Stage Turbine Rotor

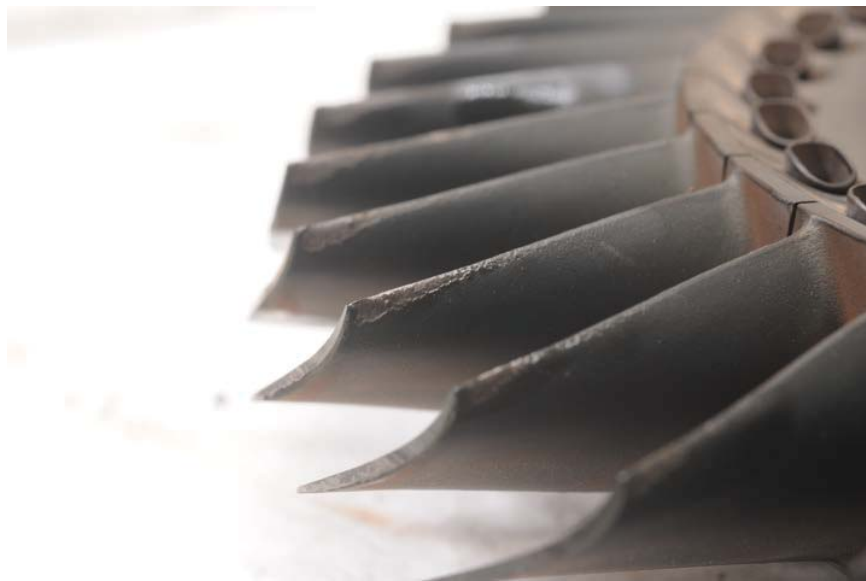
**Figure 155. Second-Stage Turbine Rotor**

- The second-stage turbine rotor was intact and appeared undamaged (Figure 153 and Figure 154).
  - There was light rotational scoring on the blade tips of the second-stage turbine rotor (Figure 155).

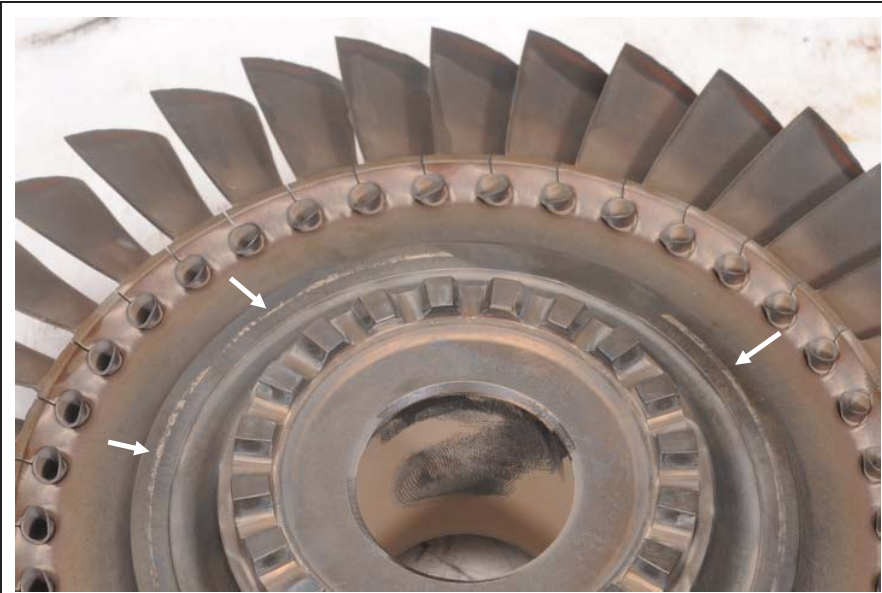
**Figure 156. Second-Stage Turbine Rotor**

- There was light erosion on the blade leading edge of the second -stage turbine rotor at tips (Figure 156).
  - There were contact marks on the aft side of the disk of the second-stage turbine rotor (Figure 157).

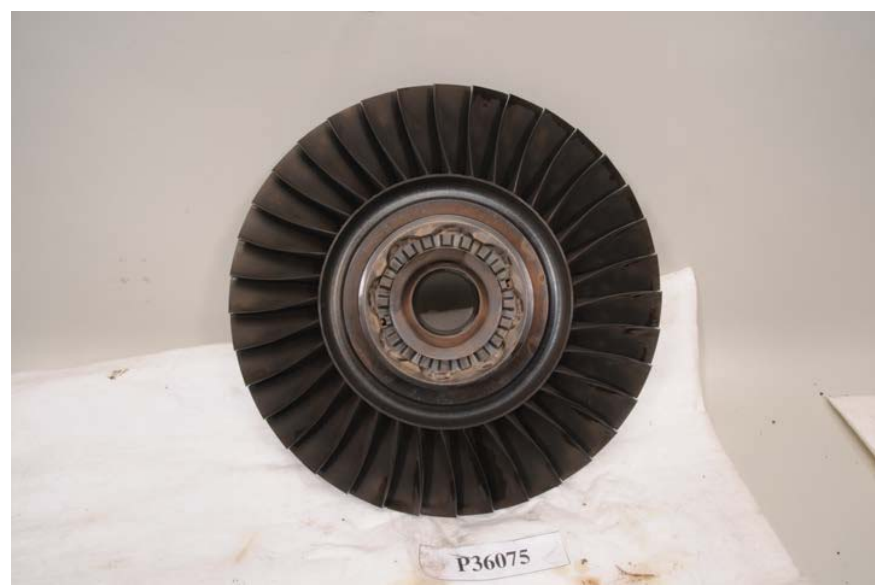
**Figure 160. Third-Stage Turbine Stator**

- (h) Third-Stage Turbine Stator
- The third-stage turbine stator was intact and appeared undamaged (Figure 158 and Figure 159).
  - There were contact marks on the forward inner diameter outboard of seal on the third-stage turbine stator (Figure 160).

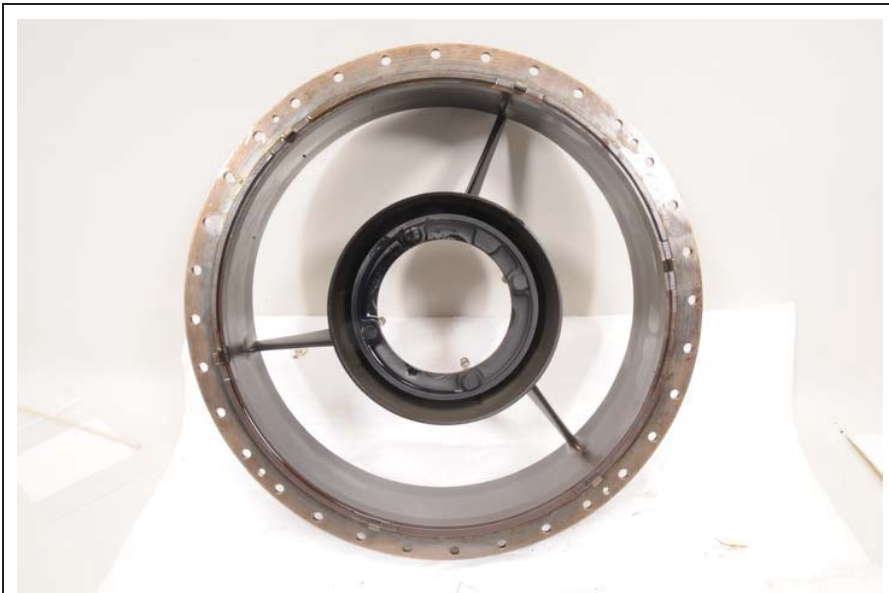
**Figure 168. Engine Exhaust Duct**

- The fitting for the P5 pressure was pulled out of the engine exhaust duct (Figure 168).
- (l) Thermocouple Harness Assembly
- Three probes on the thermocouple harness assembly were damaged.

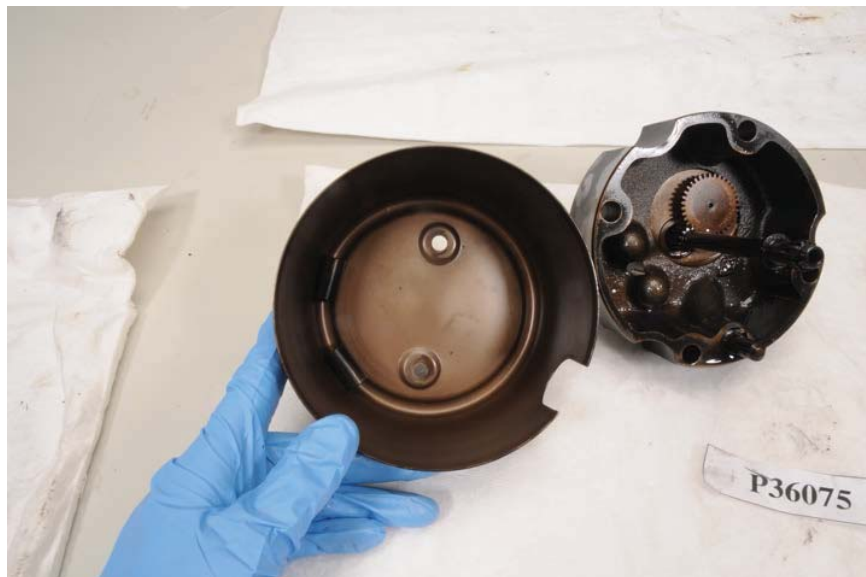
**Figure 173. Turbine Bearing Retainer**

- The turbine bearing retainer was intact and appeared undamaged ([Figure 173](#)).
- (p) Turbine Sump Cover
  - The turbine sump cover was intact and appeared undamaged ([Figure 174](#)).
- (q) Turbine Oil-Scavenge Pump and Drive Shaft:
  - The turbine oil-scavenge pump and drive shaft were intact and appeared undamaged ([Figure 175](#)).
- (r) Turbine Air/Oil Carbon Seal
  - The turbine air/oil carbon seal was intact and appeared undamaged ([Figure 176](#)).
- (s) Aft Carbon Seal Rotor
  - The aft carbon seal rotor was intact and appeared undamaged ([Figure 177](#)).
- (t) Turbine Bearing:
  - The turbine bearing was intact and appeared undamaged ([Figure 178](#)).
- (u) Aft (Turbine) Main-Shaft Nut
  - The aft main-shaft nut was intact and appeared undamaged ([Figure 179](#)).

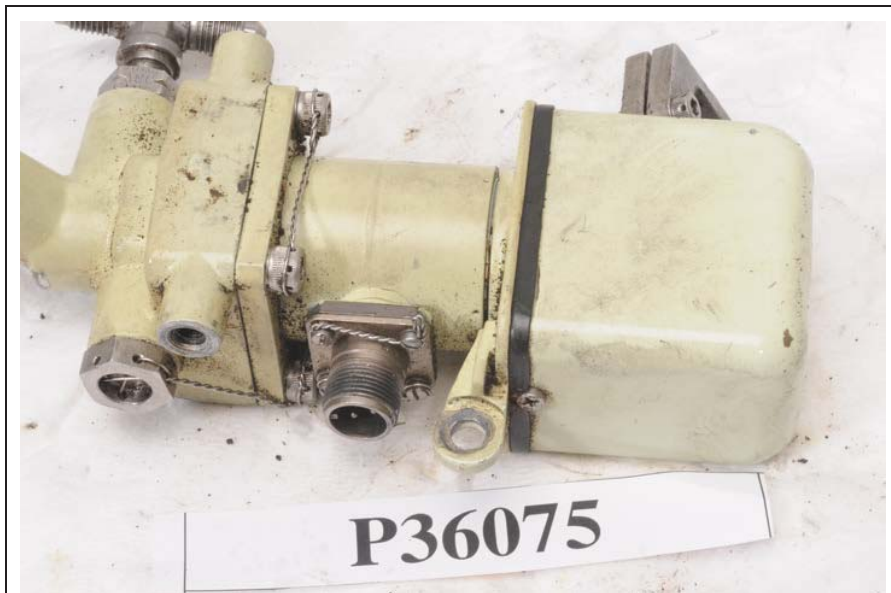
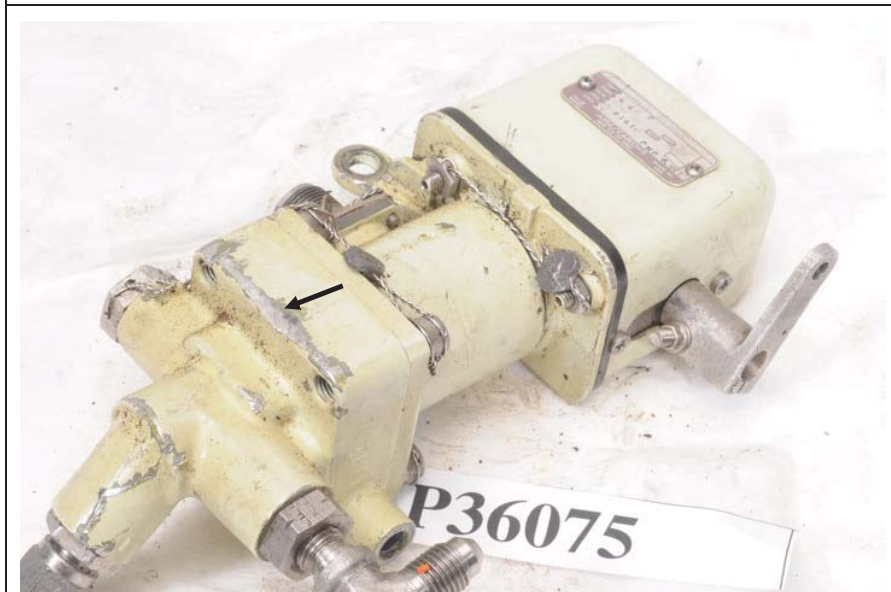
**Figure 180. Fuel Shutoff Valve**

- (a) Fuel Shutoff Valve
  - The fuel shutoff valve was intact and appeared undamaged ([Figure 180](#) and [Figure 181](#)).
  - There was an impact mark on the lower housing (square portion of the body) along the external surface ([Figure 182](#)).
  - The fuel shutoff valve was functionally tested and CT scanning. The results are presented in [APPENDIX B](#).
- (b) Fuel Pump Assembly
  - The fuel pump assembly was intact and appeared undamaged ([Figure 183](#)).
  - There was a small amount of debris inside the filter bowl of the fuel pump assembly ([Figure 184](#)).
  - The fuel pump was submitted for functional tests. The results are presented in [APPENDIX C](#).
- (c) Fuel Control Unit

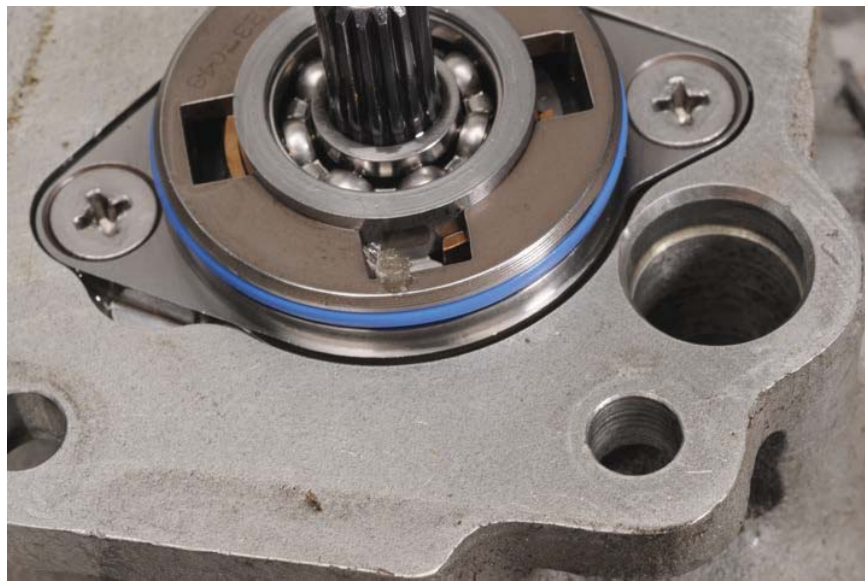
Figure 185. Fuel Control Unit

- The fuel control unit was intact and appeared undamaged ([Figure 185](#)).
- Debris was present near the input shaft of the fuel control unit ([Figure 186](#)). The debris was collected and submitted for material analysis. The results are presented in [APPENDIX A](#).
- The fuel control unit was returned to the vendor for functional testing. The results are presented in [APPENDIX D](#).

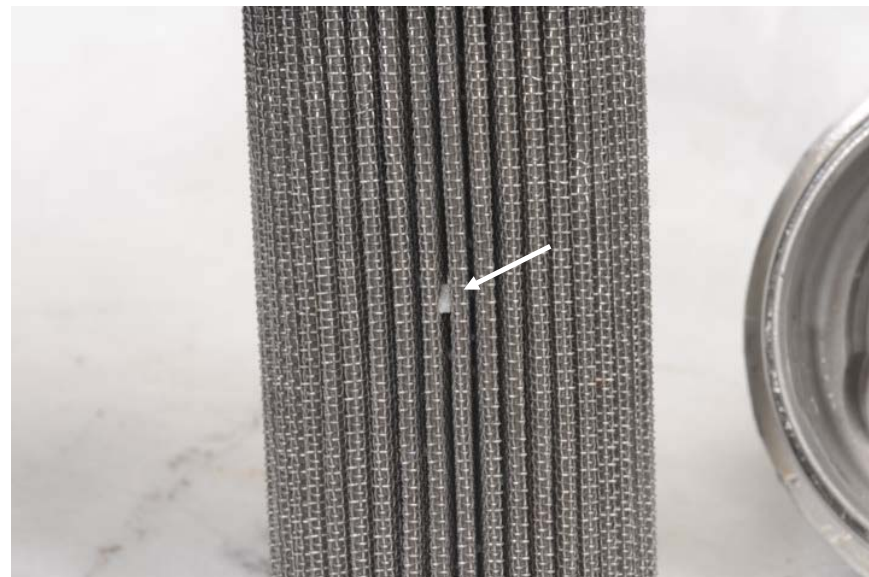
Figure 187. Fuel Filter

- The fuel filter was intact and appeared undamaged ([Figure 187](#)).
- A fuel sample obtained from the fuel filter housing.
- Soft, white material was found in the fuel filter ([Figure 188](#)).
- White debris was noted in the fuel filter cap.

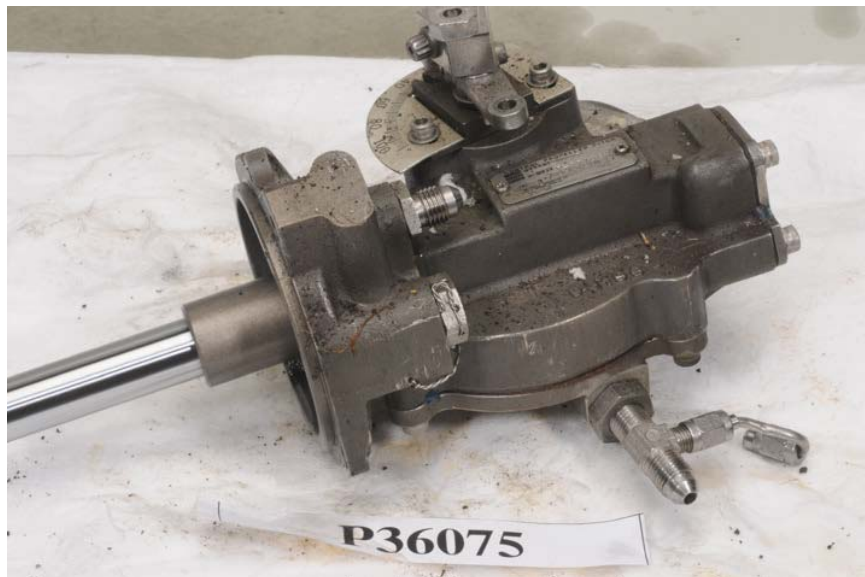
Figure 191. Propeller Governor

- The propeller governor was intact and appeared undamaged ([Figure 191](#)).
- The propeller governor was returned to the vendor for functional tests. The results are presented in [APPENDIX F](#).

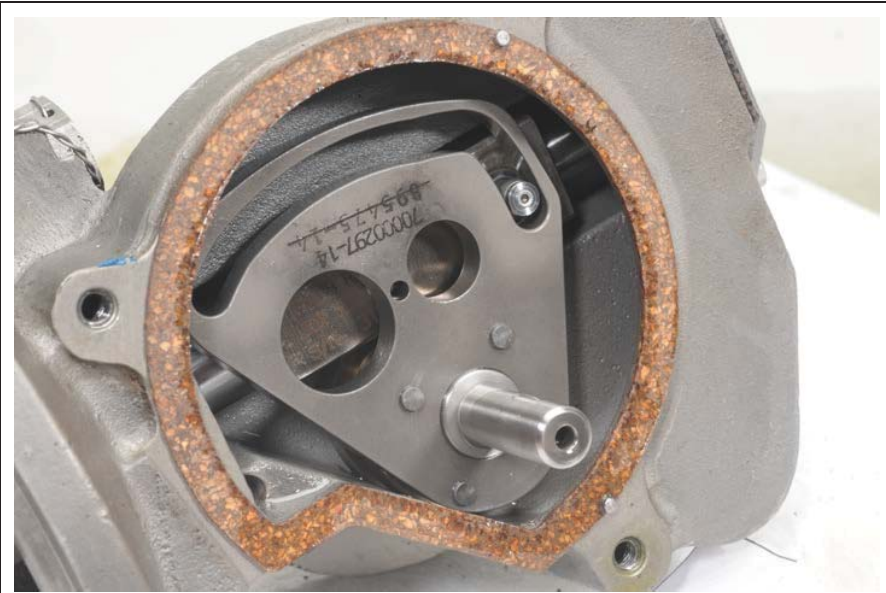
Figure 192. Propeller Pitch Control

- The propeller pitch control was intact and appeared undamaged ([Figure 192](#)).
- The pin in the propeller pitch control was intact and appeared undamaged ([Figure 193](#)).

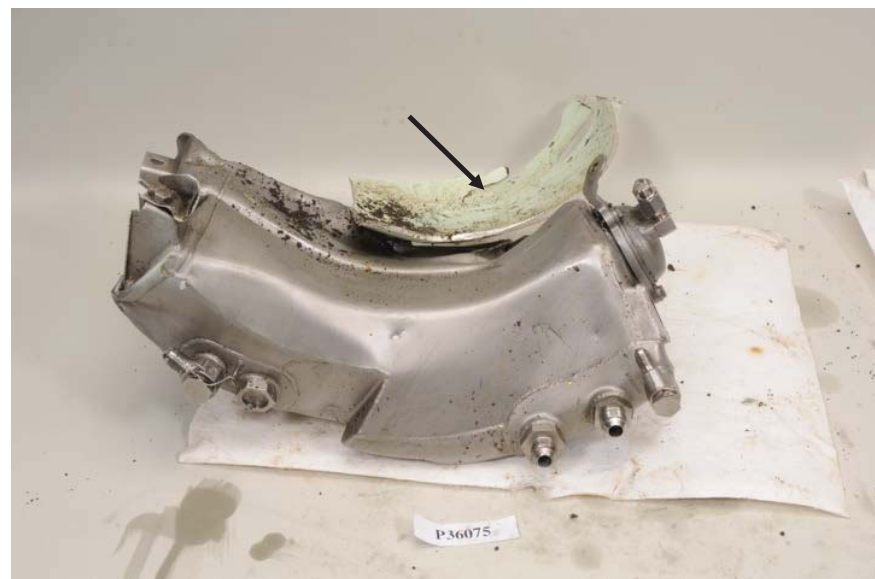
**Figure 195. Oil Tank**

- The oil tank was crushed and torn on bottom ([Figure 195](#)).

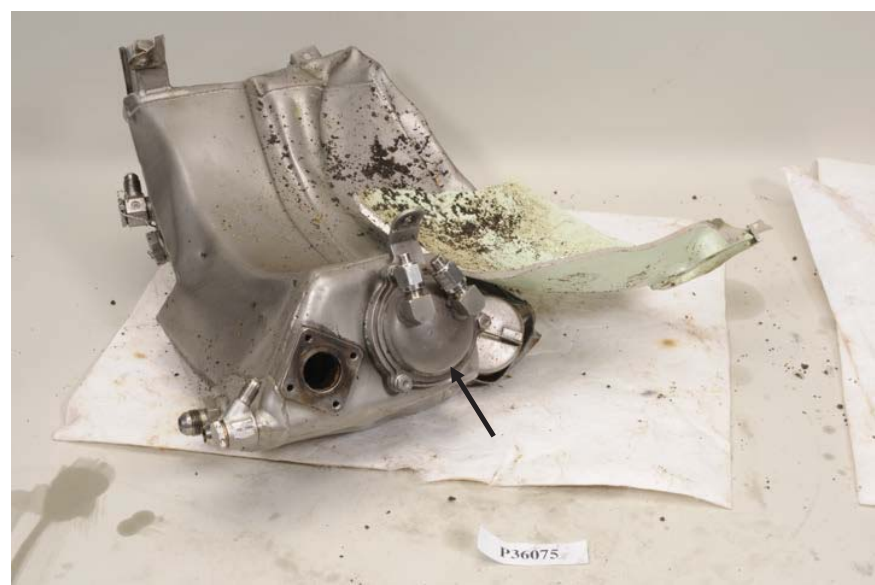
**Figure 196. Oil Tank**

- The oil tank remained attached to the inlet housing of the accessory gear case ([Figure 196](#)).
  - The fuel oil heater remained installed in the oil tank ([Figure 197](#)).

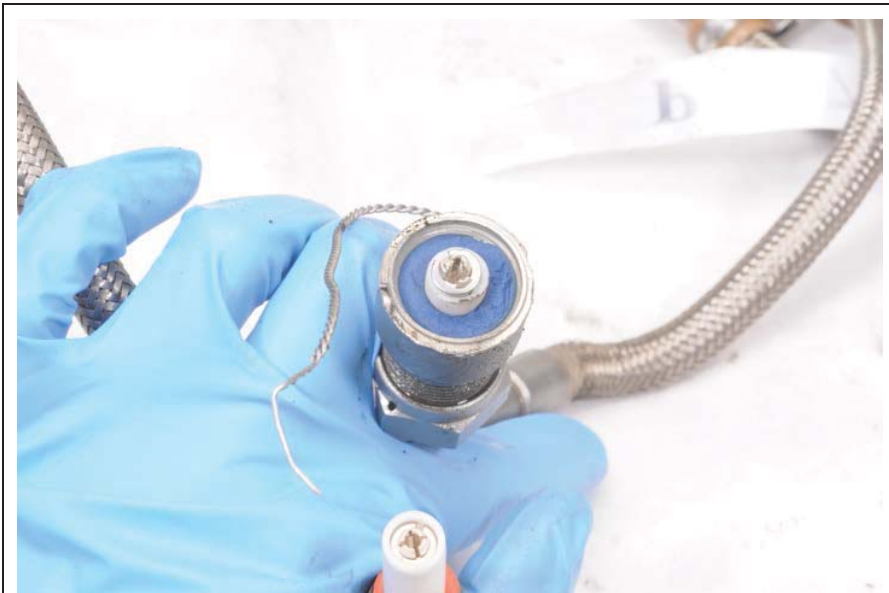
**Figure 200. Exciter to Ignitor Lead Assemblies**

- (l) Exciter to Ignitor Lead Assembly
- The exciter lead to the 7 o'clock ignitor was intact and appeared undamaged ([Figure 200](#)).
  - The connector on the exciter lead to the 5 o'clock ignitor remained attached to the lead ([Figure 201](#)).
