**TEARDOWN REPORT  
OF ONE MODEL TPE331-10-511M  
TURBOPROP ENGINE  
SERIAL NUMBER P36075C**

**August 29, 2019**

This report, prepared by Honeywell Aerospace, presents the findings of a teardown and inspection conducted on one Honeywell Model TPE331-10-511M engine, Serial Number P36075C. The inspection took place at the Honeywell Investigation Laboratory in Phoenix, Arizona, on October 16 – 18, 2018.

On April 29, 2018, at 15:30 pm local time, a Grumman / Schweizer G-164C/C, single engine agricultural airplane, N6674K, was substantially damaged following a forced landing due to a loss of engine power near Maxwell, CA. The commercial pilot was not injured. The pilot reported, while flying at 200 feet altitude, that the engine surged three times, followed by what he believed was a total engine failure. The aircraft was recovered to a secure facility where the engine was removed and shipped to Honeywell for teardown.

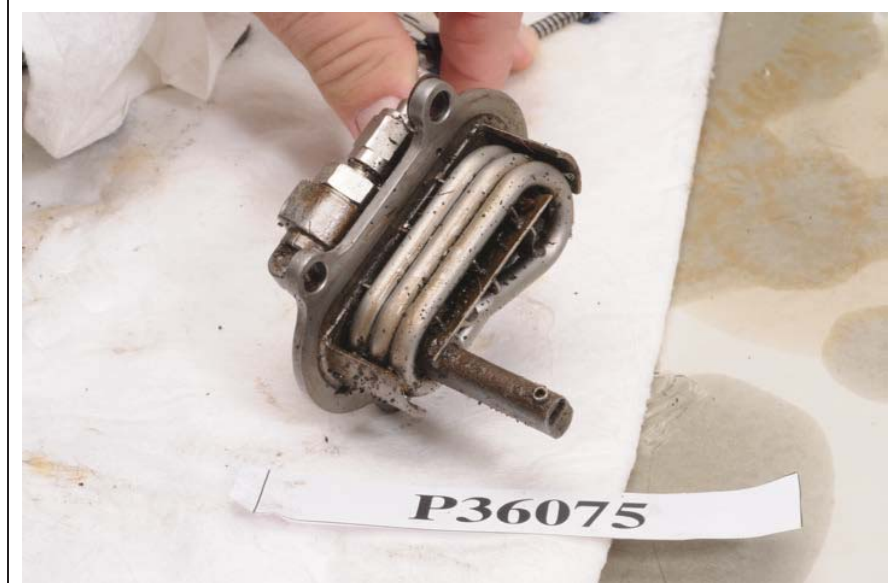
Figure 203. Feather Valve

- The feather valve was intact and appeared undamaged ([Figure 203](#)).
- (r) P<sub>2</sub>T<sub>2</sub> Inlet Sensor
- The P<sub>2</sub>T<sub>2</sub> inlet sensor was intact and appeared undamaged ([Figure 204](#)).

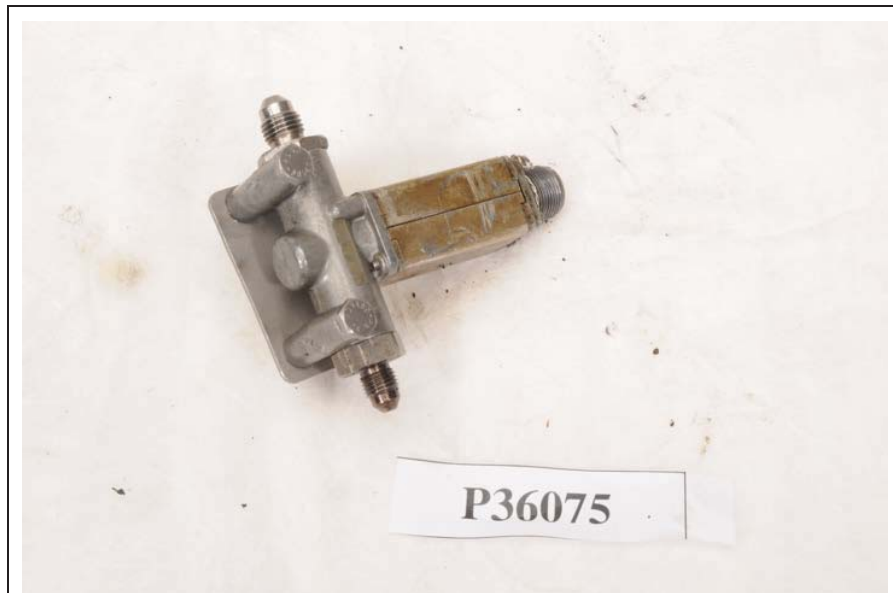
**Figure 207. Fuel Enrichment Solenoid**

- (u) Lockout and Fuel Enrichment Solenoids
  - The lockout and fuel enrichment solenoids were intact and appeared undamaged ([Figure 207](#)).
  - The fuel enrichment solenoid was functionally tested. The results are presented in [APPENDIX G](#).

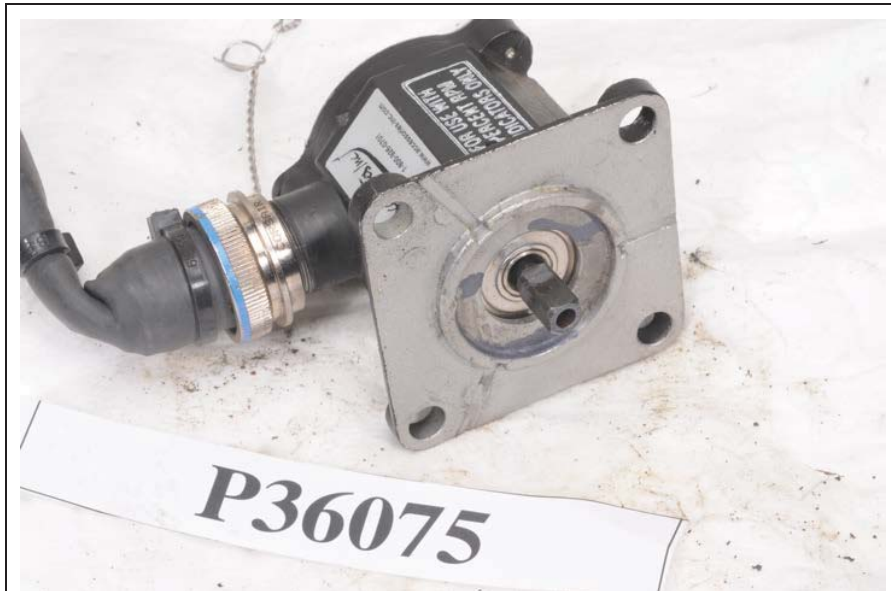
Figure 209. Tach Generator

- (x) Tact Generator
  - The tach generator was intact and appeared undamaged ([Figure 209](#)).
- (y) Fuel Manifold and Nozzle Assembly
  - The fuel manifold and nozzle assembly was intact and appeared undamaged ([Figure 210](#)).

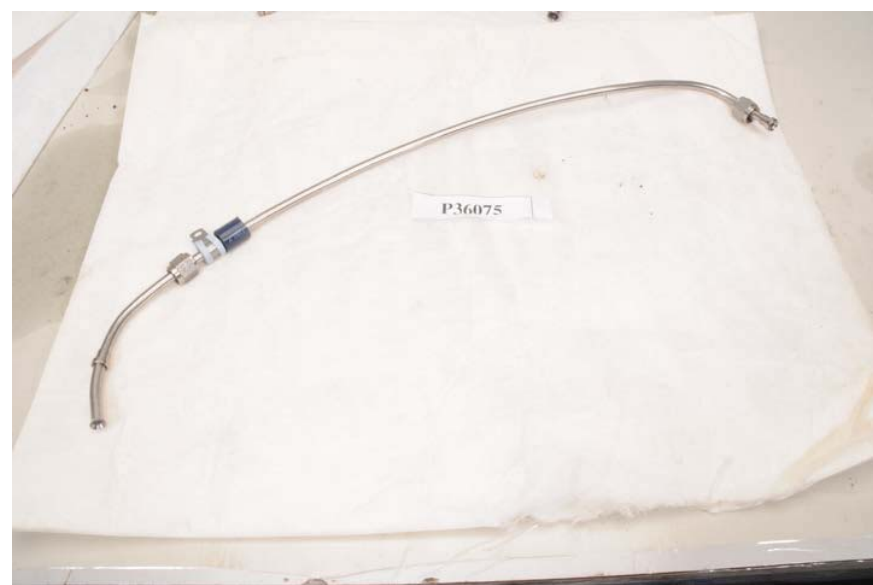
- The fuel manifold and nozzle assembly was functionally tested. The results are presented in [APPENDIX H](#).
- (z) Fuel System Plumbing
  - The line from the fuel shutoff valve to the primary only solenoid appeared to be an unapproved part and not P/N 3102219-1 as called out in the engine assembly drawing ([Figure 211](#)).

**Figure 211. Installed Fuel Line In Place of P/N 3102219-1**

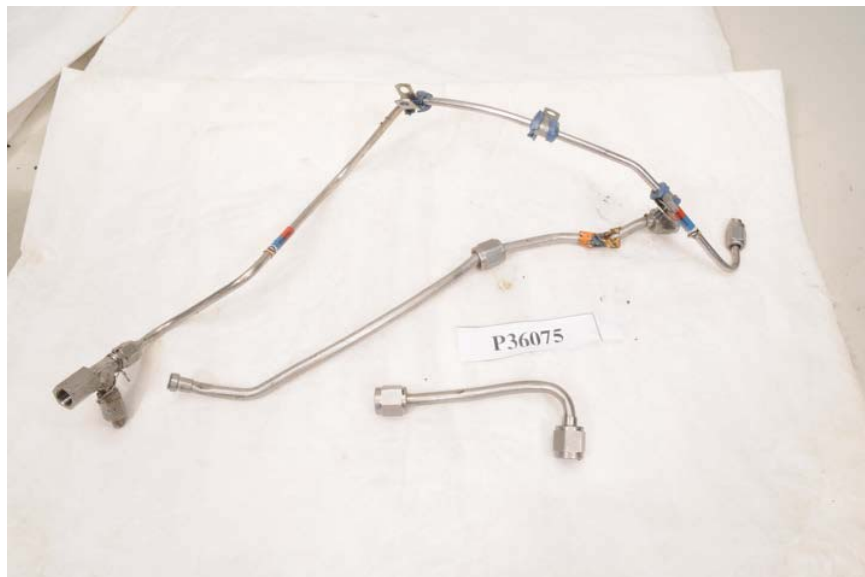
**Figure 212. Pneumatic Plumbing**

- (aa) Pneumatic Plumbing
  - The pneumatic system plumbing was intact and appeared undamaged ([Figure 212](#)).
- (bb) Lubrication System
  - The lubrication system plumbing was intact and appeared undamaged ([Figure 213](#)).

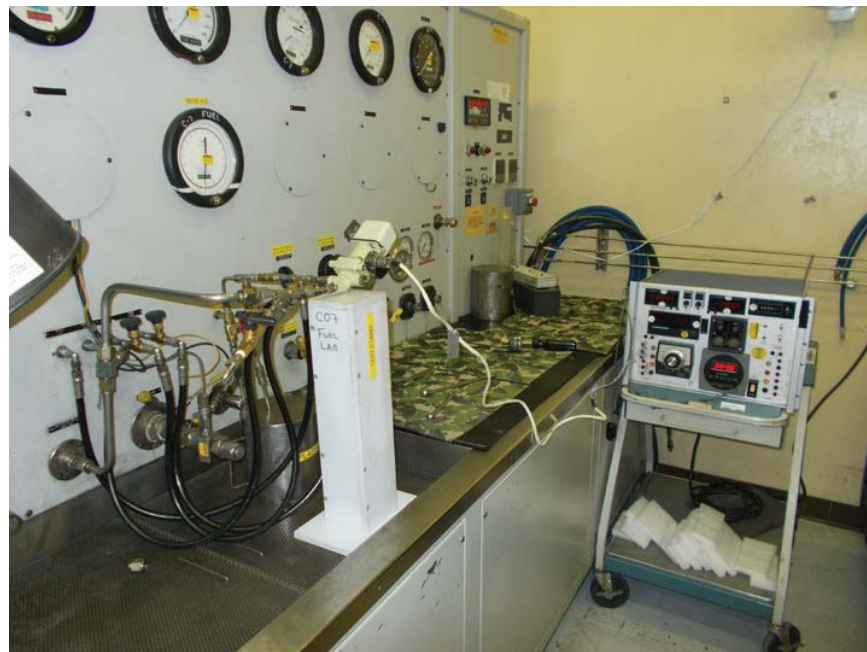
**Figure 214. Functional Testing of Fuel Shutoff Valve**

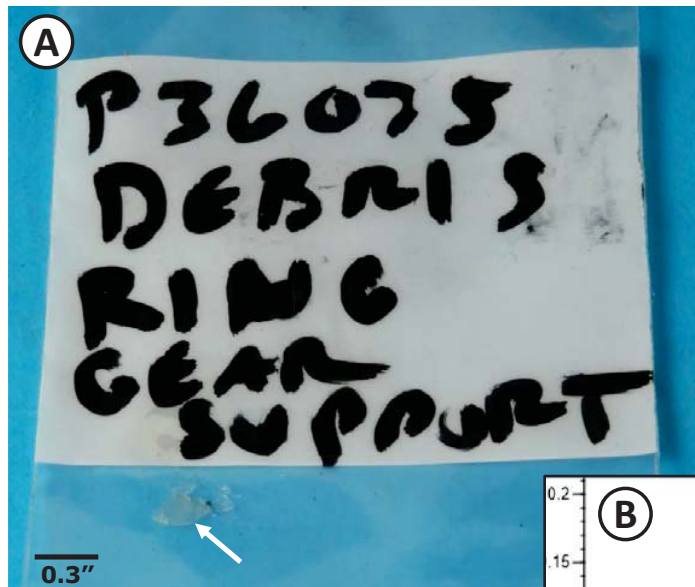
**Figure 3.**

- FTIR analysis of the clear debris collected from the ring gear support produced a spectrum suggestive of a silicone elastomer (Figure 3).
- FTIR analysis of the fibrous white debris collected from the fuel control door produced a spectrum suggestive of a polyurethane foam (Figure 4).

(A) Overall photo showing the clear debris collected from the ring gear support (white arrow). (B) FTIR spectra generated from analysis of the ring gear support debris (black spectrum) and the lab database for comparison (red spectrum). Note the ring gear support debris was suggestive of a silicone elastomer.

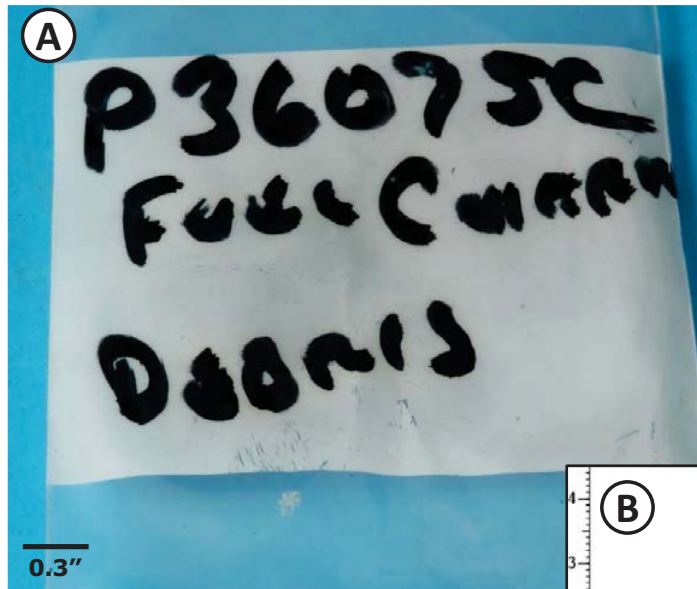
**Figure 4.**

(A) Overall photo showing the white, fibrous debris collected from the fuel control doors (white arrow). (B) FTIR spectra generated from analysis of the fuel control doors debris (black spectrum) and the lab database for comparison (red text). Note the fuel control doors debris was suggestive of a polyurethane foam.

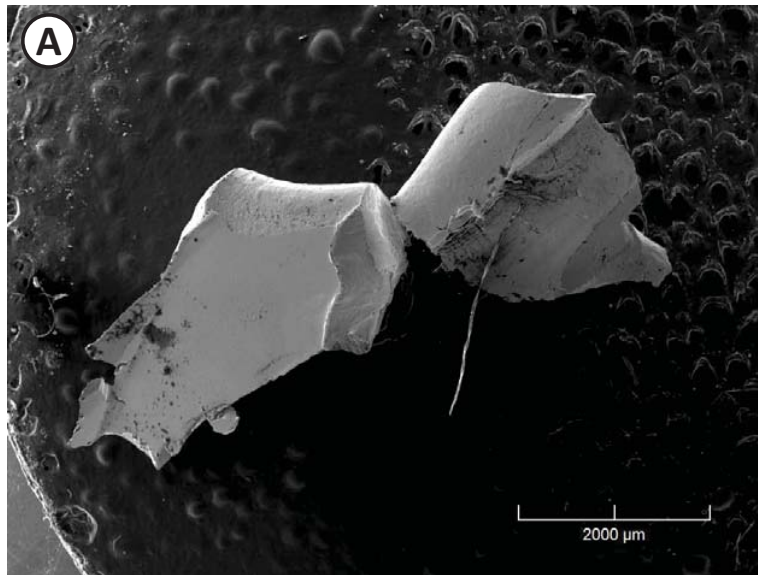
**Figure 5.**

- The metallic debris collected from the ring support gear was silver, as determined by energy dispersive X-ray (EDX) analysis (Figure 5).
- Metallic debris was observed on the submitted spur gear. EDX analysis of the debris produced a spectrum indicative of a material similar to Al 356 (Figures 6-7).

(A) Representative secondary electron (SE) scanning electron microscope (SEM) image showing the metallic debris collected from the ring gear support. (B) Energy dispersive X-ray (EDX) analysis of the particles produced a spectrum rich in silver.
