## **NATIONAL TRANSPORTATION SAFETY BOARD**

### **LANDING GEAR OPERATIONAL CHECKS KSJC**

**WPR18LA153**

Location: KSJC  
Date: May 20, 2018  
Aircraft: Piper PA-24 N244TW, Serial # 24-554  
NTSB IIC: Michael Huhn

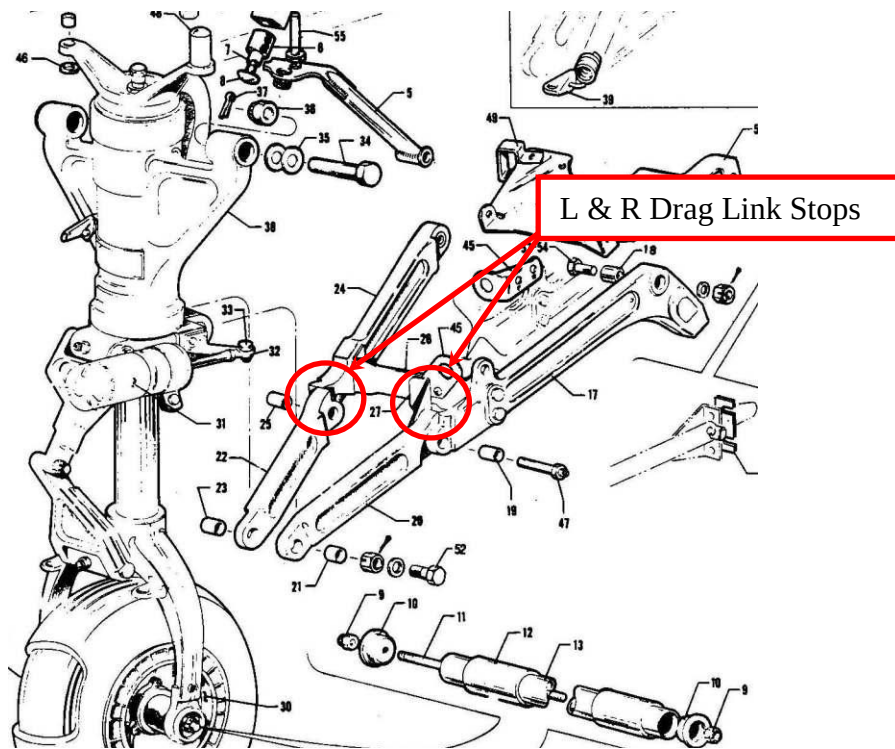
Figure 6 - NLG Diagram

- The NLG was pulled forward/down to 'relock' the gear
  - The NLG 'kicks' were repeated several times, with the same 'unlock' results
- Upward pressure on the NLG left forward drag link, just forward of its rotating joint with the left rear drag link, resulted in the gear 'unlocking' and able to move freely towards the retracted position

- The NLG tab did not visually appear to actuate/depress the microswitch button when the NLG was extended
