## **NATIONAL TRANSPORTATION SAFETY BOARD**

### **Specialist's Factual Report**

# **METEOROLOGY**

WPR18LA163

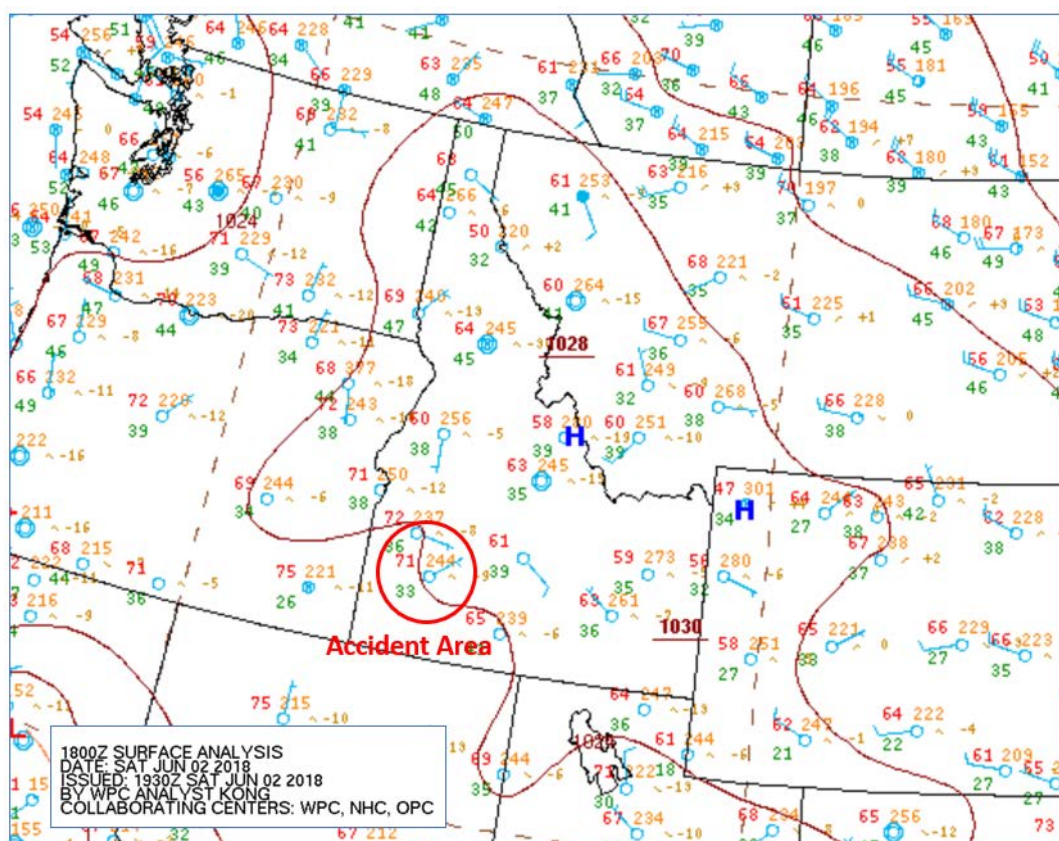
Figure 1- NWS Surface Analysis Chart for 1200 MDT

The northwest section of the NWS Surface Analysis Chart for 1200 MDT (1800Z) on June 2, 2018, depicted two high pressure systems over Idaho and western Wyoming at 1028- and 1030-hectopascals (hPa)<sup>1</sup> respectively, dominating over the area with a weak pressure gradient. No other significant boundaries were identified over the area. High pressure systems are areas of subsiding air, and thus typically produce clear skies with light anticyclonic or counterclockwise winds outward from the “high’s”.

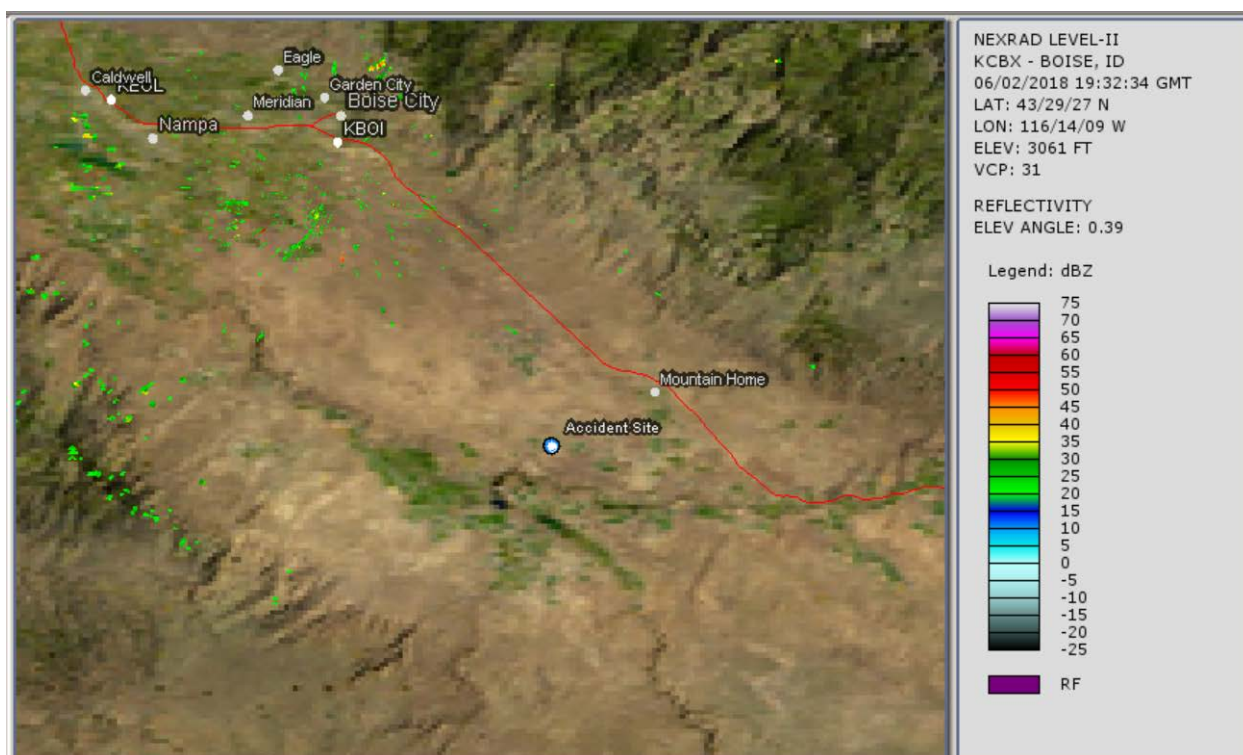
Figure 2 – NWS Boise WSR-88D 0.4° base reflectivity image at 1332 MDT

A review of the imagery surrounding the period from the NWS Boise (KCBX) Weather Surveillance Radar 1988 Doppler (WSR-88D), which was located approximately 30 miles northwest of the accident site, depicted no significant meteorological echoes associated with any precipitation or defined boundaries over the area. Figure 2 is the KCBW WSR-88D 0.4° base reflectivity image at 1332 MDT, or at the approximate time of the accident. Very light intensity echoes less than 20.0 dBZ have been eliminated from the image to reduce the impact from ground clutter and other false returns associated with non-meteorological echoes and ducting of the radar beam.

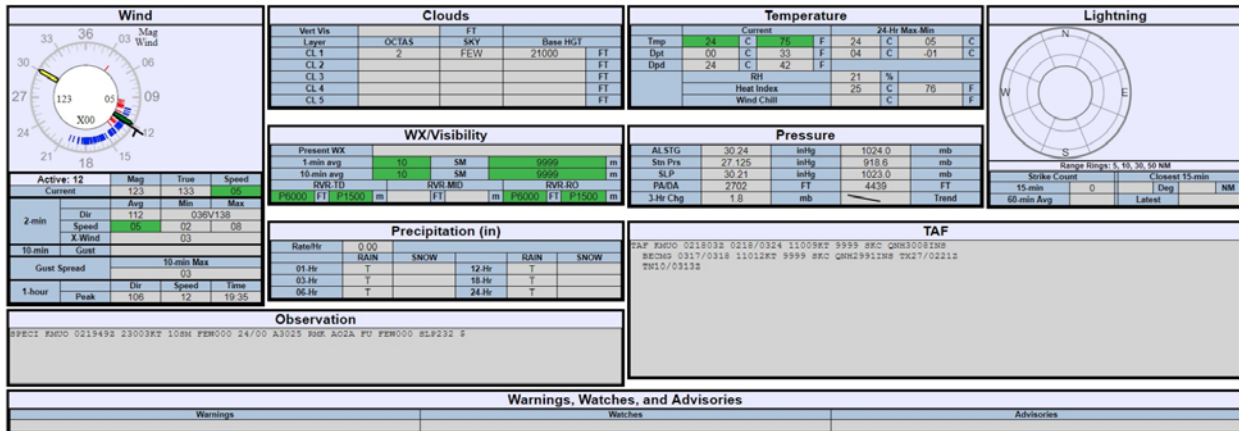
Figure 4 - KMUO Runway 30 weather display at 1350 MDT

The KMUO runway 30 weather display at 1350 MDT indicated a 2-minute average wind from 130° at 5 knots, visibility 10 miles or more, a few clouds at 21,000 ft agl, temperature of 24° C, a dew point of 0° C, altimeter 30.24 inches of Hg. The display also indicated a relative humidity of 21%, and a density altitude of 4,439 ft. The 1-hour maximum wind was noted from 106° at 12 knots occurred at 1335 MDT.

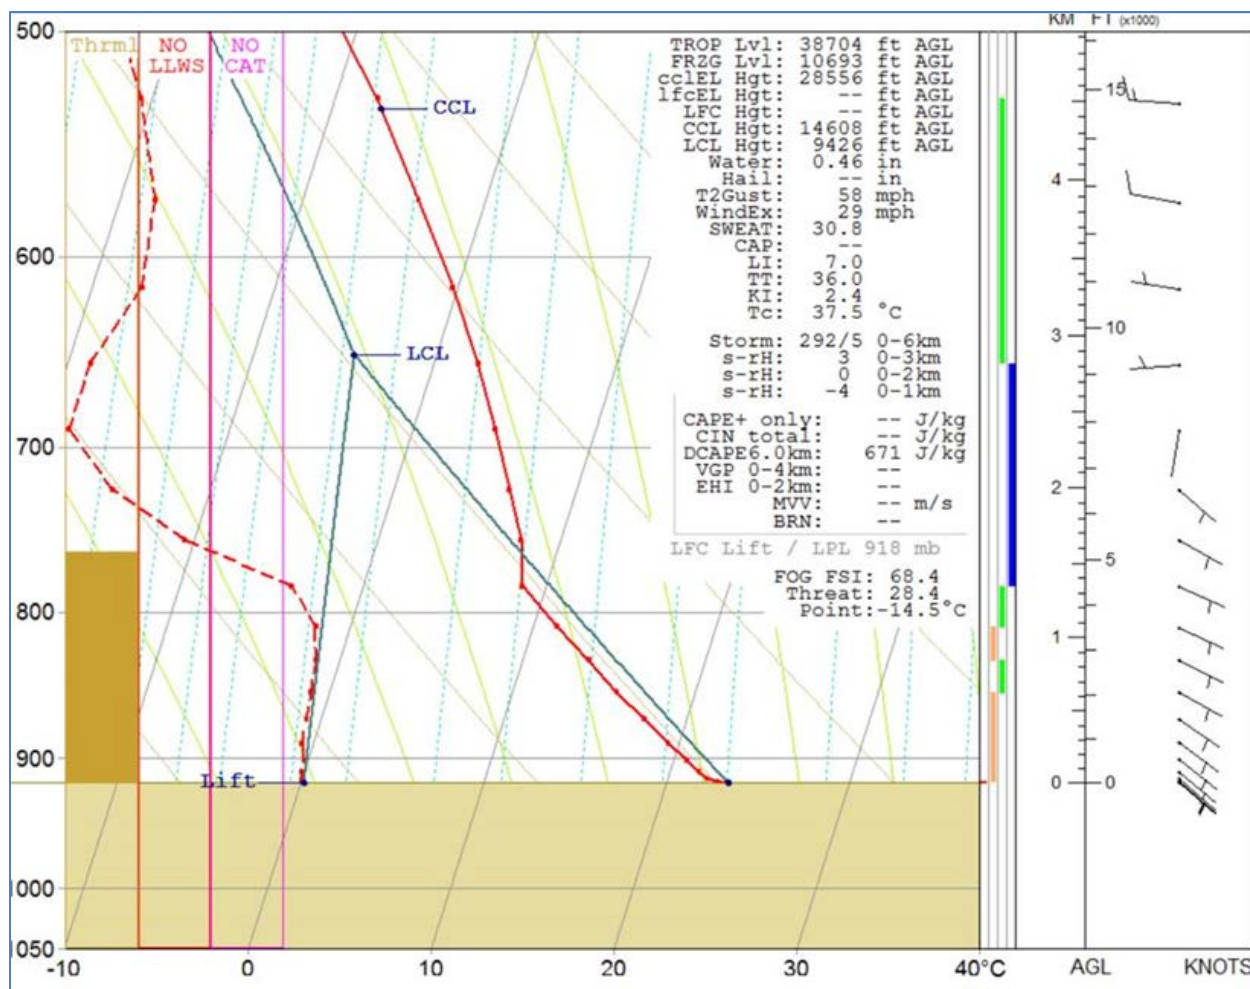
Figure 6 - HRRR numerical model sounding for 1300 MDT over the accident site

High Resolution Rapid Refresh (HRRR) numerical model<sup>5</sup> output was obtained from the NOAA Air Resource Laboratory for 1300 and 1400 MDT and reviewed. Figure 6 is the 1300 MDT HRRR sounding over the accident site plotted on a Skew T log P diagram<sup>6</sup> using the complete Rawinsonde Observation (RAOB) software<sup>7</sup> from the surface to 500-hPa (about 18,000 ft).

The 1300 MDT HRRR model sounding produced a surface temperature of 23.4° C (74° F), a dew point temperature of 0.2° C (32° F), and a relative humidity of 22%, which provided a density altitude of 4,376 ft based on the International Standard Atmosphere (ISA). The lifted condensation level (LCL) was at 9,426 ft agl, with the convective condensation level (CCL) at 14,608 ft agl. The freezing level or height of the 0° C isotherm was at 10,693 ft agl (13,692 ft). The precipitable water content was 0.46 inches. The moisture profile did not depict any favorable conditions for clouds (where relative humidity exceeded 80%) through 18,000 ft. While the HRRR sounding was overall characterized as stable based on the Lifted Index of +7, the layer from the surface through 4,400 ft agl (7,400 ft) was extremely unstable (indicated by the red and yellow bars on the right side of the diagram) with a lapse rate that exceeded the dry adiabat and supported strong thermal activity through 5,000 ft agl (also indicated on the left side of the sounding in brown).

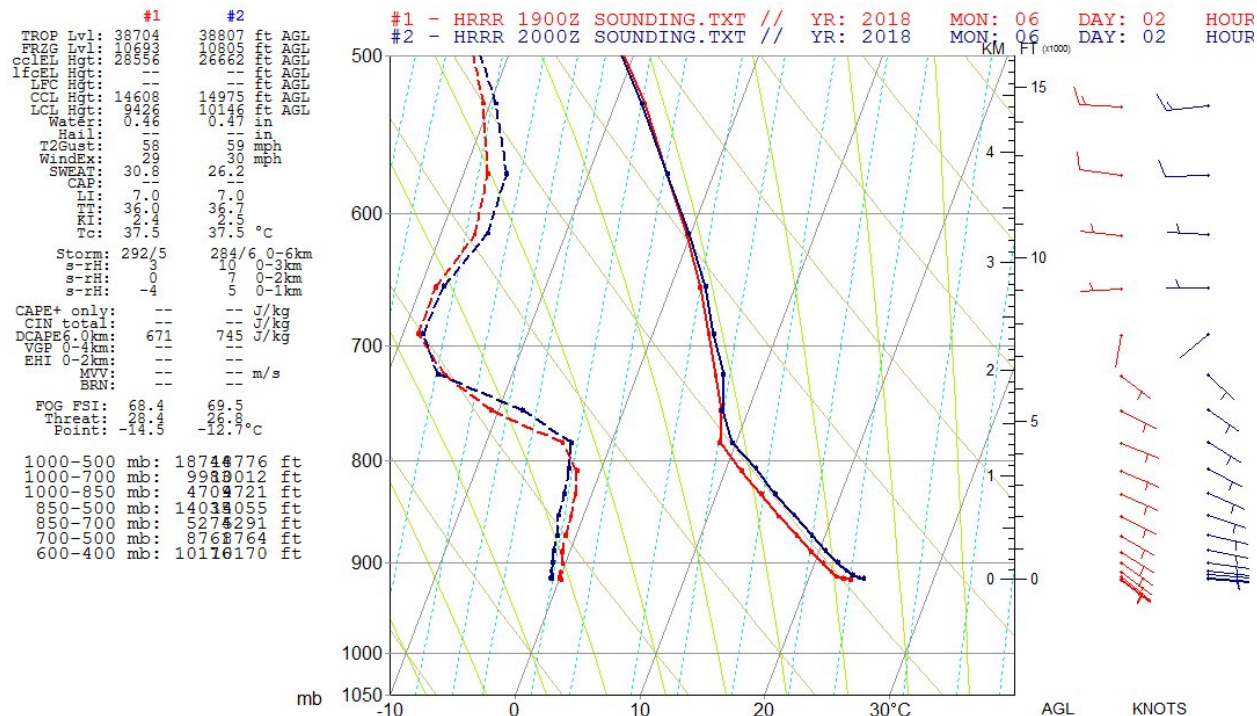
Figure 8 - Comparison of the 1300 and 1400 MDT HRRR soundings

The HRRR sounding for 1400 MDT indicated similar conditions, with minor changes in temperature with surface temperature of 24.4° C (76° F), dew point temperature of -0.6° C (31° F) with a relative humidity of 24%, and the surface wind from 097° at 4 knots. A comparison of the soundings is plotted in figure 8. The layer from the surface through approximately 5,000 ft agl remained unstable and supported strong thermals.

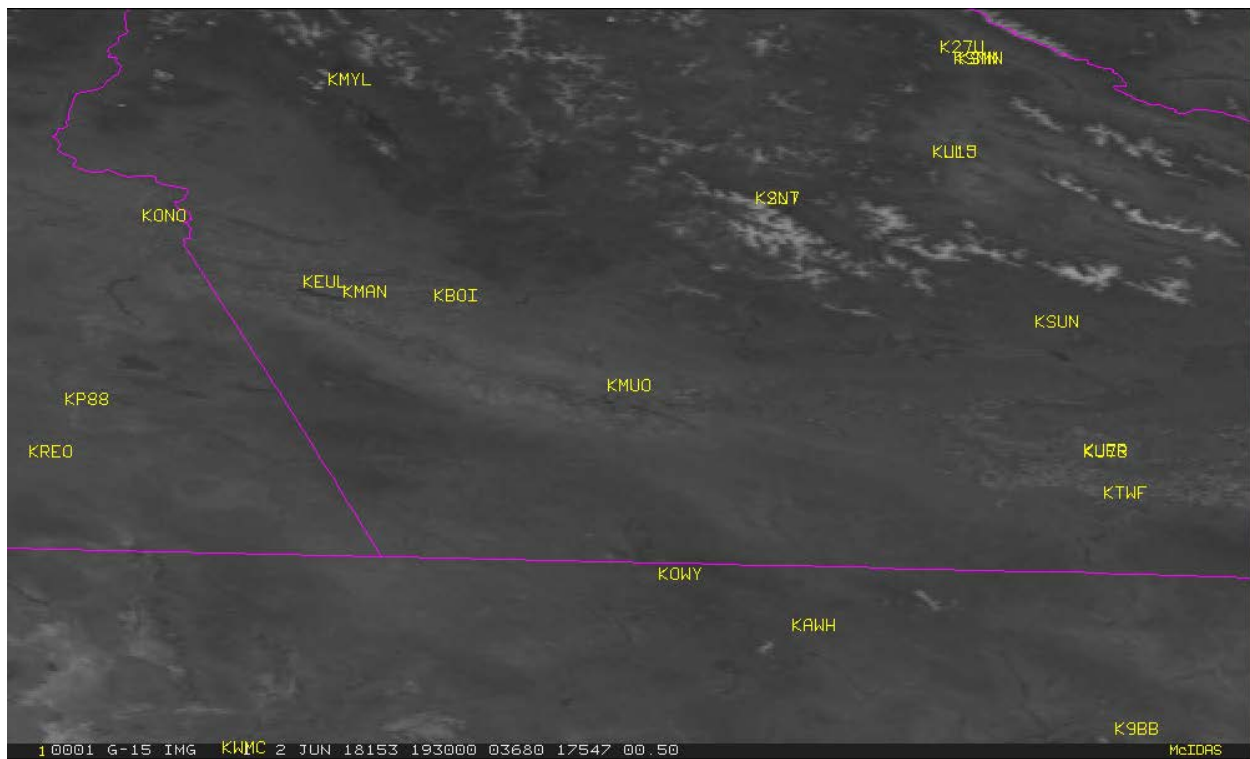
Figure 9 - GOES-15 visible image at 1330 MDT

The Geostationary Operational Environmental Satellite number 15 (GOES-15) data was obtained from an archive at the Space Science Engineering Center at the University of Wisconsin-Madison in Madison, Wisconsin, and processed using the Man-computer Interactive Data Access System (McIDAS) software. Both the infrared long wave and visible band imagery were obtained surrounding the time of the accident. Figure 9 is the GOES-16 visible image at 1530 MDT at 2X magnification centered over KMUO. The image depicted clear skies over the accident site, with snow-capped mountains indicated to the north and northeast.

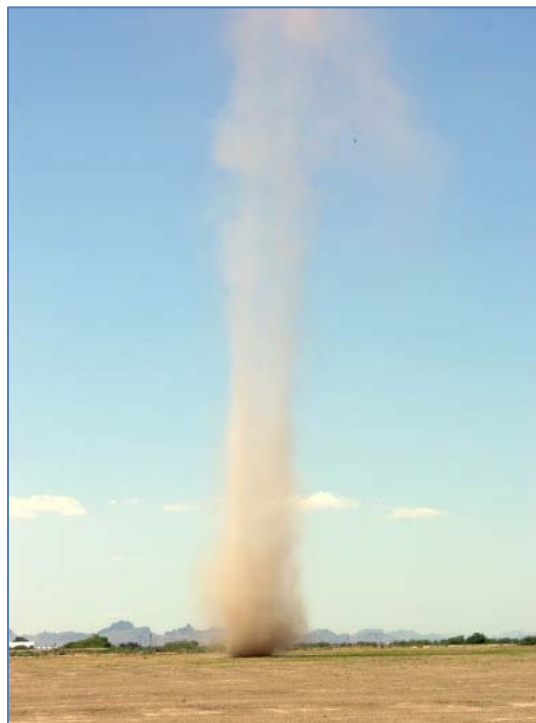
**Figure 11 - Dust Devil**

Figure 11 is a photograph of dust devil in Arizona, which had a diameter of 40 ft and extended several hundred feet in the vertical.
