# Continental Motors

## ENGINE EXAMINATION REPORT

| ENGINE MODEL | IO-550-N50B conv. to turbo-normalized TAT STC |
| FILE NUMBER | 17-630 |

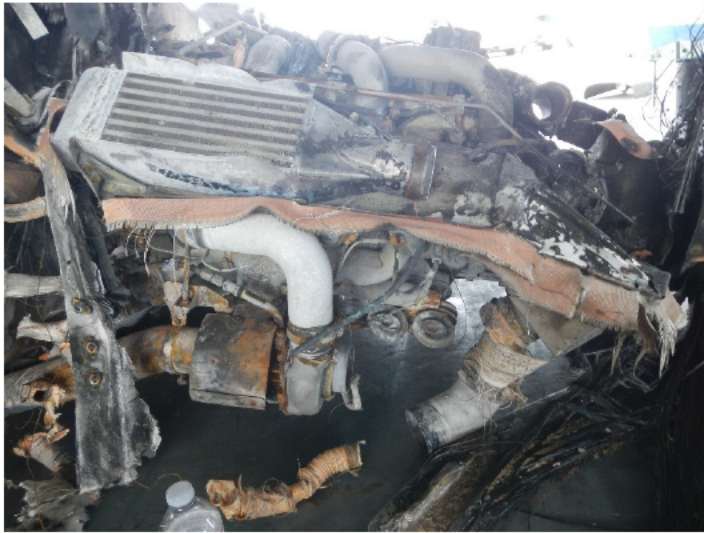
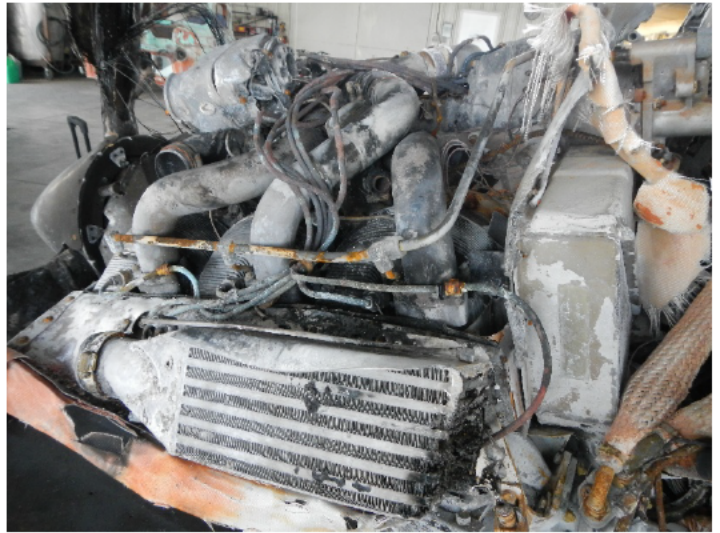
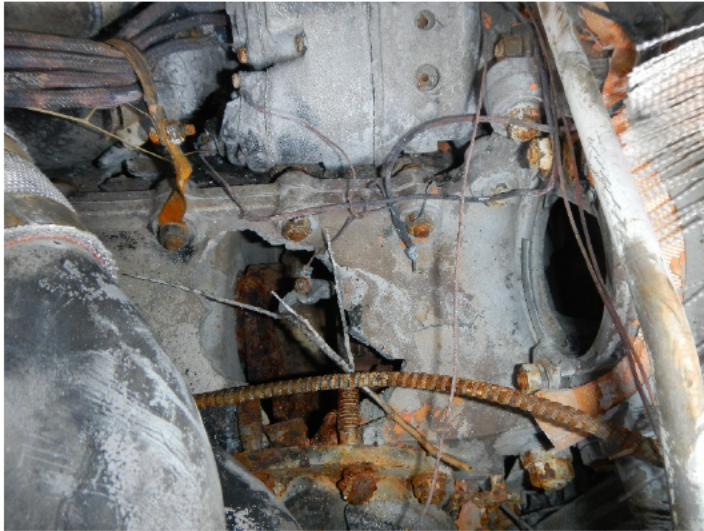
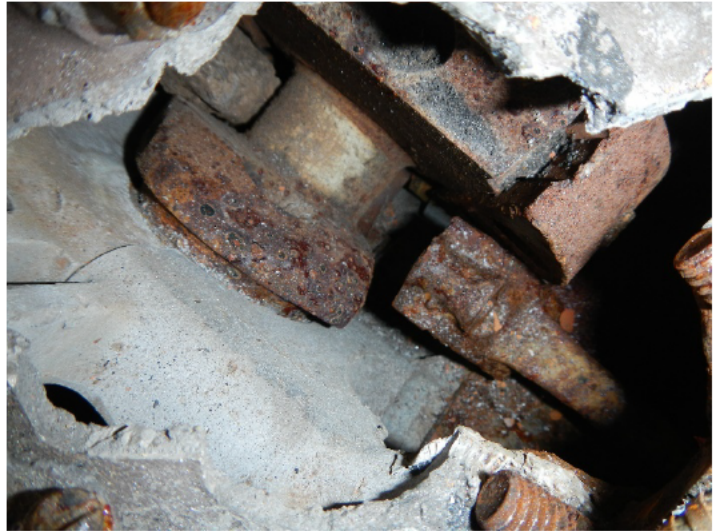
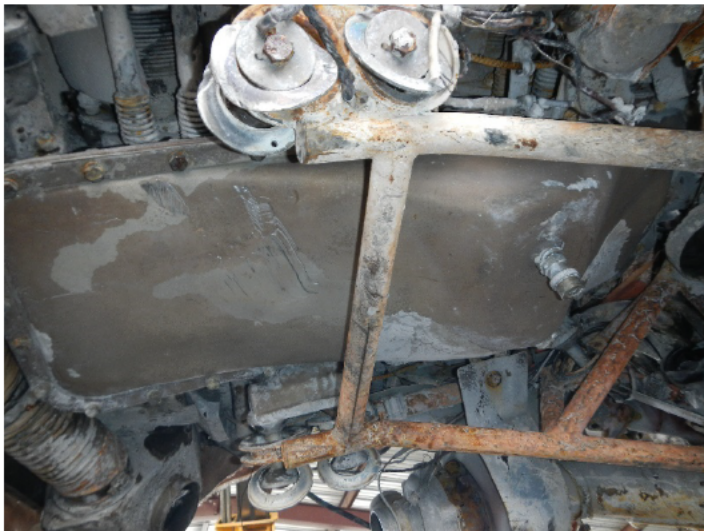
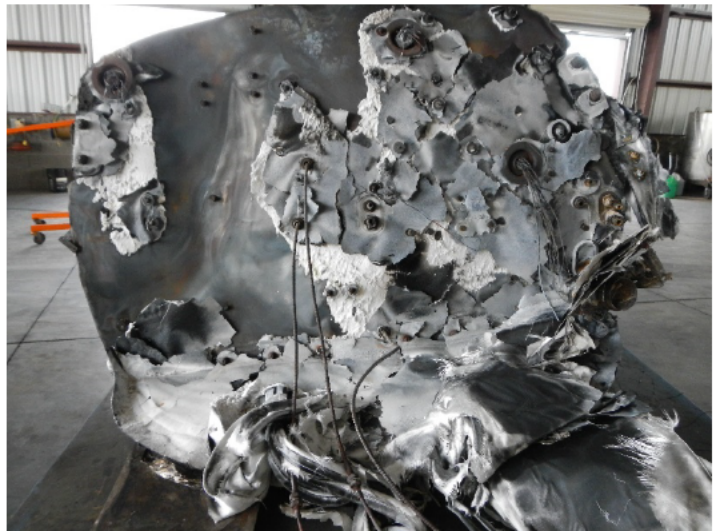
The engine sustained significant thermal damage that destroyed many of the engine-related systems. The engine remained attached to the firewall and the engine mount. The throttle, mixture, and propeller control cables remained intact and attached to their respective control levers; however, the cockpit controls were destroyed. The left magneto was separated from its mounting pad and remained attached to the engine via the burnt remains of the ignition harness. The crankcase in the vicinity of the #2 cylinder displayed a large hole. The rusted crankshaft and fractured #2 connecting rod pieces were visible through the hole.

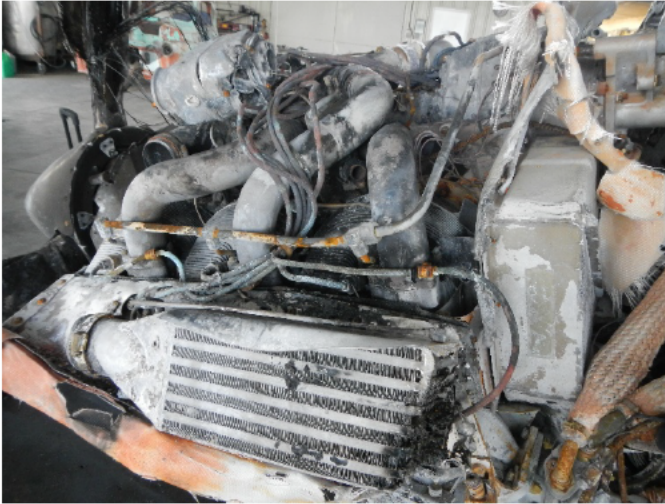
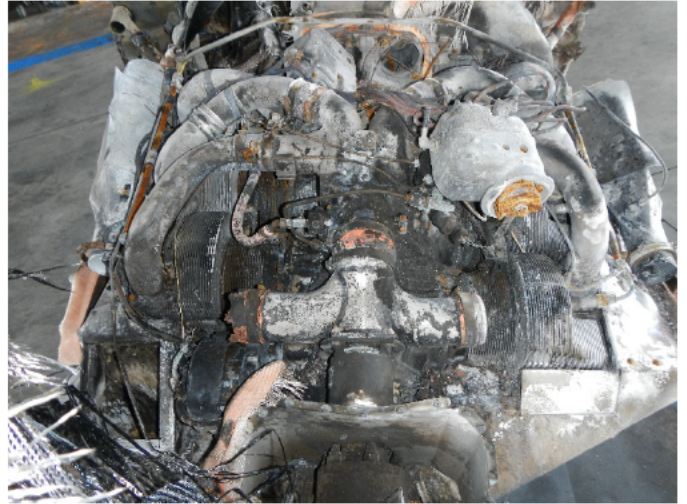
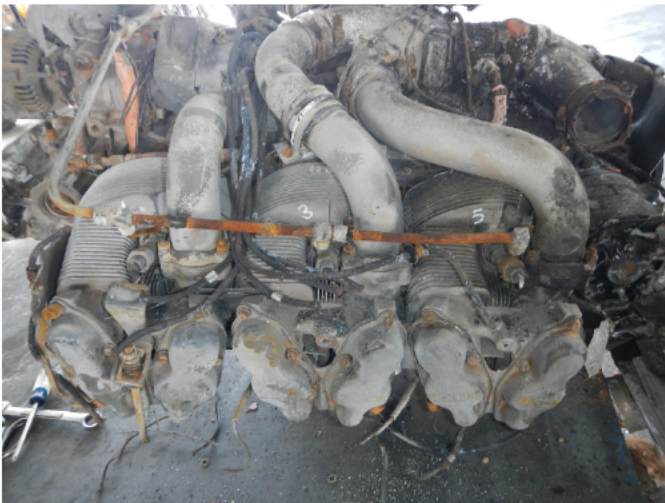
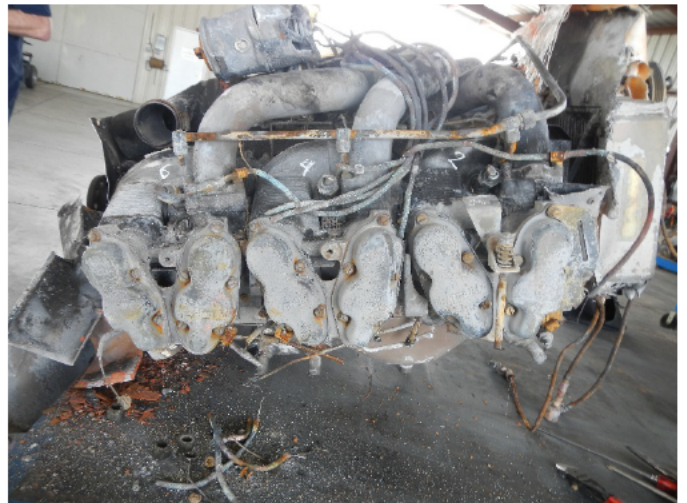
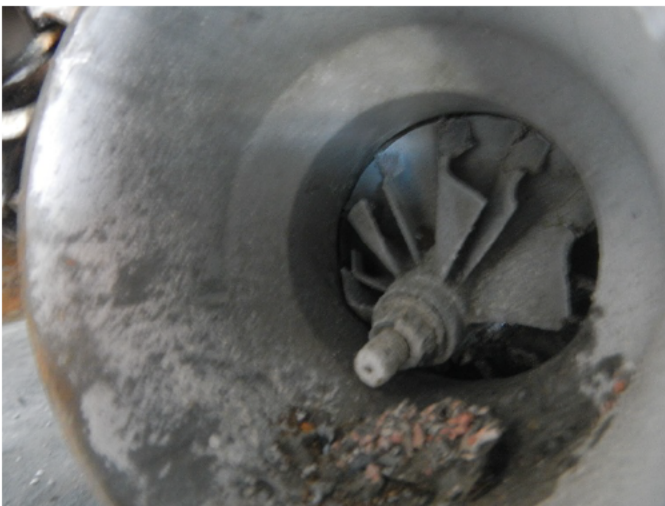
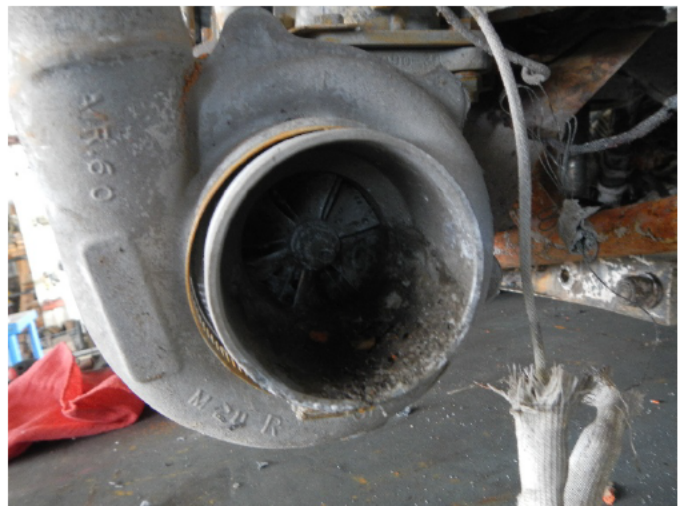
The thermally damaged remains of the induction system remained intact. The left turbocharger's impeller was damaged with the blades bent opposite the direction of rotation. The impeller housing was deformed and thermally damaged. Otherwise, the induction system was unremarkable.

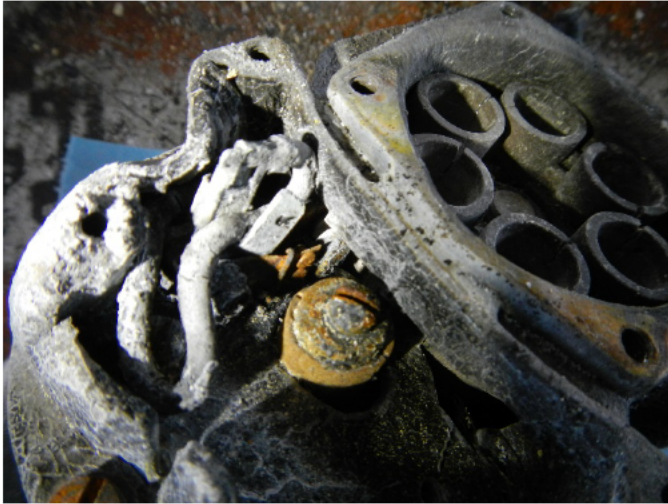
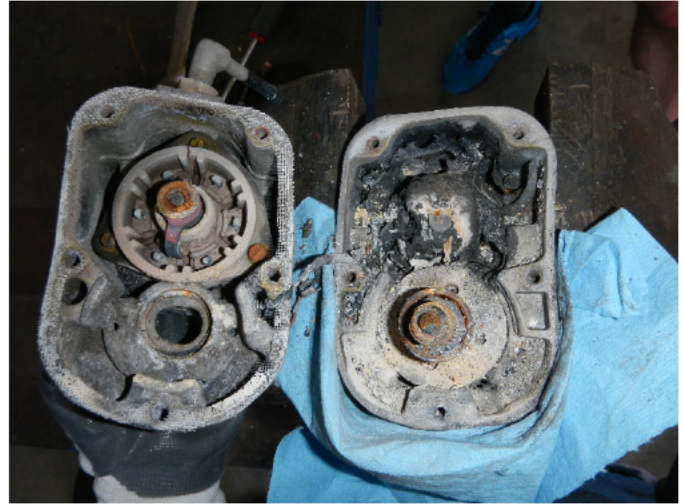
**Condition:** The left magneto was separated from its mounting pad and remained attached to the engine via the ignition harness. The mounting flange was fractured and the housing sustained thermal deformation damage that partially melted the capacitor and point cover. Disassembly of the magneto revealed that internal components were destroyed. The distributor gear was melted away and the distributor finger was positioned between the #2 top and #5 bottom distributor poles.

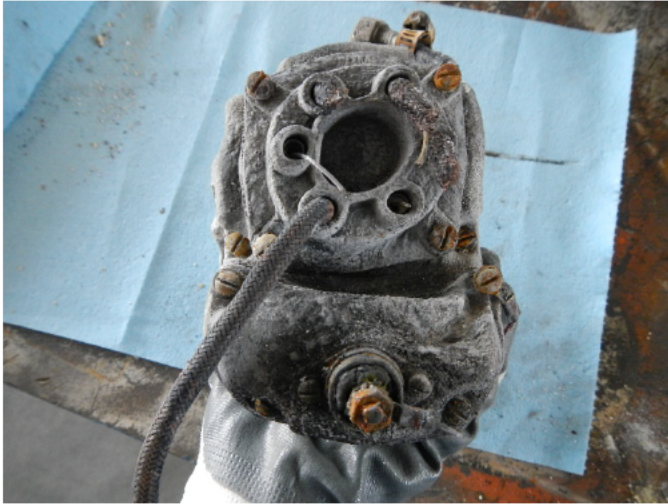
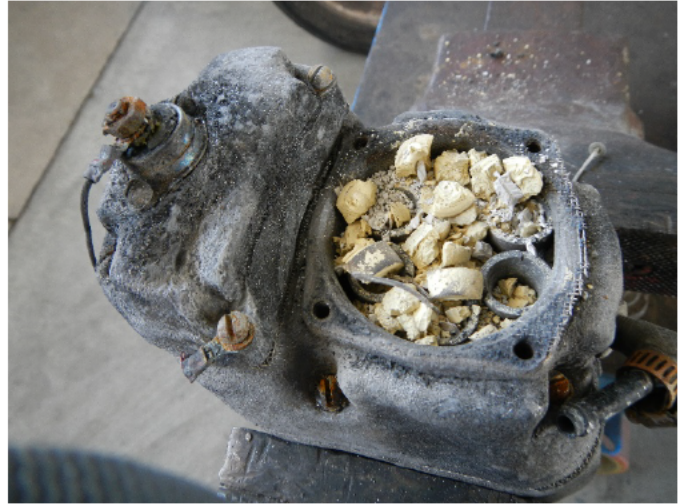
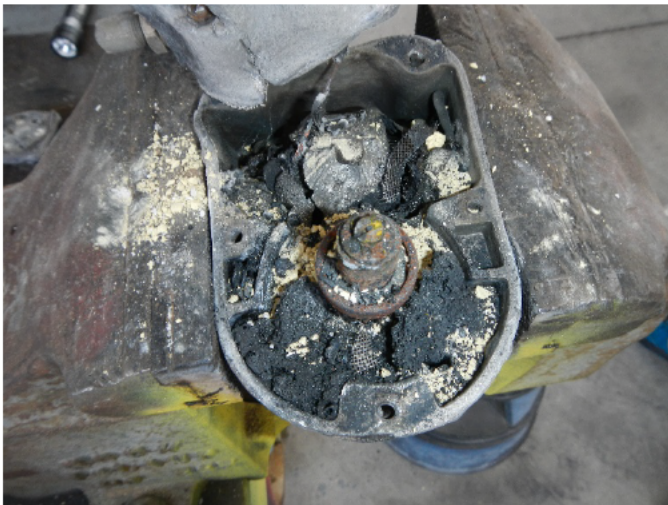
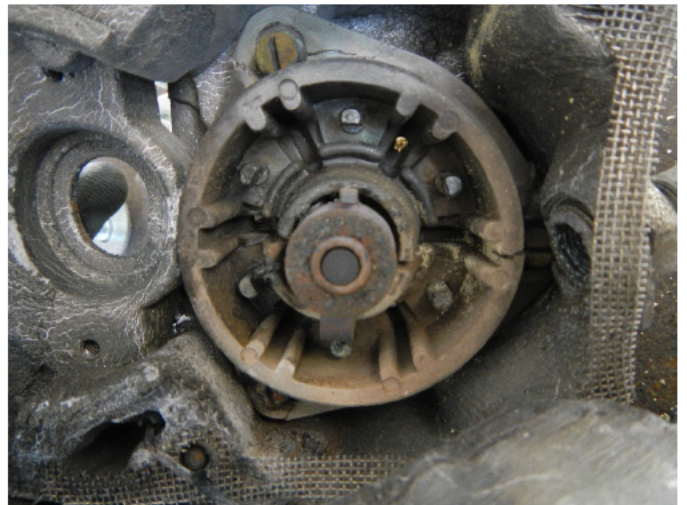
The right magneto remained attached to the mounting pad and manual manipulation of the magneto did not result in any slipping or rotation of the magneto. The housing sustained thermal deformation damage that partially melted the capacitor and point cover. Disassembly of the magneto revealed that internal components were destroyed. The distributor gear was melted away and the distributor finger was positioned at the #3 top distributor pole.

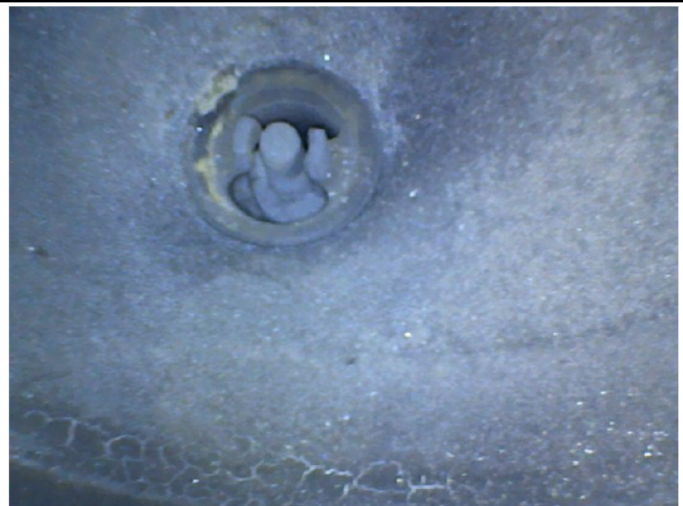
1B

All of the sparkplugs remained secured to their respective cylinders and their ignition terminals remained attached. Removal of the top sparkplugs revealed that their electrodes were significantly worn, the insulator core noses were fractured and missing material (consistent with detonation as per the Champion AV6-R Aviation Service Manual), and re-solidified molten metal beads were observed on the metallic surfaces. The bottom sparkplugs, which were observed via a lighted borescope, displayed similar signatures as the top. The #5 top sparkplug displayed a large clump of solid material on one side and the #6 sparkplugs were discolored green. Initial visual examination of the terminal end insulators in the top sparkplugs revealed they were intact.

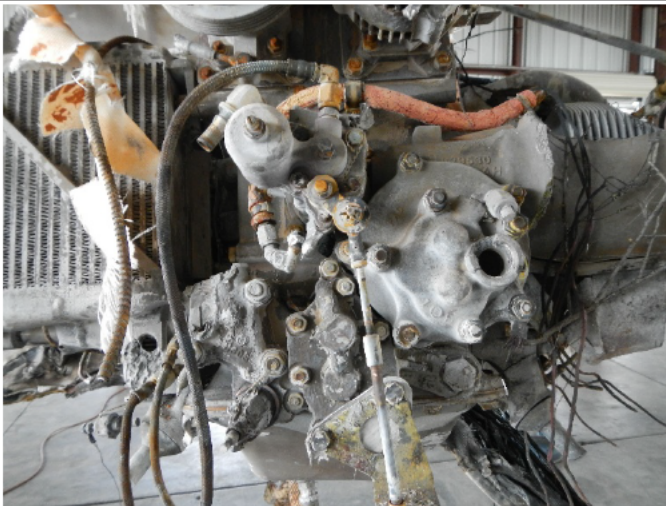
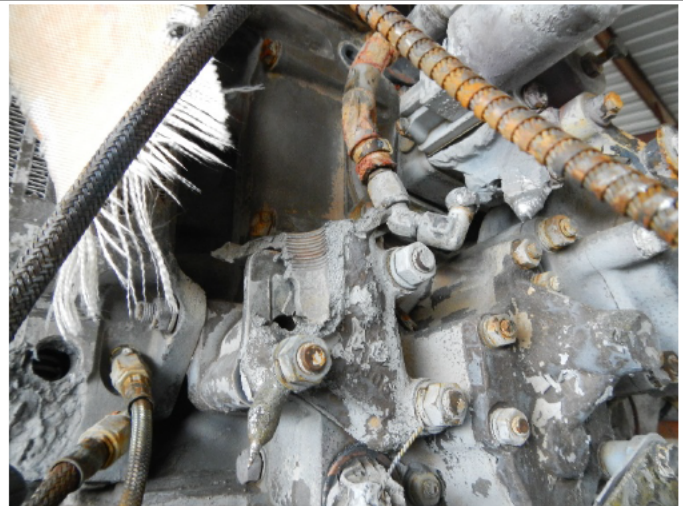
Condition: The oil filter was separated from the adapter as the housing was partially melted away. The oil filter will be examined at a later date.

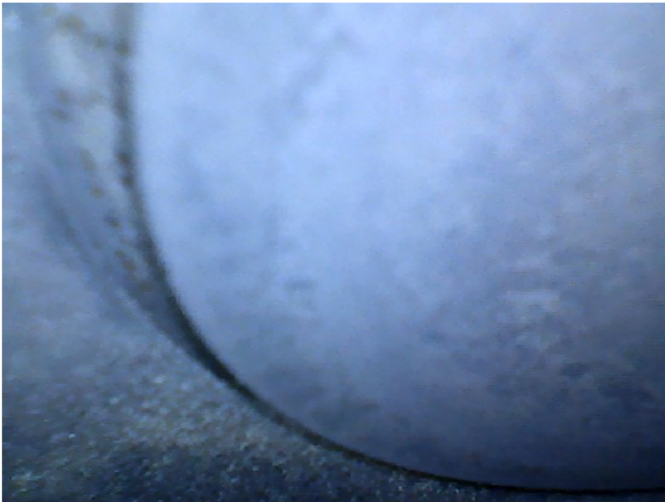
### CYLINDER #3

Condition: The cylinder remained attached to the crankcase with no external anomalies noted with the exception of the post-crash fire damage. Examination of the internal components with the use of a lighted borescope revealed that the piston was almost devoid of its normal combustion deposits and the face displayed incipient piston erosion. The valves and valve seats were intact and also appeared to be devoid of normal combustion deposits. The barrel could not be observed due to the position of the piston.

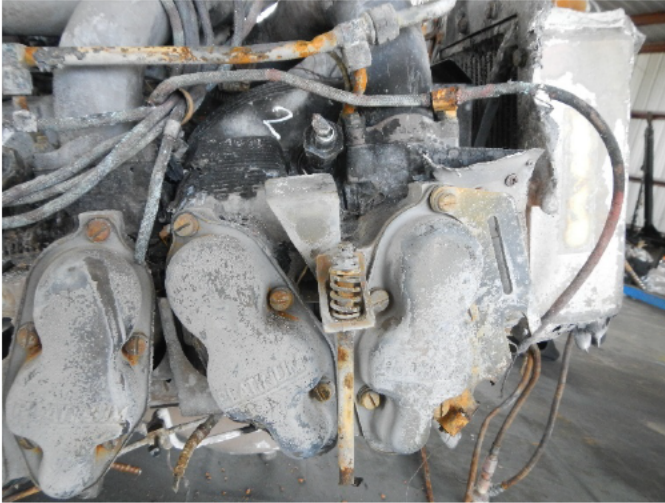
### CYLINDER #2

Condition: The cylinder remained attached to the crankcase with no external anomalies noted with the exception of the post-crash fire damage. Examination of the internal components with the use of a lighted borescope revealed that the piston was almost devoid of its normal combustion deposits and the face displayed incipient piston erosion. The valves and valve seats were intact and also appeared to be devoid of normal combustion deposits. The barrel could not be observed due to the position of the piston.

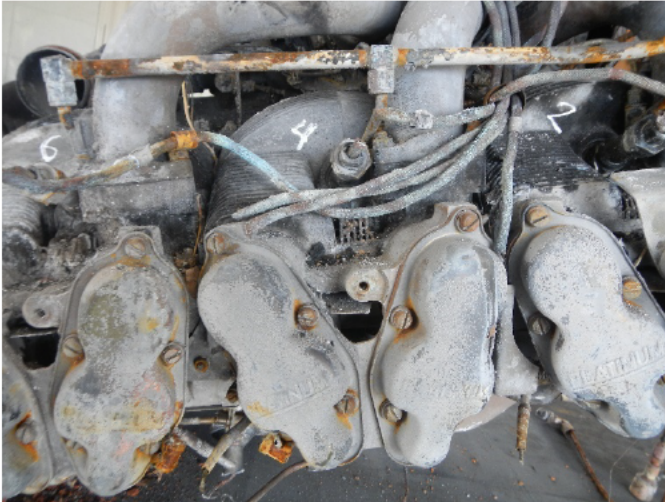
### CYLINDER #4

Condition: The cylinder remained attached to the crankcase with no external anomalies noted with the exception of the post-crash fire damage. Examination of the internal components with the use of a lighted borescope revealed that the piston was almost devoid of its normal combustion deposits and the face displayed incipient piston erosion. The valves and valve seats were intact and also appeared to be devoid of normal combustion deposits. The barrel could not be observed due to the position of the piston.

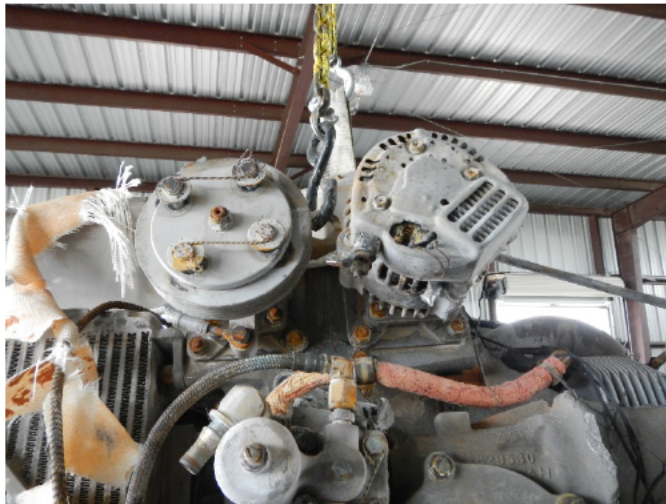
Condition:

The #2 alternator remained attached to the right accessory mounting pad. It was not examined as part of this inspection.

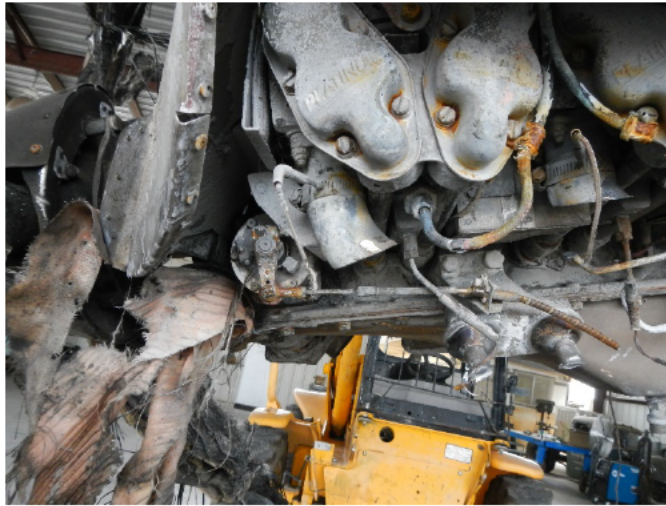
Condition:

The governor remained attached the front left side of the engine with the control cable attached to the control lever.
