AmSafe Observations to WPR18LA174

11 July 2018

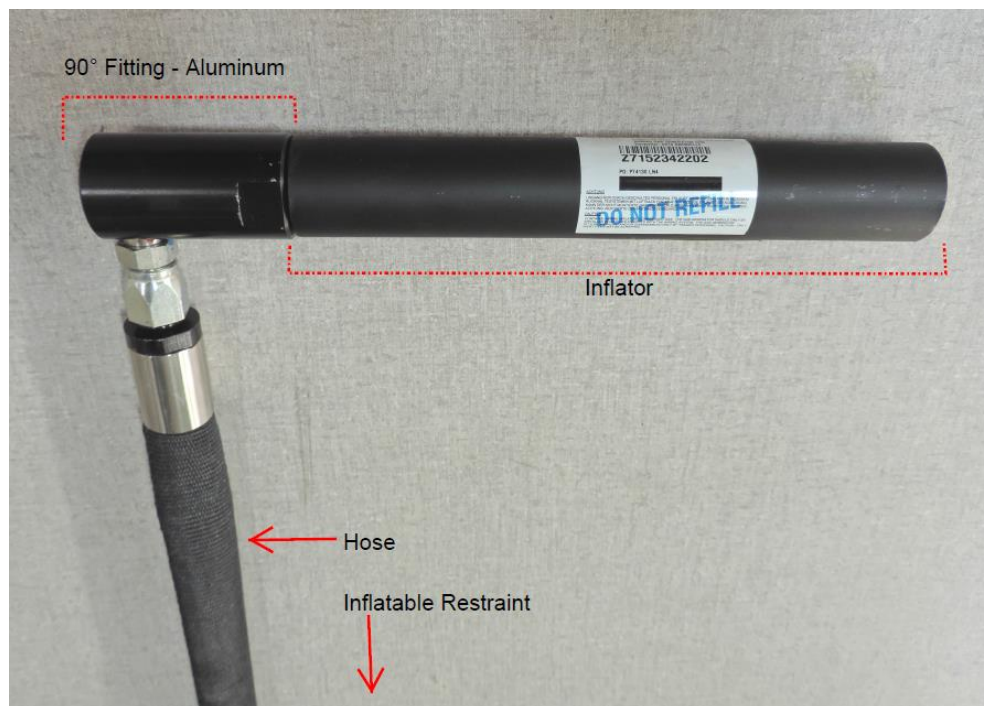
Figure 9-For Reference- Inflator interfaced and assembled to inflatable restraint

- The Aluminum hose fitting (ref Fig 9) was completely absent from the threaded diffuser of the inflator, (ref Figs 1&2), completely melted off. No evidence of consumable restraint components surviving in the recovered debris.
