## **NATIONAL TRANSPORTATION SAFETY BOARD**

# **AIRFRAME AND ENGINE EXAMINATION**

**WPR18LA214**

Location: Basin City, WA  
Date: August 7, 2018  
Aircraft: Bell 206B, N607RA, Serial # 678

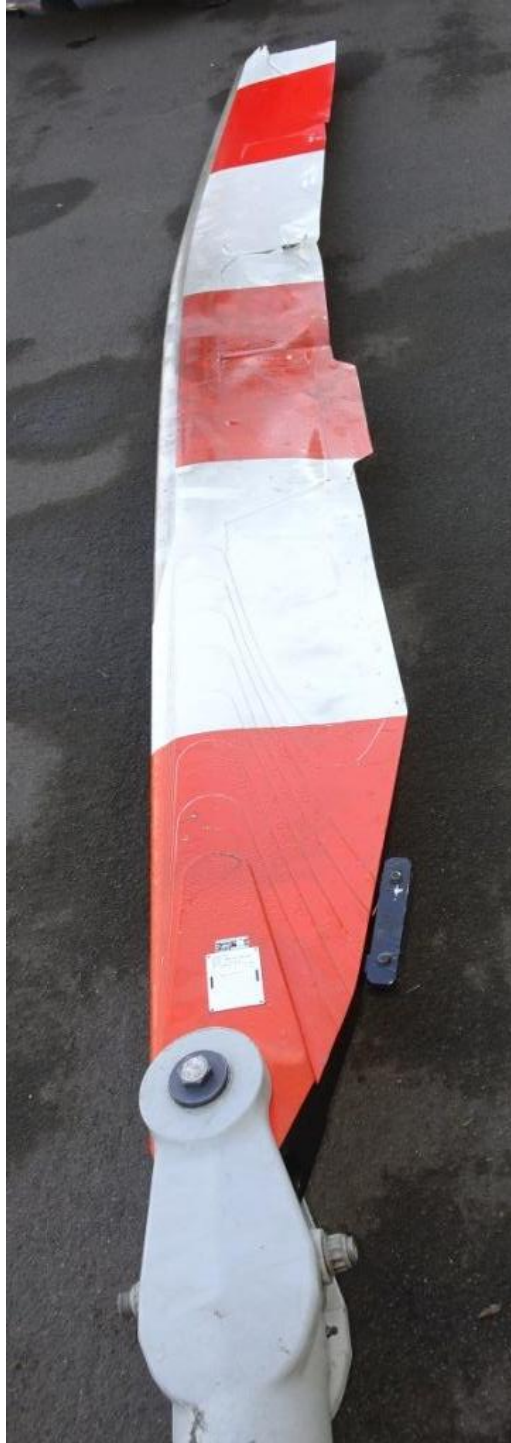
**Figure 6 - Main Rotor Blade**

- The mast was fractured immediately below the hub
- Both main rotor blades remained attached to the MRB hub
- Main rotor blade s/n A-8101 was fractured at the outboard end of the blade doublers, with additional fracturing near the blade tip
  - Upward bending of the fractured portion of the blade was noted
  - This was consistent with ground contact
- Main rotor blade s/n A-7835 was missing the tip of the blade, and exhibited aft and upward bending.
- Both main rotor blades exhibited additional damage (scrapes, dents, and gouges)
- Main drive continuity was demonstrated by rotating the input drive quill by hand, and observing the rotation of the mast.

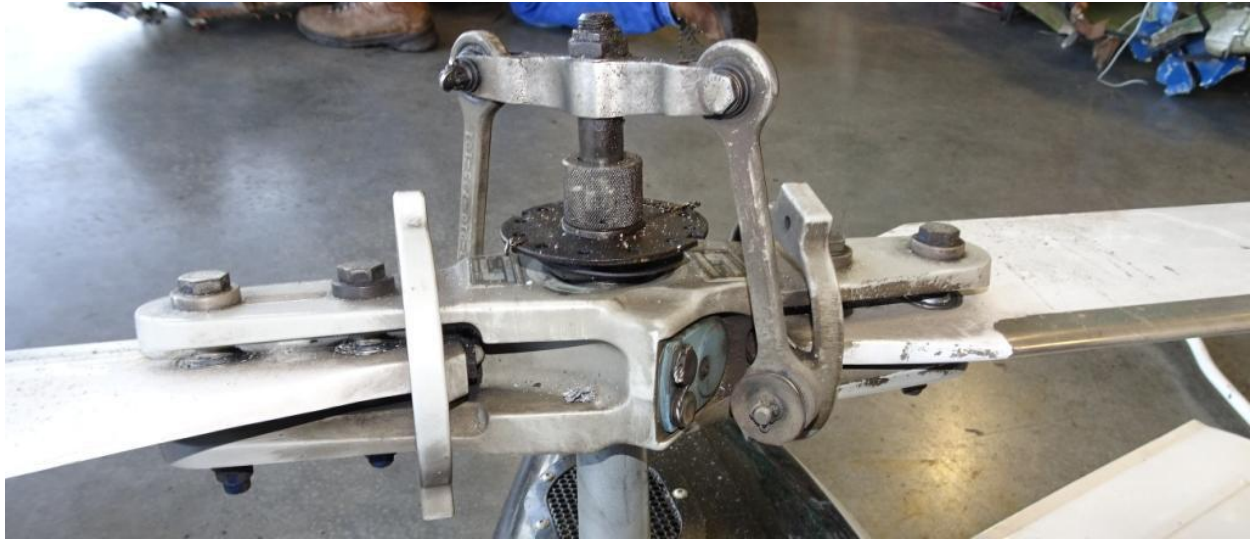
**Figure 10 - Tail Rotor Hub**

- The helicopter was equipped with aftermarket composite tail rotor blades (TRBs)
- Both TRBs remained attached to the TRB hub
- Both tail rotor blades were unremarkable except for the tip of blade s/n A592 that appeared to have contacted the ground with the tip broken off
- The other TRB (s/n unable to be read) was undamaged
- The tail rotor hub was unremarkable
- Due to fragmentation and consumption by fire, tail rotor drive continuity could only be established from the tail rotor through the tail rotor gear box
- The majority of the tail rotor driveshaft segments were consumed by fire
- The forward short shaft (steel shaft) and the oil cooler blower shaft were identified in the wreckage
- Oil was present in the tail rotor gearbox; it appeared normal in color and no contaminants were present
- The chip detector was removed and visually inspected, with no chips observed

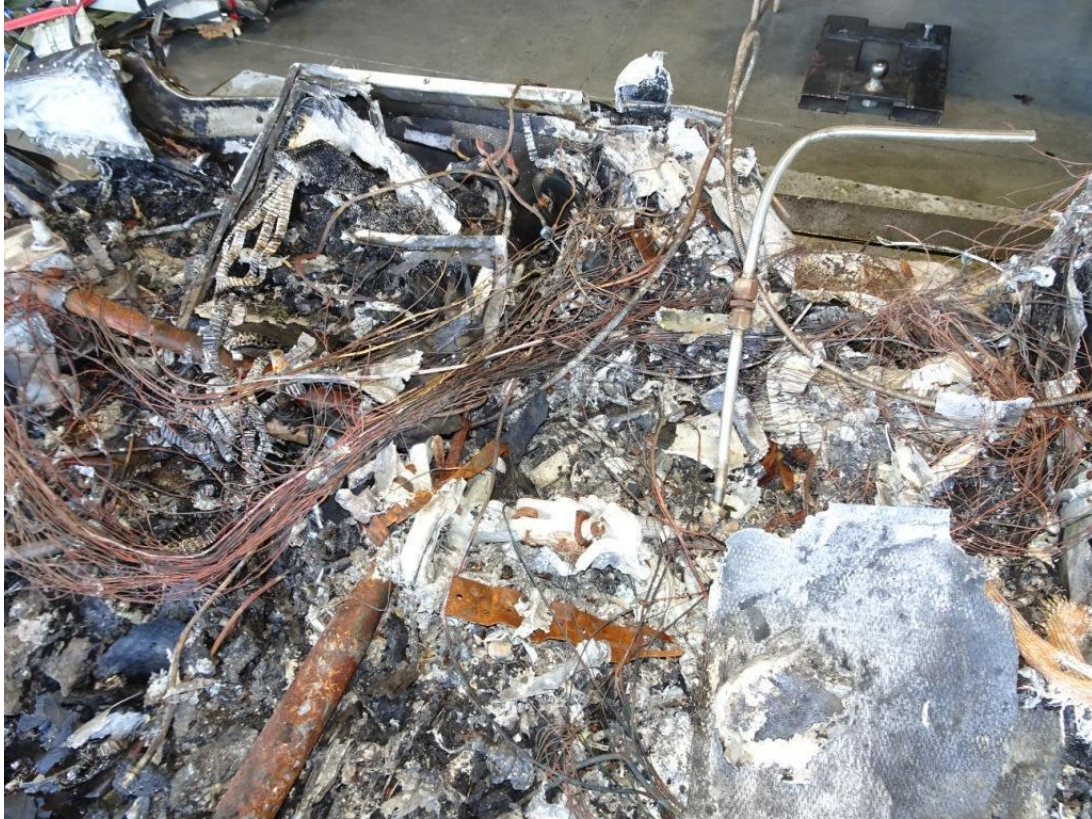
**Figure 14 – Collective Jackshaft and Pilot's Collective**

- Most of the flight controls were consumed in the post-crash fire
- The right collective stick was present, but the throttle twist grip was missing
- The left collective stick was missing
- Both cyclic sticks were missing
- The yoke that connects the right and left cyclic sticks was missing
  - The mixing lever was present, with significant thermal damage
- The left seat anti-torque pedals were missing
- The right seat inboard pedal remained, but the outboard pedal was not located
- Only one of the three servo actuators was identified, and it was thermally damaged
- No other flight control components were located; they were apparently consumed by fire
