## Accident / Incident Report

**Report No.: 18-124**

**AirSpray Airtankers  
Air Tractor AT-802F, N397AS  
Stevens County, Washington, USA  
14 August 2018  
PT6A-67F, RZ0138**

**Date of Issue: 20 November 2019**

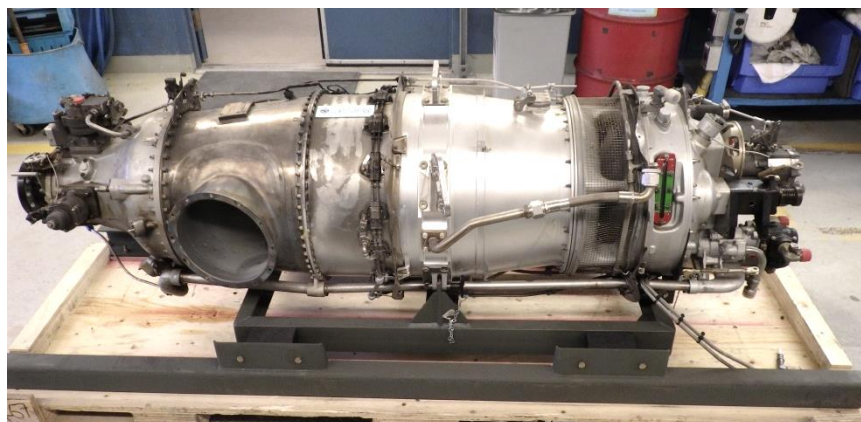
**Photo No. 1**

The shipping box was in good condition. Removal of the shipping box, revealed the engine with parts of the airframe mount, some airframe accessories, wiring harnesses, and firewall still attached (Photo No. 1). The external surfaces of the engine, mainly in the fuel nozzles area, showed signs of post-impact fire (PIF). The compressor rotor and the power turbine (PT) / propeller shaft rotor were both seized. The PT blades were examined on the downstream side through the exhaust duct ports. The first stage PT (PT1) and second stage PT (PT2) blades were all fractured (Photo No. 2). The gas generator module and power section module data plates confirmed the engine serial No. RZ0138 (Photo No. 3).

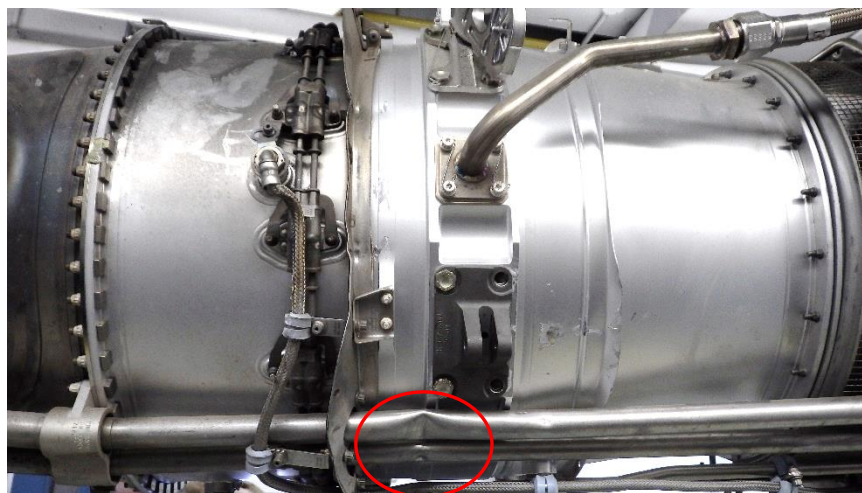
**Photo No. 8**

**Gas Generator Case (GGC):** The GGC upper external surfaces showed signs of PIF (Photo No. 7). The GGC was displayed impact damages. The fuel line and oil scavenge lines were mechanically deformed (circled, Photo No. 8). All fuel nozzle manifolds were still secured and tightened. Both igniter plugs were still secured and tightened.

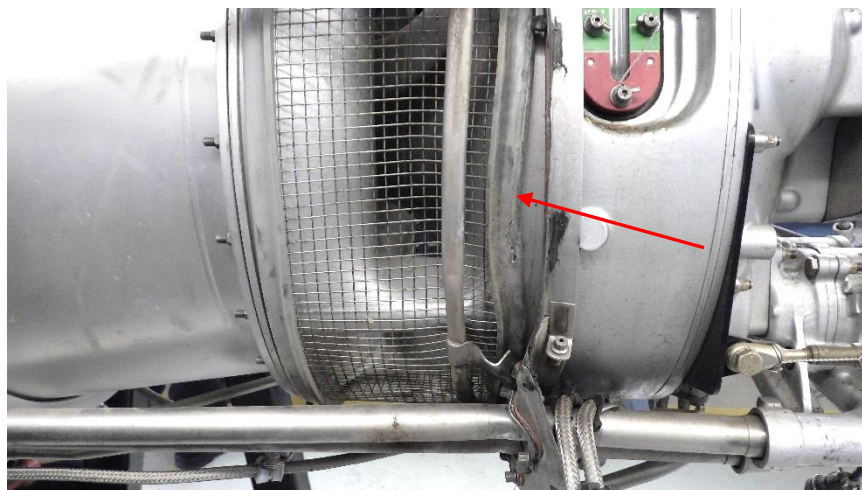
**Photo No. 9**

**Accessory Gearbox (AGB) and Inlet Case / Oil Tank:** The inlet screen was not punctured, but was slightly soiled. A portion of the inlet screen and wash ring had been compressed inwards from impact (arrow, Photo No. 9). The internal gas path of the inlet case was covered by a light layer of dust.

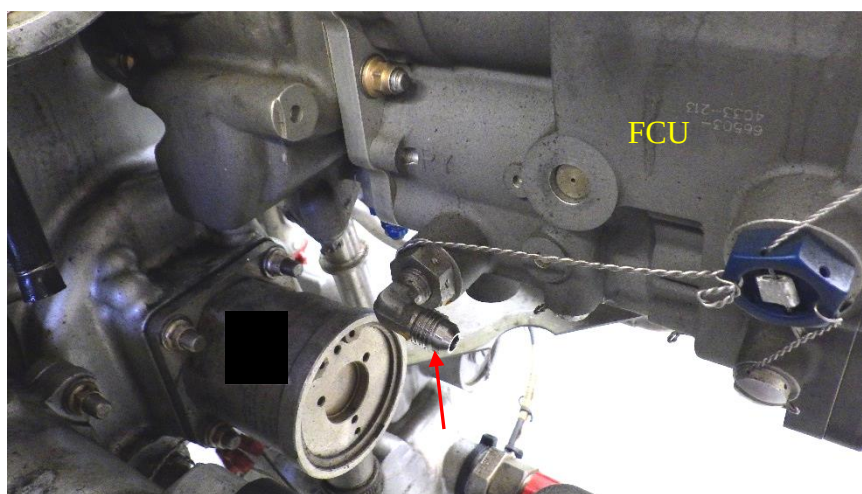
**Photo No. 12**

**Power Turbine Control (Py):** The Py pneumatic line was not received. Based on cleanliness of the FCU and propeller governor (CSU) fittings threads (arrows, Photo No. 11 and Photo No. 12), the Py line was likely removed post-accident during engine removal.

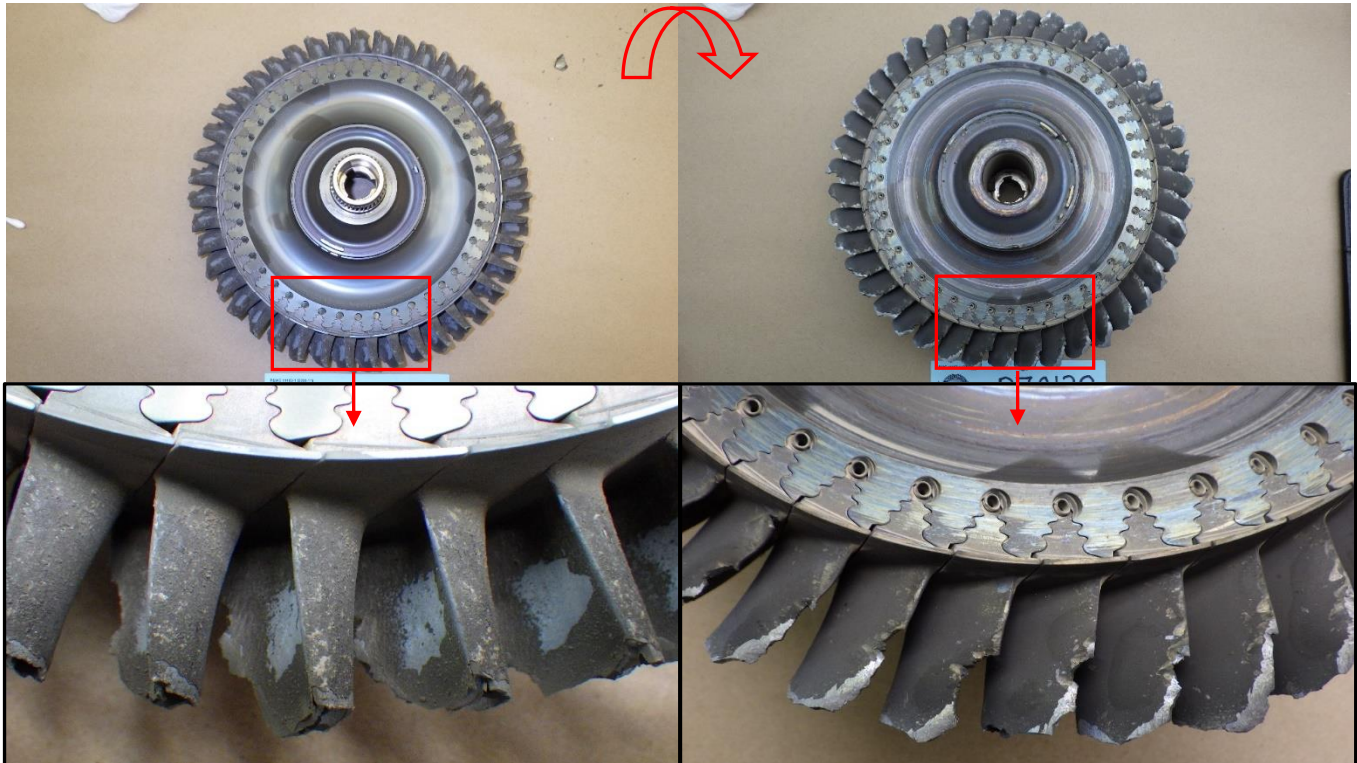
**Photo No. 17**

The engine was split at “C” flange to access the hot section components. The compressor turbine (CT) blades were all fractured near the tip (Photo No. 16). All CT blades were coated with foreign melted debris, dark grey in appearance (Photo No. 17). The CT disk downstream side exhibited heat discoloration and severe circumferential rubbing (Photo No. 17). The CT shroud segments presented rub, material transfer and fused debris accumulation (Photo No. 18). The CT vane ring showed normal operational wear, but displayed foreign melted debris build-up (Photo No. 19). The CT blades were sent to the P&WC Materials Laboratory for further analysis (see section 4.0). Sample of the foreign melted debris was collected from the CT vane ring and was submitted to the P&WC Chemical Laboratory for further analysis (see section 5.0).

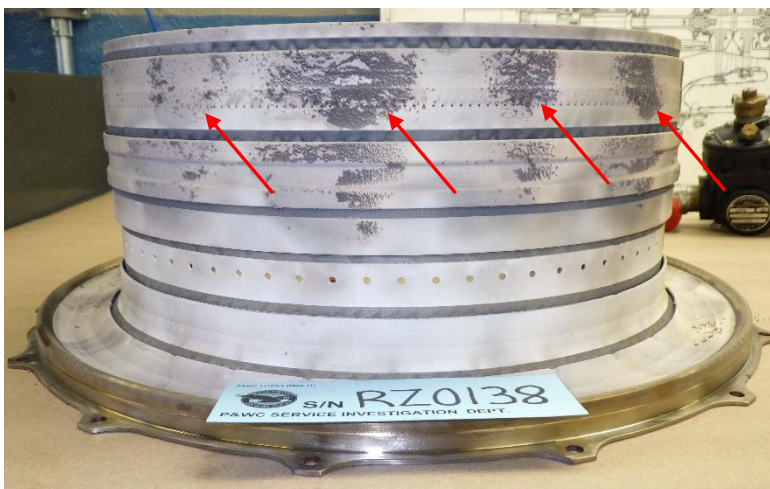
**Photo No. 22**

The combustion chamber displayed a significant accumulation of dislodged foreign melted debris, dark grey and tan in appearance (Photo No. 20 to Photo No. 22). The combustion chamber inner and outer liners did not show evidence of overtemperature exposure. The small exit duct showed normal operational wear, but also displayed foreign melted debris build-up. Samples of the foreign melted debris was collected from the combustion liners and were submitted to the P&WC Chemical Laboratory for further analysis (see section 5.0).

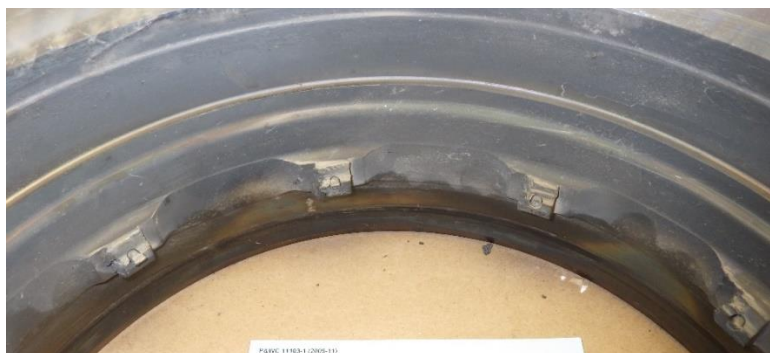
**Photo No. 23**

The PT section components were coated with foreign melted debris, dark grey in appearance (inset, Photo No. 24). All Inter Turbine Temperature (ITT) probes had fractured (Photo No. 23). The PT vane ring was fractured and some fragments were not retrieved (Photo No. 25). The interstage baffle was severely deformed, battered and showed severe circumferential rubbing marks due to contact with the CT disk assembly on the upstream side and the PT1 disk assembly on the downstream side (Photo No. 24 and Photo No. 26). The PT shroud was deformed and fractured (red arrow, Photo No. 27). The PT1 and PT2 blades were all fractured. All PT1 blades were pushed backward and were fractured at about the same airfoil heights, close to the base (yellow arrow, Photo No. 27). The PT interstage vane ring was fractured and displayed foreign melted debris build-up (Photo No. 28). Some PT2 blades were pushed backward and were fractured at various airfoil heights (Photo No. 29). The PT2 disk downstream and upstream sides showed circumferential rubbing. The No. 3 roller bearing showed normal operational wear. The PT1 and PT2 blades were sent to the P&WC Materials Laboratory for further analysis (see section 4.0). Sample of the foreign melted debris was collected from PT1 vane ring and was submitted to the P&WC Chemical Laboratory for further analysis (see section 5.0).

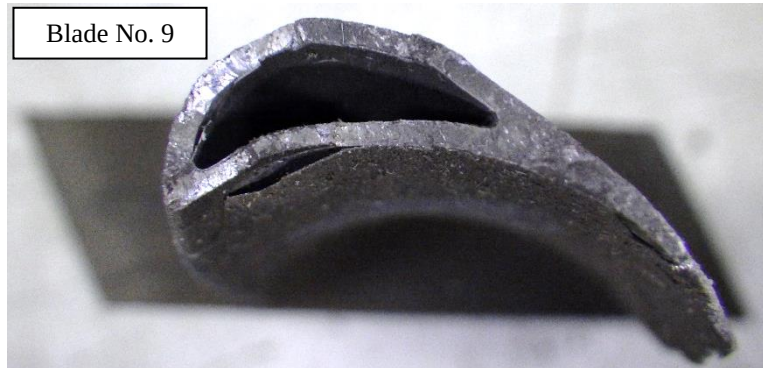
**Photo No. 38**

- 4.1 Examination of the CT blades showed that they exhibited overload fractures, likely corresponding to secondary damage (Photo No. 36 to Photo No. 38).

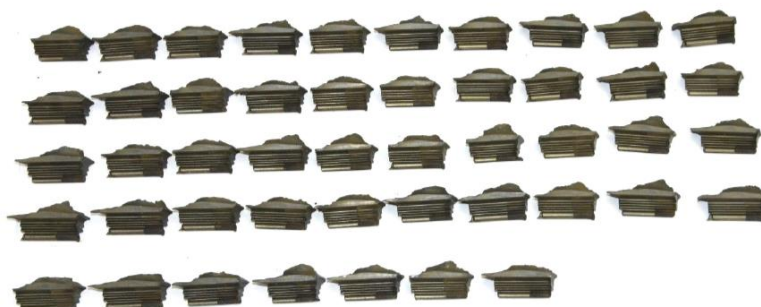
**Photo No. 40**

4.2 PT1 blades as received are shown in Photo No. 40 and Photo No. 41. Examination of the PT1 blades showed that they exhibited overload fractures (Photo No. 42), likely corresponding to secondary damage.

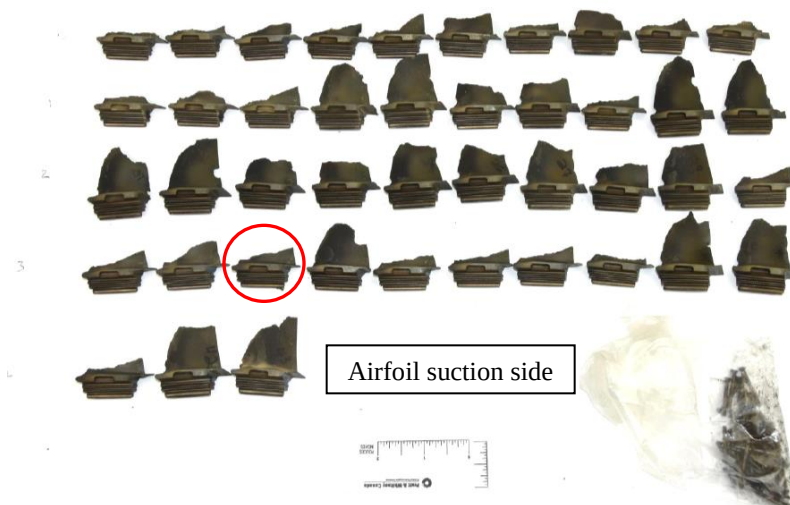
**Photo No. 44**

impact damage consistent with secondary damage, with the exception of blade No. 33 (circled, Photo No. 43 and Photo No. 44).

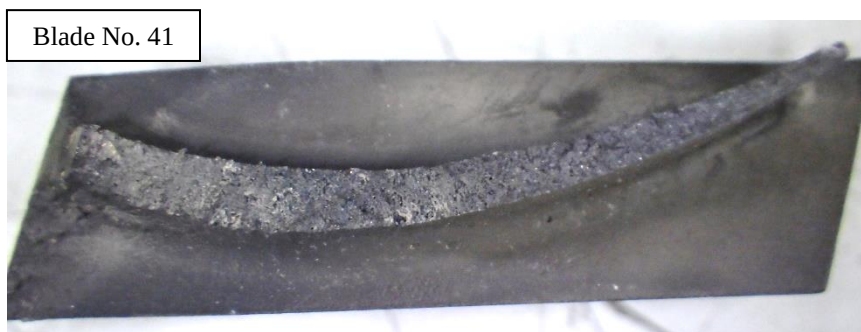
**Photo No. 45**

- 4.3 Examination of the PT2 blades showed that the blades with the longer airfoil remnants exhibited overload fractures and impact damage consistent with secondary damage. All of the other blades with airfoil fractures slightly above their platform also exhibited overload fractures (Photo No. 45) and

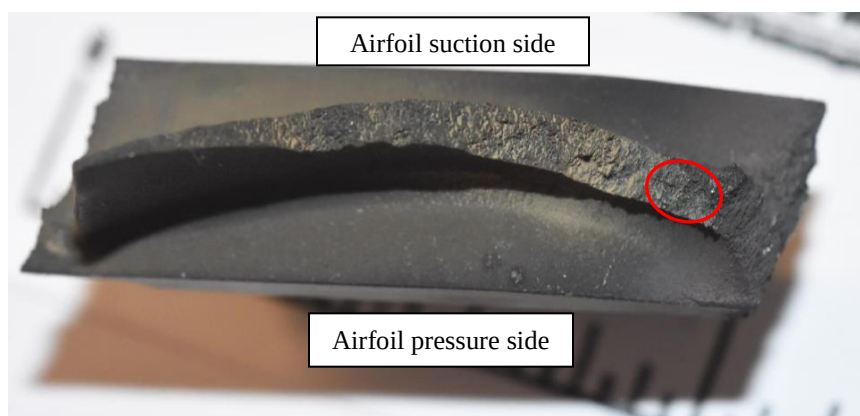
**Photo No. 46**

- 4.3.1 Examination of the blade No. 33 showed that the fracture surface immediately downstream from the leading edge secondary impact area exhibited evidence of fatigue (circled, Photo No. 46 to Photo No. 49). The PT2 blade No. 33 fracture portion immediately downstream from the leading edge secondary impact damage (delimited by the green dashed line, Photo No. 50) showed an area of the fracture with a granular aspect, of which several regions of fatigue initiated from microshrinkage porosities (Photo No. 51). This suggests that the microshrinkage likely acted as preferential initiation sites for the fatigue cracking. Due to the impact damage sustained by the blade leading edge, the exact origin area could not be established with certainty.

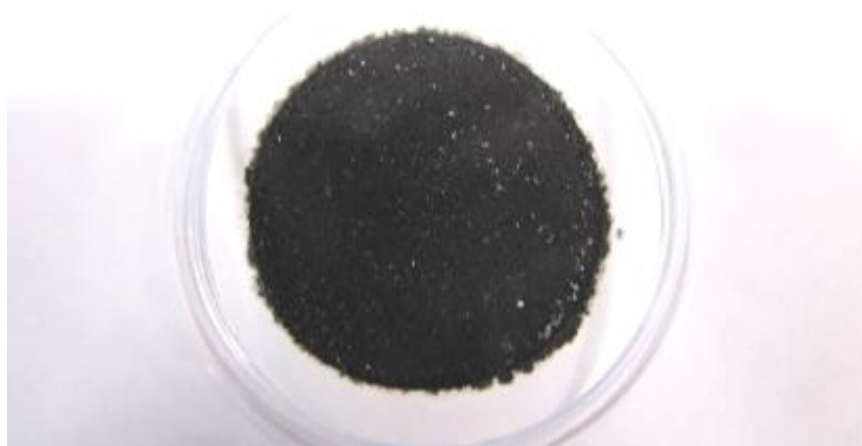
**Photo No. 56**

| Sample ID | Summary of Analysis |
|---|---|
| Oil filter<br><b>Sample No. 1</b> (Residue collected from the oil filter, Photo No. 55)<br>(Patch with presence of large metallic particles, Photo No. 56) | The particles analysed by APA were mainly composed of : <ul style="list-style-type: none"><li>• Iron base alloy, some particles were similar to low alloy steel and similar to 300 series SST. The low alloy steel particles included particles similar to UNS G93106 (AMS6260, 6265, 6267)</li><li>• An interaction between the low alloy steel UNS G93106 and the 300 series SST particles is observed.</li><li>• Traces of Cadmium particles and presence of Cadmium contamination on some Iron base particles</li><li>• Traces of Aluminum particles</li></ul> The large particles analysed by SEM-EDX were composed of Aluminum alloy. |

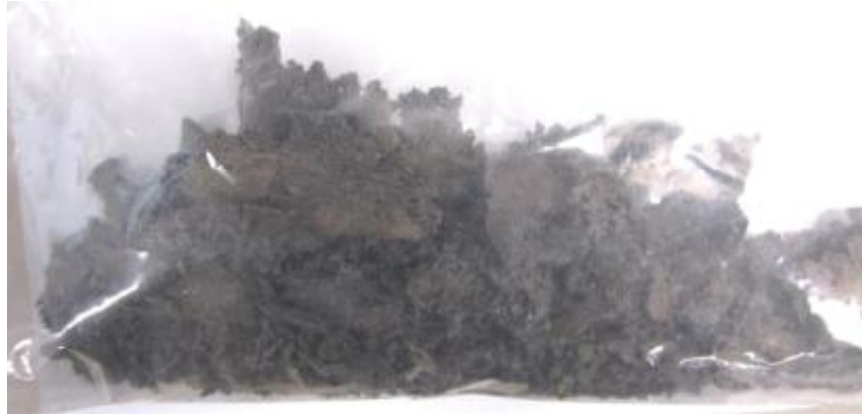
**Photo No. 57**

| Sample ID | Summary of Analysis |
|---|---|
| Debris from combustion chamber outer liner<br><b>Sample No. 1</b> (Photo No. 57 and Photo No. 58) | The debris were mainly composed of Silicon with some Aluminum in presence of Oxygen. Traces of Sodium, Potassium, Calcium, Titanium and Iron were also detected. |

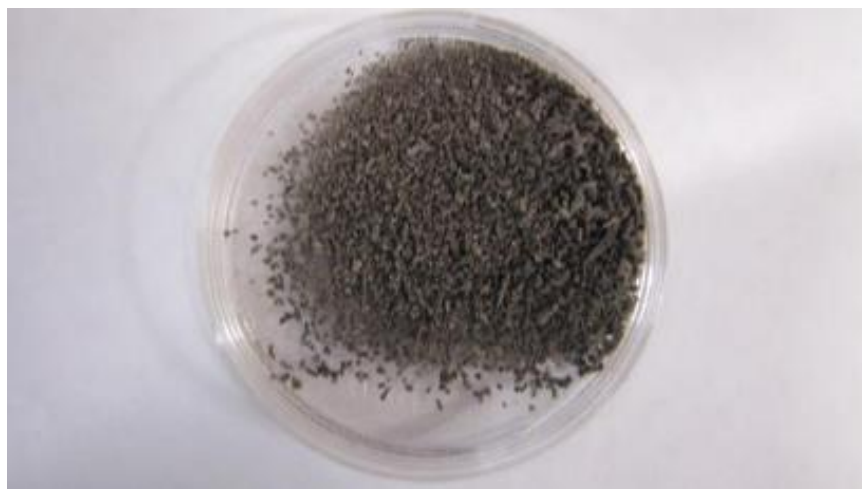
**Photo No. 59**

| Sample ID | Summary of Analysis |
|---|---|
| Debris from combustion chamber inner liner<br><b>Sample No. 2</b> (Photo No. 59) | Idem to sample No. 1 |

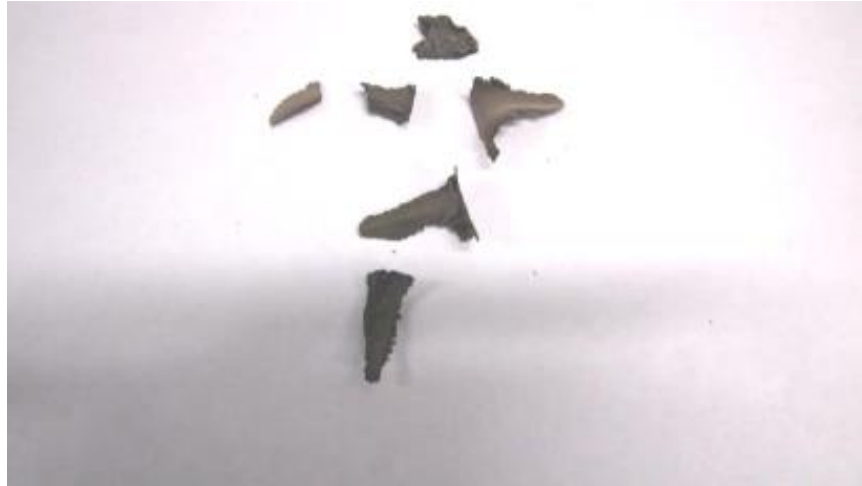
**Photo No. 60**

| Sample ID | Summary of Analysis |
|---|---|
| Debris from CT vane ring<br><b>Sample No. 3</b> (Photo No. 60) | Idem to sample No. 1, but traces of Magnesium were also detected. |

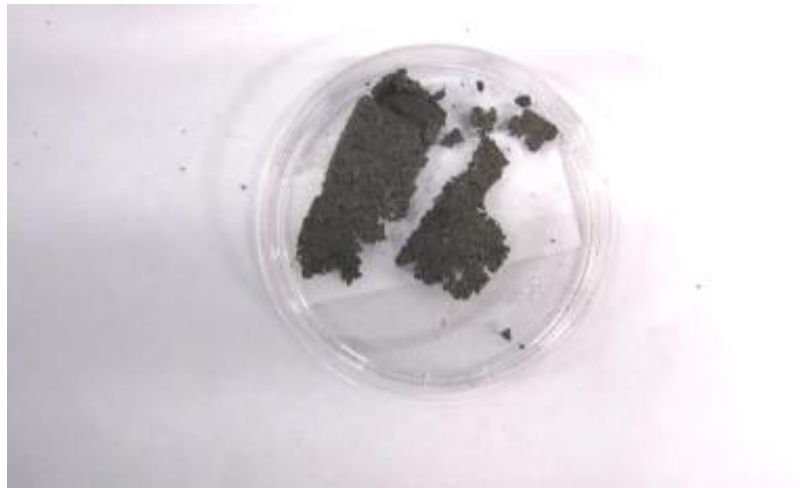
**Photo No. 61**

| Sample ID | Summary of Analysis |
|---|---|
| Debris from PT1 vane ring<br><b>Sample No. 4</b> (Photo No. 61) | The debris were mainly composed of Silicon with some Aluminum in presence of Oxygen. Traces of Sodium, Potassium, Calcium, Titanium, Chromium, Iron, Cobalt and Nickel were also detected. In some areas the Nickel is higher, suggesting traces of Nickel alloy; however the alloy identification cannot be determined. |

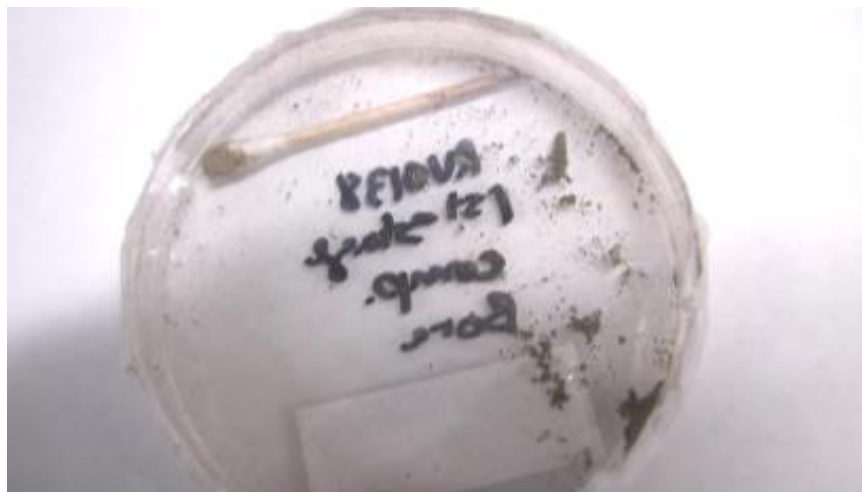
**Photo No. 62**

| Sample ID | Summary of Analysis |
|---|---|
| Residue from 1 <sup>st</sup> stage compressor bore<br><b>Sample No. 1</b> (Photo No. 62) | The debris were mainly composed of Silicon with some Aluminum in presence of Oxygen. Traces of Iron and Potassium were also detected. |

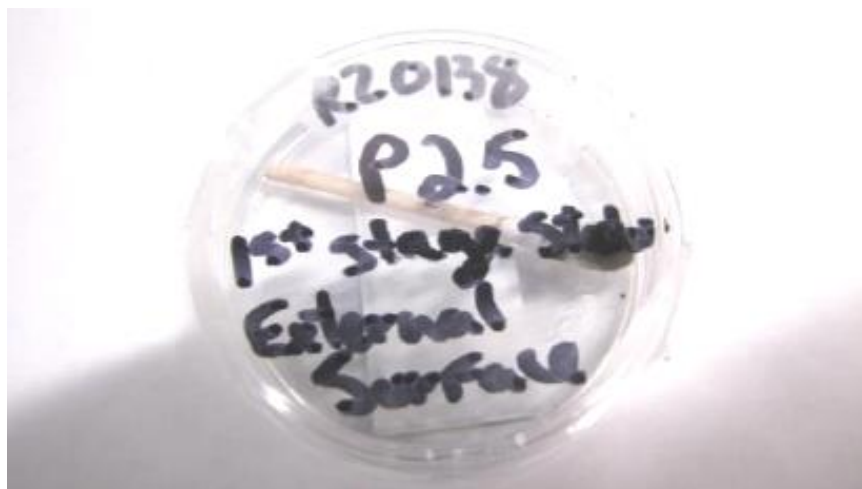
**Photo No. 63**

| Sample ID | Summary of Analysis |
|---|---|
| Residue from P2.5 1 <sup>st</sup> stage stator external surface<br><b>Sample No. 2</b> (Photo No. 63) | Similar to sample No. 1, but traces of Calcium and Titanium were also detected. |

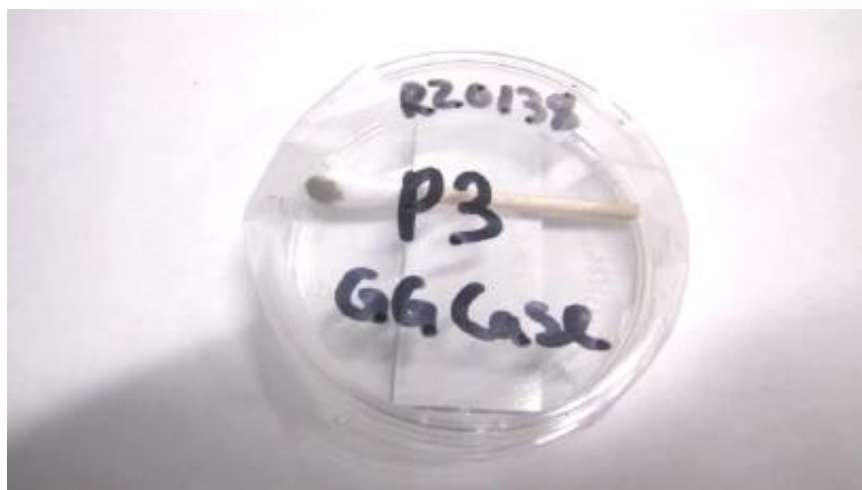
**Photo No. 64**

| Sample ID | Summary of Analysis |
|---|---|
| Residue from P3 GG case<br><b>Sample No. 3</b> (Photo No. 64) | Similar to sample No. 1, but traces of Sodium and Calcium were also detected. |

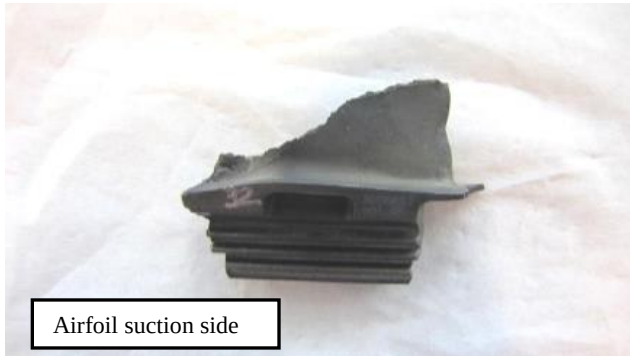
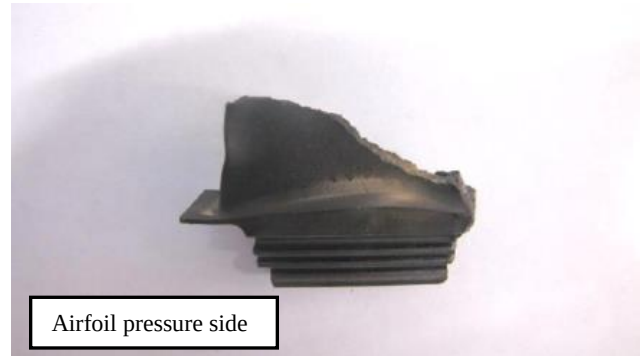
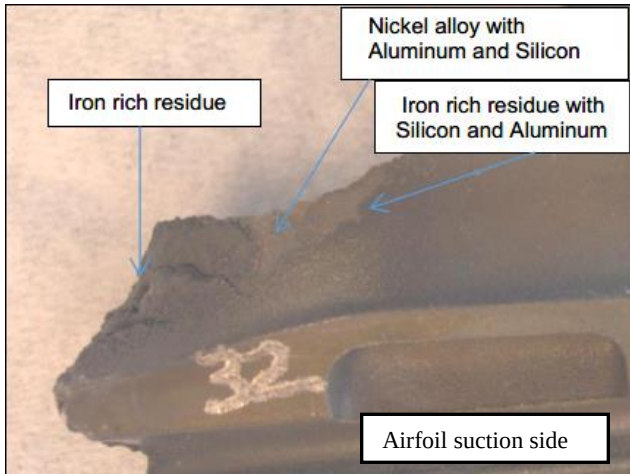
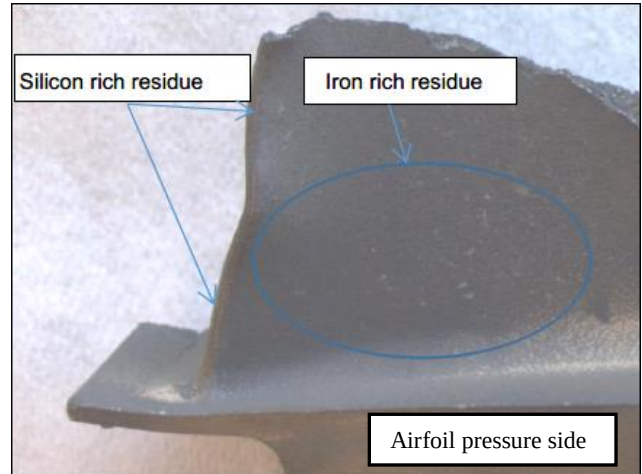
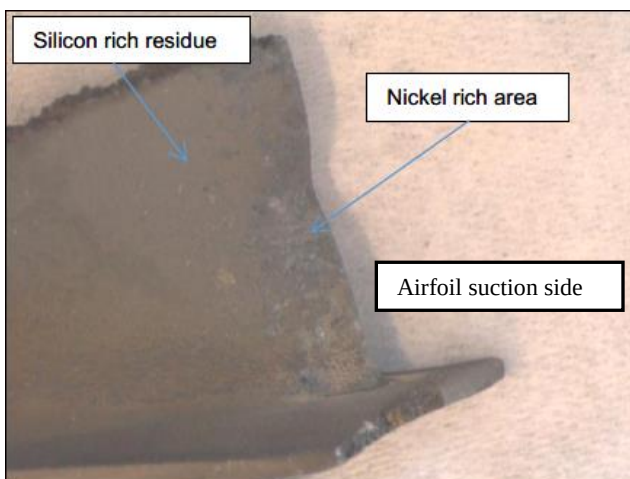
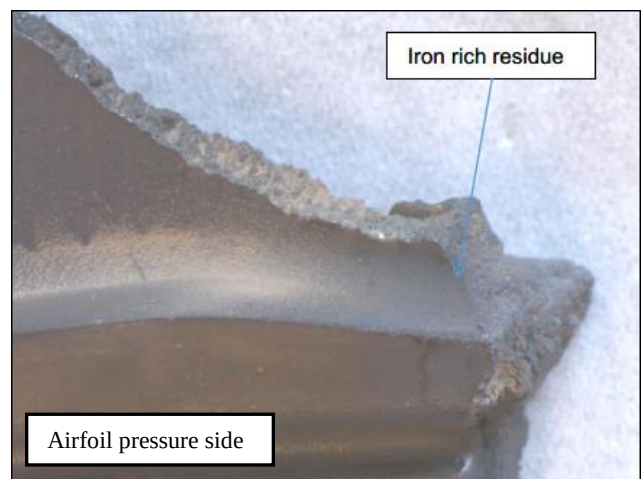
| Sample ID | Summary of Analysis |
|---|---|
| Blade No. 32<br>(Photo No. 67 to<br>Photo No. 72) | Fracture area: Nickel base alloy similar to specifications. Some areas showed significant level of Silicon.<br>On the airfoil edge and on the suction side: Presence of Silicon<br>Close to the airfoil edge and mainly on the pressure side: Presence of high level of Iron with presence of Oxygen, Chromium and Nickel with traces of Silicon and Aluminum |

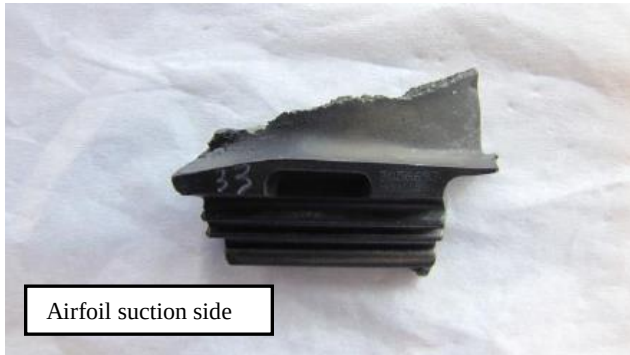
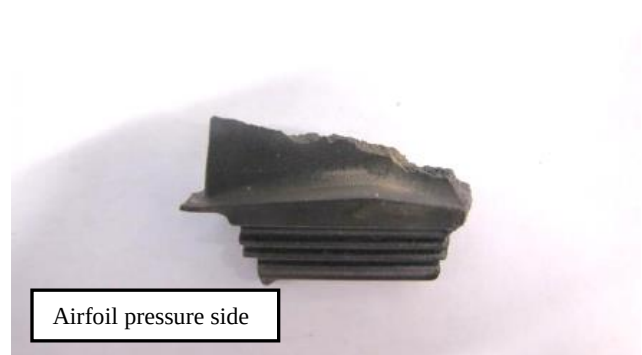
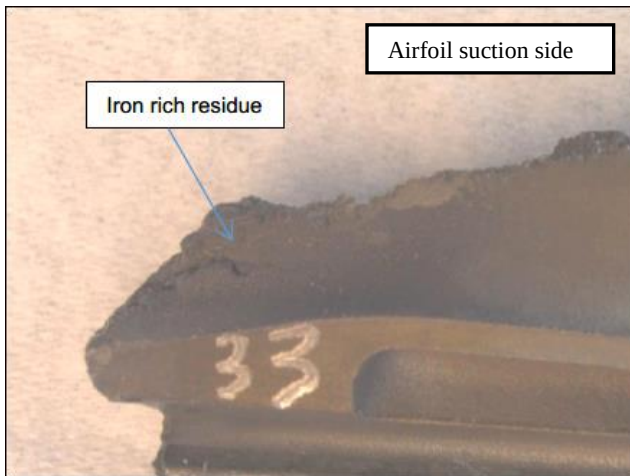
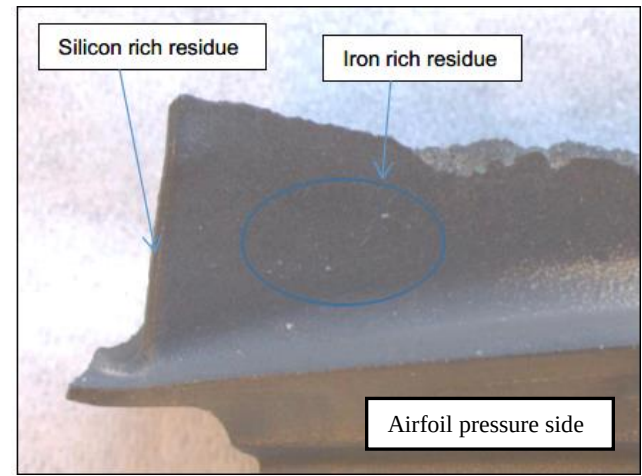
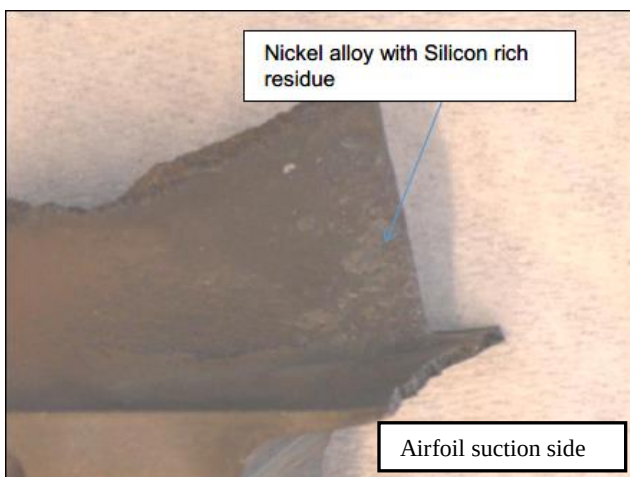
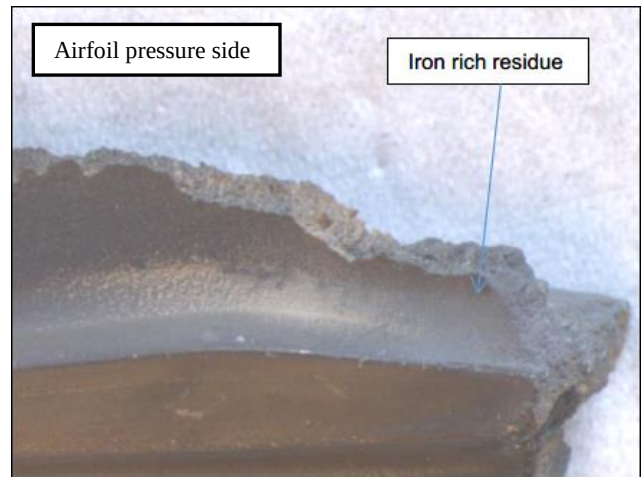
| Sample ID | Summary of Analysis |
|---|---|
| Blade No. 33<br>(Photo No. 73 to<br>Photo No. 78) | Fracture area: Nickel base alloy similar to specifications. Some areas with significant level of Silicon.<br>On the airfoil edge and on the suction side: Presence of Silicon<br>Close to the airfoil edge and mainly on the pressure side: Presence of high level of Iron with presence of Oxygen, Chromium and Nickel with traces of Silicon and Aluminum |

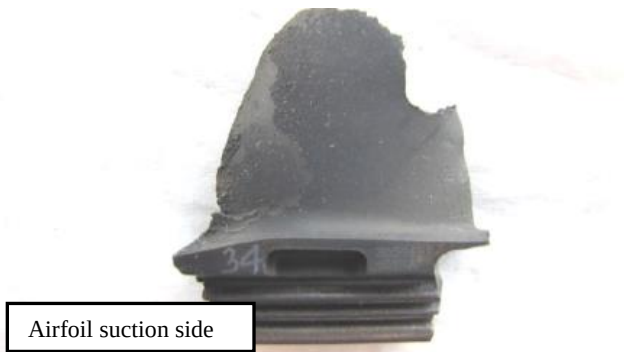
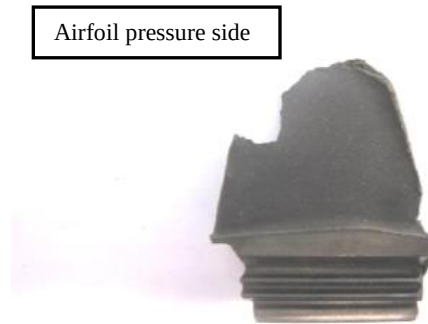
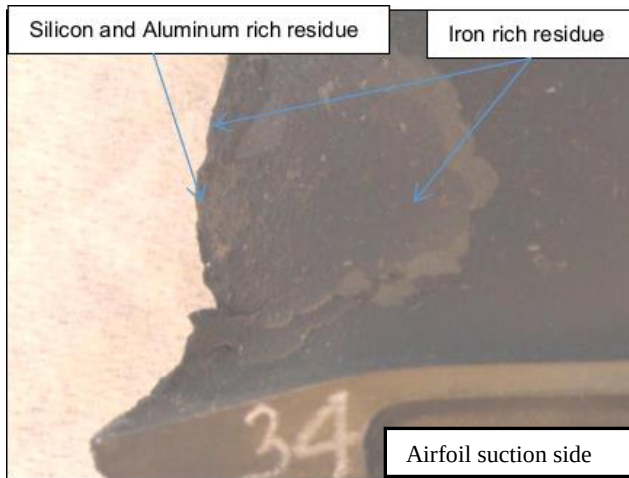
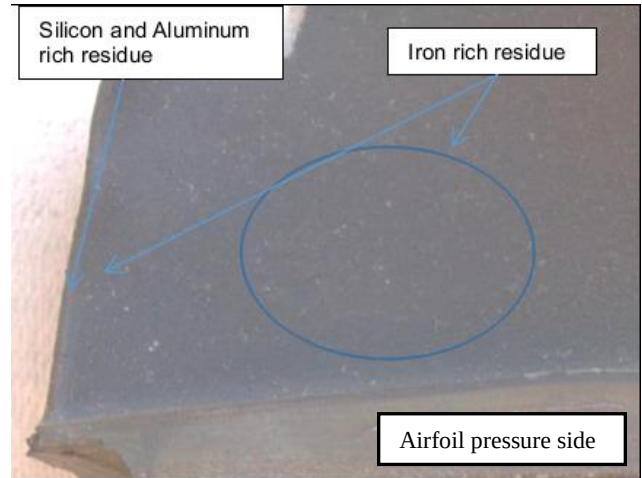
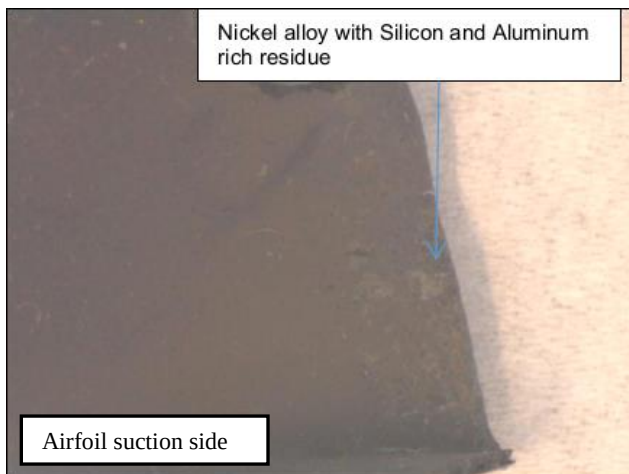
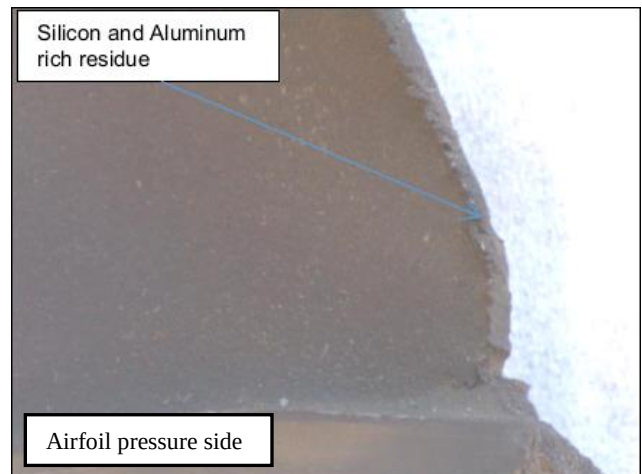
| Sample ID | Summary of Analysis |
|---|---|
| Blade No. 34<br>Photo No. 79 to<br>Photo No. 84) | Fracture area: Nickel base alloy similar to specifications. Some areas showed significant level of Silicon. At the shortest end of the fracture, high level of Iron was detected.<br>On the airfoil edge and close to the leading edge on suction side: Presence of Silicon, sometime with Aluminum and/or Iron<br>Close to the airfoil edge on pressure side and on both sides: Presence of high level of Iron with presence of Oxygen, Chromium and Nickel with traces of Silicon and Aluminum |

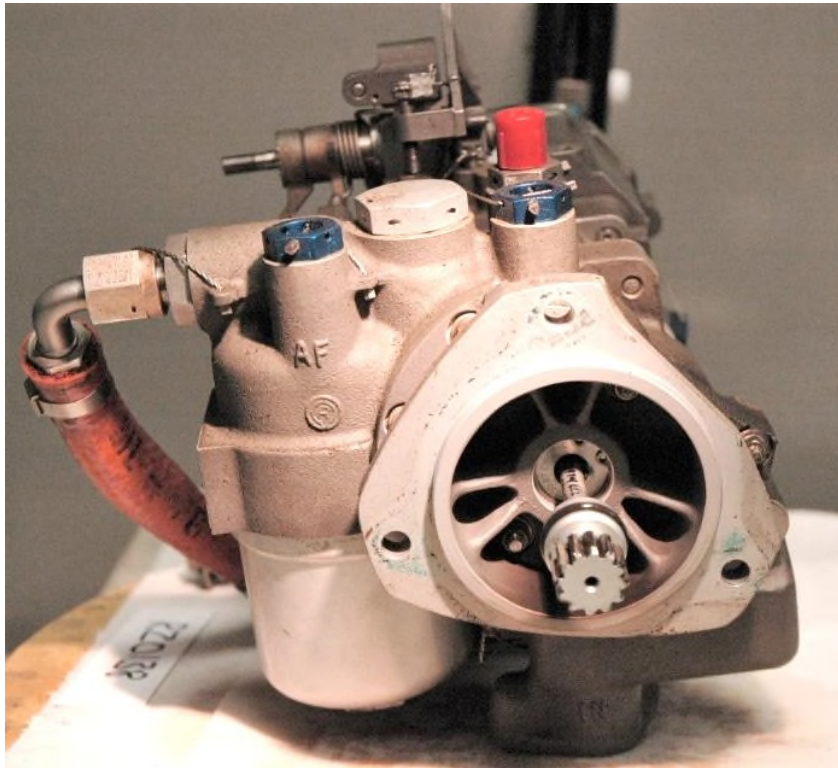
The fuel pump was removed from the engine attached to the fuel control unit. The exterior of the fuel pump was soiled. The driveshaft could not be turned by hand (this is normal for this pump configuration). Lockwire was present at all locations.

Prior to testing the fuel pump the outlet filter and inlet screen were removed for inspection and a small amount of fuel residue was collected. There was no significant debris in the outlet filter or inlet screen and no evidence of water or solid contamination in the fuel residue. A slave outlet filter was installed and the fuel pump was tested in accordance with [REDACTED]. The test was satisfactory.

Figure 1  
Fuel pump and fuel control unit as received

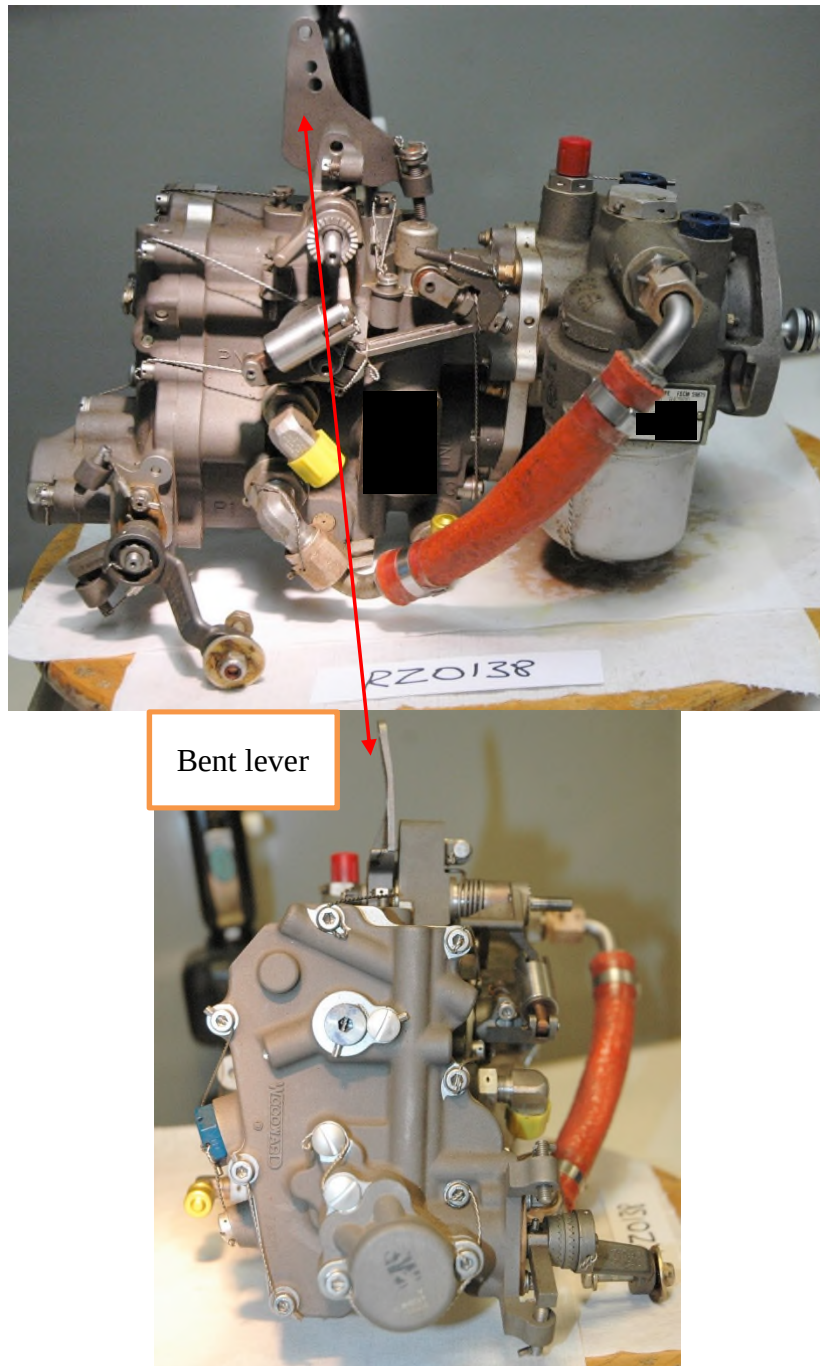
The FCU was removed from the engine attached to the fuel pump. The exterior of the FCU was soiled. The condition lever, power lever and manual override lever moved freely over their full ranges. The condition lever was bent and the gap between the lever and the housing was greater than would normally be present (arrow, Figure 3). There was un-broken orange anti-tamper paint in the socket of the condition lever shut-down stop screw. There was unbroken orange anti-tamper paint in the socket of the base screws, and on the bellows locknut. Lockwire was present at all locations. The lockwire seals were marked [REDACTED].

Figure 3  
FCU and pump as received

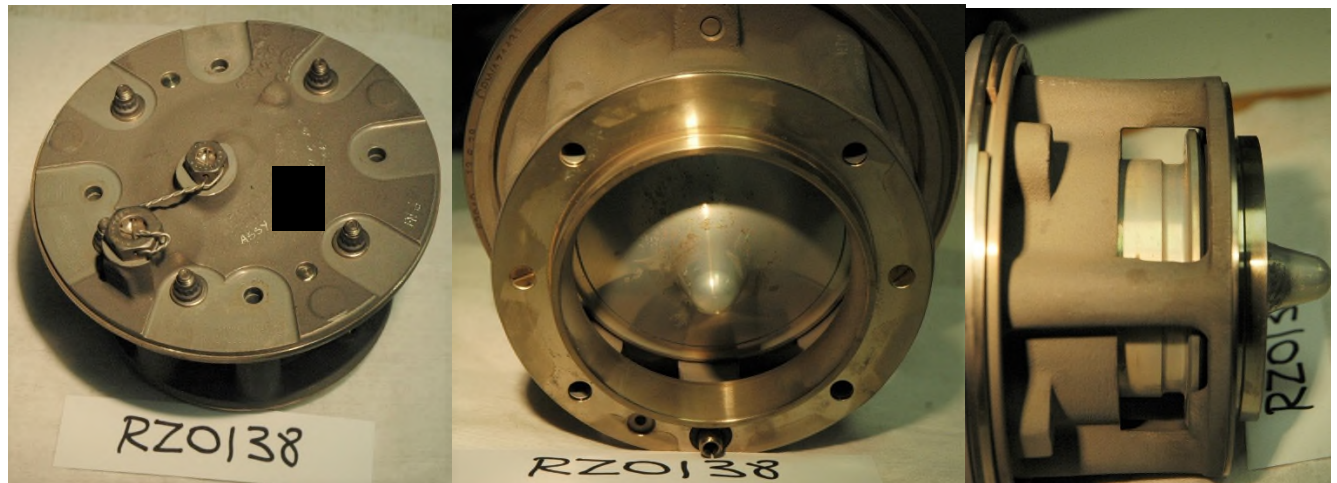
The exterior of the BOV was lightly soiled. The piston moved freely and there was a light ring of ash around the sides of the piston and slightly heavier ash deposits on the bottom of the piston. A packing was present on the seat at the guide-pin. Lockwire was present between the primary and secondary orifice plugs.

Figure 4  
BOV as received

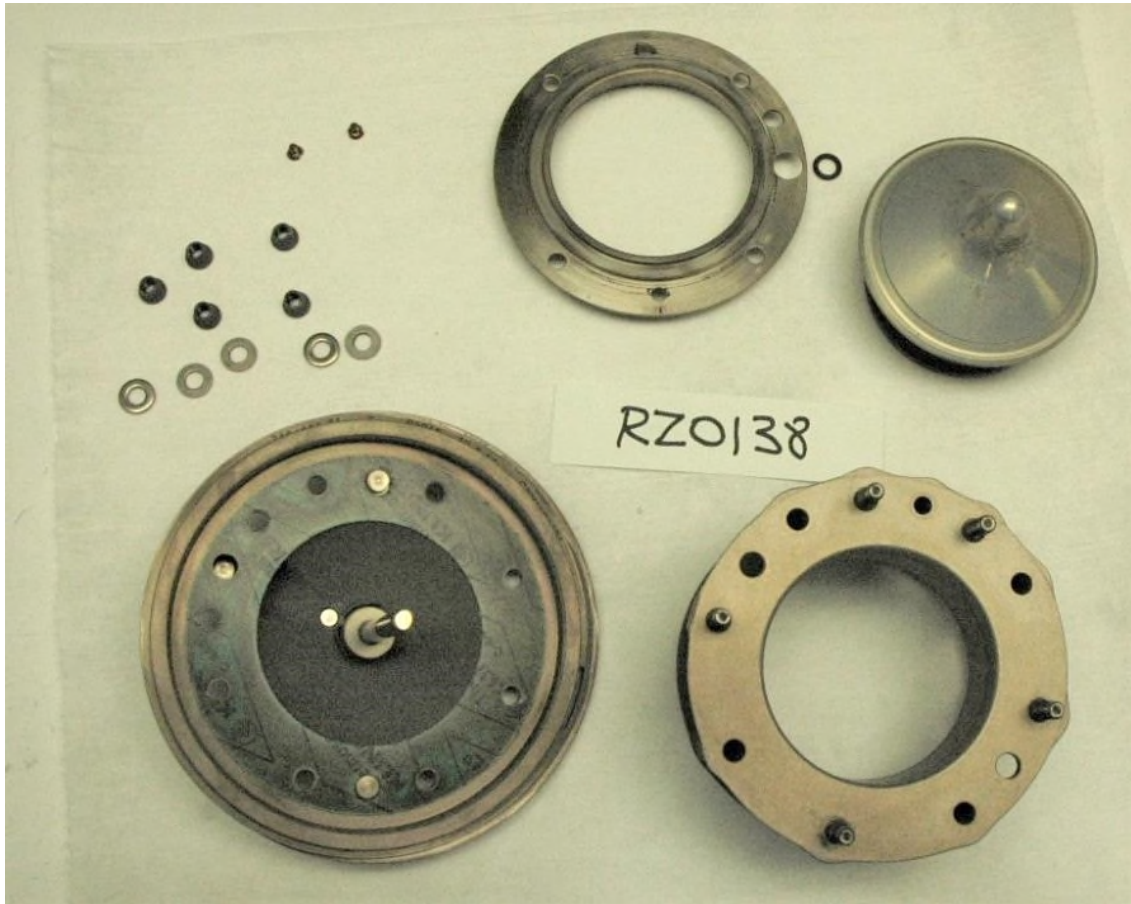
The BOV was disassembled to inspect the components. The sealing rings were present and intact. There was no significant wear or damage observed on the piston, housing, screws or seat. The gasket was present and intact between the cover and the main housing.

Figure 5  
BOV disassembled

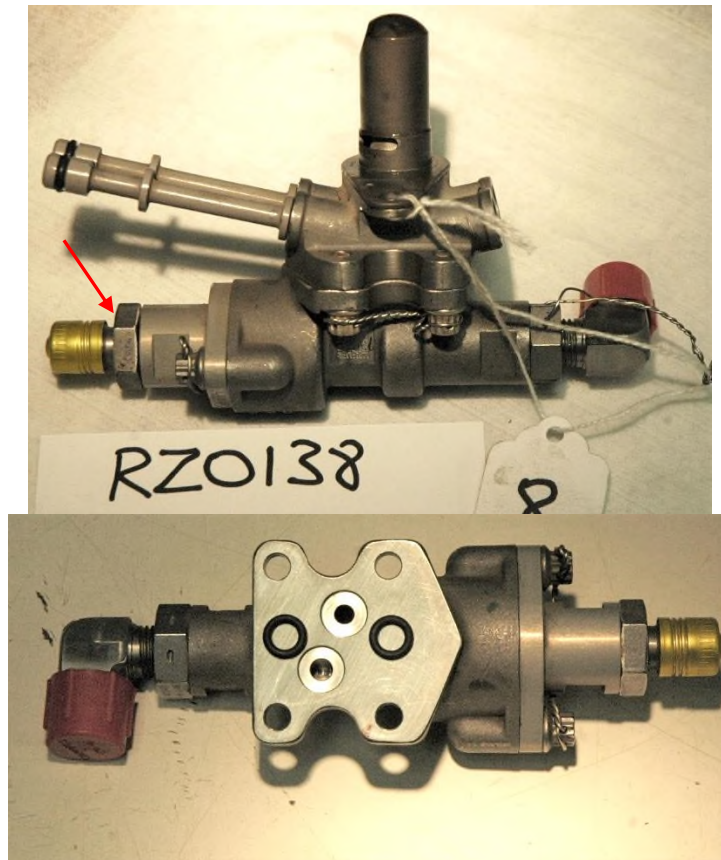
The FDV was removed from the engine attached to the No. 8 (inlet) fuel manifold adapter. The exterior of the FDV was generally clean and fuel wetting was observed. The coupling nipple at the dump port was loose and could be turned by hand (red arrow, Figure 6). Lockwire was present at the dump-port fitting screws and the inlet adapter screws. Following separation of the FDV from the inlet manifold adapter no significant scratches or leak-paths were observed on the sealing faces and the primary and secondary port passage packings were present and intact.

Figure 6  
FDV and inlet fuel nozzle as received and before testing

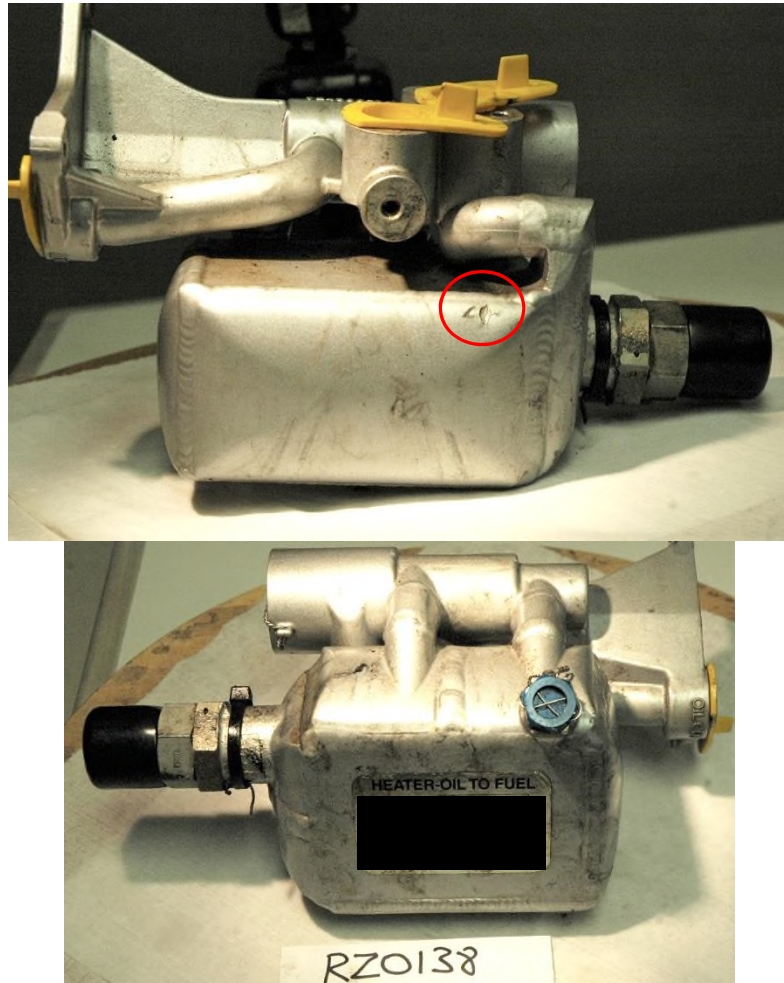
The exterior of the FOHE was soiled. The identification label was present, intact and legible. There were two impact marks on the bottom of the tank (circled, Figure 7). Lockwire was present at the thermal element cap and the core flight-plug.

Figure 7  
FOHE as received

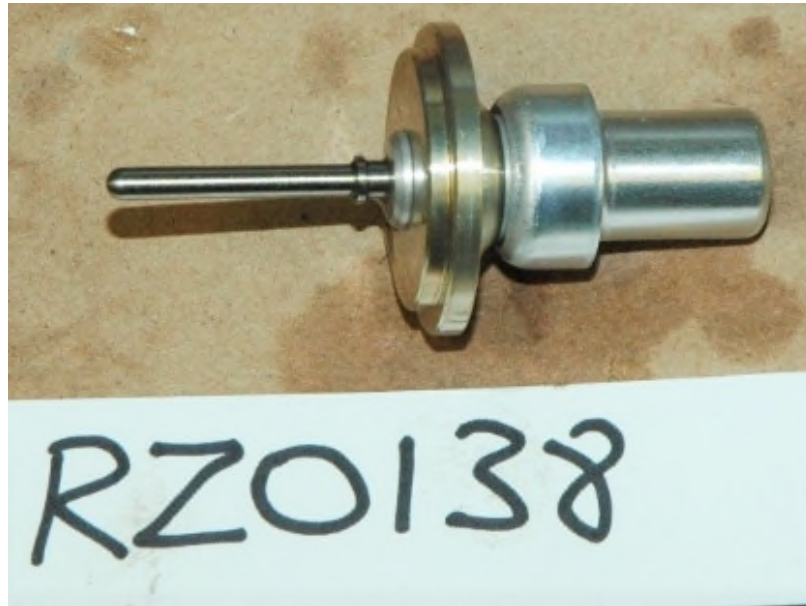
A low-pressure air supply was connected to the FOHE fuel inlet, the fuel outlet port was blanked and the unit was immersed in a water bath to check for bubbles that could indicate a breach between the oil and fuel cores. No bubbles were observed. The thermal element was removed from the unit and tested in accordance with [REDACTED]. The test was satisfactory.

Figure 8  
FOHE thermal element
