## Accident / Incident Report

**Report No.: 18-124**

**AirSpray Airtankers  
Air Tractor AT-802F, N397AS  
Stevens County, Washington, USA  
14 August 2018  
PT6A-67F, RZ0138**

**Date of Issue: 20 November 2019**

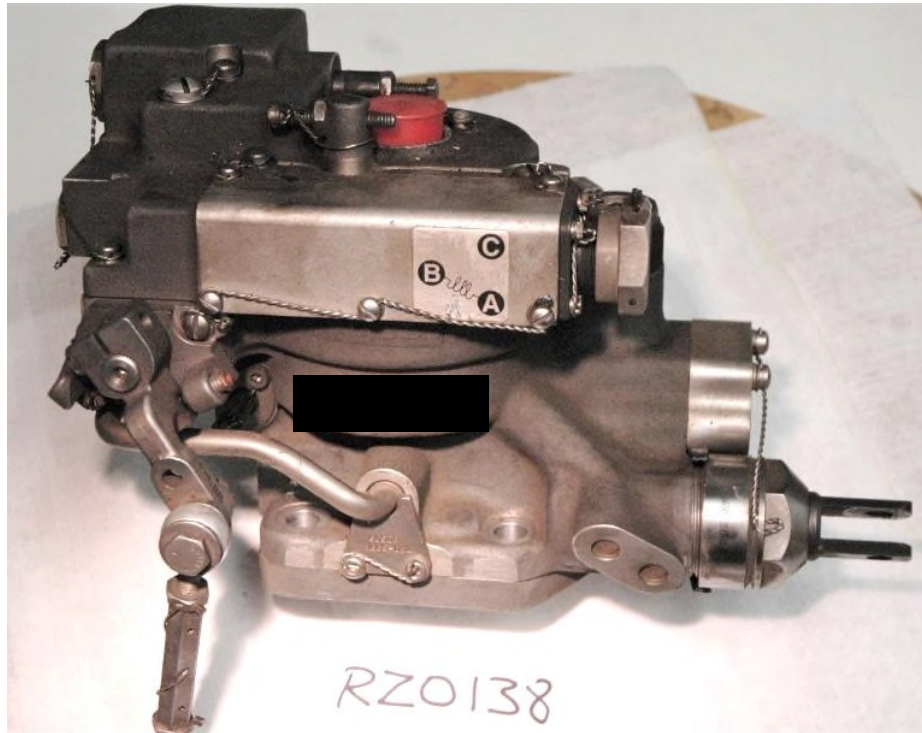
The exterior of the CSU was soiled. The speed setting lever and top of the cover were missing and a red shipping-cap had been placed in the hole. The driveshaft turned freely. The reset arm moved freely and returned under the influence of its spring. The beta-valve clevis moved freely and returned under the influence of its spring. The feathering valve plunger moved freely and returned under the influence of its spring. There was an incomplete tie-wrap around the beta-valve housing. There was no debris observed in the gasket screen. There was unbroken red anti-tamper paint on the feathering stop screw and the reset-arm stop screw. There was an impact mark on the wiring pocket cover at the wiring schematic diagram (see figure 10). Lockwire was present at all locations. The lockwire seal was marked [REDACTED].

Figure 9  
CSU as received

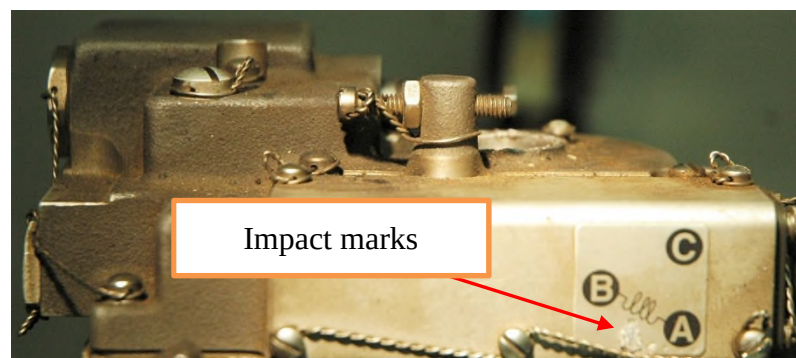
Figure 10  
CSU impact marks

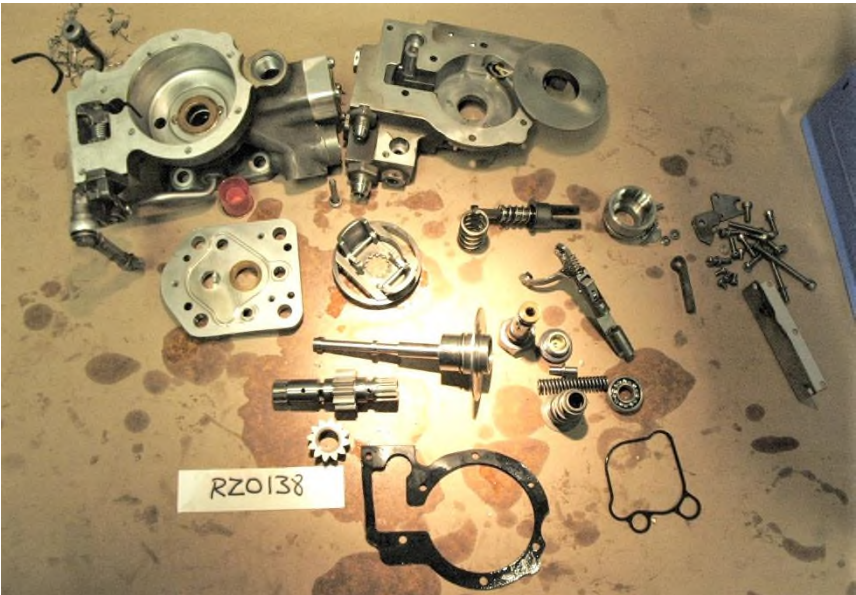
The inside of the ball-head cavity was clean and oil wetting was observed. There was no evidence of cavitation on the gears or in the pockets. The pilot valve slid freely in the gear-shaft. The packings were present on the beta-valve plunger and sleeve. The cover and bottom gaskets were present and intact. The reset rod was correctly engaged with the pilot-valve and slid freely in the bore of the housing. The packing was present and intact on the pressure relief valve housing.

Figure 11  
CSU disassembled

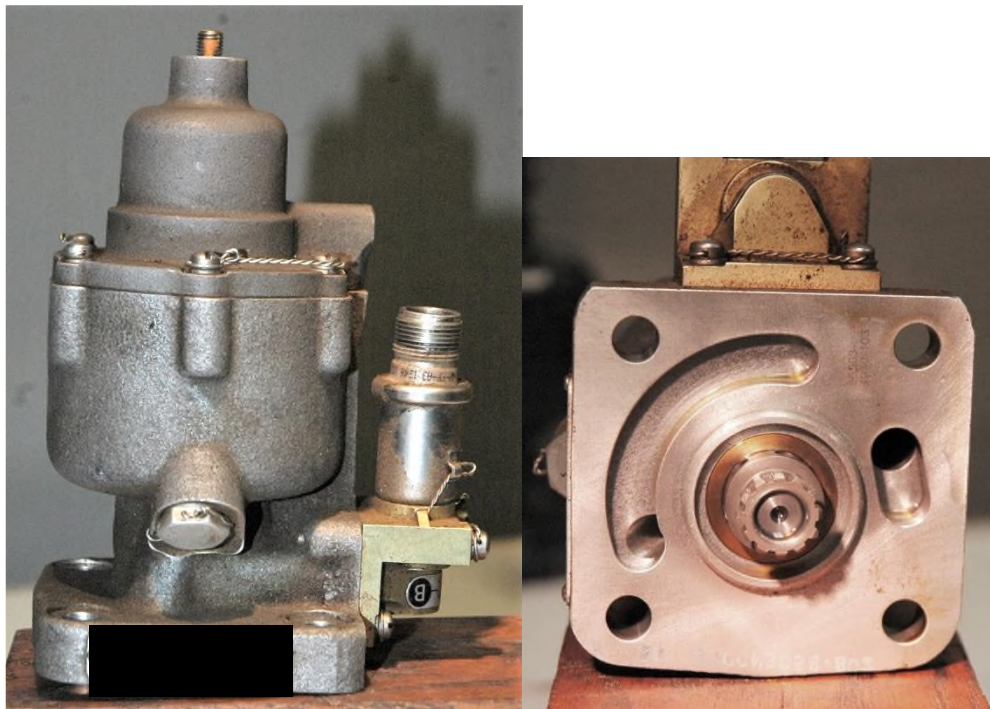
[REDACTED] Maximum speed: the speed required to achieve the target servo flow was 90RPM below the test point minimum limit.

This suggests that the OSG would react to a propeller over-speed approximately 2% earlier than the acceptance test limit.

Figure 13  
OSG as received
