# **HELICOPTER EXAMINATION REPORT**

**WPR18LA252**

**Santa Ana, California**

**Guimbal Cabri G2; N401SH**

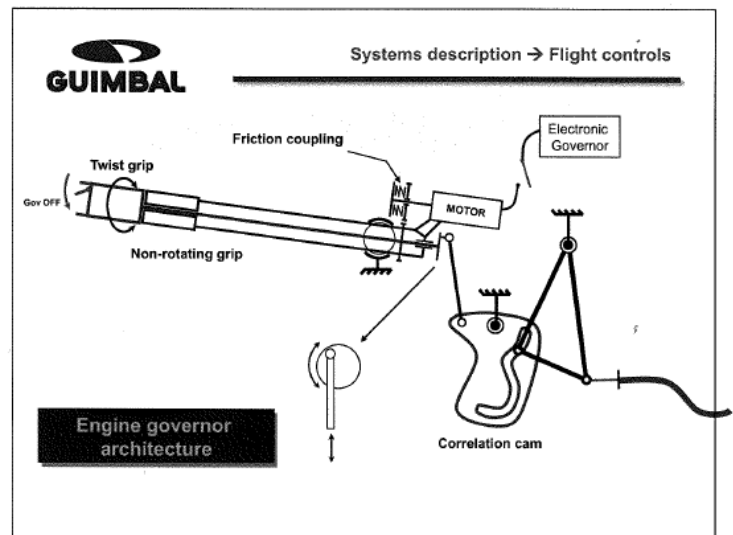
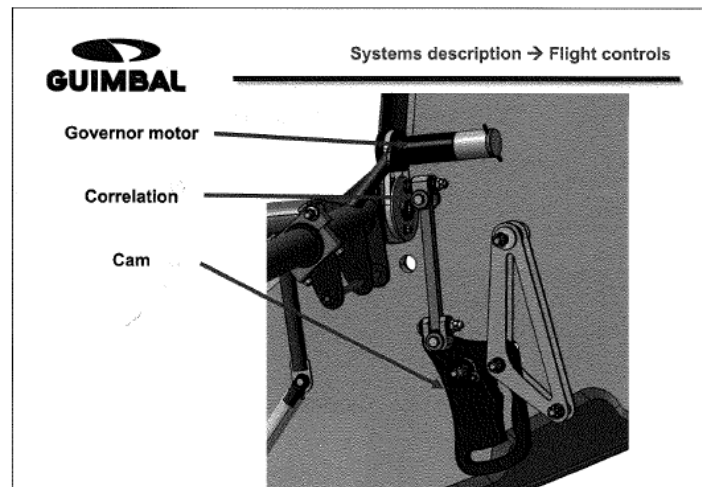
Photograph 4: Governor Assembly System Description Excerpt

According to the rotorcraft flight manual (RFM), an electric engine governor is used to control engine speed. When engaged, which occurs above 2,000 rpm (or 400 rpm NR) and disengages below these values, the governor rotates the twist grip throttle control. Additionally, the governor can be disengaged using the GOV switch located on the tip of the collective control arm, or by forcing the twist grip as a friction clutch in the governor motor enables the pilot to overtake the governor.
