**NATIONAL TRANSPORTATION SAFETY BOARD  
OFFICE OF AVIATION SAFETY**

OPERATIONS FACTUAL REPORT  
WPR18MA087

Operator: Papillon Airways, Inc.  
Location: Peach Springs, Arizona  
Date: February 10, 2018  
Time: 1719 mountain standard time  
Aircraft: Airbus Helicopters EC130 B4

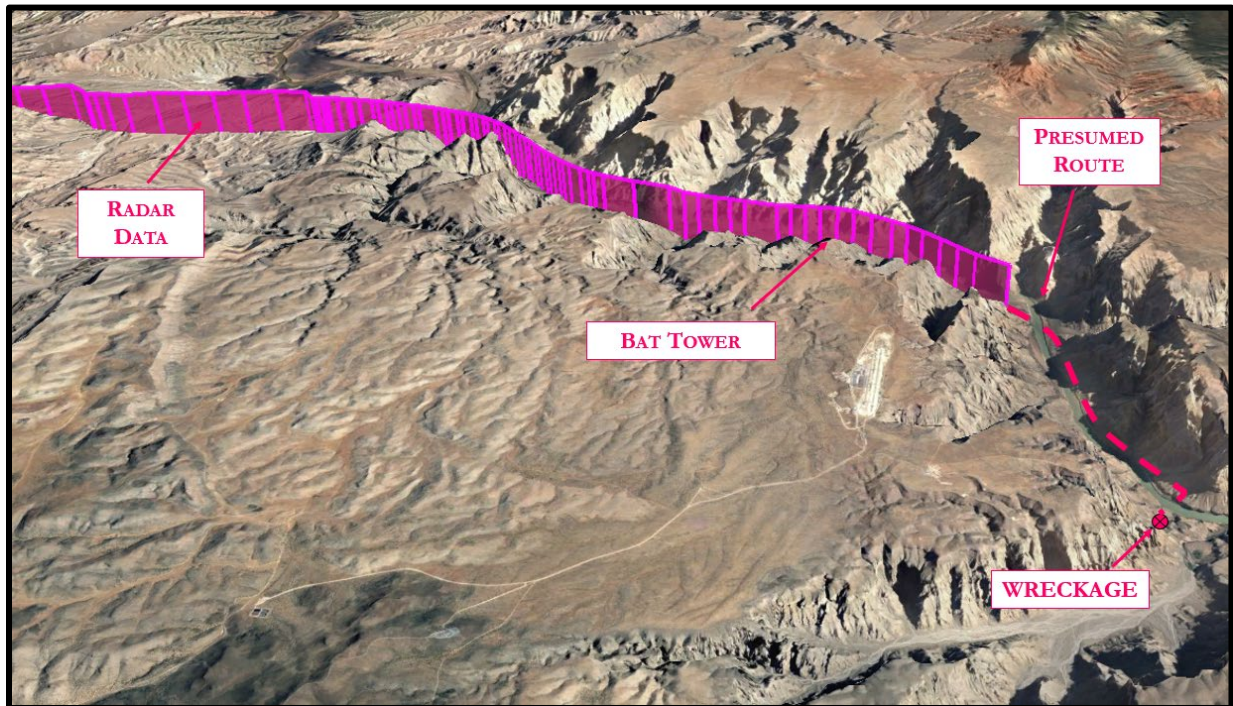
*Figure 03: Radar Data in Reference to Accident Location*

radar data consisted of approximately equidistant radar returns from 1546 to 1617, totaling about 31 minutes. The data was consistent with the helicopter departing to the south and then continuing northeast passing near the Hoover Dam about 1552:30. The helicopter continued to the south of Fortification Hill, located on the south shore of Lake Mead.<sup>14</sup> The helicopter adjoined the Grand Canyon about 1613:30 and followed the valley until the last radar hit at 1617. This track was consistent with the location the helicopter would normally descend below the surrounding canyon walls.

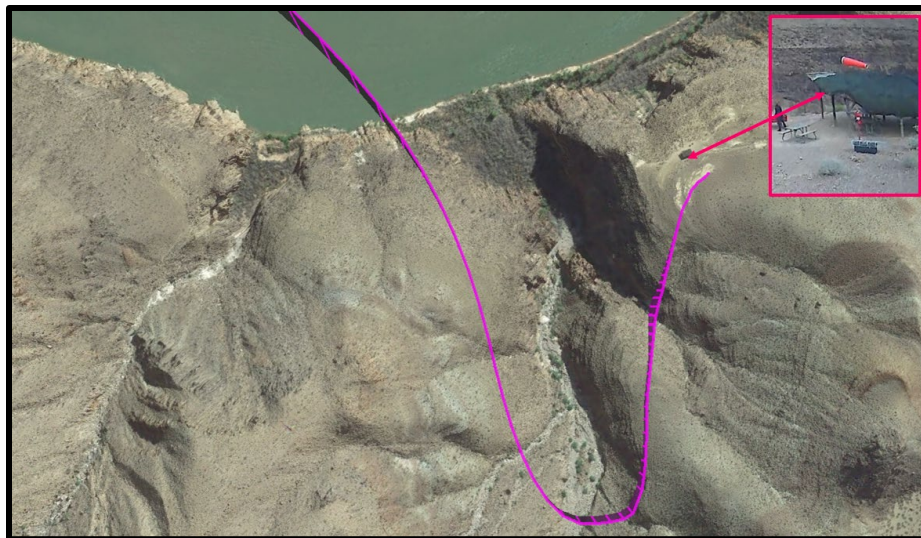
*Figure 11: Track of Helicopter 23 Landing Showing Windssock Just Prior to Touchdown*

Helicopter 23 was equipped with a video camera and global positioning system (gps) that additionally recorded speed and elevation at 1-second intervals. The pilot stated that as he approached Quartermaster, he noticed that he had a tailwind and decided to land on a west pad because the east pads were taken, and he did not want to create a collision hazard.

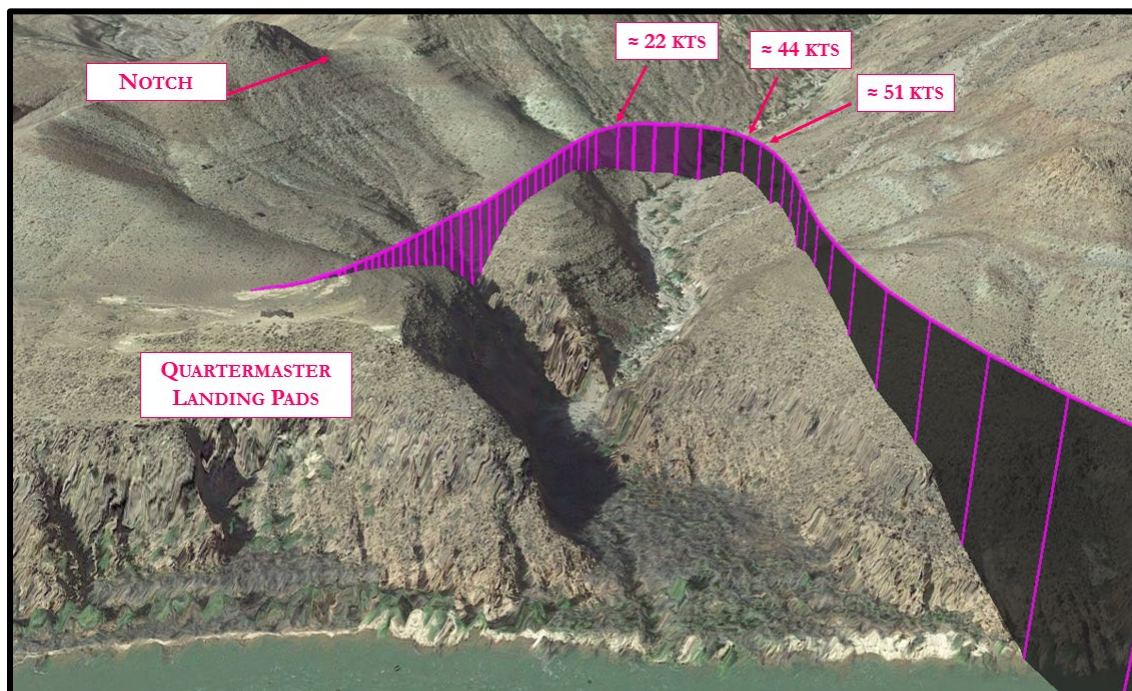
*Figure 12: Track of Helicopter 23 Landing on the Pads*

The helicopter entered into the canyon and while he was turning toward the landing zone, the helicopter's heading shifted rapidly. The tail swung around rapidly, feeling like a strong wind was pushing on the tail akin to a wind vane. With the major shift, he was immediately concerned with the helicopter's rate of descent and noted that the airspeed indicator showed 45 to 50 kts with a descent rate of about 400 feet per minute.

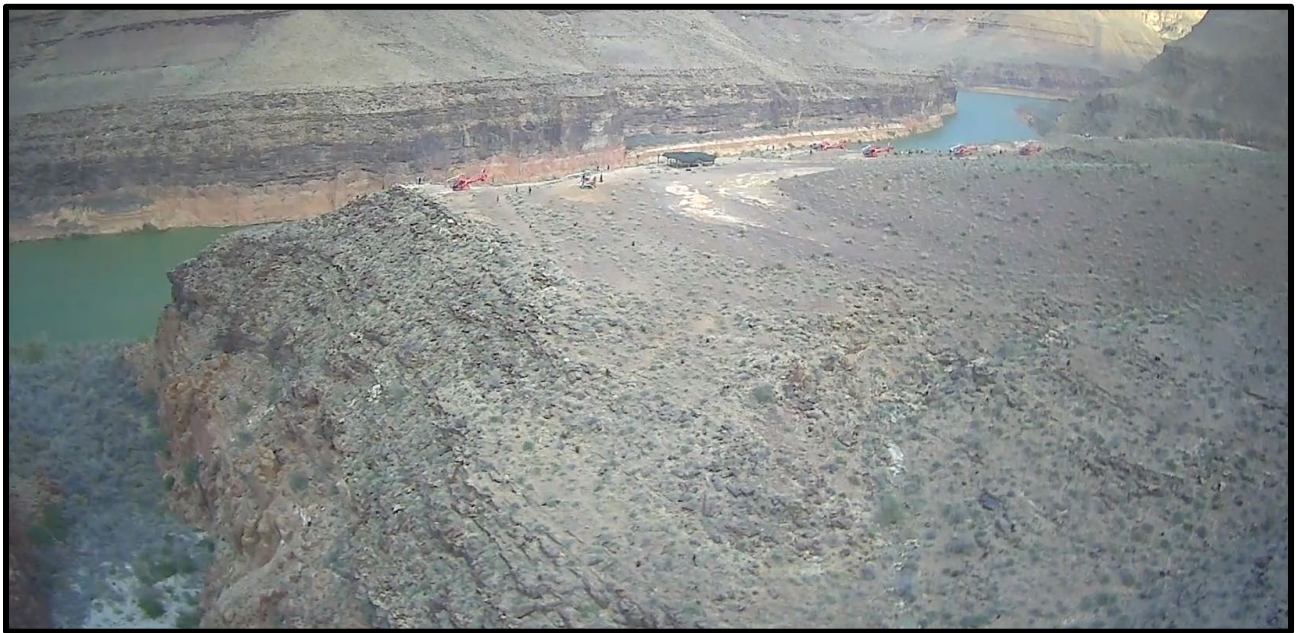
*Figure 14: Forward View from Helicopter 23 Re-Established On the Approach*

As the helicopter continued descending toward the pads, the pilot applied a heavy application of right pedal in an attempt to keep the helicopter from turning. While on final approach, the helicopter was crabbed until reaching about 15-20 feet agl.

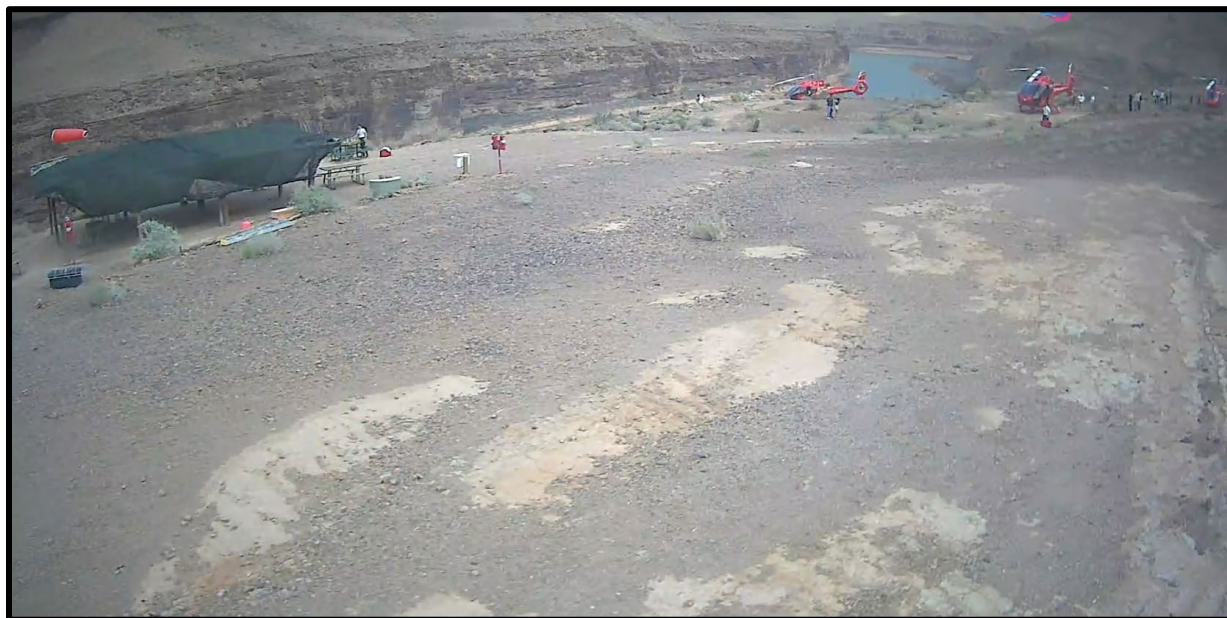
*Figure 15: Forward View from Helicopter 23 Just Prior to Touching Down*

When the helicopter entered into ground-effect, the pilot was able to perform a pedal turn and touchdown on a landing pad. He further stated that there were some gusty conditions on the ground and the windsock was bouncing back and forth a little bit, which created a tailwind component.

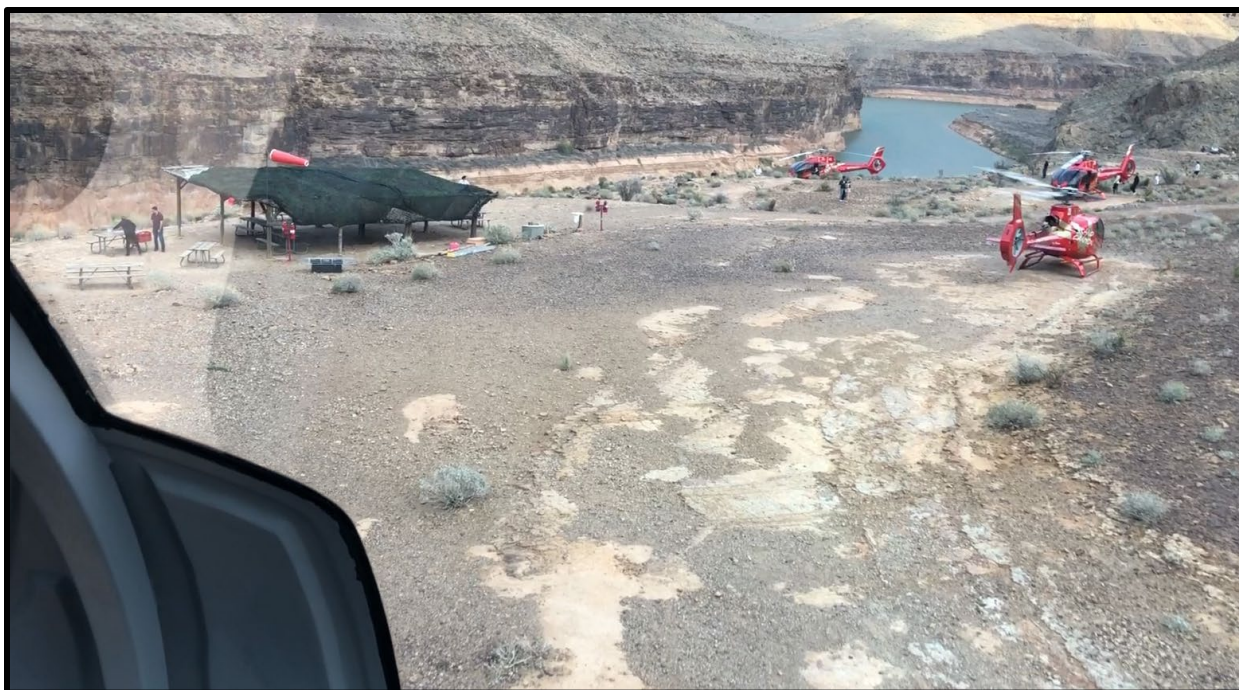
*Figure 16: Passenger View from Helicopter 53 Just Prior to Touching Down*

The eighth landing occurred about two minutes before the accident. The pilot stated that he has experience flying in mountainous terrain. As he approached Quartermaster, he knew it was windy (between 15-20 kts from the east) and was anticipating wind shear on the approach into the canyon. He crossed over the river and entered into the canyon. As soon as he made his left turn toward the landing zone, he felt a strong wind hit the helicopter and swing the nose to the left about 90°. He stated that it took all his efforts to control the helicopter and the airspeed rapidly dissipated. The helicopter began to descend, and he had to pull up on the collective adding full power to arrest the descent. He was able maintain control by pushing the cyclic forward and right to increase airspeed, while applying full right pedal to keep the nose straight. As the helicopter continued to descend, the helicopter entered into ground effect and he performed a pedal turn to face east.

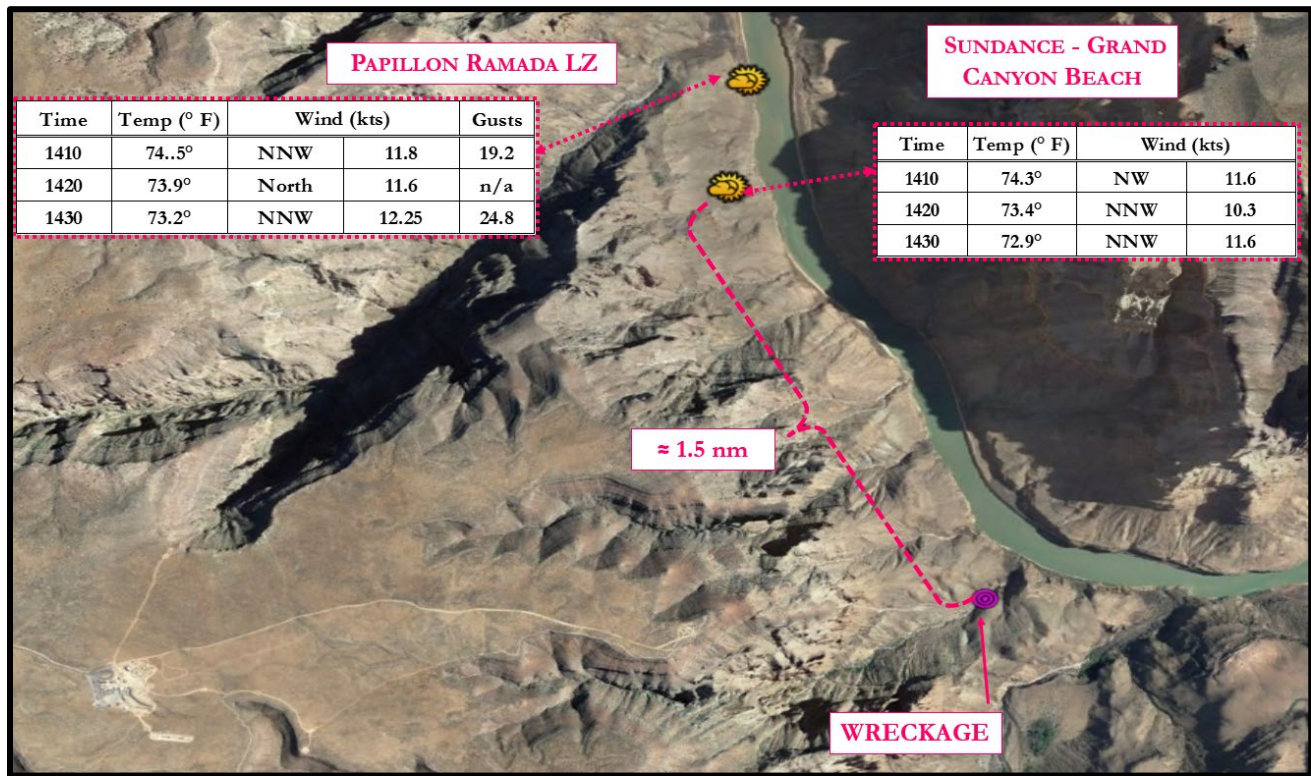
Figure 27: Windsocks and Weather at the Papillon Ramada and Sundance

referencing the windsock located at Sundance Helicopters' Grand Canyon Beach<sup>48</sup> and then monitoring the windsock at Quartermaster. He commented that when arriving at Quartermaster it was easiest to discern the wind direction based on the directions of the parked helicopters<sup>49</sup>.

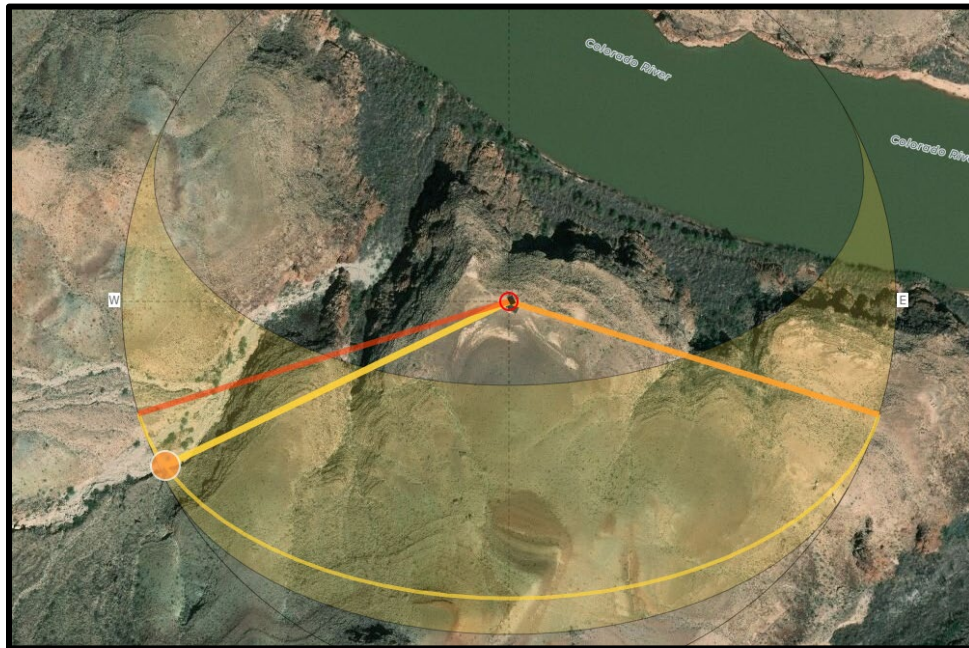
Figure 28: Position of Sun

According to the U.S. Naval Observatory, Department of Astronomical Applications, the phase of the moon was waning crescent with 22% of the moons visible disk illuminated. Sunset was at 1711 and dusk was at 1738. At the time of the accident the sun was about 9.9° above the horizon on an azimuth (heading) of 244°.

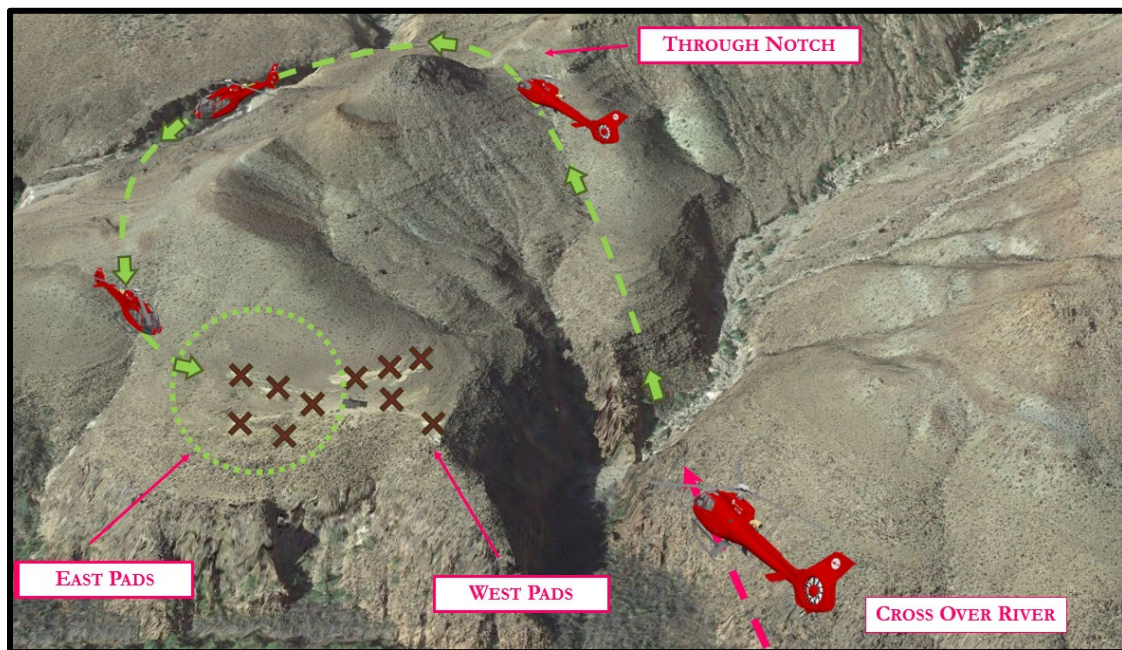
Figure 32: Approach Used to East Pads

When landing on the east pads, the pilots maneuver the helicopter south over the river and continue over a saddle-shape in the terrain, referred to as “the notch.” After passing over the notch, the pilot makes a descending left turn and touches down facing to the west-northwest.

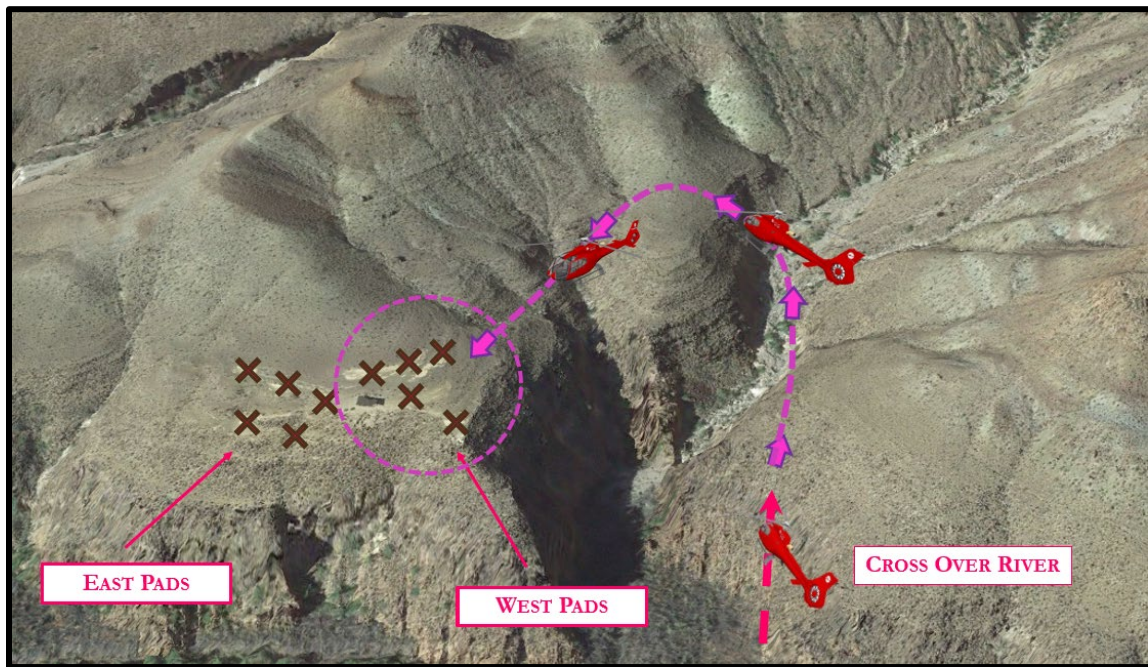
*Figure 33: Approach Used to West Pads*

The alternate approach, commonly used when landing on the west pads, entails the helicopter crossing over the river and entering into a 3,800-foot long box canyon; the distance back the pilot maneuvers into the canyon is determined by their assessment of the wind.
