# Continental Motors

## ENGINE EXAMINATION REPORT

| ENGINE MODEL | IO-520-BA |
| FILE NUMBER | 18-216 |

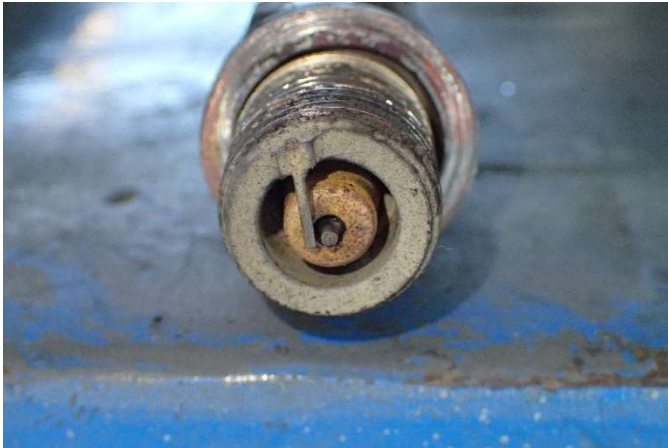
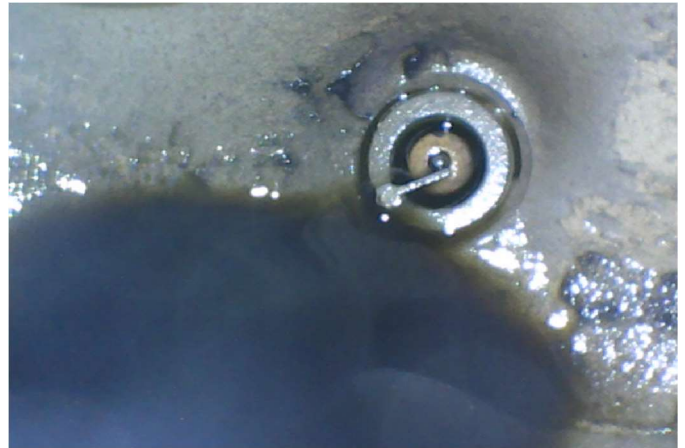
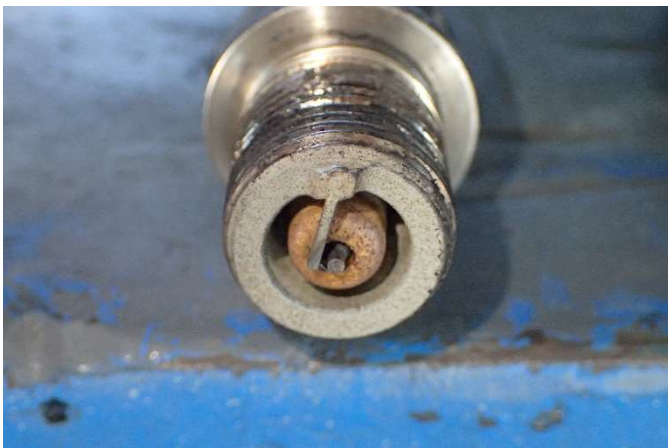
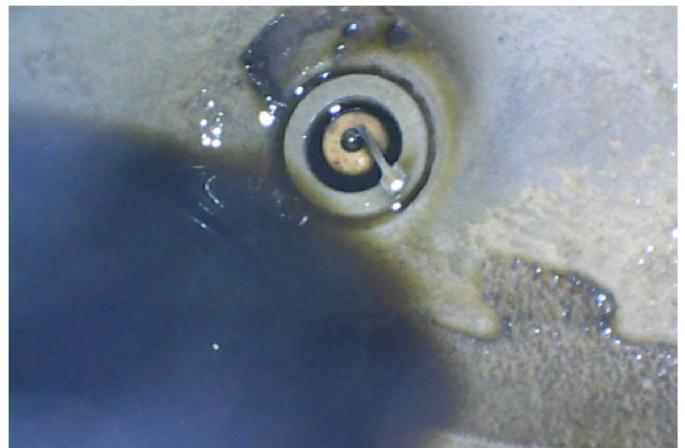
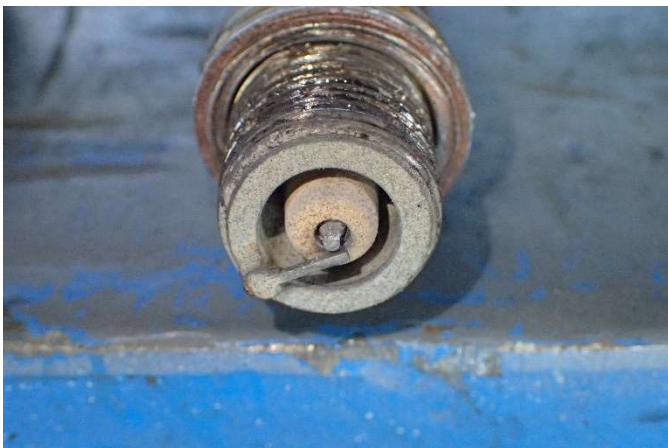
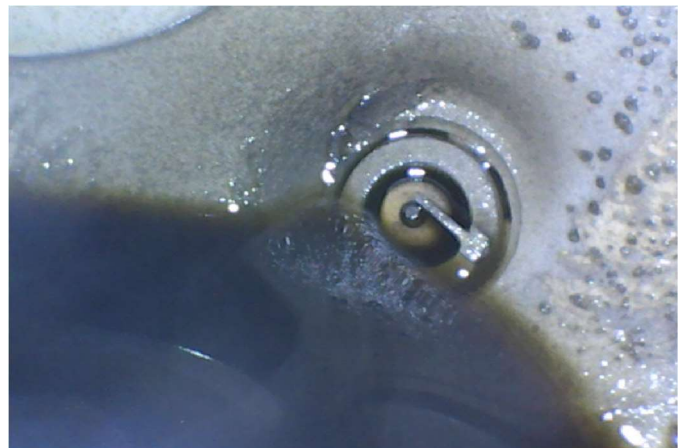
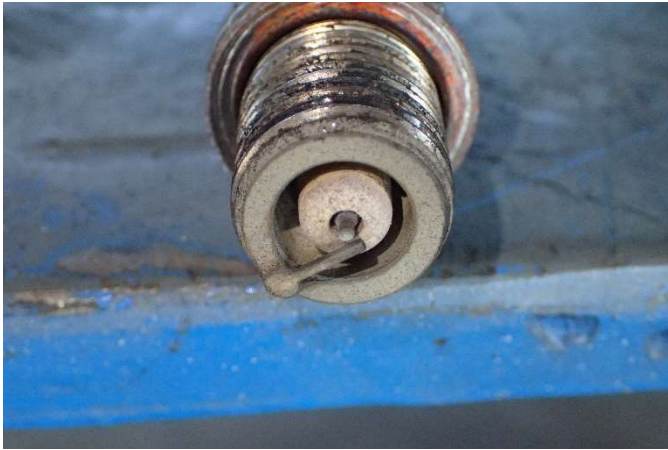
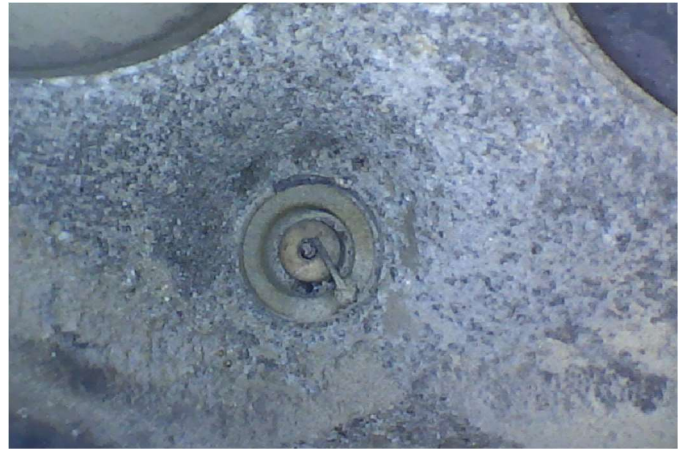
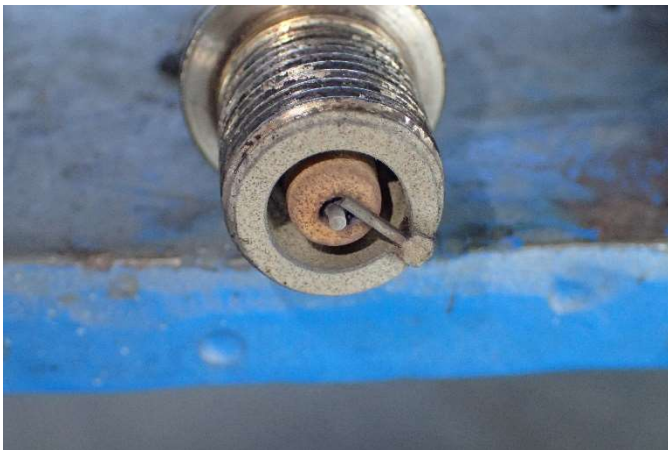
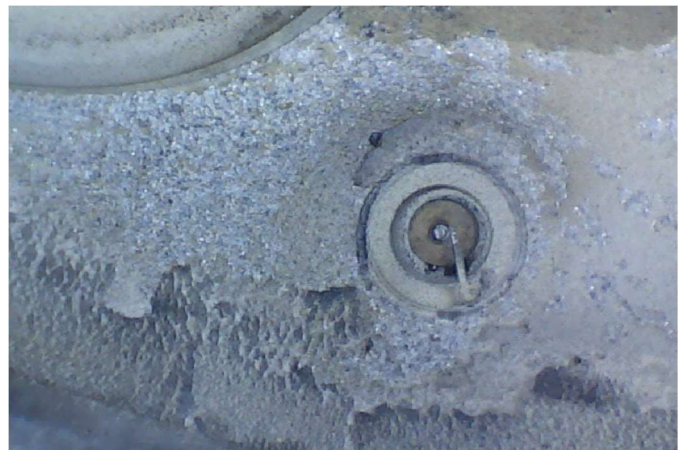
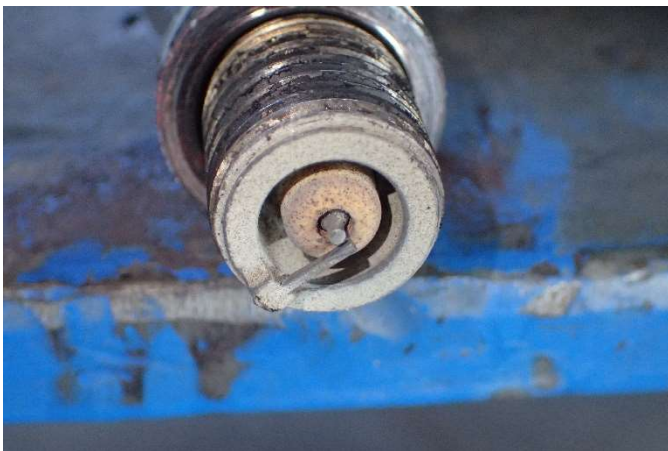
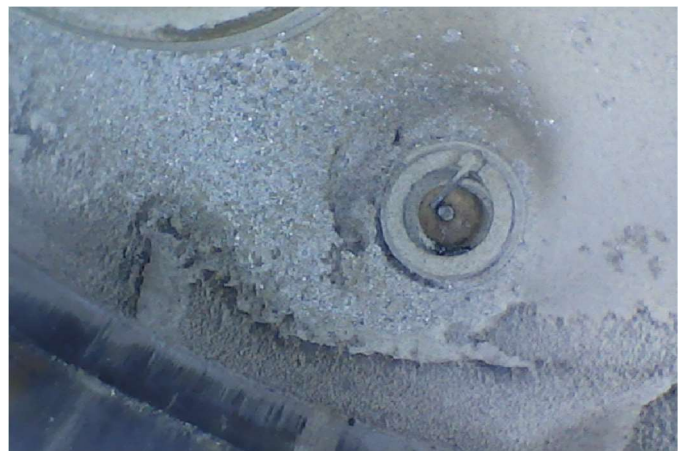
The spark plugs remained installed in their cylinders and displayed varying amounts of thermal damage signatures. The top spark plugs were removed, and the electrodes were visually inspected; the electrodes displayed normal operating and wear signatures. The bottom spark plugs were inspected using a lighted borescope; the electrodes displayed normal operating and wear signatures. There were no anomalies noted.

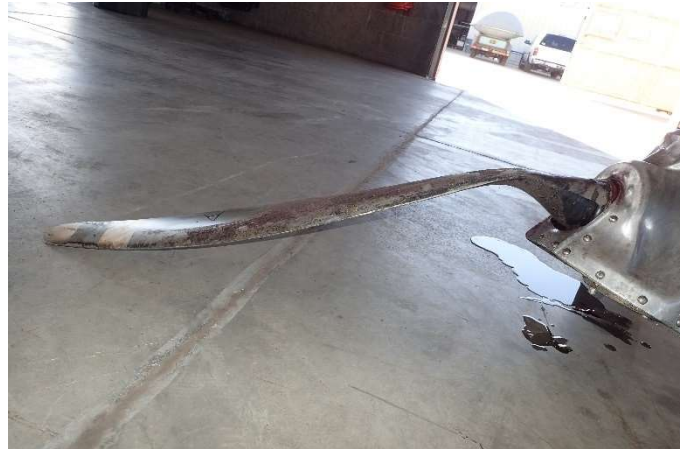
Blade "A"

| PROPELLER | Manufacturer: McCauley | P/N: 3A32 C76-QR | S/N: 890563 |
|---|---|---|---|
| Condition: | The three blade, constant speed propeller had pulled free from the propeller flange and displayed impact damage signatures. The propeller blade marked "A" was loose in the hub, displayed aft bending deformation, and leading-edge polishing and minor chordwise scratches. The propeller blade marked "B" displayed aft bending at the tip of the propeller and displayed minor chordwise scratches. The propeller blade marked "C" was unremarkable. There were no anomalies noted with the propeller. | | |
