## **NATIONAL TRANSPORTATION SAFETY BOARD**

### **SITE and ON-SCENE INFORMATION (Rev B)**

**NTSB Accident: WPR19FA080  
Accident Date: February 5, 2019**

Location: Desert Hot Springs, California  
Date: February 5, 2019  
Aircraft: Cessna 172M, N20556, Serial # 1726139  
NTSB IIC: Michael Huhn

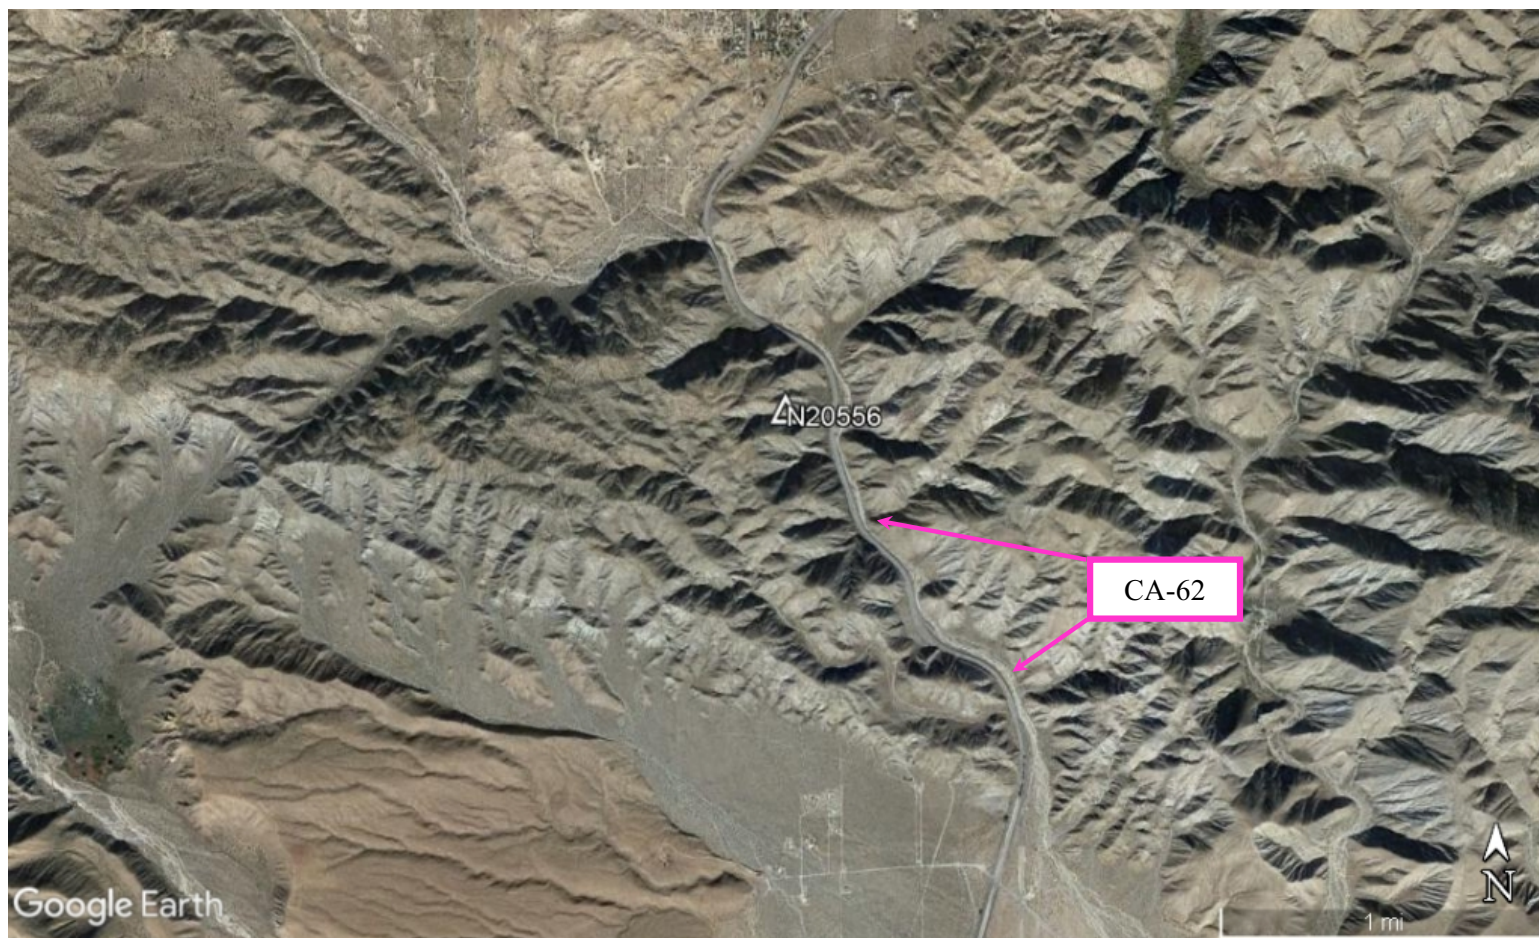
Figure 2 - Closer View of Site Location (pilot reportedly following CA-62)

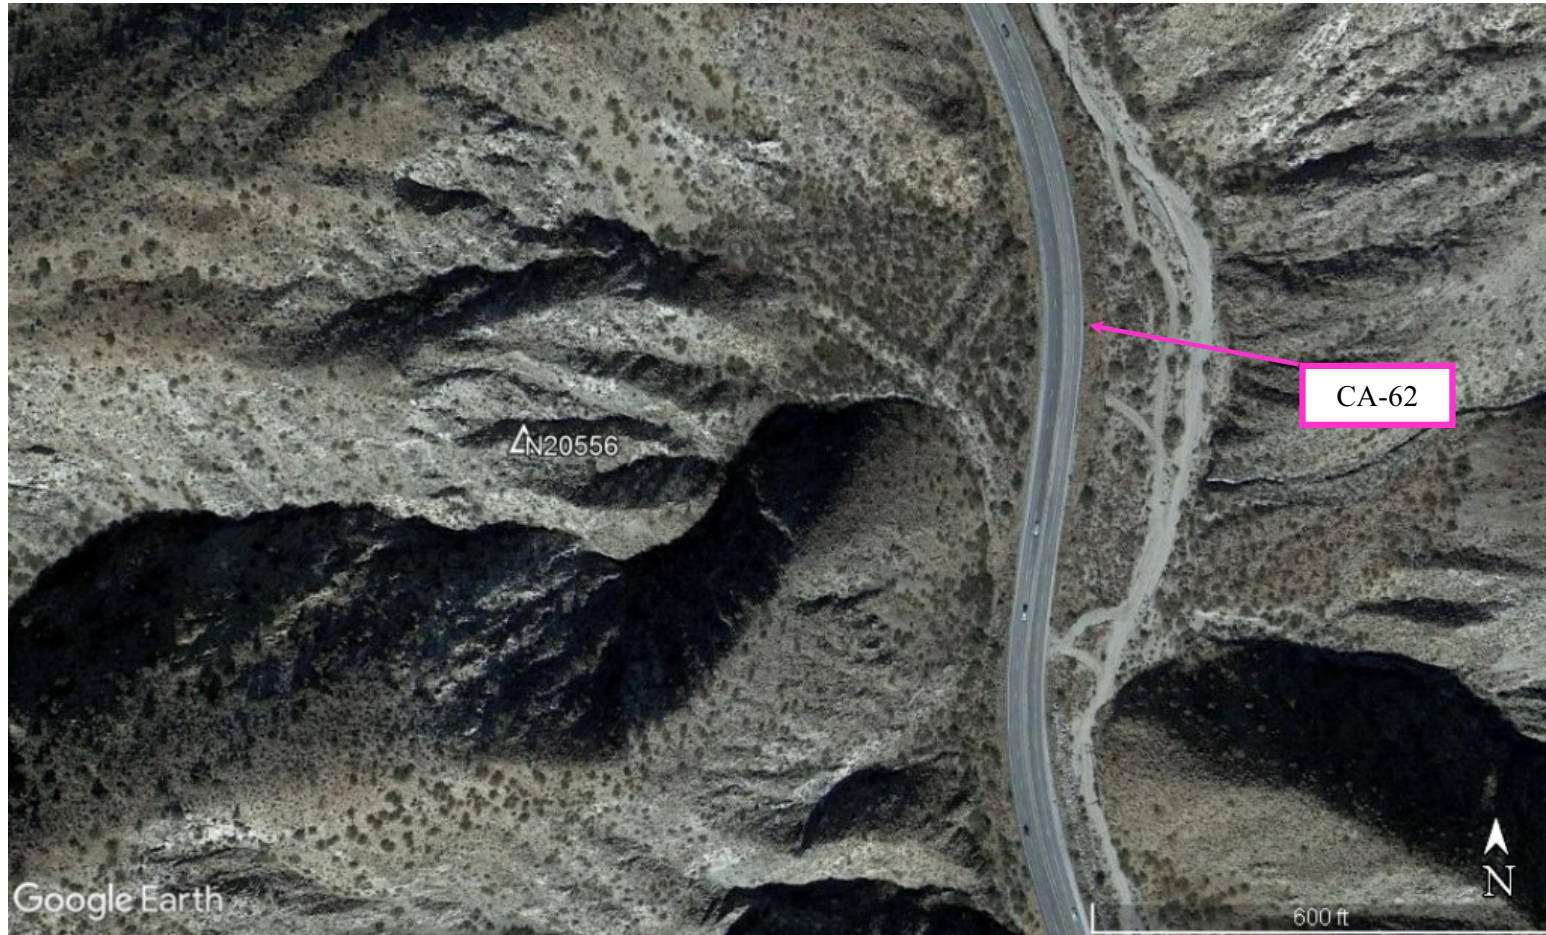
Figure 3 - Site Relative to Road & Terrain

- The accident site coordinates were 34.02574 N, -116.58775 W
- The accident site elevation was about 2,465 ft, above and west of the road that the pilot was believed to be following

- The wreckage was about 800 ft west of the north-south road, which was a paved 4-lane highway (CA Rte 62) that was situated in the river/wash valley that formed a pass through a small mountain range

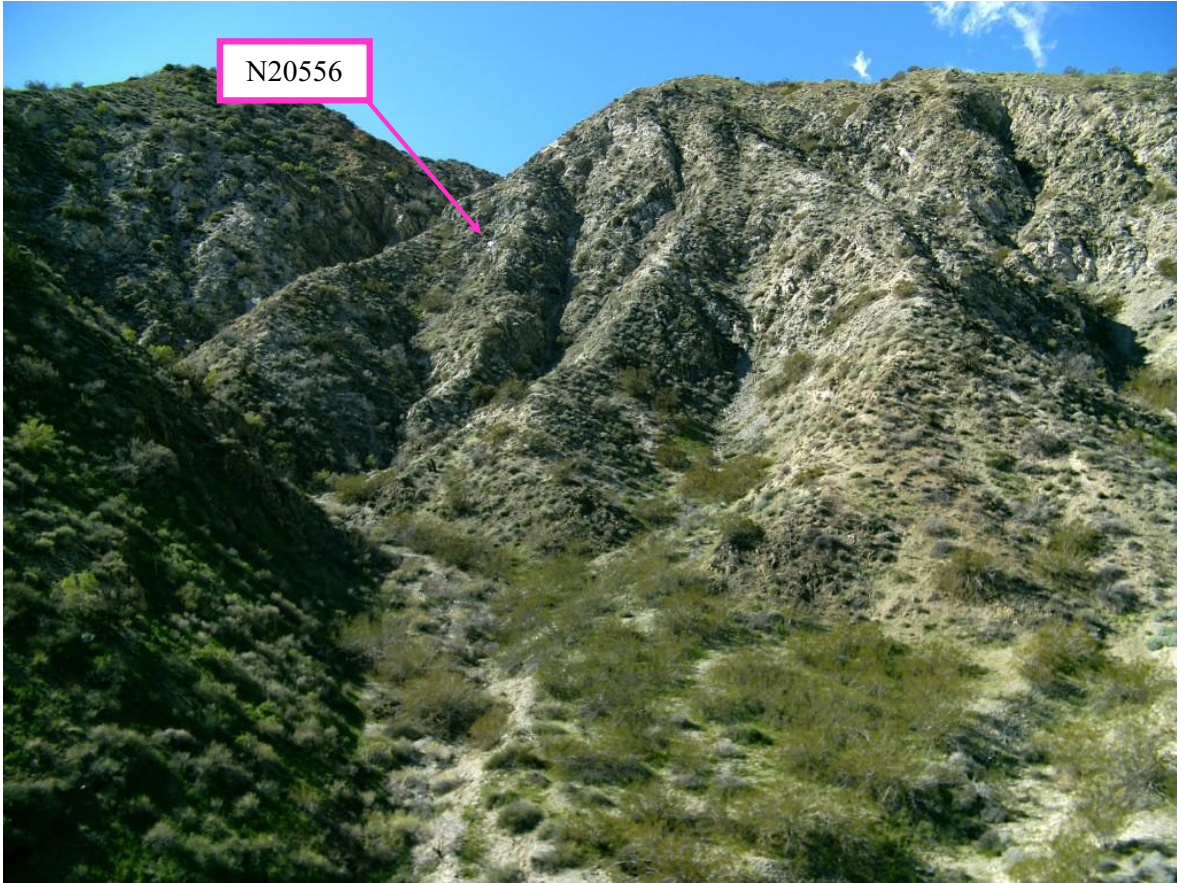
**Figure 4 - Site Location as Seen from Road**

- The wreckage was on steep, unstable terrain about 300 ft above the road
- The wreckage was observed to be precariously situated on the mountain slope, which limited the extent of the examination of the wreckage in situ

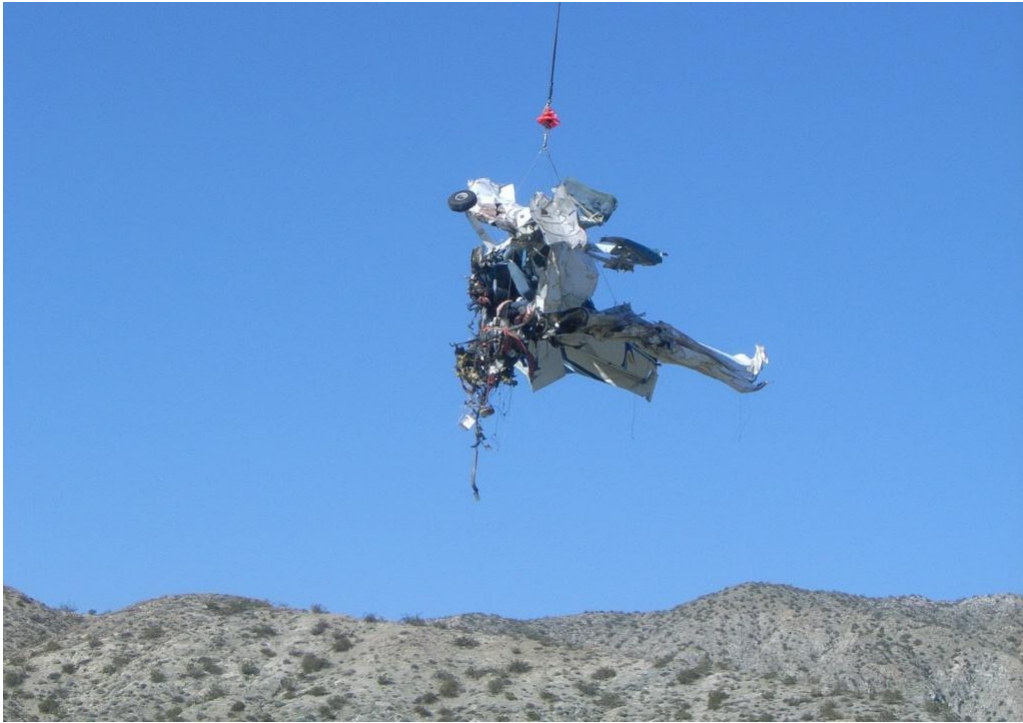
**Figure 21 - Main Wreckage Aerial Extraction**

- The condition and location of the wreckage warranted its extraction by helicopter
- The helicopter crew packaged and recovered the wreckage to a clearing about a mile from the accident site
- The two (and only) victims were recovered from the wreckage
- The wreckage was partially examined and photographed and loaded onto a truck for transport to a secure facility where it could be examined in detail
- The all metal fixed pitch two blade propeller was fracture-separated from the engine at its attach flange

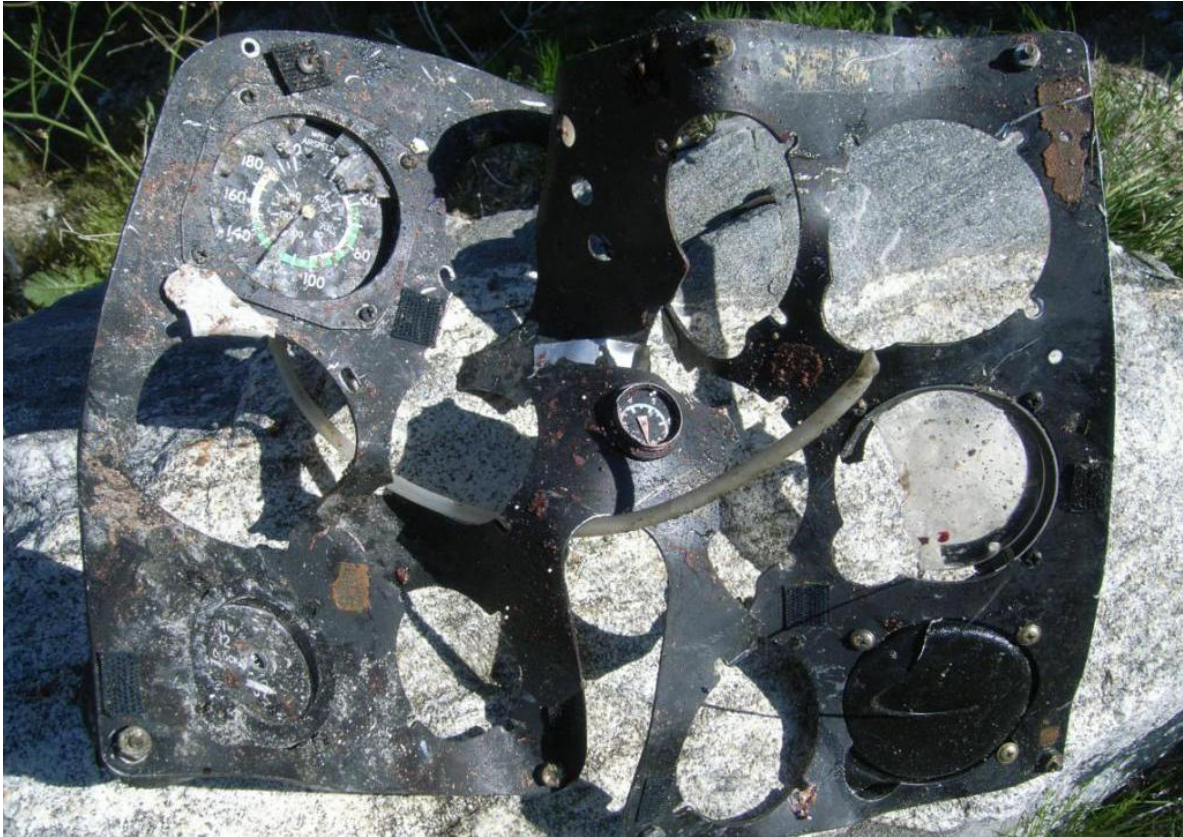
**Figure 29 - Pilot-Side Instrument Panel**

- The onboard clock was stopped at 0115:47 (consistent with being set to UTC time, equivalent to 1815:47 PST)
- The artificial horizon was fracture-separated from the instrument panel
  - It was date stamped January 2, 2019
- No other useful instrument or control indications were able to be made at this time
