## **Engine Investigation Report**

**Rolls-Royce Corporation  
Model M250-C20B  
Engine CAE-830577**

**Nick Shepler  
Air Safety Investigations**

**Accident Date: 16 April 2019  
Investigation Date: 17-18 April 2019  
Report Date: 5 June 2019**

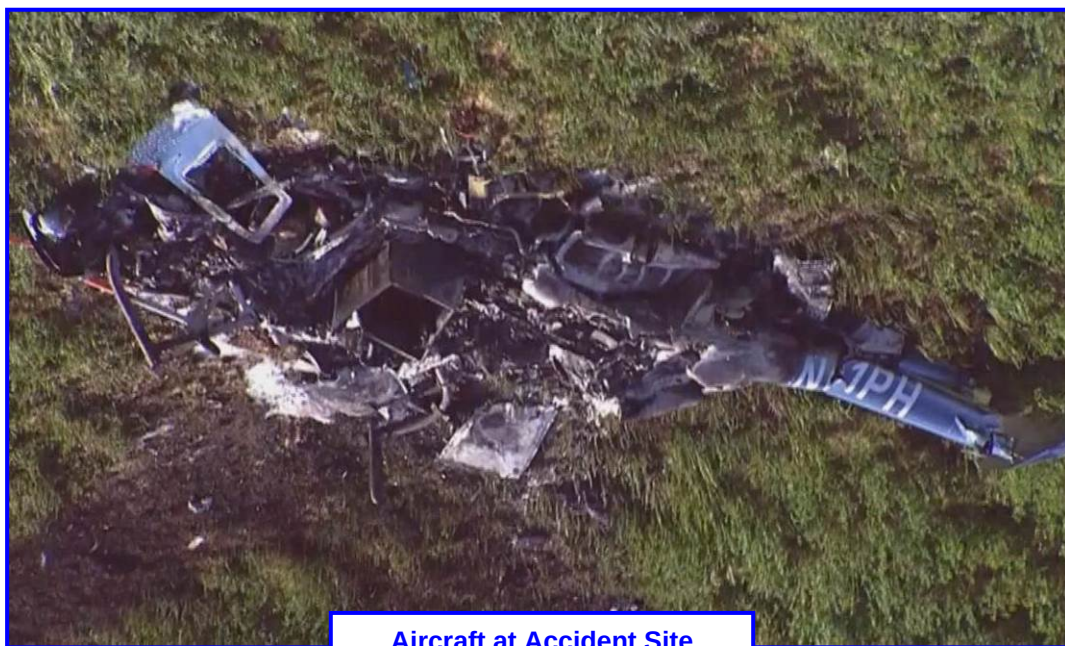
**Aircraft at Accident Site**

Initial examination of the main wreckage revealed postcrash fire and impact damage consistent with a right side-down, nose-level attitude during ground impact. The main rotor hub assembly, vertical tail, tail rotor assembly, tail rotor driveshaft, and forward induction cowl fairing separated from the main wreckage and were found in the debris field. The debris field was about 1 mile long and 1,000 ft wide, covering an area of wooded desert terrain and flood irrigated alfalfa fields. The wreckage was recovered to a secure location for further examination.
