# NATIONAL TRANSPORTATION SAFETY BOARD

## MATERIALS LABORATORY FACTUAL REPORT

Report No. 19-071

Place : Ft. McDowell, Arizona  
Date : April 16, 2019  
Vehicle : Bell 206B, N61PH  
NTSB No. : WPR19FA109  
Investigator : Andrew Swick, AS-WPR

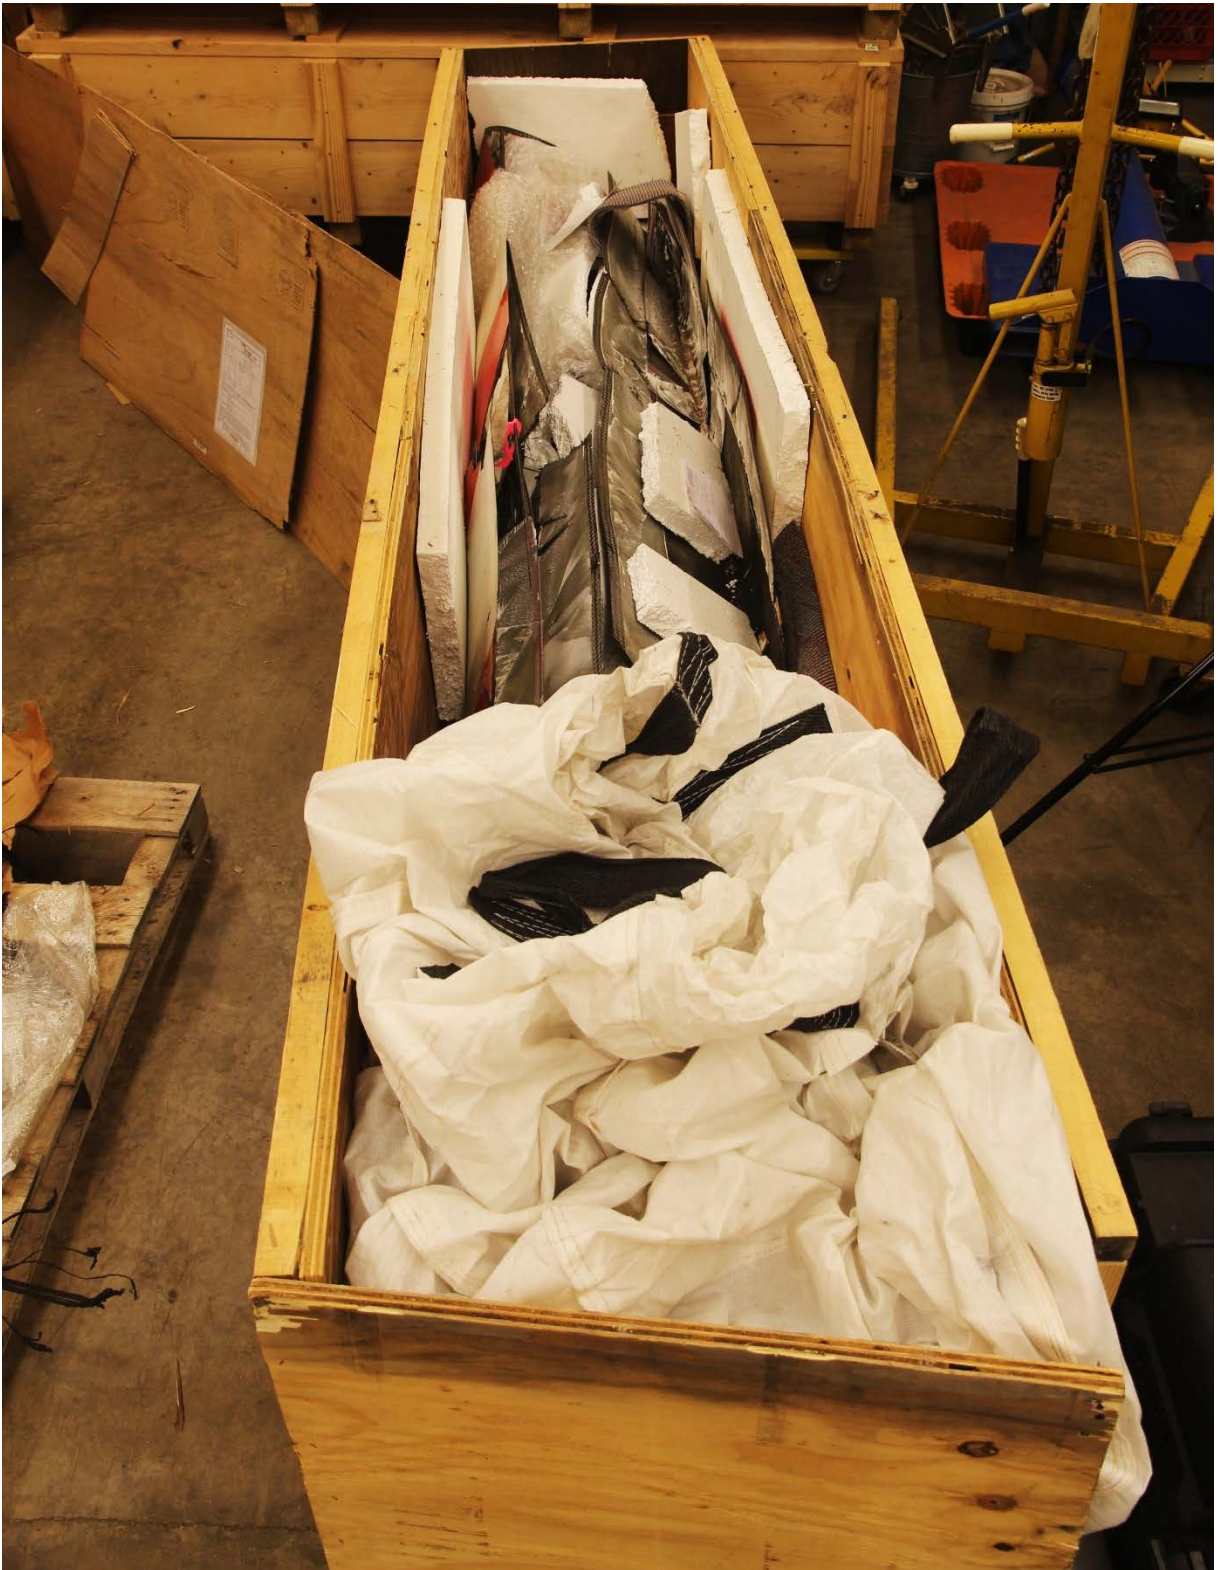
Figure 1 – Components recovered from the accident site, in the crate, as received after opening the top lid.

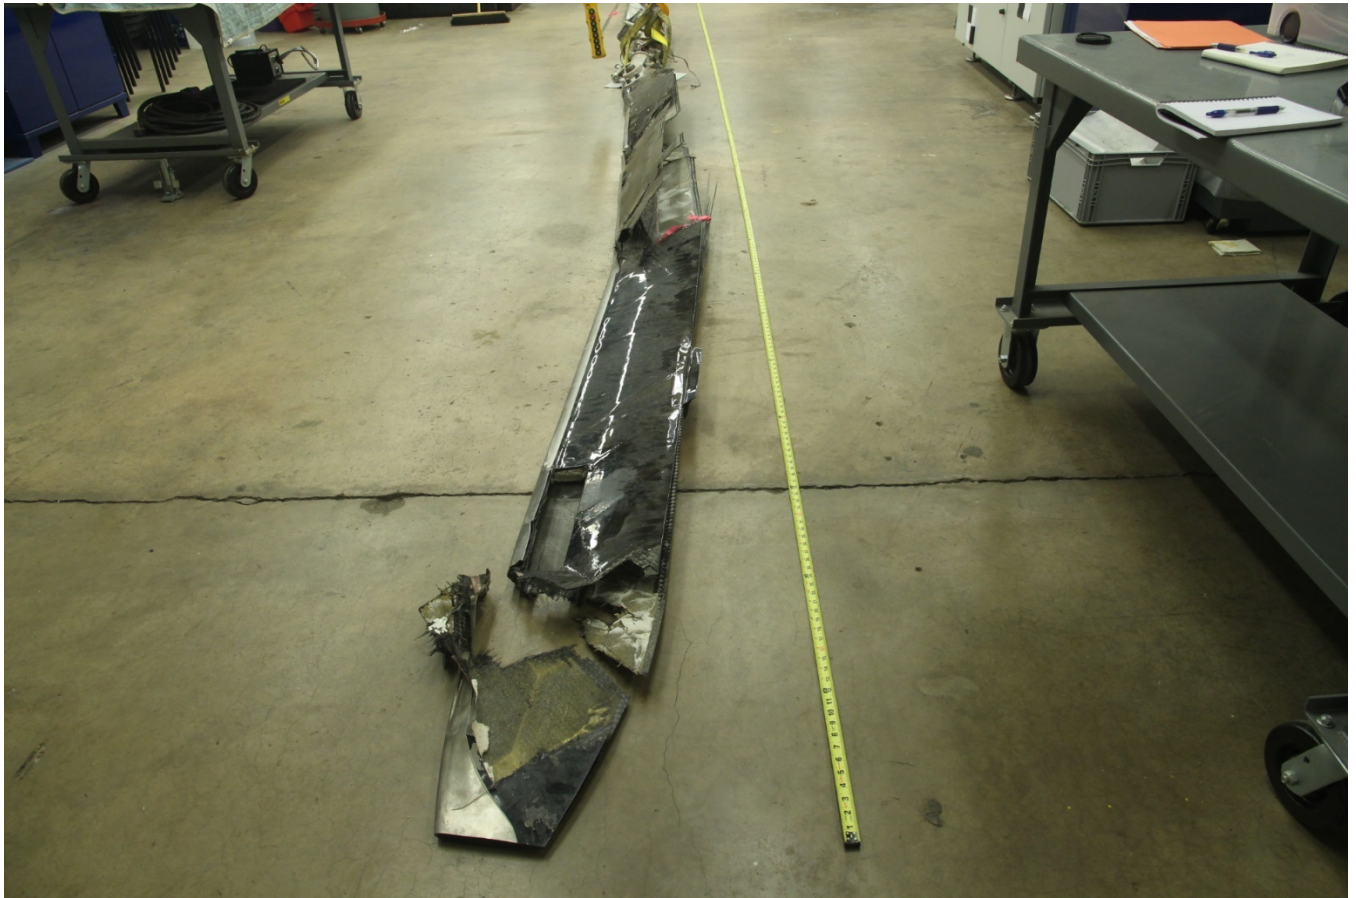
Figure 2 – One section of the main rotor blade fragments laid out in positions consistent with their positions prior to fracture. This is viewed from the tip of Blade B, the blade without instrumentation.
