## ACCIDENT WPR19FA126

On May 01, 2019, about 1100 Pacific daylight time, a Cessna T182P airplane, N7302S, experienced a loss of engine power and collided with a power line while making an emergency landing to a grassy marsh in Mill Creek, California. The flight instructor and front-seated passenger sustained serious injuries; the rear-seated pilot-rated passenger was fatally injured. The airplane sustained substantial damage. The airplane was registered to and operated by Air Carriage, Inc. under the provisions of Title 14 Code of Federal Regulations Part 91 as a personal flight. Visual meteorological conditions prevailed and no flight plan had been filed. The flight originated from Chino Airport, Chino, California, about 1010.

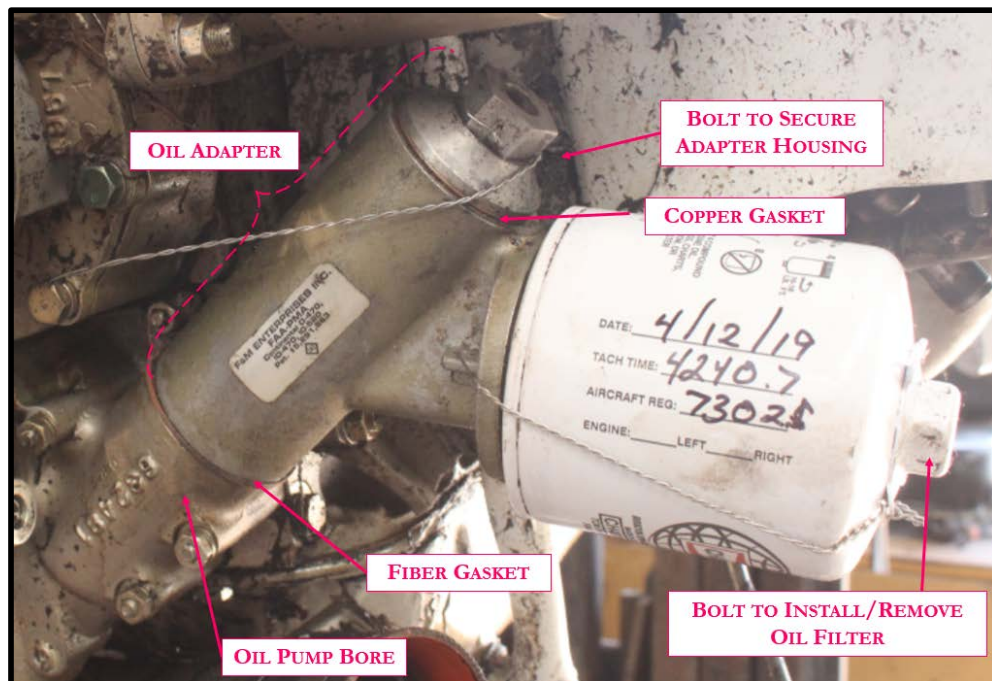
Picture 04: Oil Filter Adapter Assembly

According to the patent, the adapter included a tee casting (housing) and a hub (shaft) which was threaded to screw into the oil screen hole on the oil pump casting. The tee casting had a sleeve with a through bore and a mounting base with an end for receiving a spin-on oil filter. When installed, the hub was journaled into the bore of the sleeve and screwed into the oil screen hole, which had two oil passage openings. A crown (1-inch bolt head) at the outer end of hub secures the tee casting against the oil pump casing. Oil inlet and oil outlet passages are provided through the hub and the tee casting to circulate oil from the oil screen hole into the spin-on filter, and back into the oil screen hole from the spin-on filter.

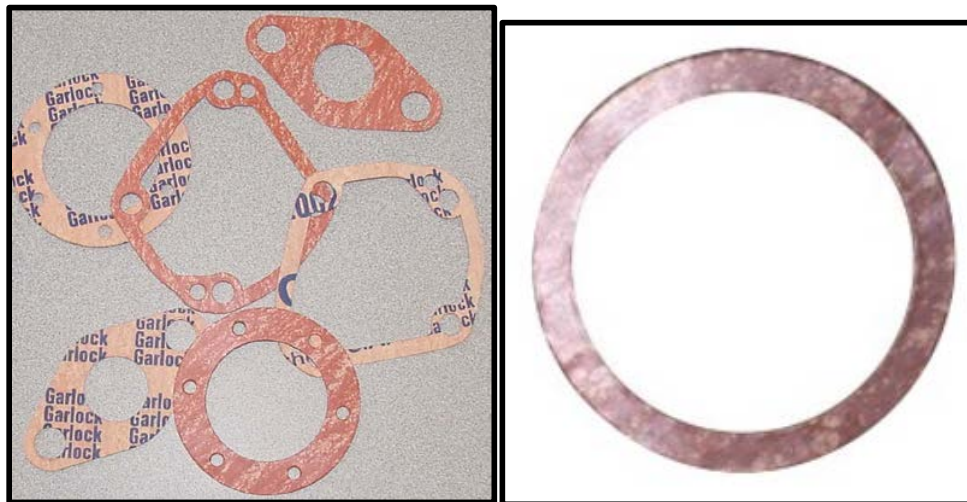
Picture 08: Gasket Material Provided by Garlock and Picture from Aircraft Spruce

The fiber gasket, part number FM07<sup>2</sup>, was manufactured by Garlock as 3750 Leak-Guard<sup>3</sup> and cut by GPI. The last order was in July 2013<sup>4</sup>. The original gasket used by Continental for the oil screen was MS35769-48 copper gasket<sup>5</sup> (AN900-28): OD 2in, ID 1.75in, ring width 0.688, thickness 0.094.

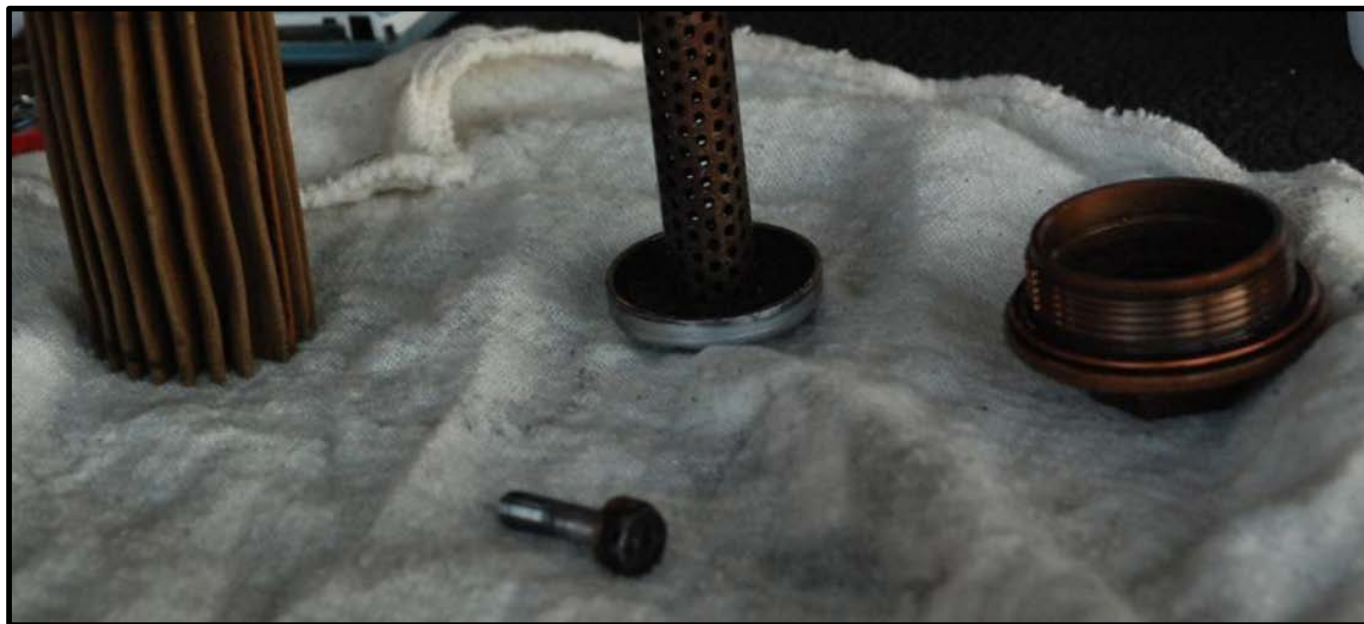
Picture 11: Oil Screen as Originally Sold

Based on the patent, forum discussions, and changes in F&M instructions, it is likely that the oil filter adapter was originally designed and sold with two AN900 copper crush gaskets. The original Continental oil screen required copper gasket MS35769-48 (OD 2.0 in, ID 1.75 in, ring width 0.688 in, thickness 0.094 in), which is likely the same gasket that was used for the adapter. GPI stated that fiber gaskets supplied to F&M were OD 2.25 in ID 1.745 in, ring width 0.505 in, thickness 0.063 in. The annular groove was 0.125 in wide and the depth is unknown.

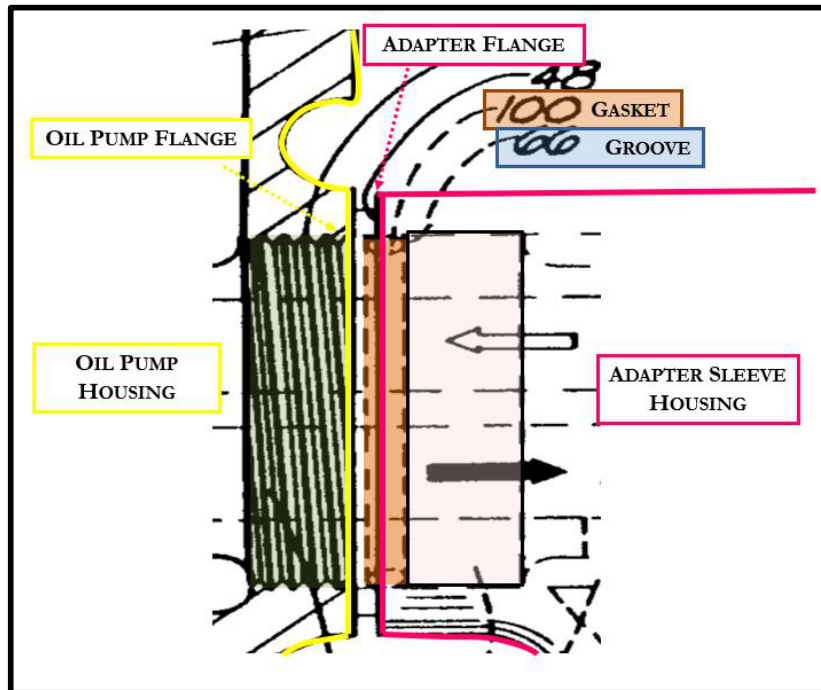
Picture 18: Patent Showing Adapter Sleeve and Annular Groove

According to the patent, at the adapter sleeve housing inner flange (48), a metal seal (100) is positioned in the annular groove (66) of the hub (14). The purpose of the metal seal (100) is to prevent fluid leakage between the oil pump housing and the adapter sleeve housing at the inner flange (48). Additionally, the patent states that the annular groove (66) is sized and shaped to receive the metallic O-ring seal (100).
