## EXAMINATION NOTES

### HISTORY OF FLIGHT

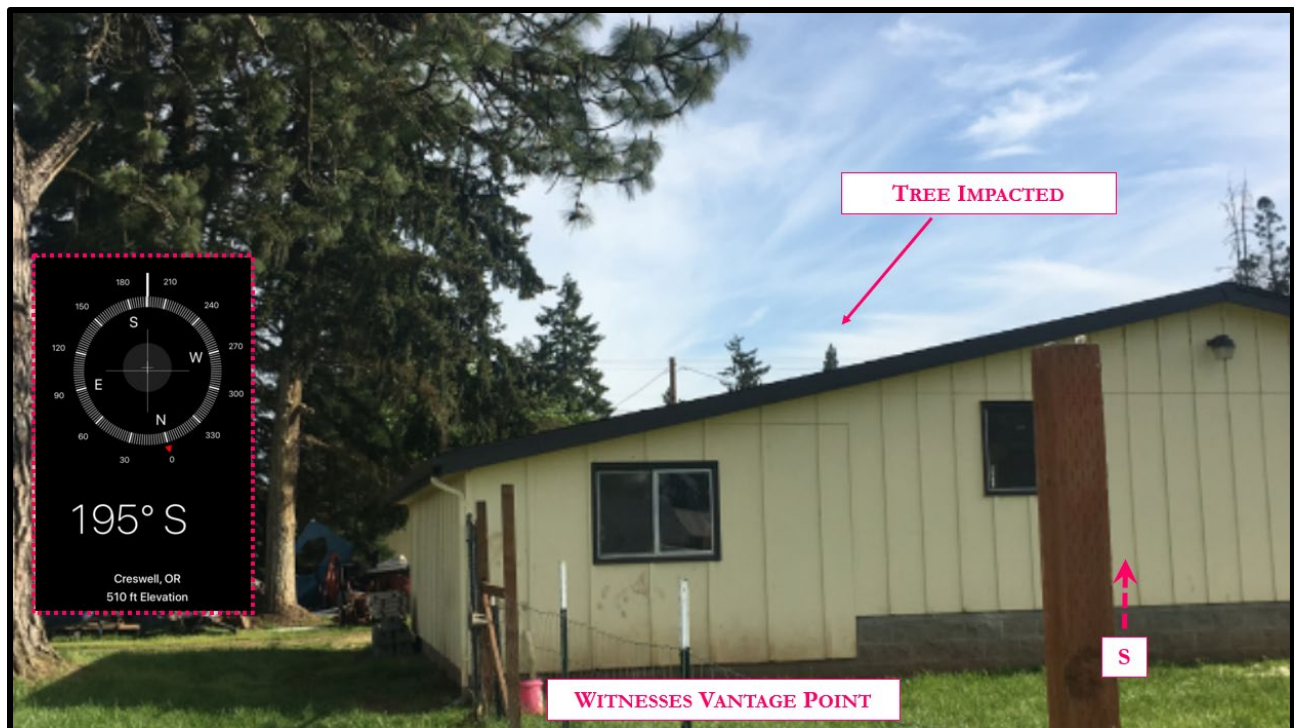
Figure 03: Witness Vantage Point

A witness, located at a residence 825 ft south of the accident site (refer to Figure 02), stated that he observed the trike maneuvering very low to the west of his location. He recalled that the trike continued south and then made a left turn. The trike impacted a tree and the wing folded over upon itself. He did not hear any unusual noises but did reference that the trike seemed lower than they normally fly.
