## **NATIONAL TRANSPORTATION SAFETY BOARD**

# **ACCIDENT SITE EXAMINATION SUMMARY**

**WPR19FA175**

Location: Santa Catalina Island, CA  
Date: June 17, 2019  
Aircraft: Robinson R44, N7187D  
NTSB Investigator-in-Charge: Maja Smith

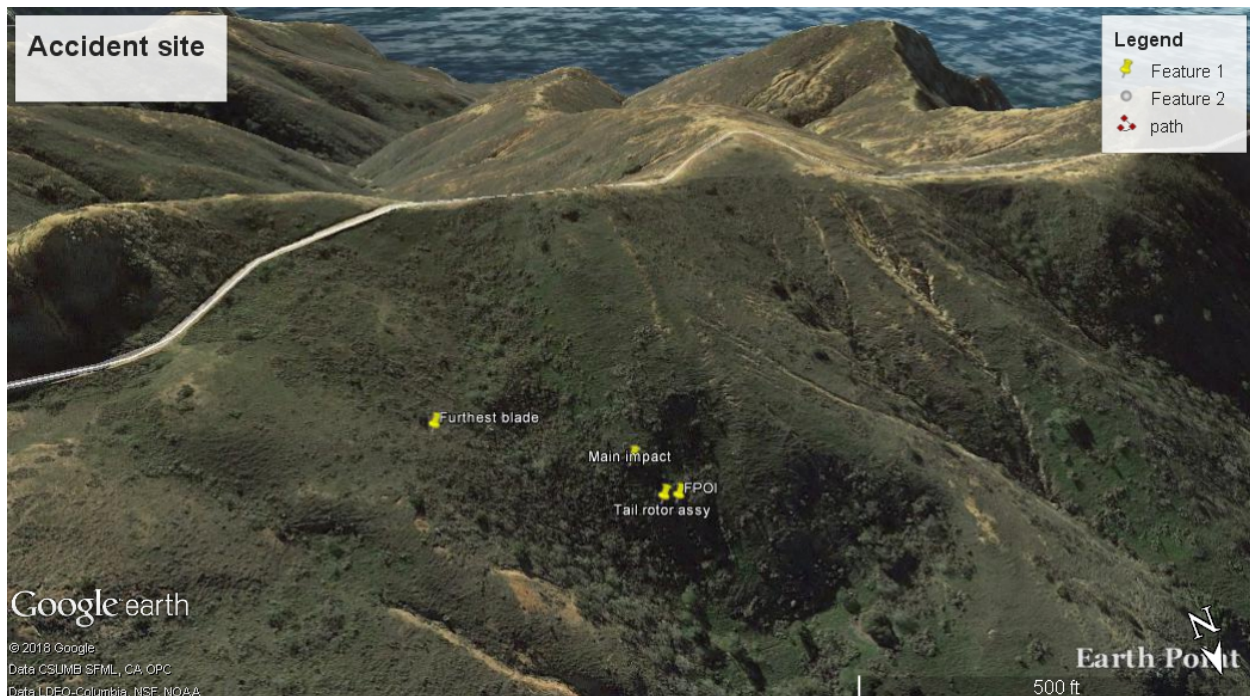
Figure 1. Accident location

The accident site was located in the mountainous terrain of Santa Catalina Island, California. Catalina Island is an island off the coast of California, about 29 miles south-southwest of Long Beach, CA.
