## **NATIONAL TRANSPORTATION SAFETY BOARD**

### **ACCIDENT SITE / AIRFRAME / ENGINE EXAMINATION SUMMARY**

**WPR19FA215**

Location: Ontario, Oregon  
Date: August 9, 2019  
Aircraft: North American T28A  
NTSB Investigator-in-Charge: Joshua Cawthra

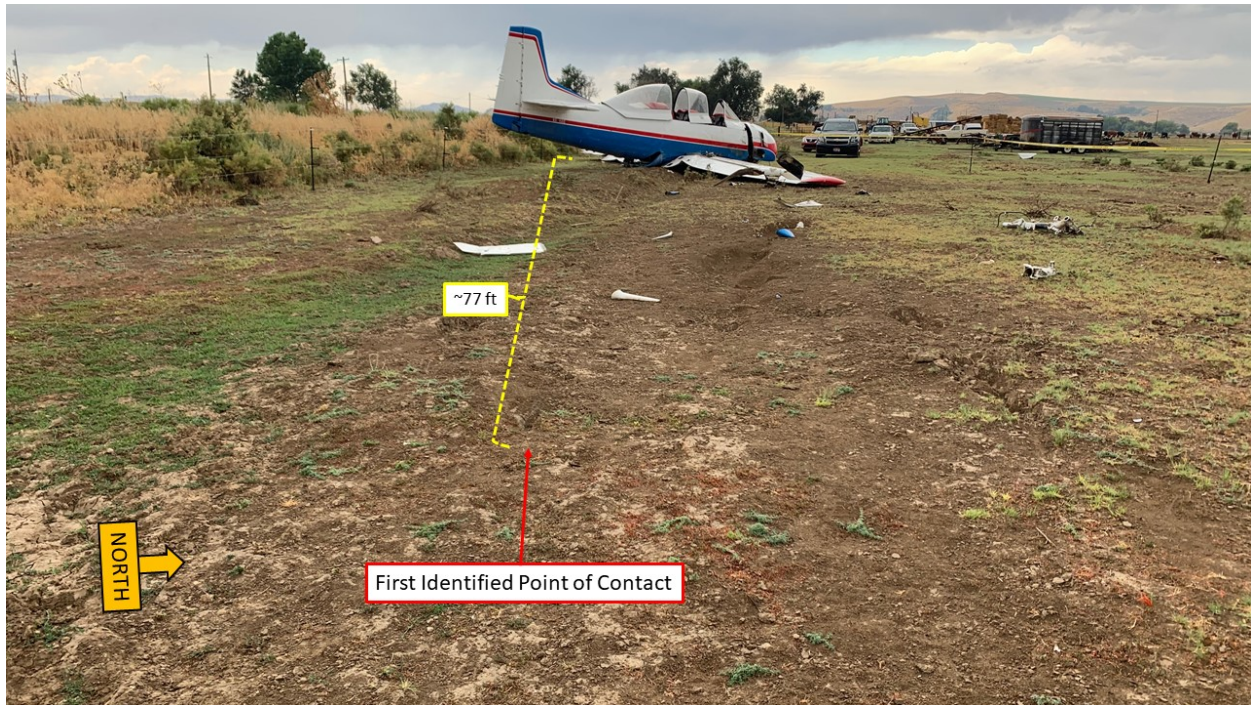
Examination of the accident site revealed that the airplane impacted an open field about 0.8 nm northwest of the airport. The debris path was about 77 ft in length oriented on a magnetic heading of about 266°. The first identified point of impact (FIPC) was a ground impression about 1-ft by 2-ft in size. Throughout the debris path, the left and right main landing gear doors, paint chips, nose landing gear, and right main landing gear were observed. The propeller assembly was located adjacent to the main wreckage. The main wreckage came to rest upright on a heading of about 303°. First responders reported no fuel odor was present following the accident. Additionally, no fuel odor was noted by investigators the following morning, until the right fuel cap was removed.
