# **NATIONAL TRANSPORTATION SAFETY BOARD**

## **Unmanned Aircraft System (UAS) Aerial Imagery Factual Report**

### **A. ACCIDENT WPR19FA230**

Location: Oroville, California  
Date: August 21, 2019

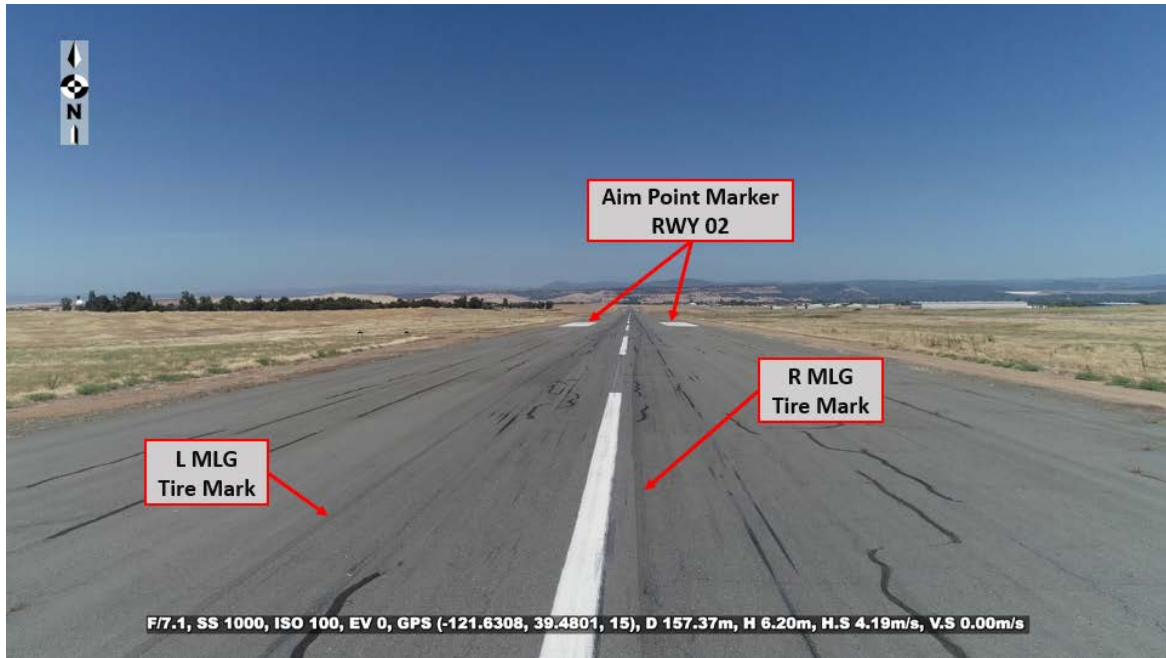
**Figure 3 – Runway 02 at start of take-off point with R MLG tire mark**

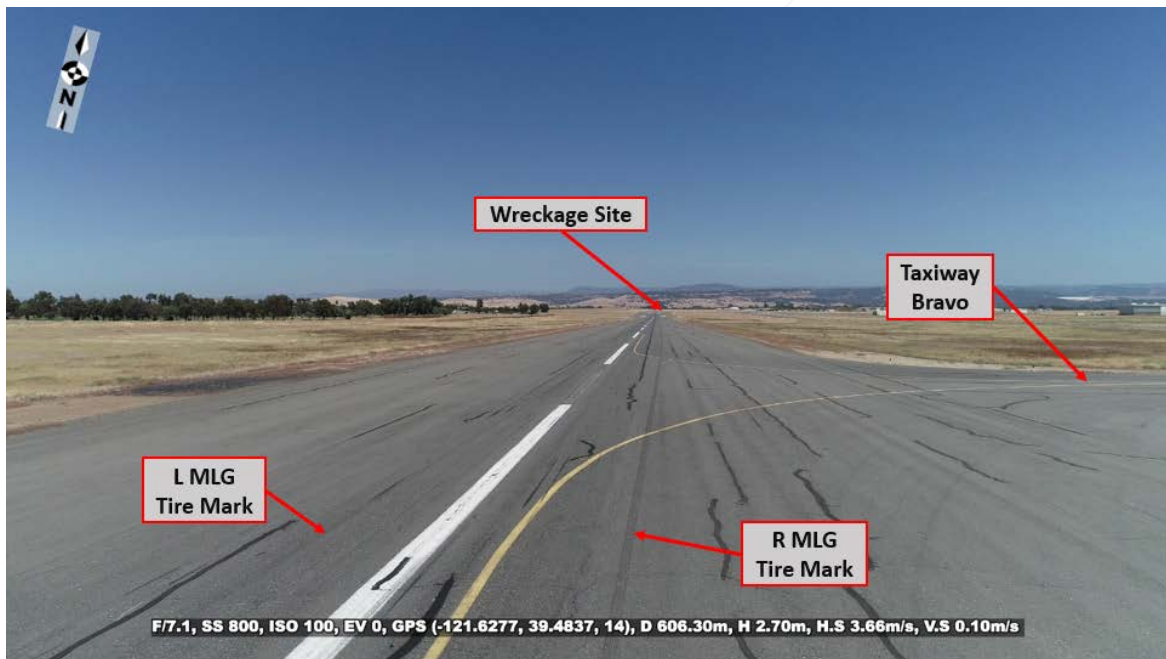
Figure 3 through Figure 8 contain screen captures from video was taken using the drone as it was flown down runway 02-20.
