## **National Transportation Safety Board**

### **Group Chairman's Factual Report**

## **OPERATIONAL FACTORS**

WPR19FA230

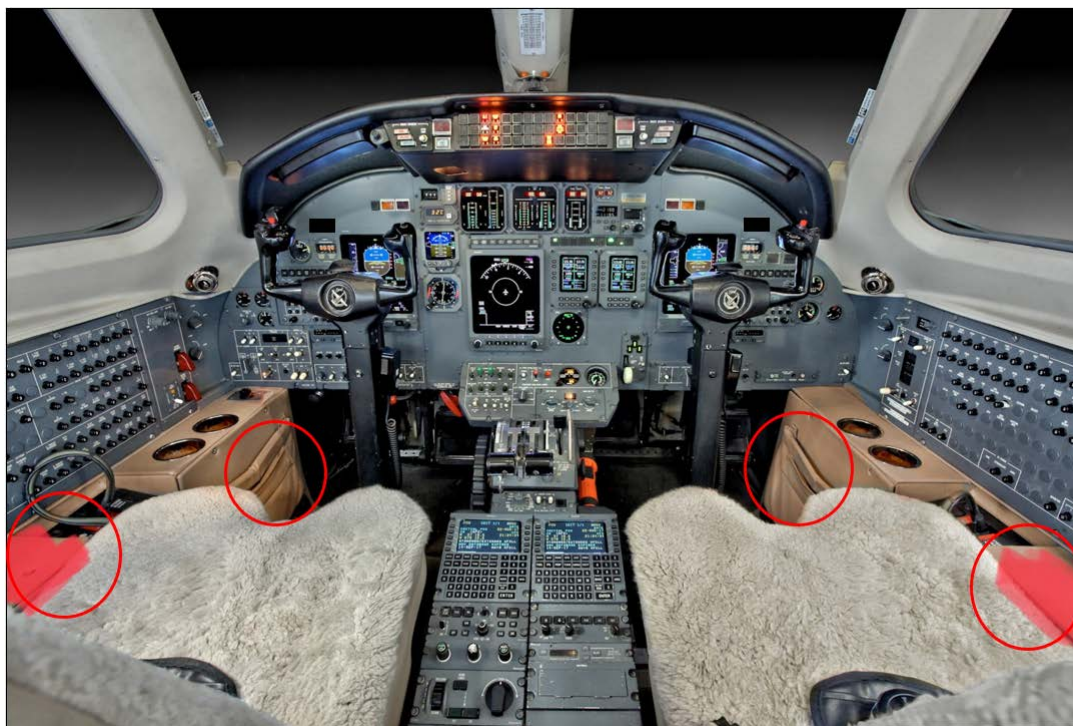
Figure 5: Red circles denoting the common placement of EFB's in the CE560XL cockpit.

According to the CE-560XL DPJ line check airman assigned to the operations group, with exception to a kneeboard, suction cup style mounts, or other types of mounts, were not commonly used during line operations on the CE-560XL. Consistent with the accident flight crew report, the line check airman also reported that he had experienced that the kneeboard would interfere with the full movement of flight controls when used in CE-560XL flight operations.<sup>33</sup> In Figure 5, red circles note the position the line check airman commonly observed EFB's placed during flight.

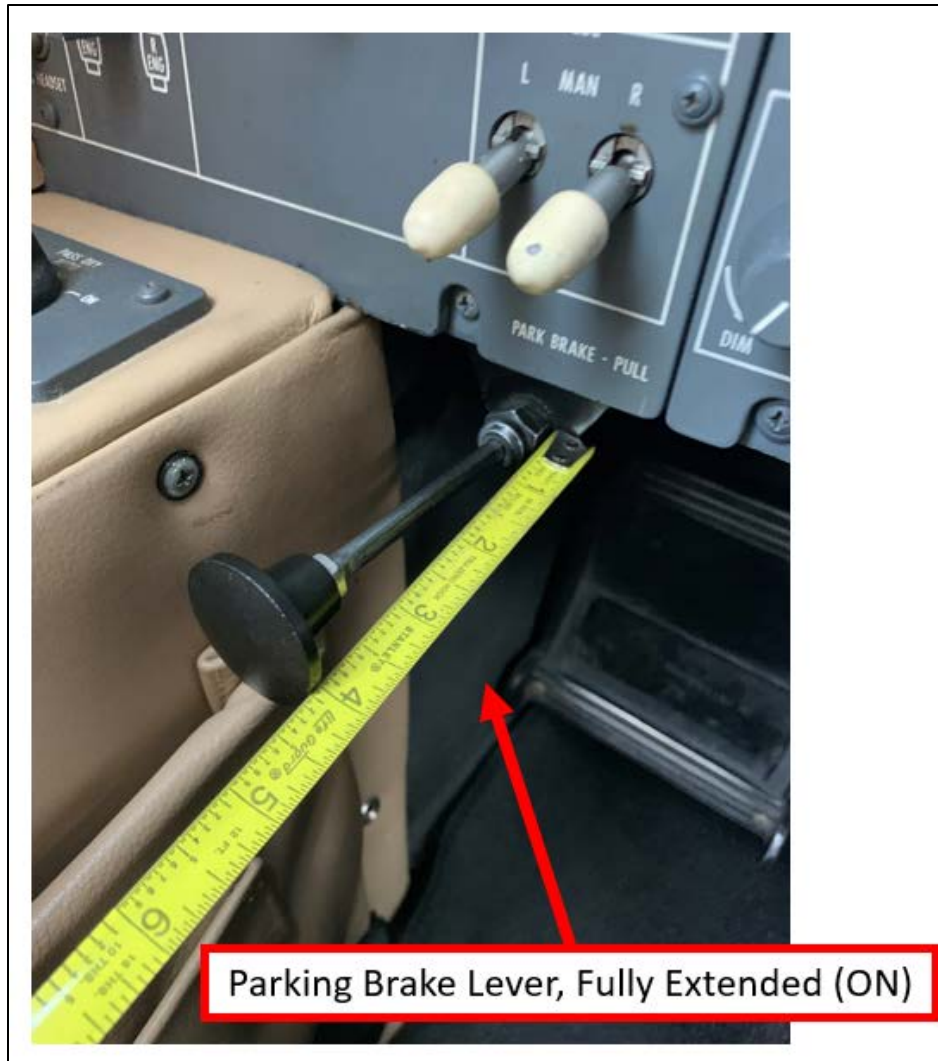
Figure 9: Exemplar parking brake lever, extended (On)

Figure 9 and 10 show an exemplar parking brake lever, in the set (on) and stowed (off) position. The parking brake lever extends to a length of about 4 inches when set (on).
