----- **SYSTEMS GROUP CHAIRMAN'S FACTUAL REPORT** -----

**1 ACCIDENT:**

Location: Oroville, California  
Date: August 21, 2019  
Time: About 1132 LCL  
Aircraft: Cessna Citation 560XL  
Serial Number: 560-5314  
Registration: N91GY

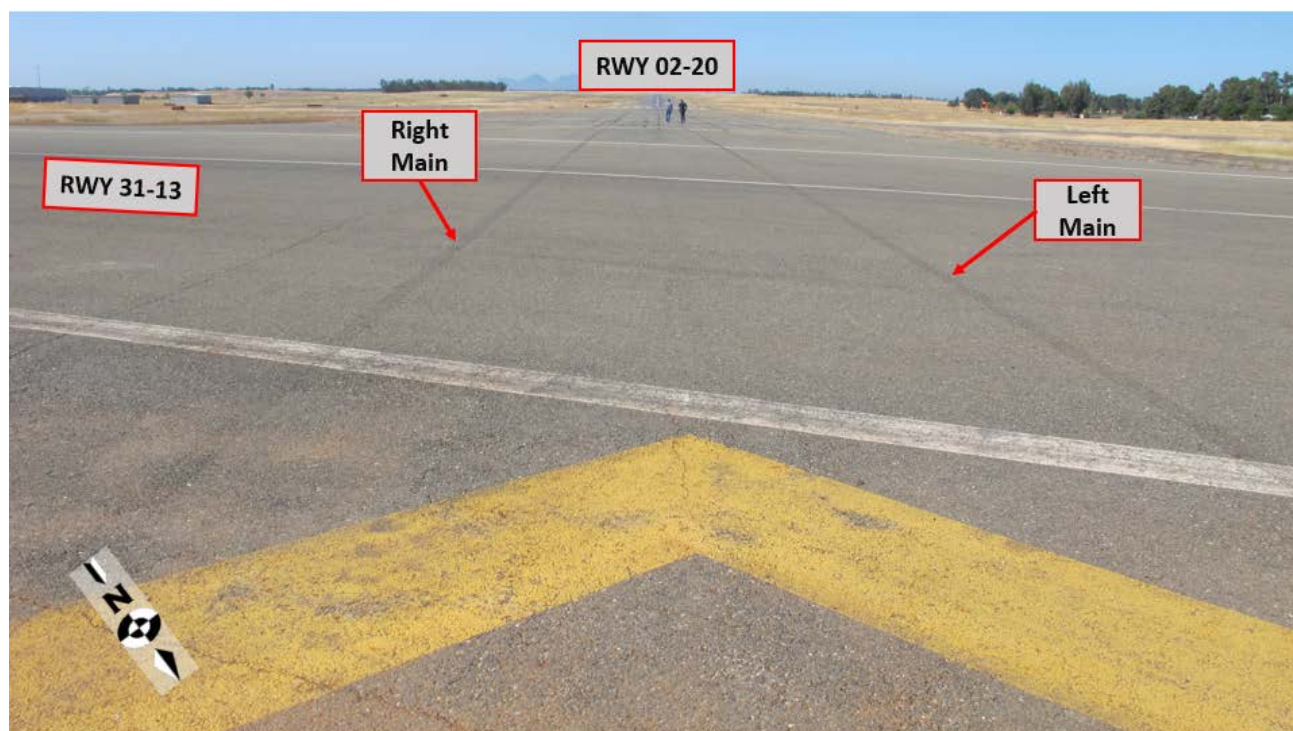
Figure 4 - Tire marks on taxiway (area 2)

Refer to Figure 3 with the following information. The aircraft arrived at OVE on August 20<sup>th</sup> at approximately 1803 LCL. After departing the runway, the aircraft came to rest on the north end of airport property (position 1). A survey of the runway was performed and tire marks from the nose, left and right main landing could be seen on the taxiway on the paved area where the aircraft departed the paved area (position 2), ref Figure 4. The aircraft continued off the paved surface between (position 2 and position 3) with distinctive gear markings in the dried grass. Tire marks from the left and right main landing gear could be seen on the runway 13-31 where the aircraft departed the paved area (position 3). The tire markings could be seen all the way through the displaced threshold all the way down runway 02-20 (position 4), ref Figure 5. Based on Google Earth measurements, the length of the visible tire marks on runway 02-20, from both the left and right main landing gear wheels was approximately 6,900 ft.

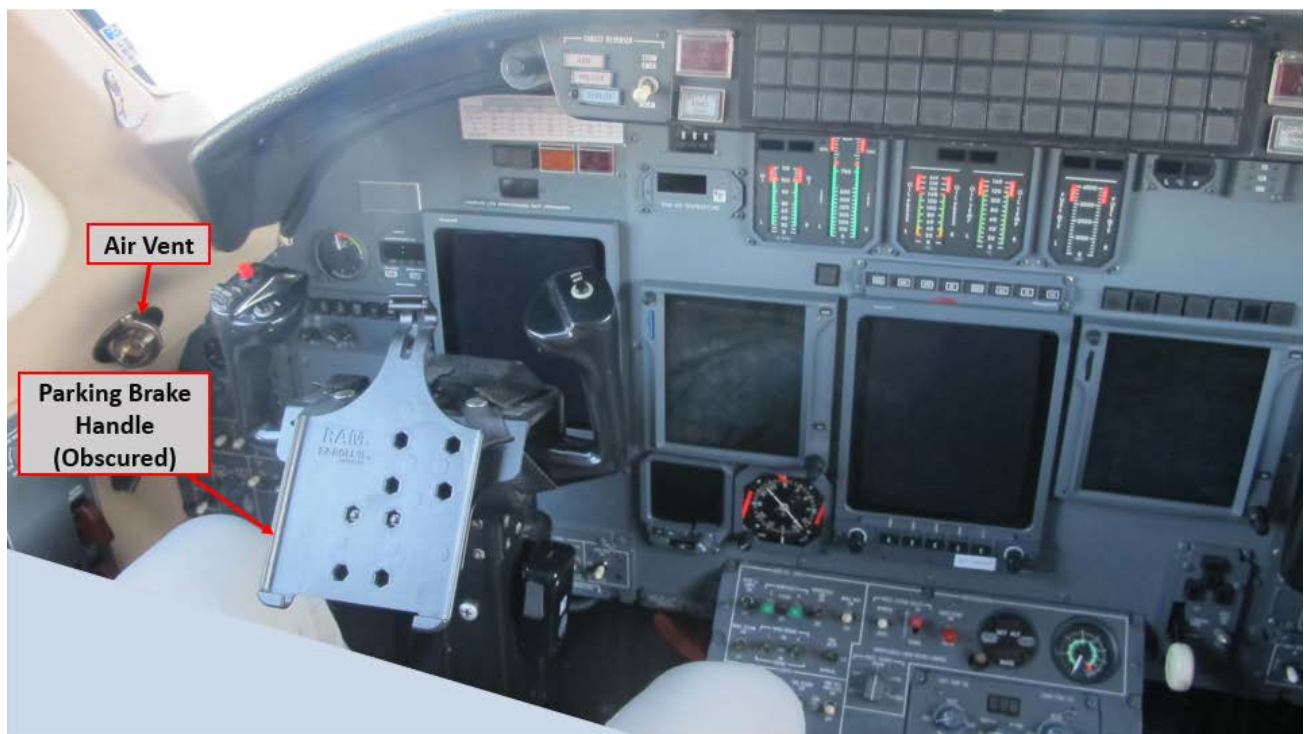
Figure 6 - View of the pilot side of the cockpit

The parking brake handle is located on the pilot side of the cockpit at the base of the instrument panel next to the side panel, ref Figure 6. The parking brake handle, when “On”, extends aft and travel is 4 inches from the “Off” position, ref Figure 7. When in the “Off” position, the handle is close to the instrument panel.

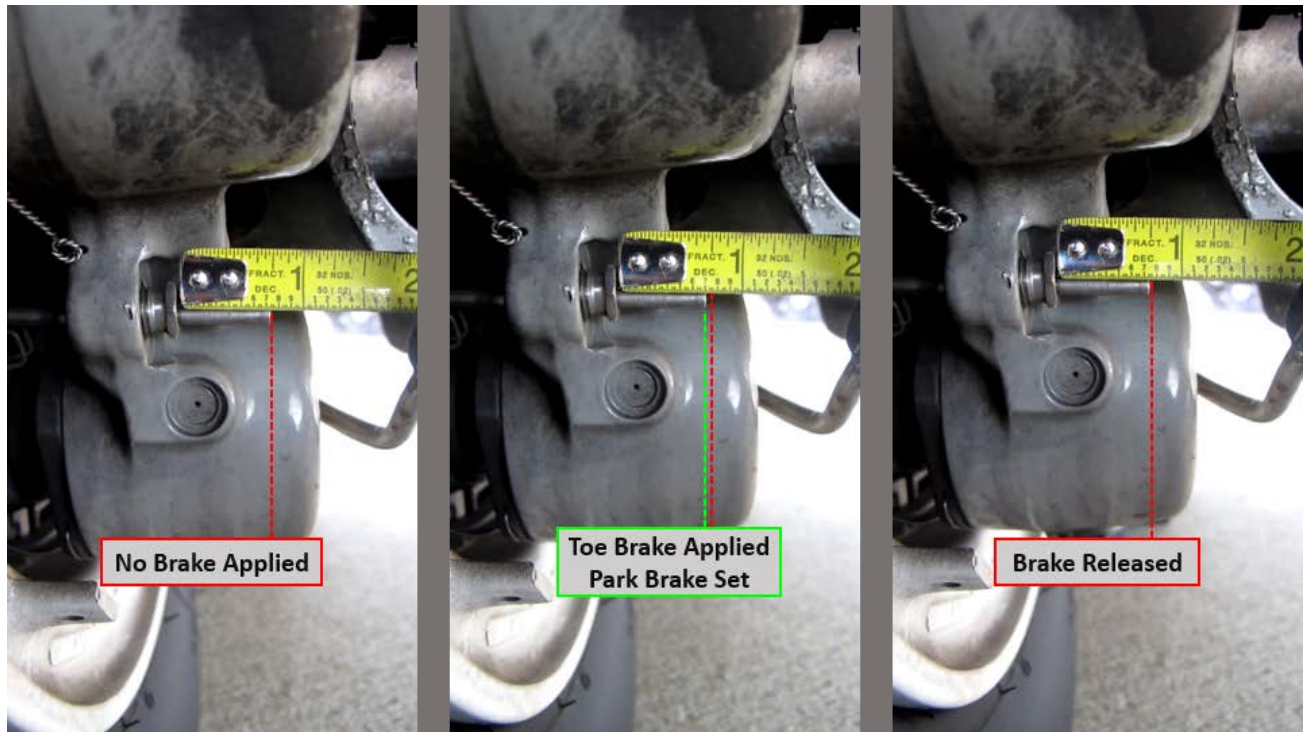
**Figure 20 - Screen shots from brake application during procedure 1**

During procedure 1, brake movement (in a direction consistent with brake application) was observed with applying pressure with the toe brakes. When the parking brake was applied (ON Position), the brake remained in the position obtained with the toe brake application. Additional toe brake pressure when the parking brake was on did not result in any additional travel. When the parking brake was released (Off Position) the brake traveled to a position consistent with no brake application. Reference photo array in Figure 20.

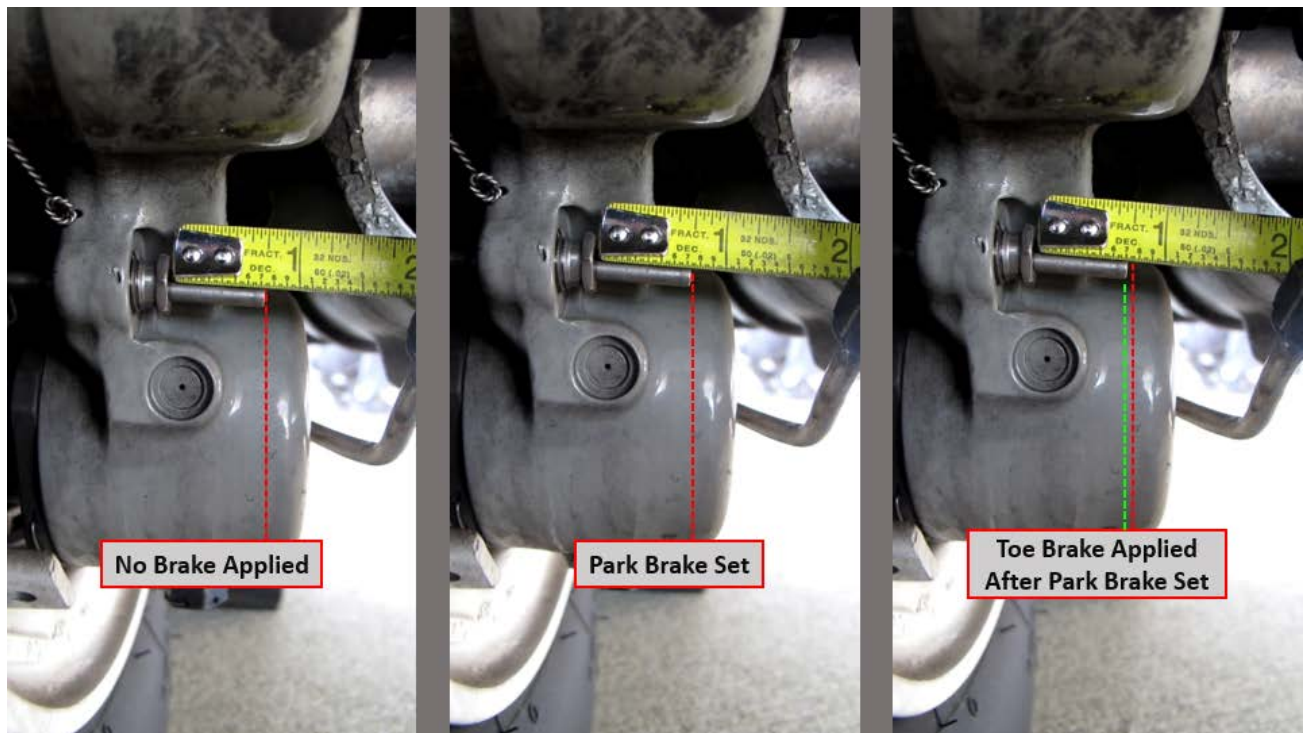
Figure 21 - Screen shots from brake application during procedure 2 (brake release not shown)

During procedure 2, brake movement (in a direction consistent with brake application) was not observed when the parking brake was applied (On Position). After applying pressure with the toe brakes and the parking brake already set, brake movement (in a direction consistent with brake application) was observed. When the parking brake was released (Off Position) the brake traveled to a position consistent with no brake application. Reference photo array in Figure 21.

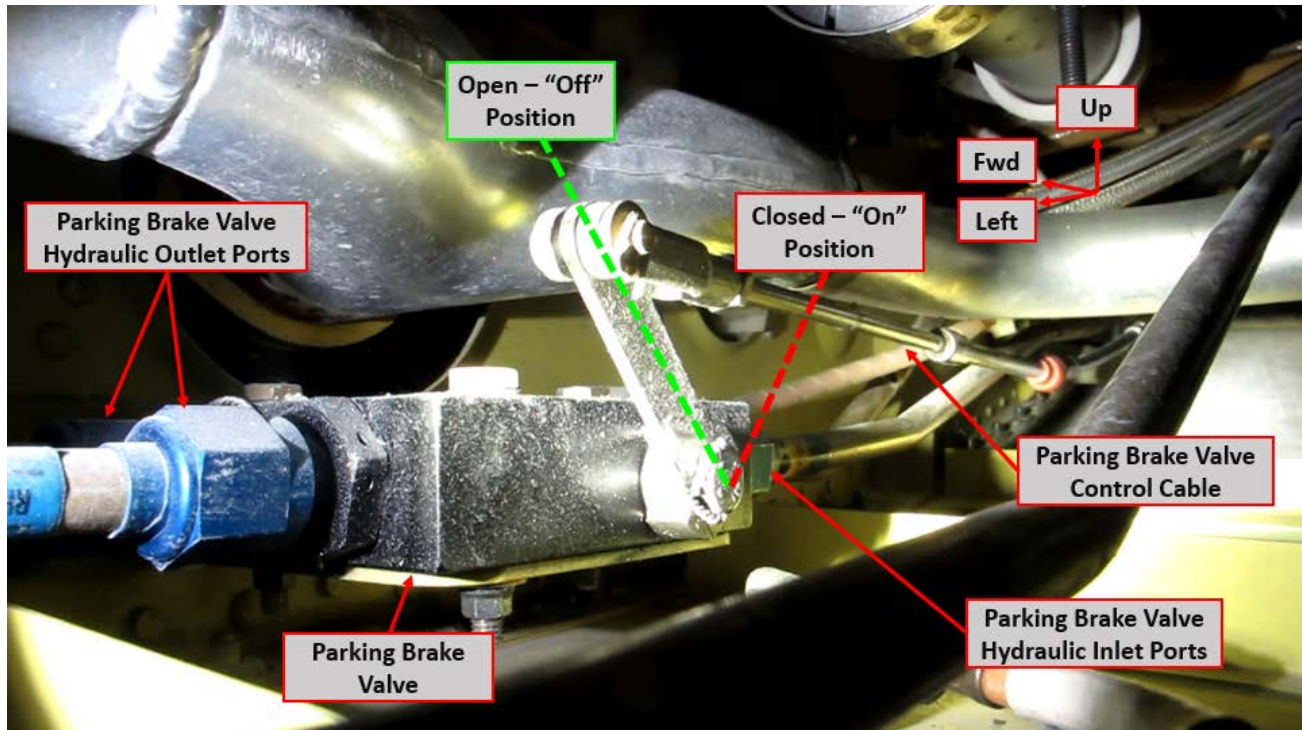
Figure 22 - Parking Brake Valve in "OFF" Position

A quick access panel was opened on the belly of an exemplar aircraft and allowed for visual inspection of the parking brake valve in operation. The parking brake handle was operated, and video was recorded showing the lever arm position in both the "OFF" and "ON" position, ref Figure 22 and Figure 23.

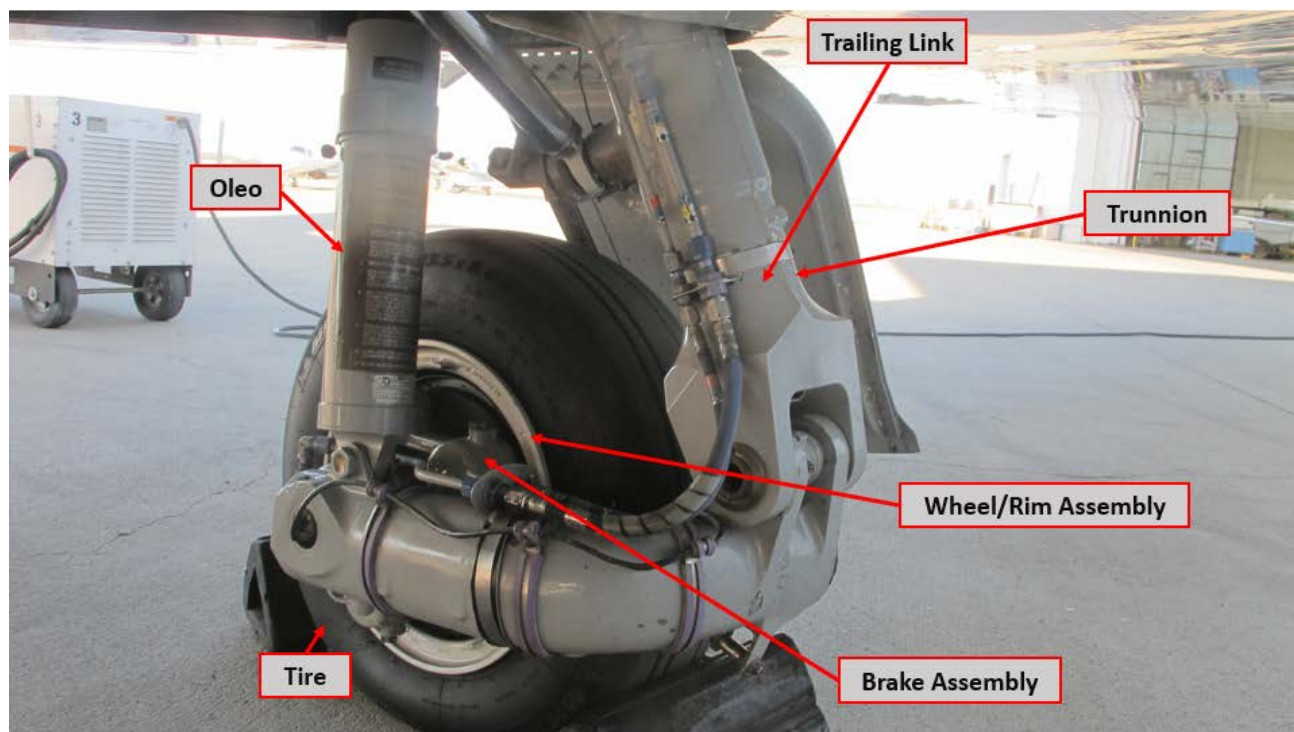
Figure 24 - Left main gear from exemplar aircraft

The aircraft's main landing gear is of a trailing link design. Each main landing gear contains a single tire/wheel assembly with a brake assembly, Figure 24. Each main landing gear tire/wheel assembly incorporates a fuse plug. The fuse plug is designed to melt at a predetermined temperature to relieve tire pressure and prevent a tire explosion, Figure 25.
