## EXAMINATION NOTES

Investigators from the Safety Board, Cessna, and Continental Motors examined the wreckage on May 05, 2019, at the recovery facility, Plain Parts in Pleasant Grove, California.

The aircraft is a Cessna T210G, serial number T210-0234, and was manufactured in 1966. According to the owner, an annual inspection was endorsed as completed on March 27, 2018, at which time the airframe had accumulated a total time in service of 8,745.6 hours. The tachometer time at the wreckage indicated 8,829.3 (Hobbs 4121.6 hours).

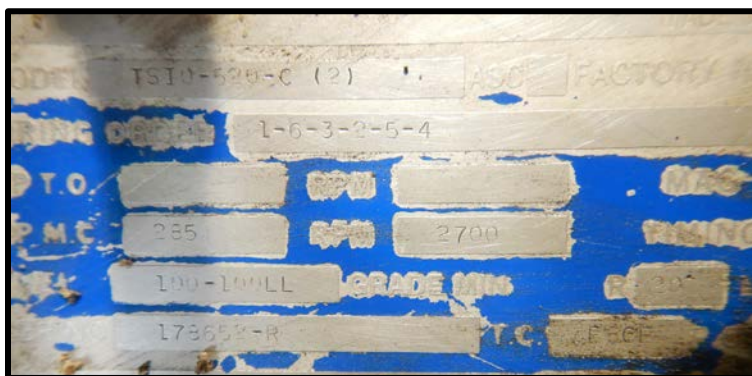
The airplane was equipped with a TSIO-520-C(2B), six-cylinder Continental Motors engine, serial number 178652-R. The owner stated that the engine had accrued a total time in service of 1,130 hours.

Figure 3: Engine Data Plate

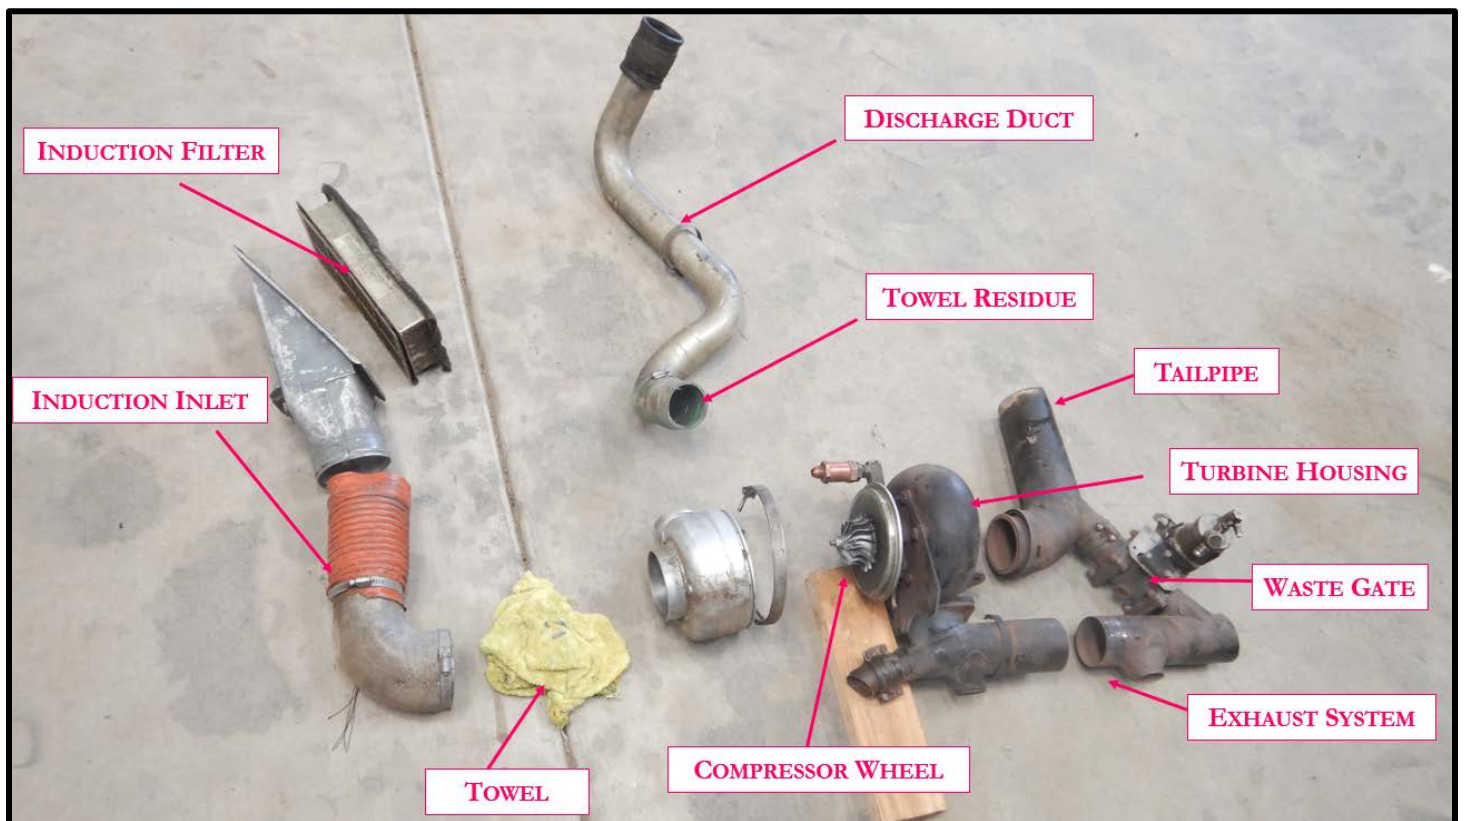
The compressor wheel was damaged, and several blades were distorted. Once the towel was removed, the compressor wheel was free to rotate.

Figure 8: System as Removed

It was determined that when the turbocharger was unable to rotate normally, ring seals which are used to seal the turbo charger shaft will allow oil to escape the shaft bearing area and enter the compressor section allowing oil to migrate to the upper deck pressure plumbing, then to the fuel injectors. From injectors the oil could build in the cylinders and, when inverted, drain into the fuel manifold. This migration of oil likely occurred while the airplane was inverted after impact with the sandy riverbed.

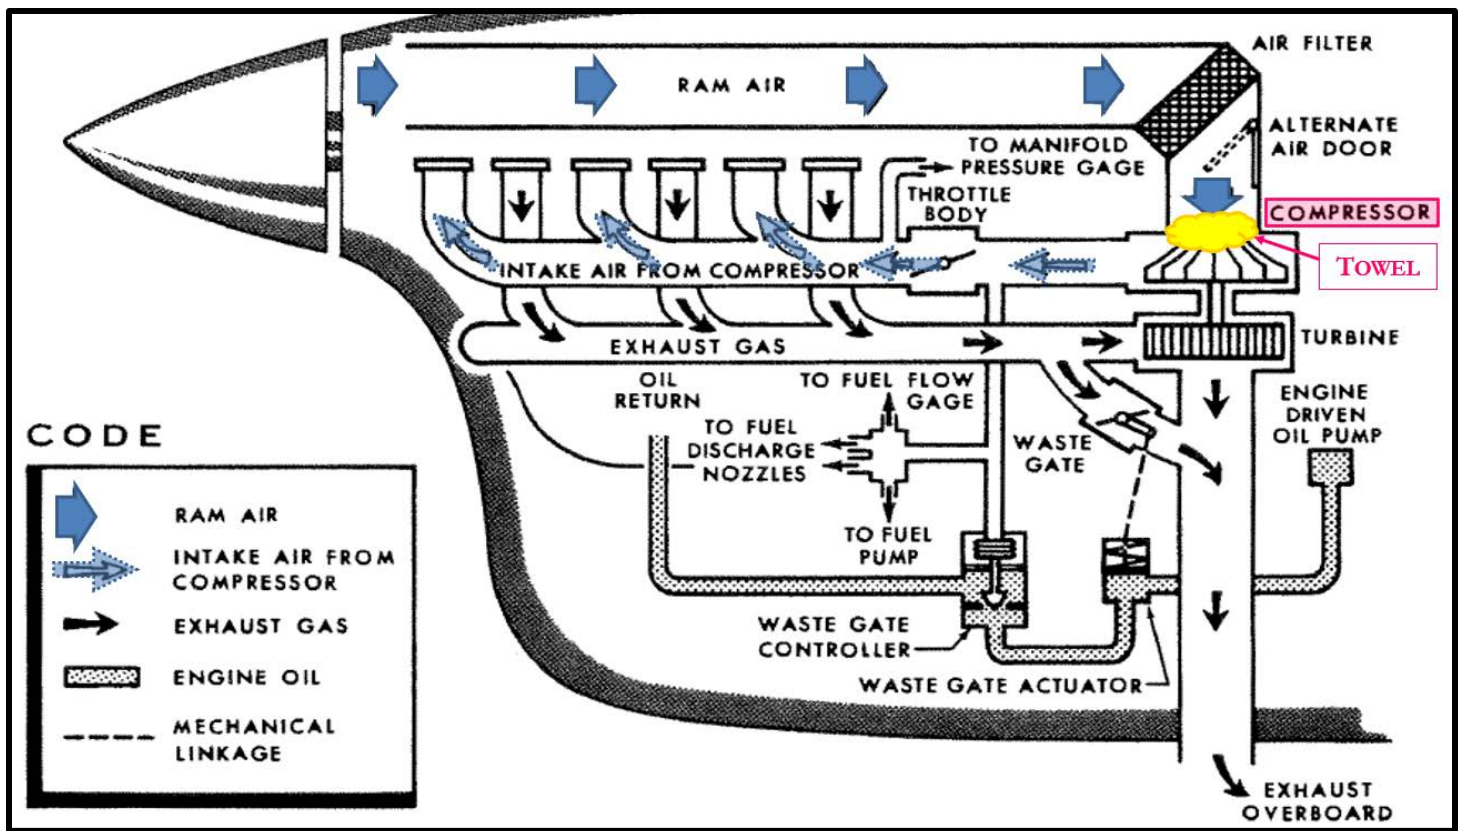
Figure 11: Turbocharger System (showing air path)
